San Mateo County Department of Public Works

Pescadero Fire Station

Site Assessment
January 13, 2014

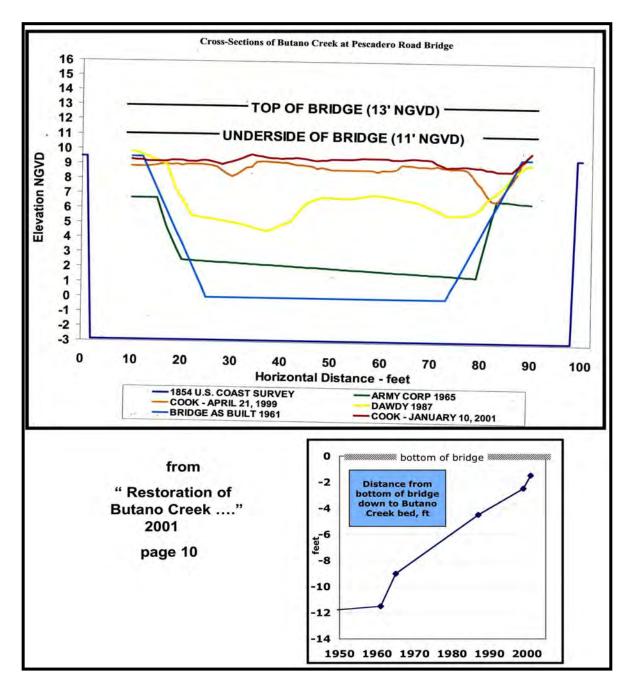
Attachment A: Silt-up Profiles of Butano Creek Bridge

This image shows the profile of the Butano Creek streambed below the Pescadero Creek Road Bridge. Early surveys show the streambed some 12 feet below the bottom of the bridge. Today, the bridge clears the silted and debris-filled creek bottom by only 2 feet.

- 4. Direct the San Mateo County Department of Public Works to periodically clean new silt, vegetation overgrowth, and debris from Butano Creek as needed to maintain flows and eliminate the recurrence of Pescadero Creek Road flooding.

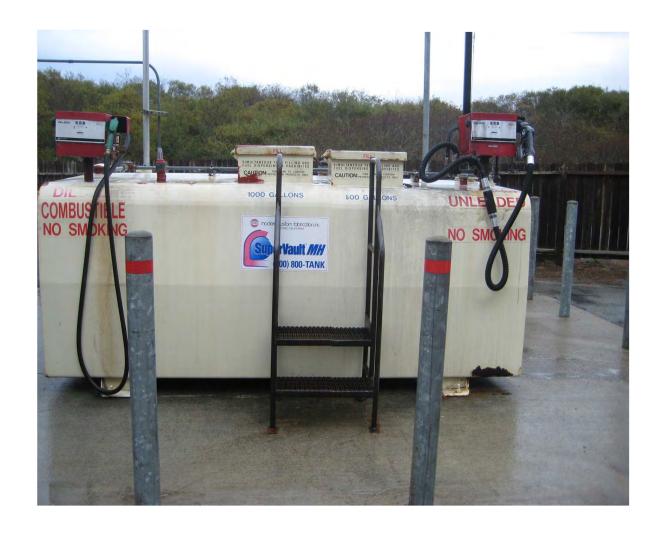
ME3 – Liquid fuel tank

The septic tank floods periodically, requiring station personnel to rent and use portable toilet facilities when the septic system is being repaired and cleaned. Fuel tanks show rust and evidence of leakage. Mechanical ventilation to occupied spaces is missing or inadequate. Some rooms have not heat. The consultant recommends demolishing all existing mechanical, plumbing, fuel, and electrical systems.

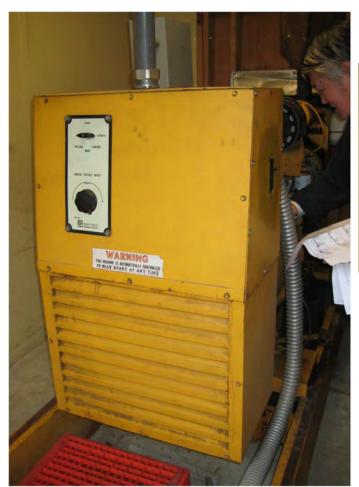
Most of the electrical equipment, including the standby generator (see EE2), and automatic transfer switch (see EE3), has been in use for more than thirty years. The coastal climate, severe weather conditions, and some flooding have caused rusting of the enclosed outdoor service entrance equipment (see EE1). Many broken, inadequate, or unsafe electrical conditions are noted in the report (Appendix 8.3).

EE2 – Single phase diesel fuel standby generator

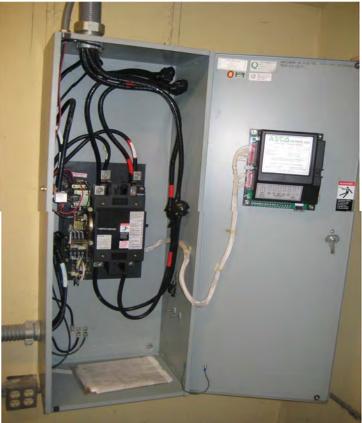
EE3 – Automatic transfer switch

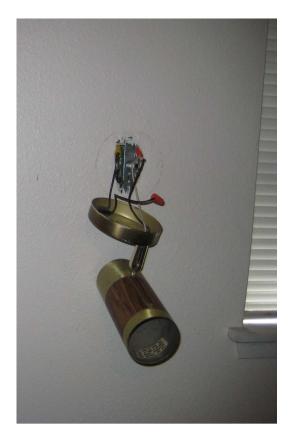
EE6 – Damaged light, Living Quarters

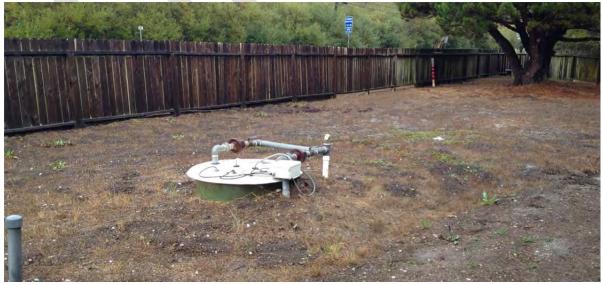
A new septic system will likely be required. The location of the existing system would be the ideal location if it has adequate space and soil conditions to accommodate a system that meets current code. Due to the likelihood of high groundwater at the location of the existing system, a shallow pressure dosing system would likely be required. However, because this location becomes inundated with water during flood events (see Photo 1), it is unlikely that this location will meet code. As such, alternative locations on site should be considered such as the western side of the site or on the hillside along the southern end of the site. It is unlikely, however, that the southern end will be feasible due to the steep slope and the confined area.

Septic field with flood elevation marker (white post with red marks) shown in the background
