County of San Mateo - Planning and Building Department

ENGINEERING GEOLOGIC &
GEOTECHNICAL INVESTIGATION
4LOT RESIDENTIAL DEVELOPMENT
ZMAY PROPERTY
1551 CRYSTAL SPRINGS ROAD
SAN MATEO COUNTY, CALIFORNIA

February 10, 2014 Project No. 1847-1R1

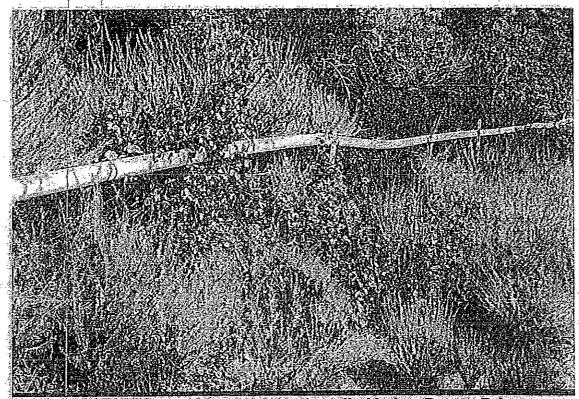
The result is a temporary, unmonitored system which is highly subject to small sewage spills of unknown quantity or duration. This writer has twice witnessed this condition during field visits. Both instances have resulted in an immediate report to County maintenance crews for quick remediation.

Temporary 4" PVC bypass pipe installed below Parrott Drive

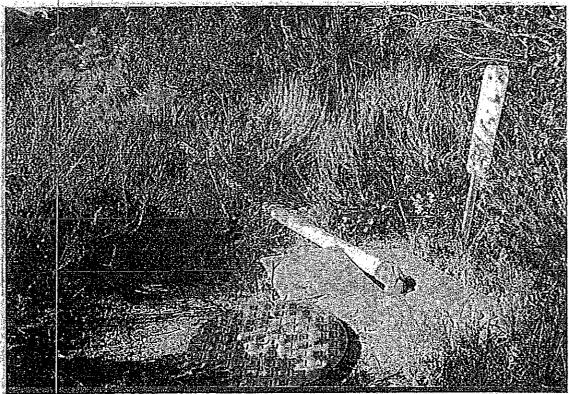
Temporary Bypass Pipe from MH 17 entering MH 15

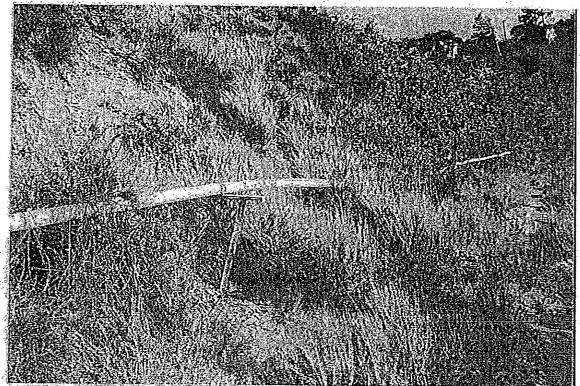
Temporary Bypass Pipe Supports between MH 15 and MH 17

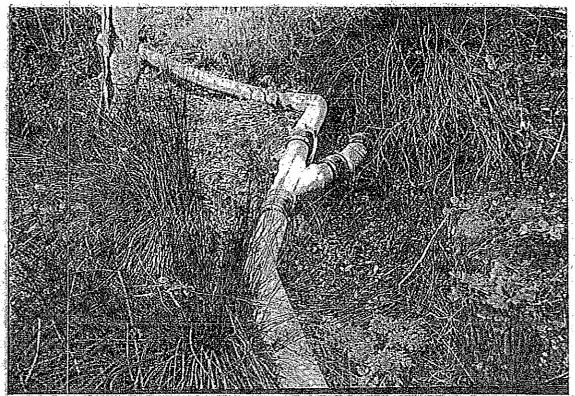
Laterals from 1306 & 1312 Bel Aire Road are connected into one 4" flex pipe

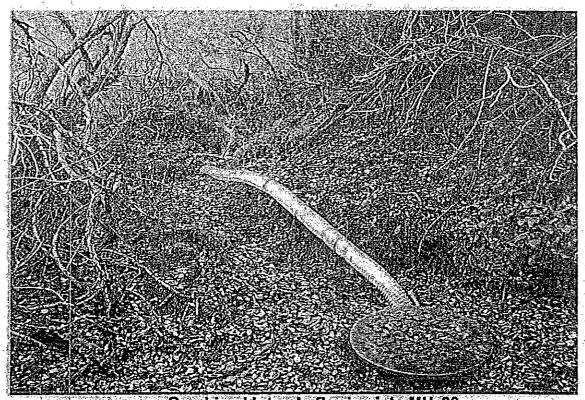
Combined laterals flowing into MH 30

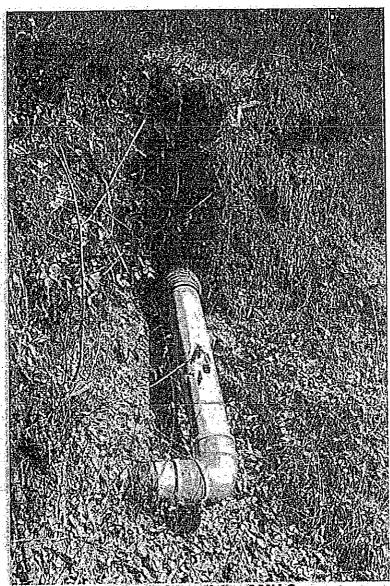
Near the lower end of the hillside, the pipeline approaches a creek and parallels the bank of the creek down to Polhemus Rd. MH 6 was originally located adjacent to the creek bank. During the heavy rainstorms in the mid 1990's, the bank became severely eroded and eventually exposed the base of MH 6 which ultimately fell into the creek thus allowing raw sewage to run into the creek for an unknown period of time. State Fish and Game personnel reported the discovery of the broken pipe to County maintenance crews. Both the repair of the pipeline and the abandoned MH are shown:

Former Location of MH 6

It is likely that, as the MH base began to move and become separated from the pipe, sewage flow from the exposed pipe caused the final erosion around the MH base. The resulting erosion left the brick MH upside down and completely in tact, approximately 30 feet down the hill near the creek. While difficult to pick out in the following photograph, it serves as a reminder of the potential that a remote pipeline on a slipping hillside has to cause damage.

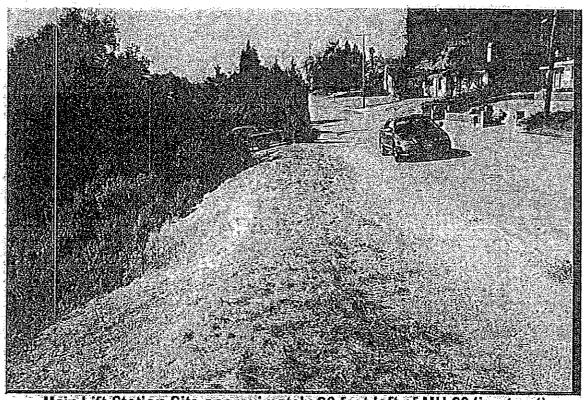
Main Lift Station Site approximately 30 feet left of MH 20 (in street)

Upon completion of the pump system, the existing hillside system could be entirely abandoned or be used to carry away drainage water from those lots which appear to be particularly susceptible.
