Tree Assessment

**Juliana Way
Moss Beach CA**

Prepared for:
**Verde Design
2455 The Alameda Suite 200
Santa Clara CA 95050**

May 2015

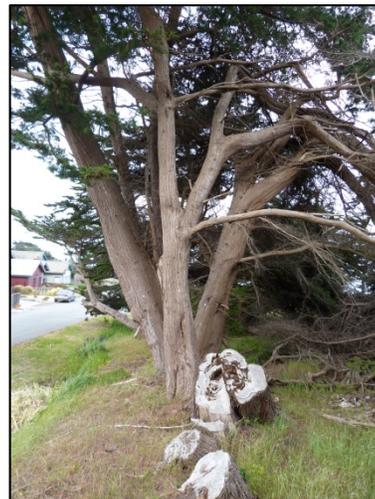
- #153 – 160 formed an irregular line running from east to west, parallel to Juliana St. In addition to the standing trees, there were numerous stumps in between existing cypresses (Photo 1). Stumps lean towards Juliana St., suggesting that trees failed in that direction and were then cut off.

Photo 1. Looking west at trees #155, 156 and 157. Juliana St. is on the left.

Trees #156 and 160 were in poor condition. Trees #160 had failed at the base and was laying on the ground.

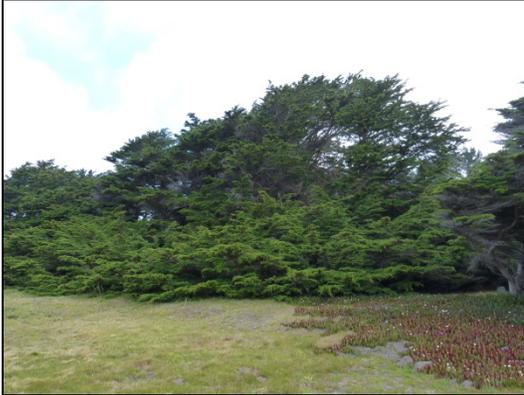
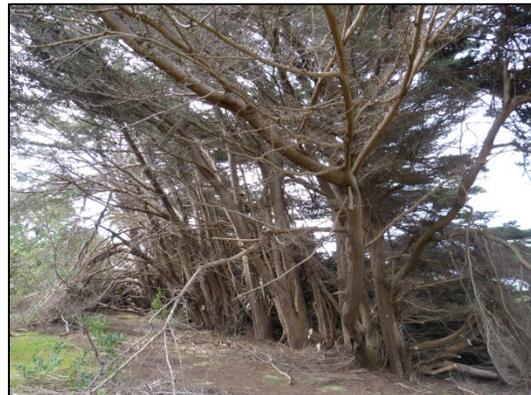
- #162 – 177 formed a well-defined row on the south side of the property. Trees had been planted close together and were mature in development. Crowns were very asymmetric (Photo 2). On the west, low branches ran along the ground for some distance from the trunk. On the east, no low branches were present leaving trunks exposed to the top of the trees. On the south, trees #162, 163 and 164 had numerous failed but still green branches laying on the ground.

Photo 2. Crowns of cypresses #163 – 177 were very asymmetric. Left: west side. Right: east side.

Tree structure was characterized by 2 or more stems that arose near the base of the trunk. Stems varied widely in orientation, ranging from vertical to sharply leaning from the base to bowed almost flat. Branch failures were common. Eleven trees were in poor condition while #166, 173, 174, 175 and 178 were fair.

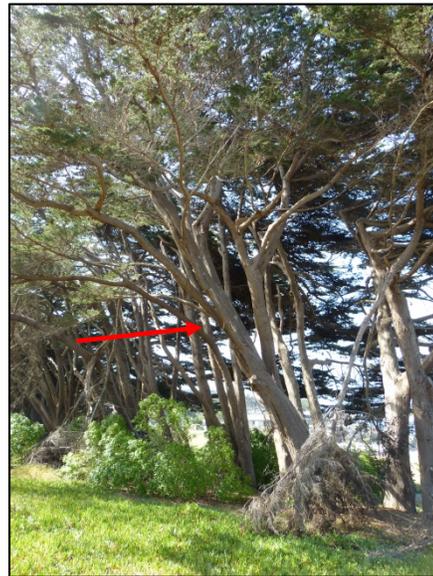
- #179 – 188 formed a second row on the north side of the property (Photo 3). Trees were farther apart than in the group above but as mature in development. Low branches had been removed leaving numerous pruning wounds and high canopies of foliage. Six trees were in poor condition while #179, 180, 183 and 186 were fair.

Photo 3. Looking southwest along trees #179 – 188. Tree #188 leans to the southeast (red arrow).

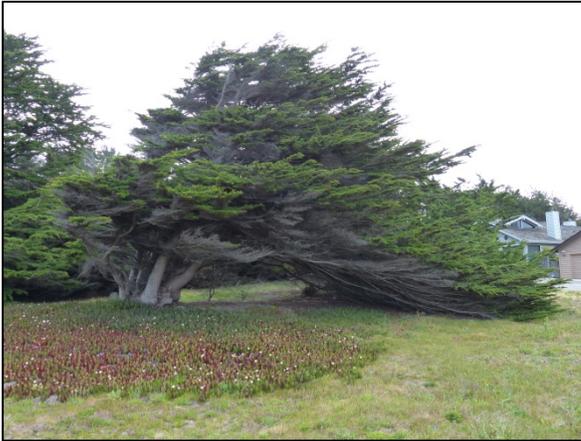
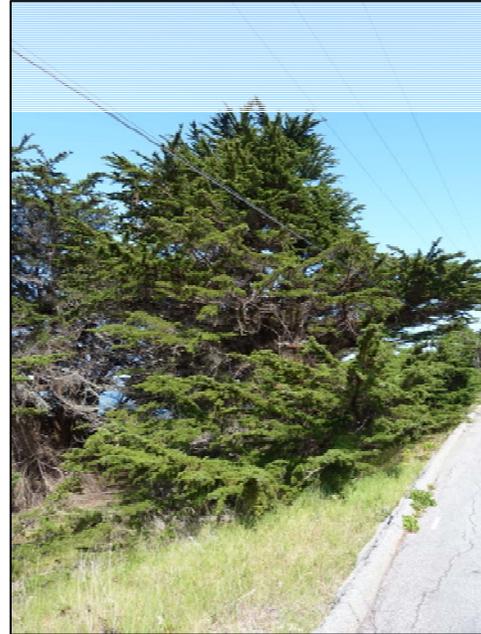
- Cypresses #161, 189, 178, 193 and 194 were large mature trees growing alone rather than in a group (Photo 4, following page). As a result, trees were shorter but crowns were much larger. This group ranged from a single stem (#189) to codominant stems (#193) to multiple stems arising near the base (#161, 178, 194). Tree #178 had the largest single stem of any cypress on the site: 54". Condition was poor for #189, 193, 194 but fair for #161 and 178. Trees #178, 193, 194 had been pruned to clear the overhead/adjacent electrical lines.

Photo 4. Above: looking east at cypress #161. Right: looking north along Vallemar St. at cypress #178. Note numerous low branches in the foreground.
