## TECHNICAL MEMORANDUM

Date: October 31, 2022  
To: Akin Okupe, EPASD General Manager  
From: Jeffrey C. Bensch, P.E.  
Cc:

**RE: CCTV Survey Results Evaluation and Pipeline Replacement Priorities  
Areas 1, 3, and 4**

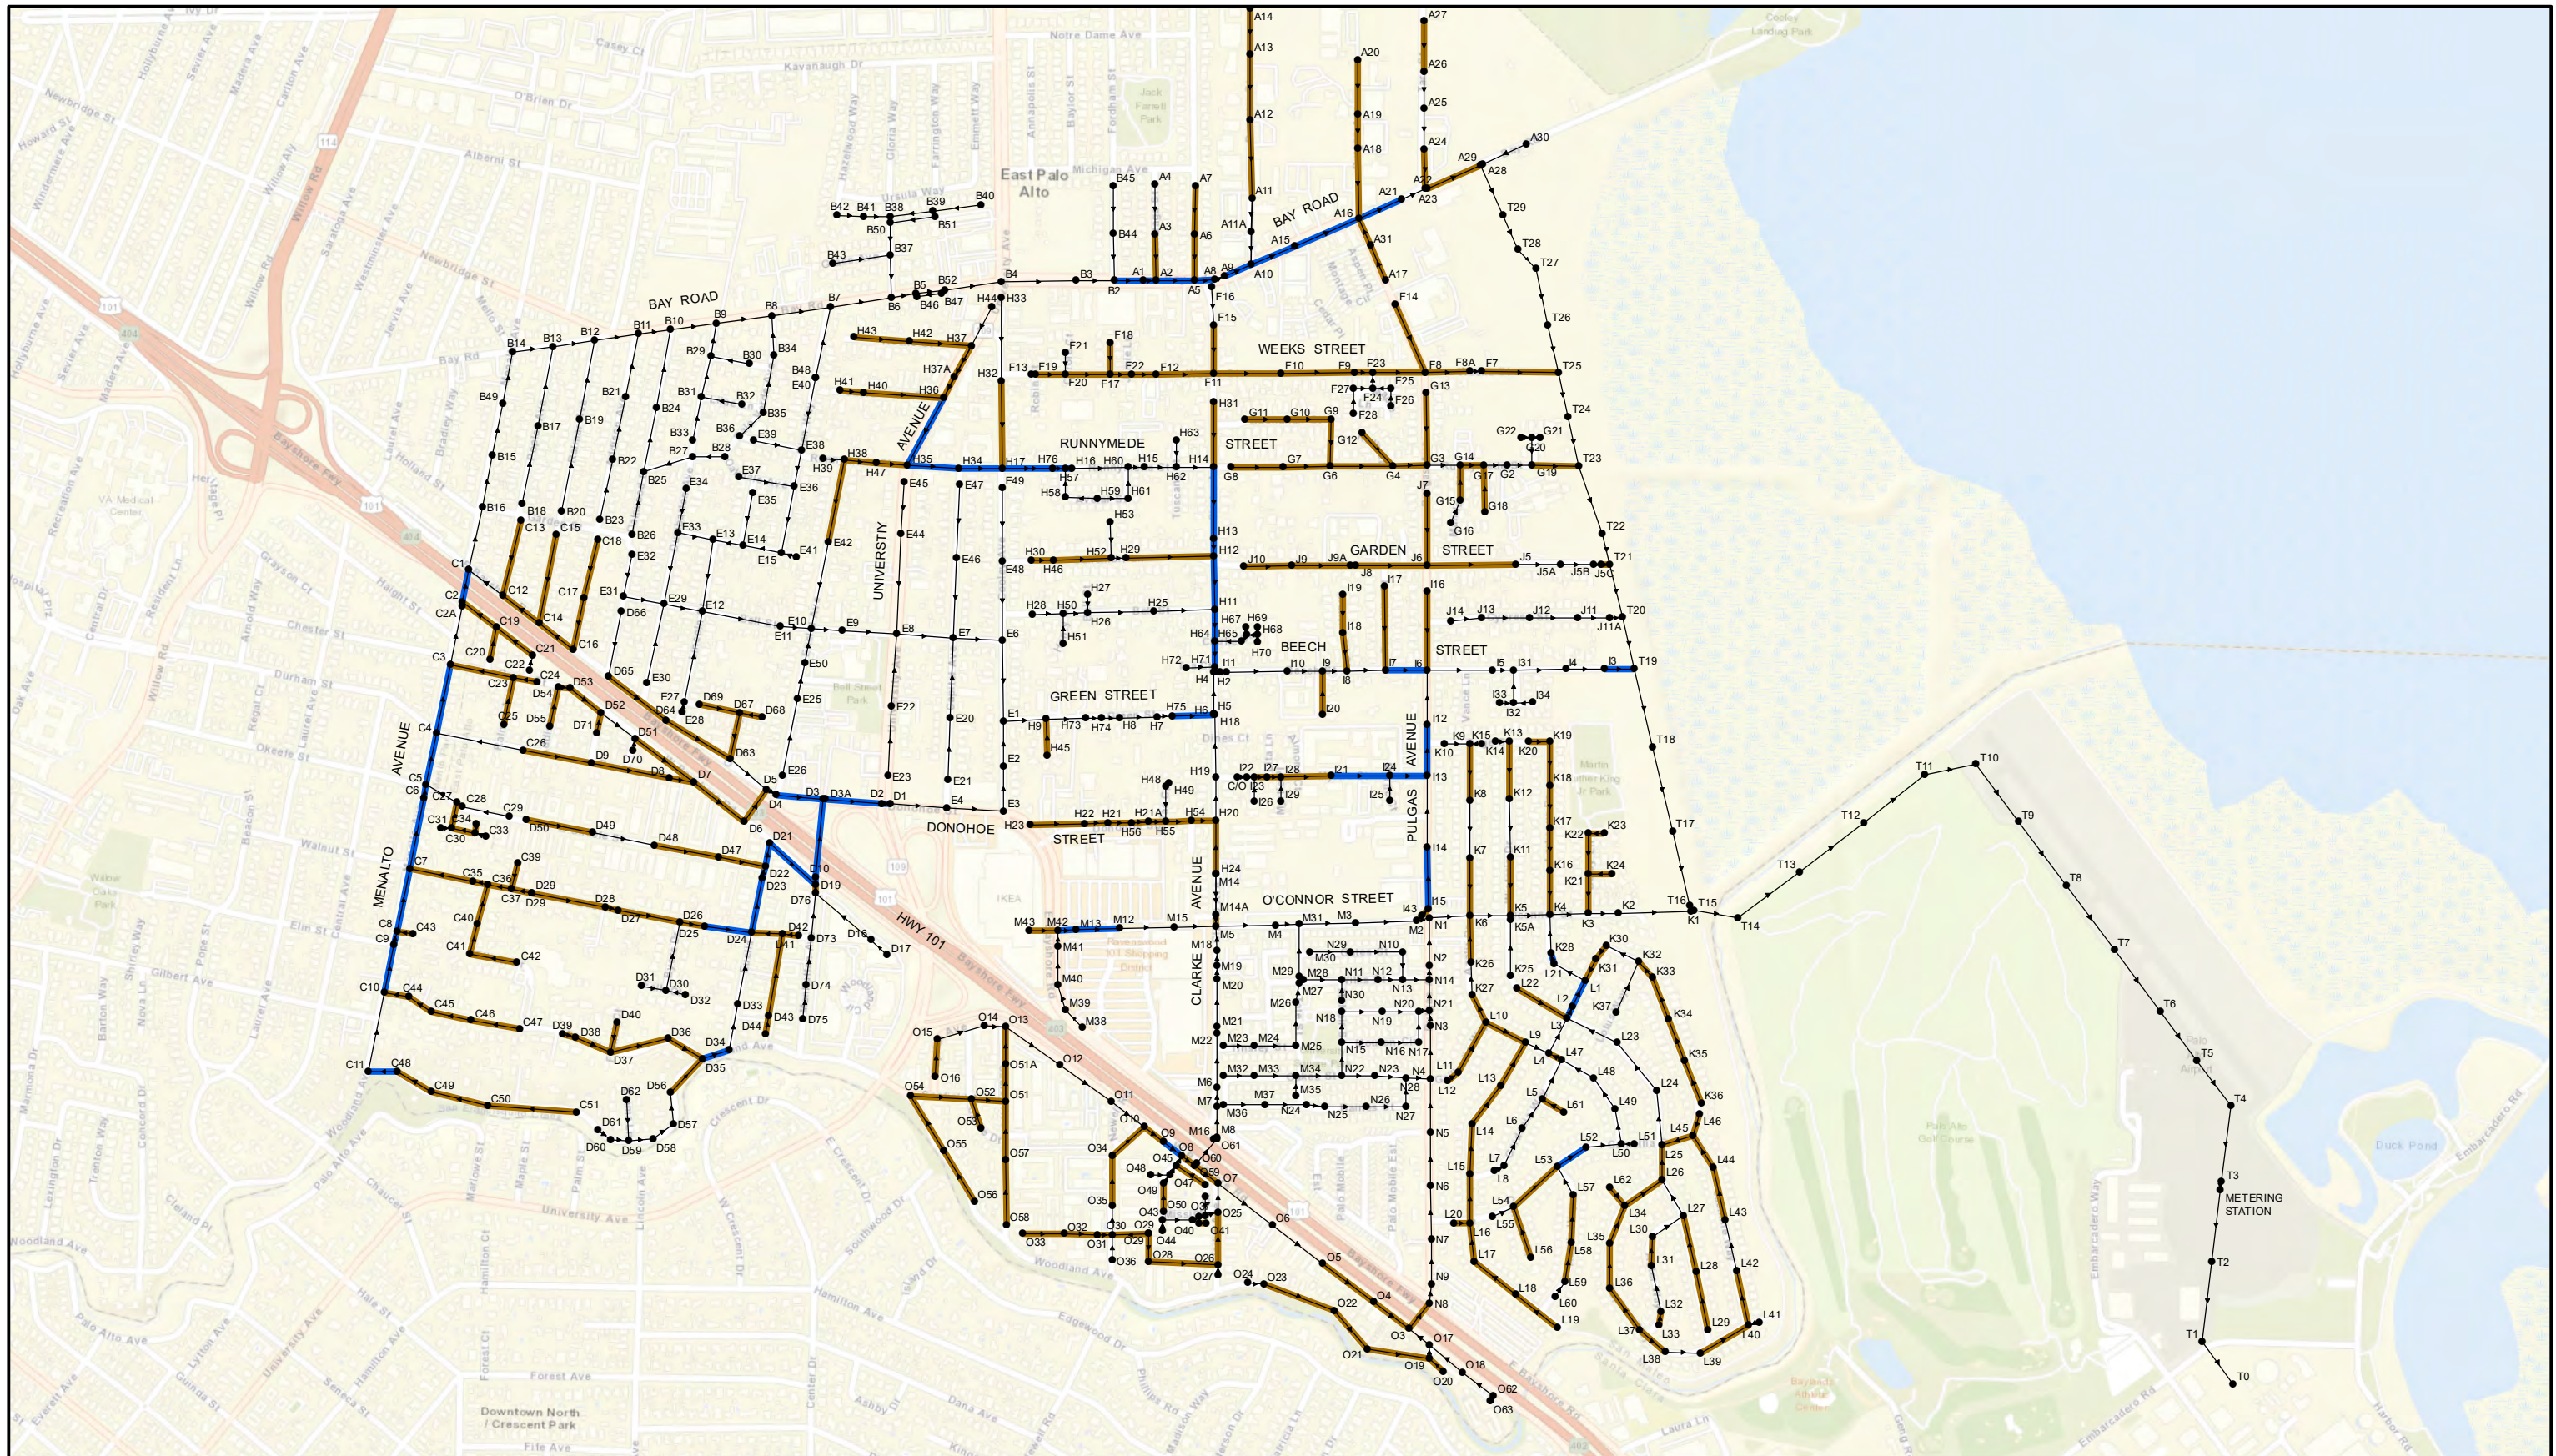
The Structural, Notable Defects, and Sagging scores are added to create the Total Score for each pipeline segment. The Total Scores are ranked from highest to lowest to generate a priority list of pipelines to replace (Table 1). Pipelines with a score greater than 25 from each Area were selected as the group with significant structural defects needing replacement. A geographic information system (GIS) was used to generate Figure 2 showing the pipelines that need to be replaced to resolve structural defects in Areas 1, 3, and 4.

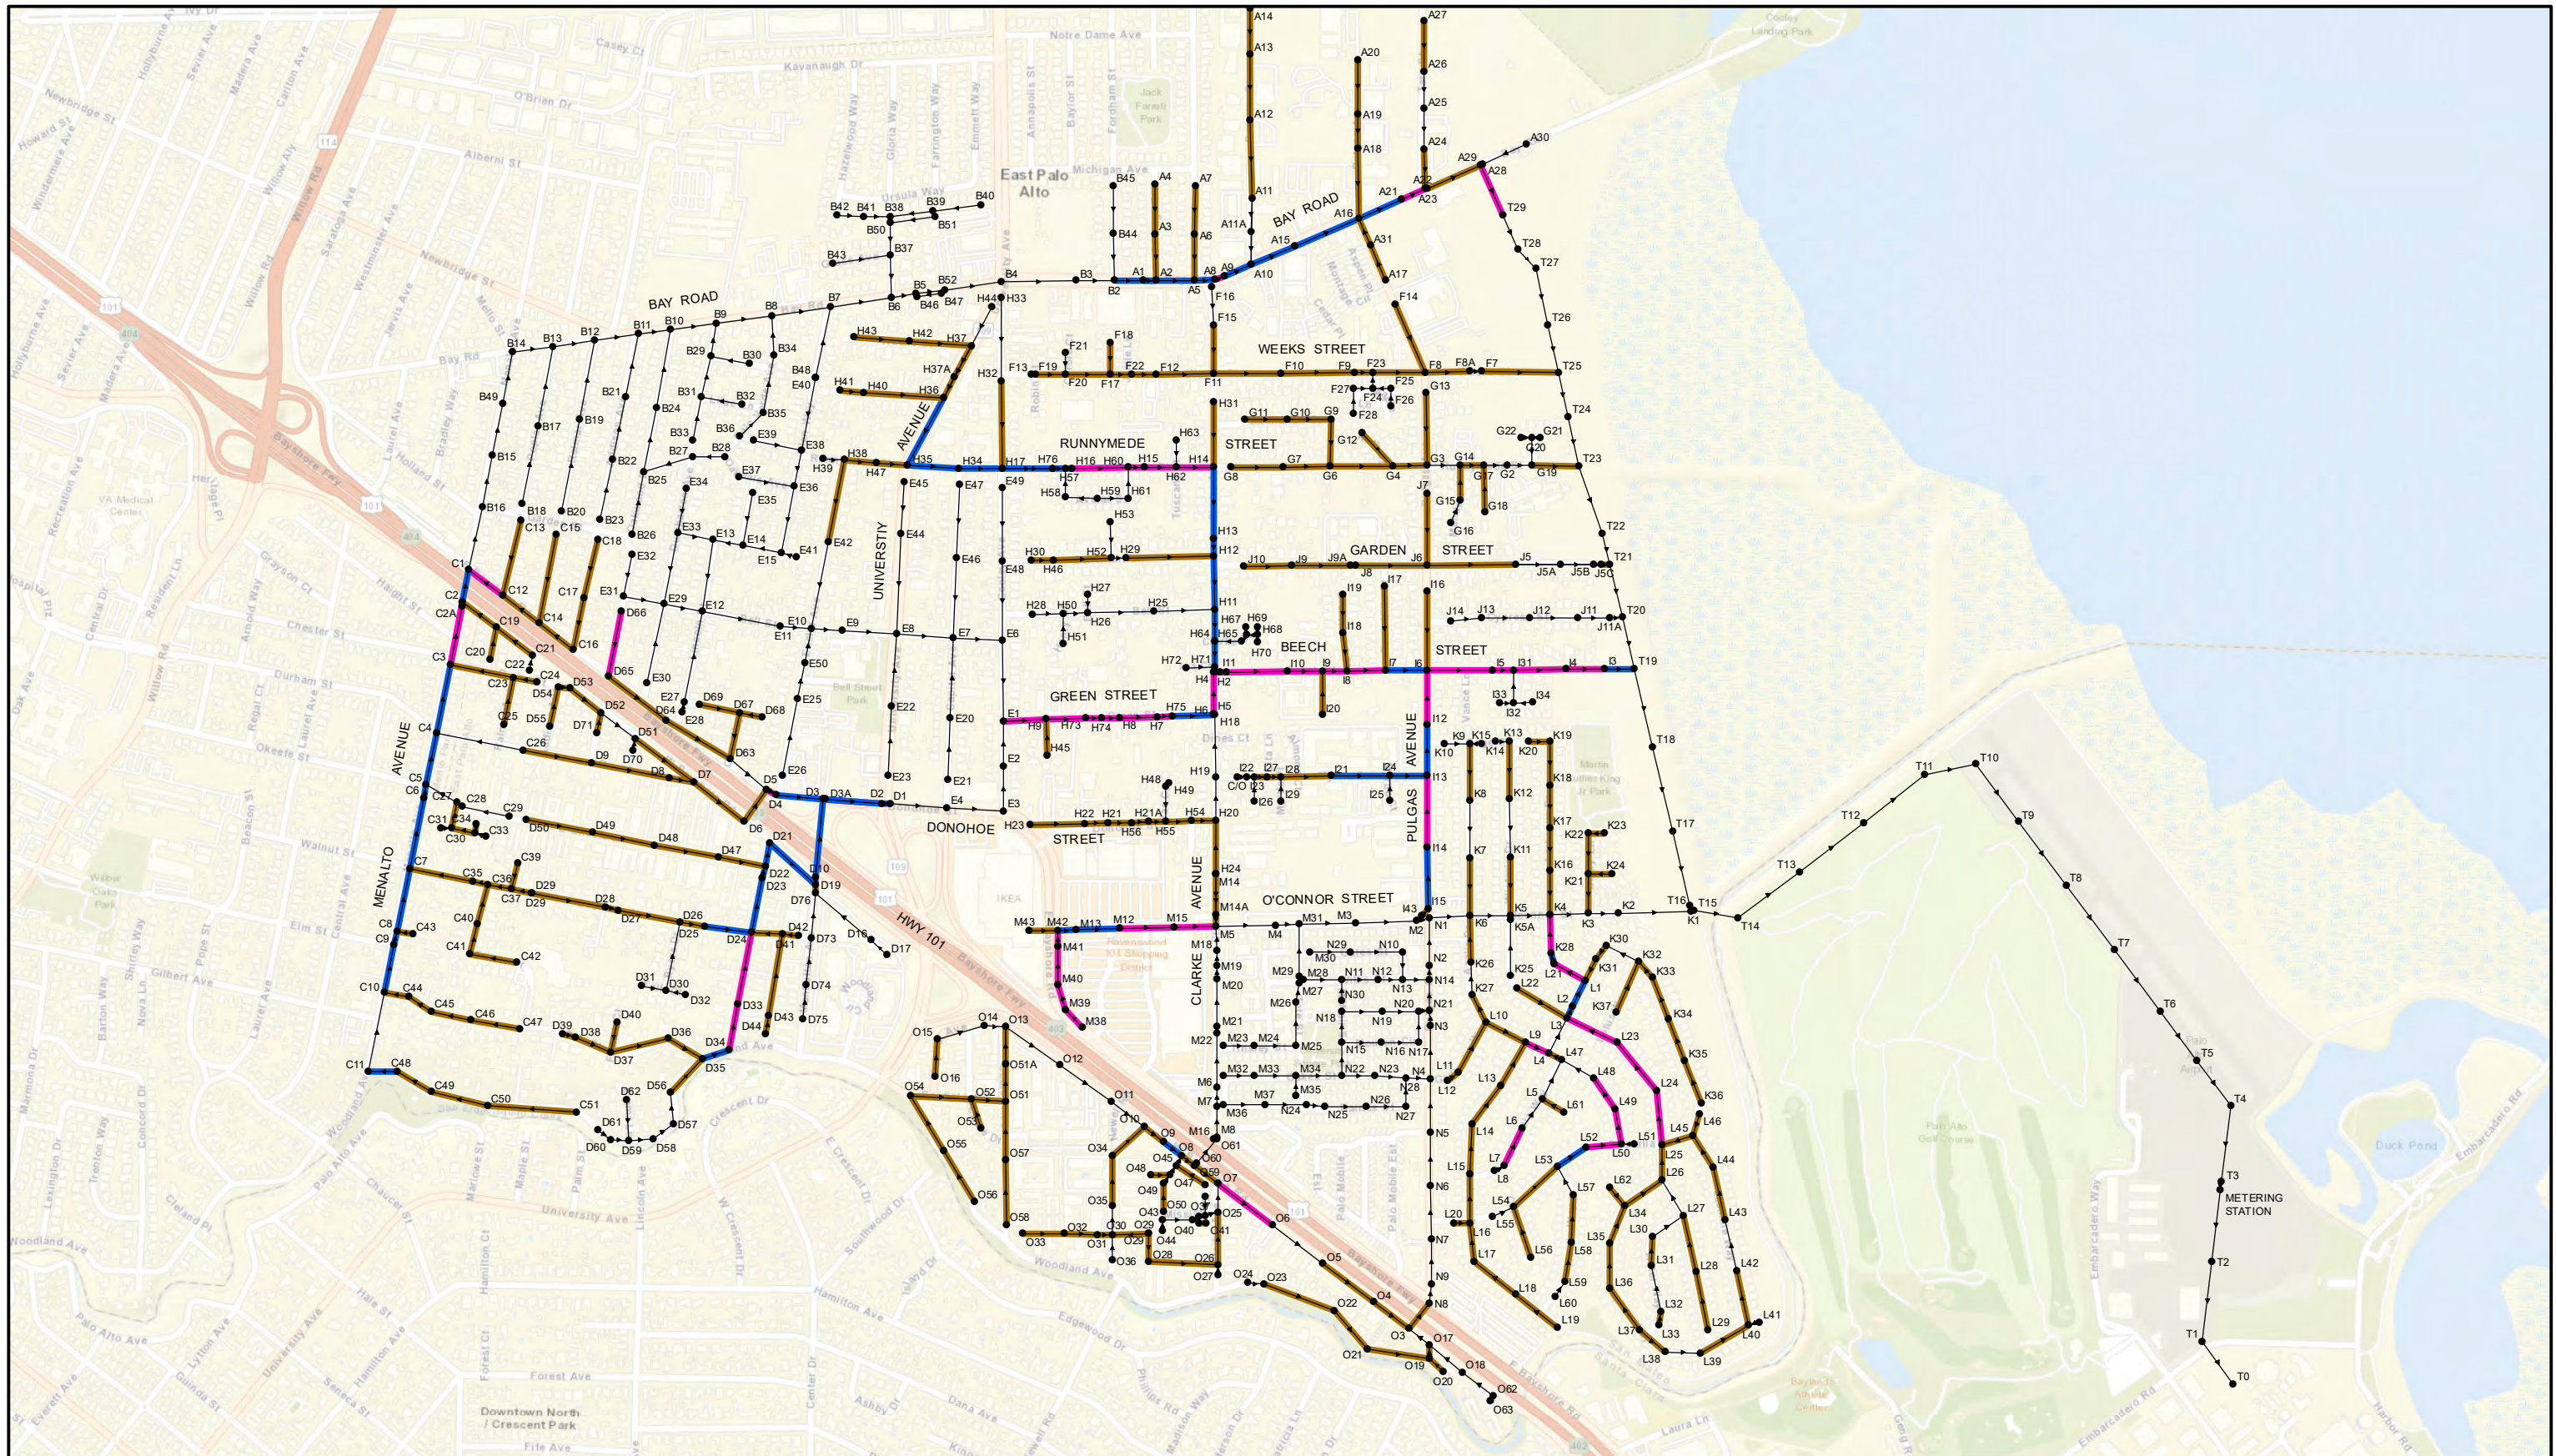
**3**

The Structural, Notable Defects, and Sagging scores, and the Capacity score, are added to create the Total Score for each pipeline segment. The Total Scores are ranked from highest to lowest to generate a priority list of pipelines to replace. Pipelines with a Total Score greater than 25 were selected as pipelines for replacement (Table 4). The GIS was used to generate Figure 3 showing the pipelines that need to be replaced to resolve structural defects and capacity inadequacies in Areas 1, 3, and 4.

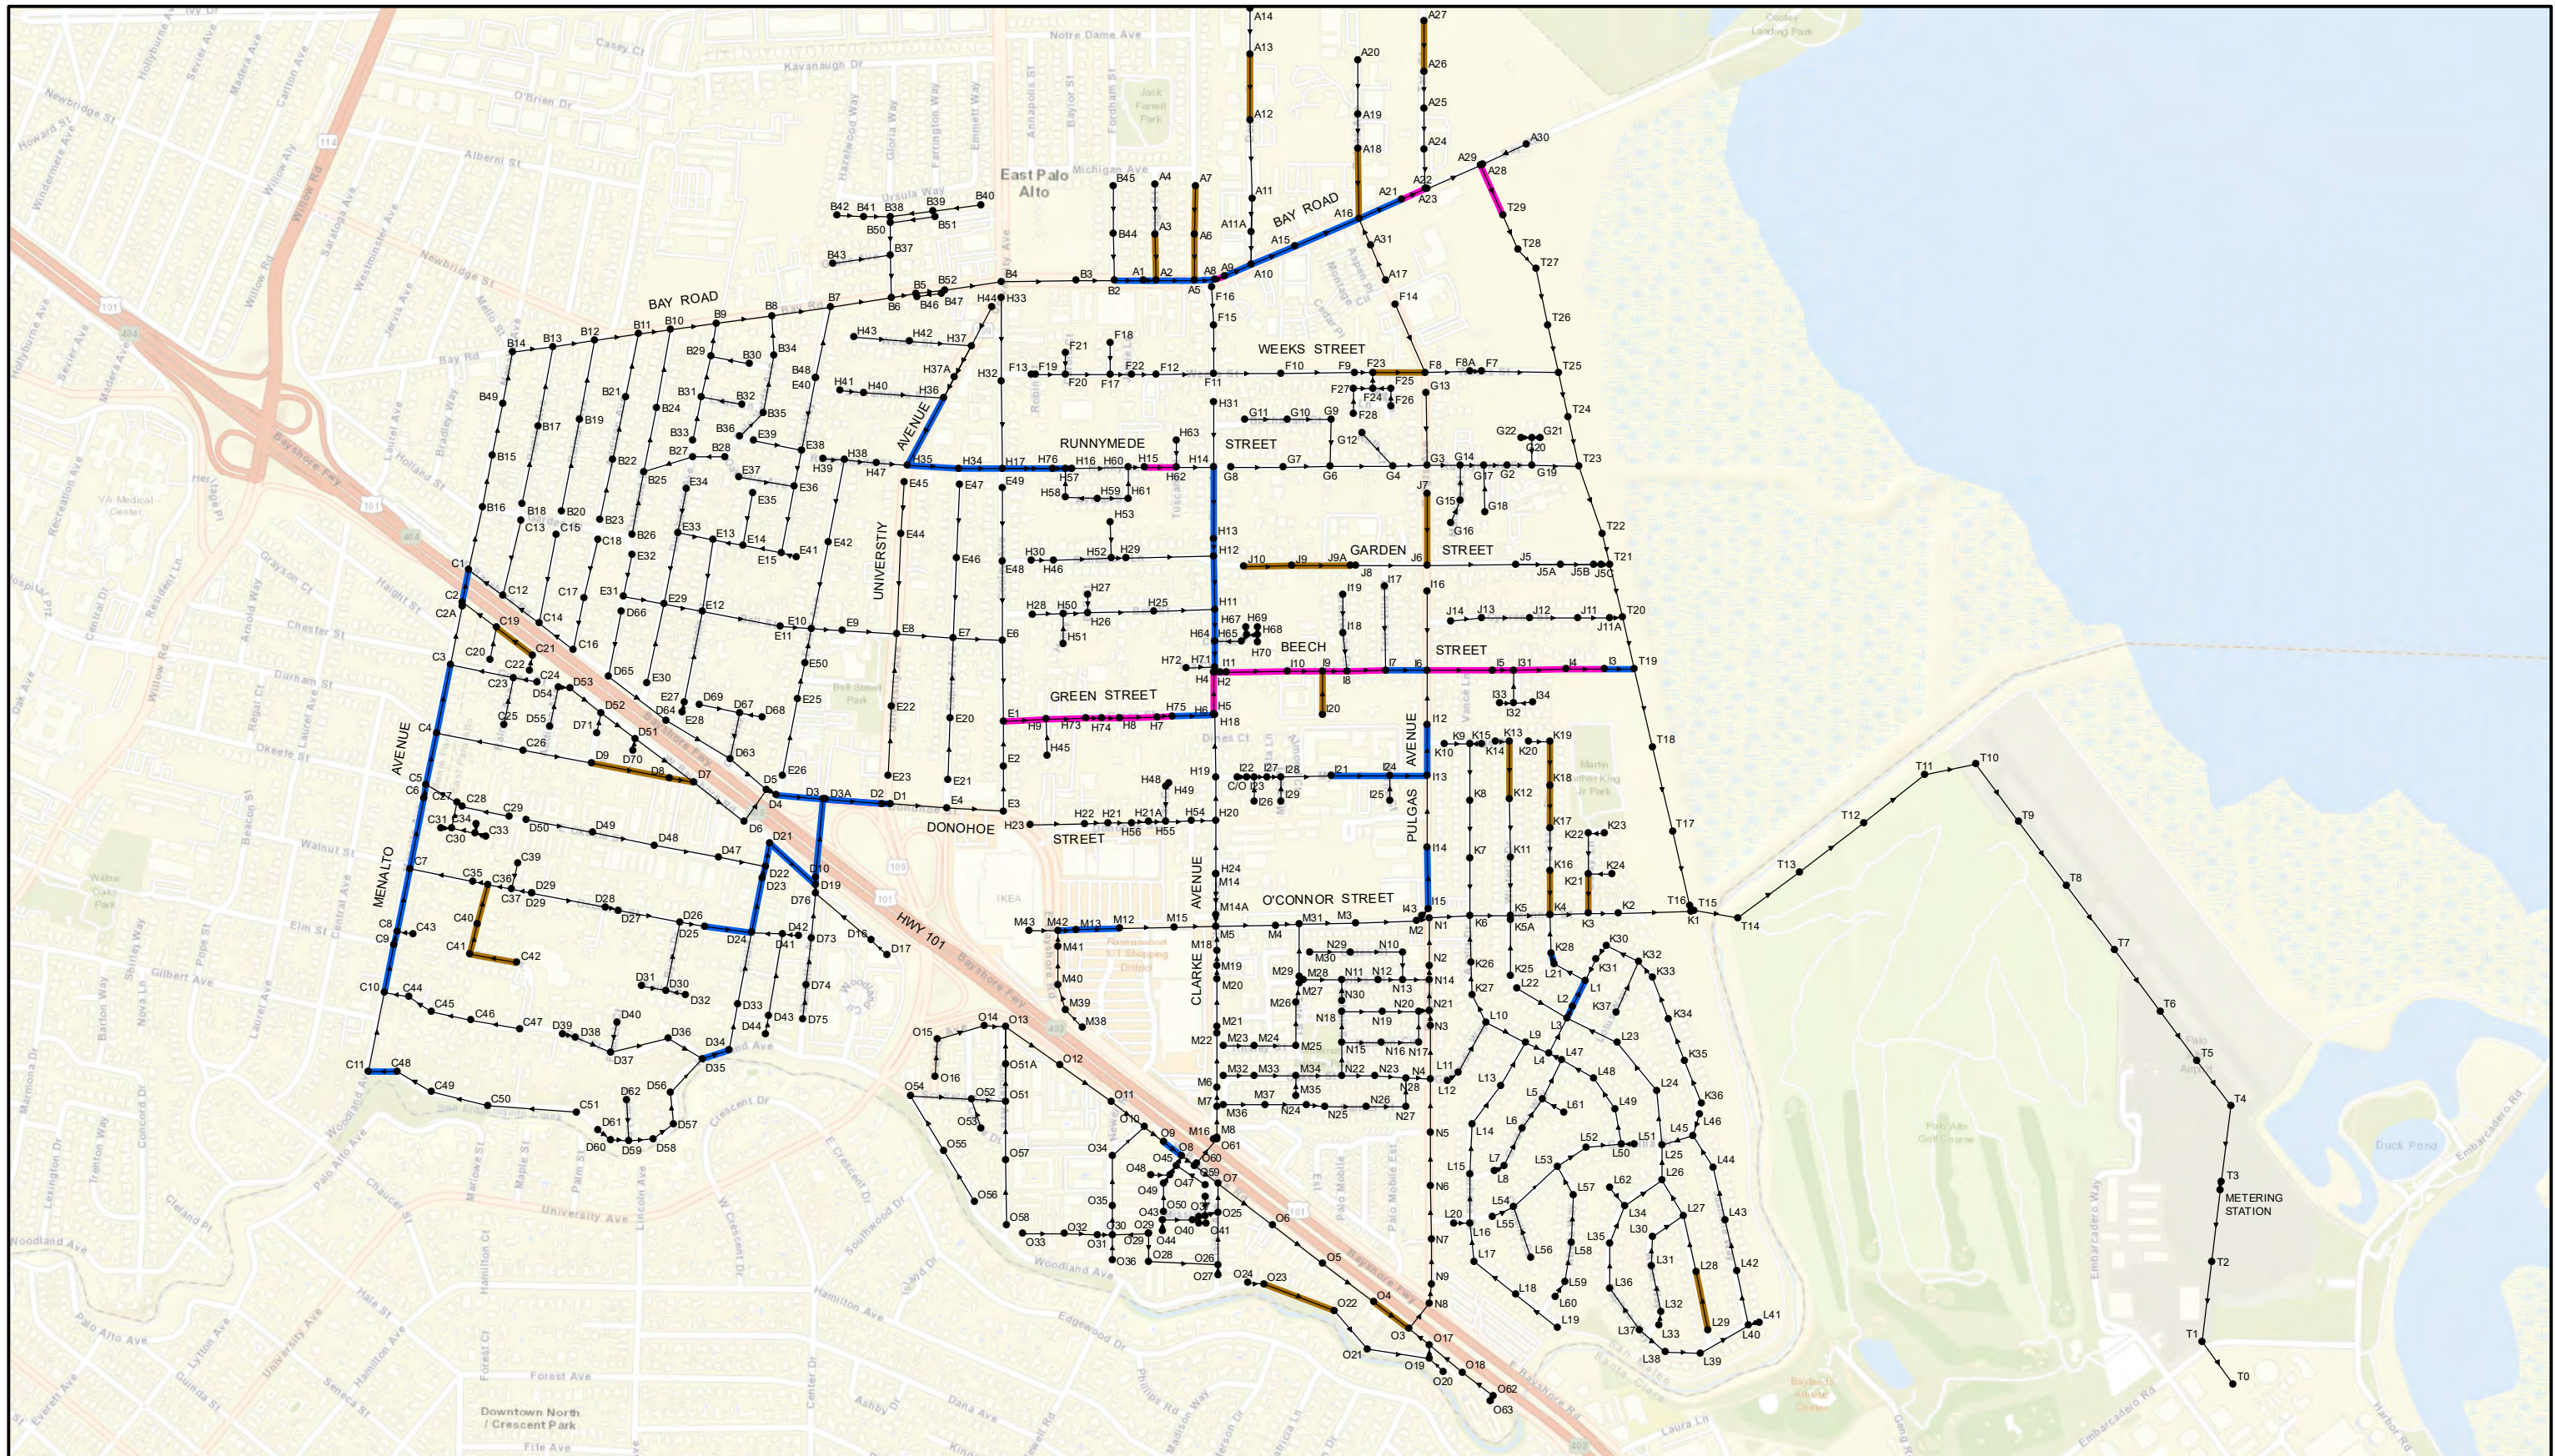
Pipeline segments with a Total Score greater than 75 were selected as the group of pipelines to be replaced (Table 7). A geographic information system (GIS) was used to generate Figure 4 showing the pipelines that need to be replaced.
