Shangfang LLC 0 Lakemead Way Emerald Hills, CA 94062

Site: 0 Lakemead Way, Emerald Hills, APN:057-264-160

At your request I visited the above site for the purpose of inspecting and commenting on the regulated trees around the property. A new home and ADU is planned, prompting the need for this tree protection report.

0 Lakemead Way, Emerald Hills March 28, 2023

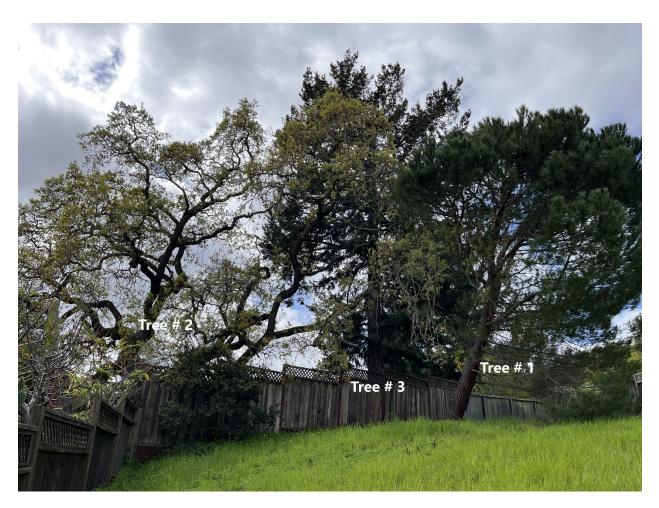
Tree #s 1, 2 and 3

Tree # 1 is an Italian stone pine in good health but poor condition. The tree has a very severe lean. The trunk separates into 2 stems at 8 feet above grade. The codominant stems are poorly attached with included bark. I recommend that this tree be removed.

Tree # 2 is a valley oak on the rear neighbor's property. The tree is an old tree in good health and fair condition. The tree is a Class 2 Heritage tree that should be protected during construction.

Tree # 3 is a Douglas fir on the rear neighbor's property. The tree is in fair health and condition. The tree has been topped at 30 feet above grade. This tree should be protected during construction.

Tree # 2: TPZ should be at 40 feet from the trunk closing on the property line in accordance with Type I Tree Protection as outlined and illustrated in image 2.15-1 and $2^{(6)}$. Shown as a thin red line.

A proposed retaining wall and ADU will be within the TPZ of the tree. The proposed construction will impact 7% of the entire root zone of the tree, area shaded in blue and will have negligible affect on the health and condition of the tree. The fencing can be reduced to edge of construction shown as a thick red line.

Tree # 3: TPZ should be at 20 feet from the trunk in accordance with Type I Tree Protection as outlined and illustrated in image 2.15-1 and $2^{(6)}$.

There will be some pruning required for clearance to Tree # 2, but none to exceed 15% of the entire canopy.

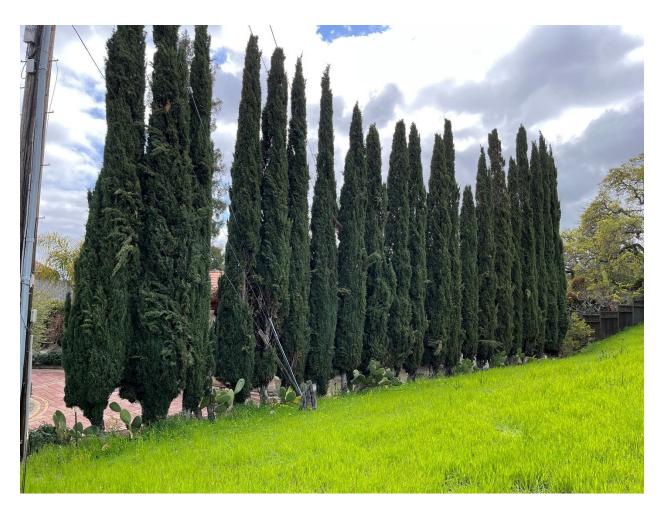
<u>Tree #s 4</u>

Tree # 4 is a row of Italian cypress along the property line. The trees are in excellent health and condition. The trees are not regulated.
