## TECHNICAL MEMORANDUM

Date: October 13, 2023  
To: Akin Okupe, EPASD General Manager  
From: Jeffrey C. Bensch, P.E.  
Cc:

**RE: CCTV Survey Results Evaluation and Pipeline Replacement Priorities  
Area 2, Trunk Line, and All Areas**

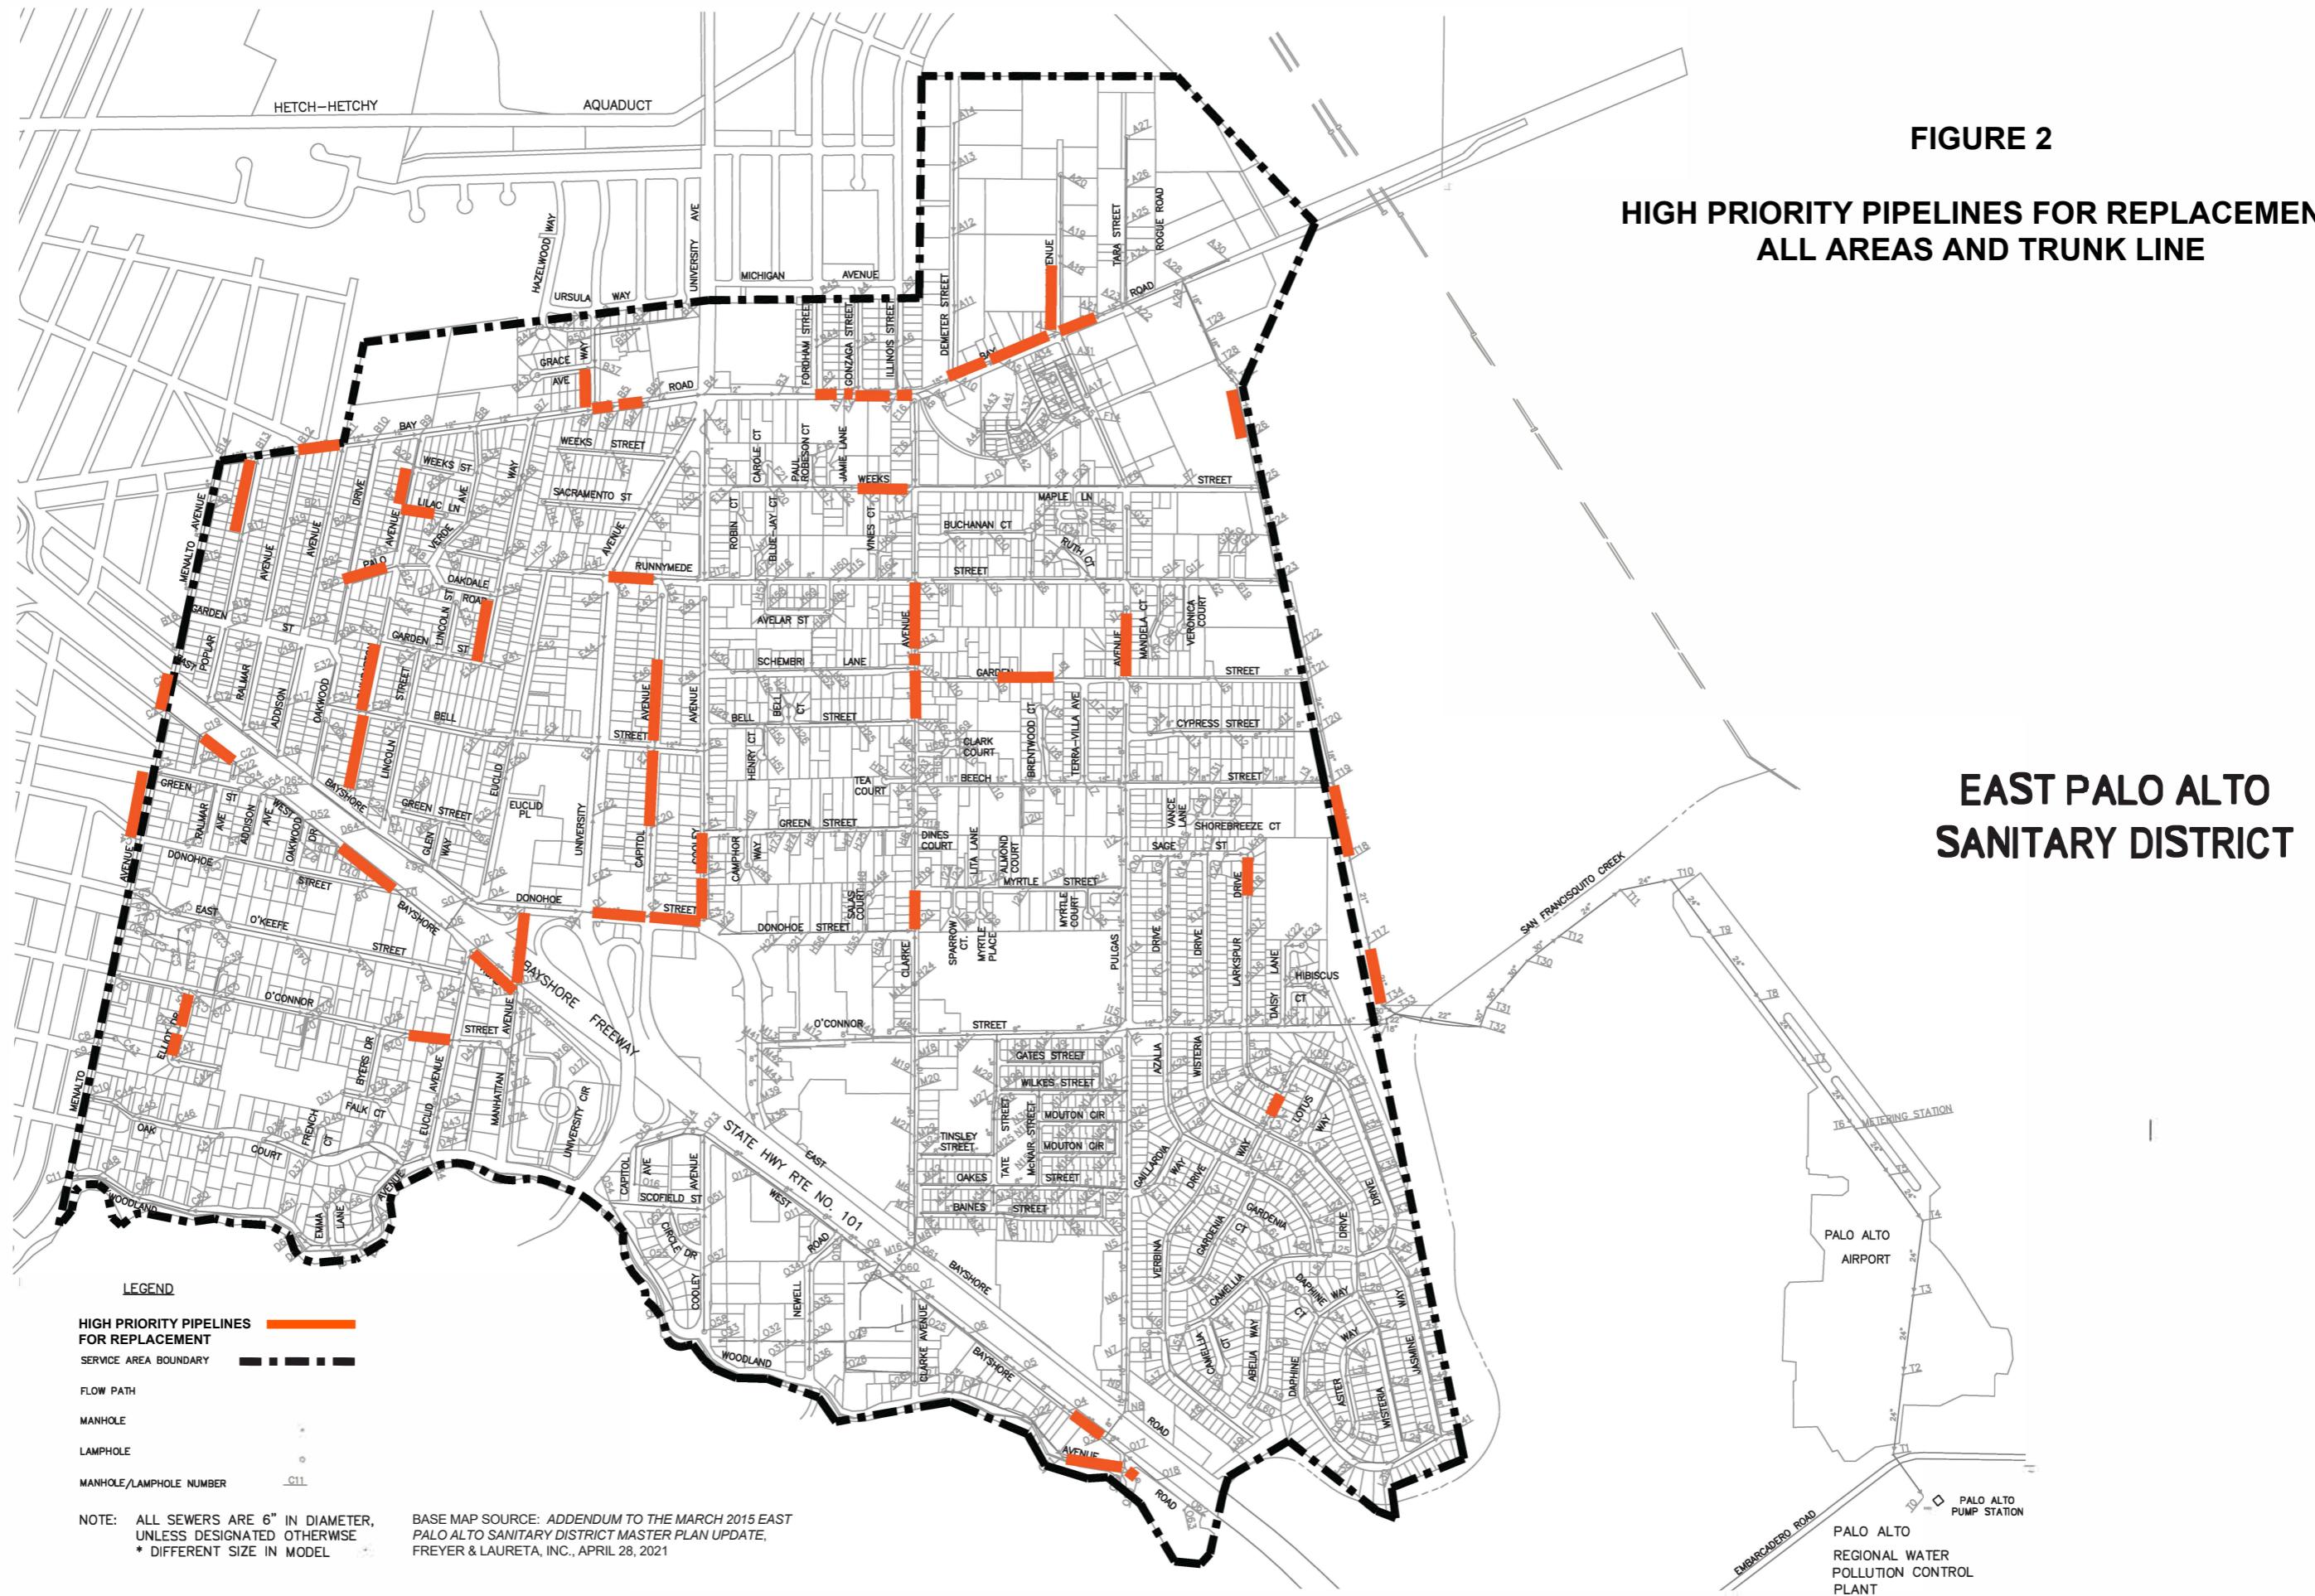
## FIGURE 2

The Structural, Notable Defects, and Sagging scores, and the Capacity score, are added to create the Total Score for each pipeline segment. The Total Scores are ranked from highest to lowest to generate a priority list of pipelines to replace. Pipelines with a Total Score greater than 105 were selected as pipelines for replacement in the near future (**Table 2**). This priority list is also anticipated to have a construction budget approximately \$10M. **Figure 2** shows the pipelines with priority for replacement (scores > 105) considering all Areas and the trunk line.

## **HIGH PRIORITY PIPELINES FOR REPLACEMENT ALL AREAS AND TRUNK LINE**

The total scoring spreadsheets, figures, and the opinion of probable costs presented in Tables 1 through 4 and summarized in Figure 2, develop a listing of high priority pipelines for replacement under a phased approach. An implementation schedule is beyond the scope of this evaluation because various non-engineering factors will be considered as each implementation project is undertaken.
