REPORT
SUPPLEMENTAL GEOTECHNICAL ENGINEERING INVESTIGATION
SENECA LANE MUDSLIDE
SEWER STABILIZATION STUDY
APN: 041-090-160
SAN MATEO COUNTY, CALIFORNIA

March 1, 2018
BAGG Job No: BKFEN-34-00

**Supplemental Geotechnical
Engineering Investigation**
Seneca Lane Mudslide
Sewer Stabilization Project
San Mateo County, California

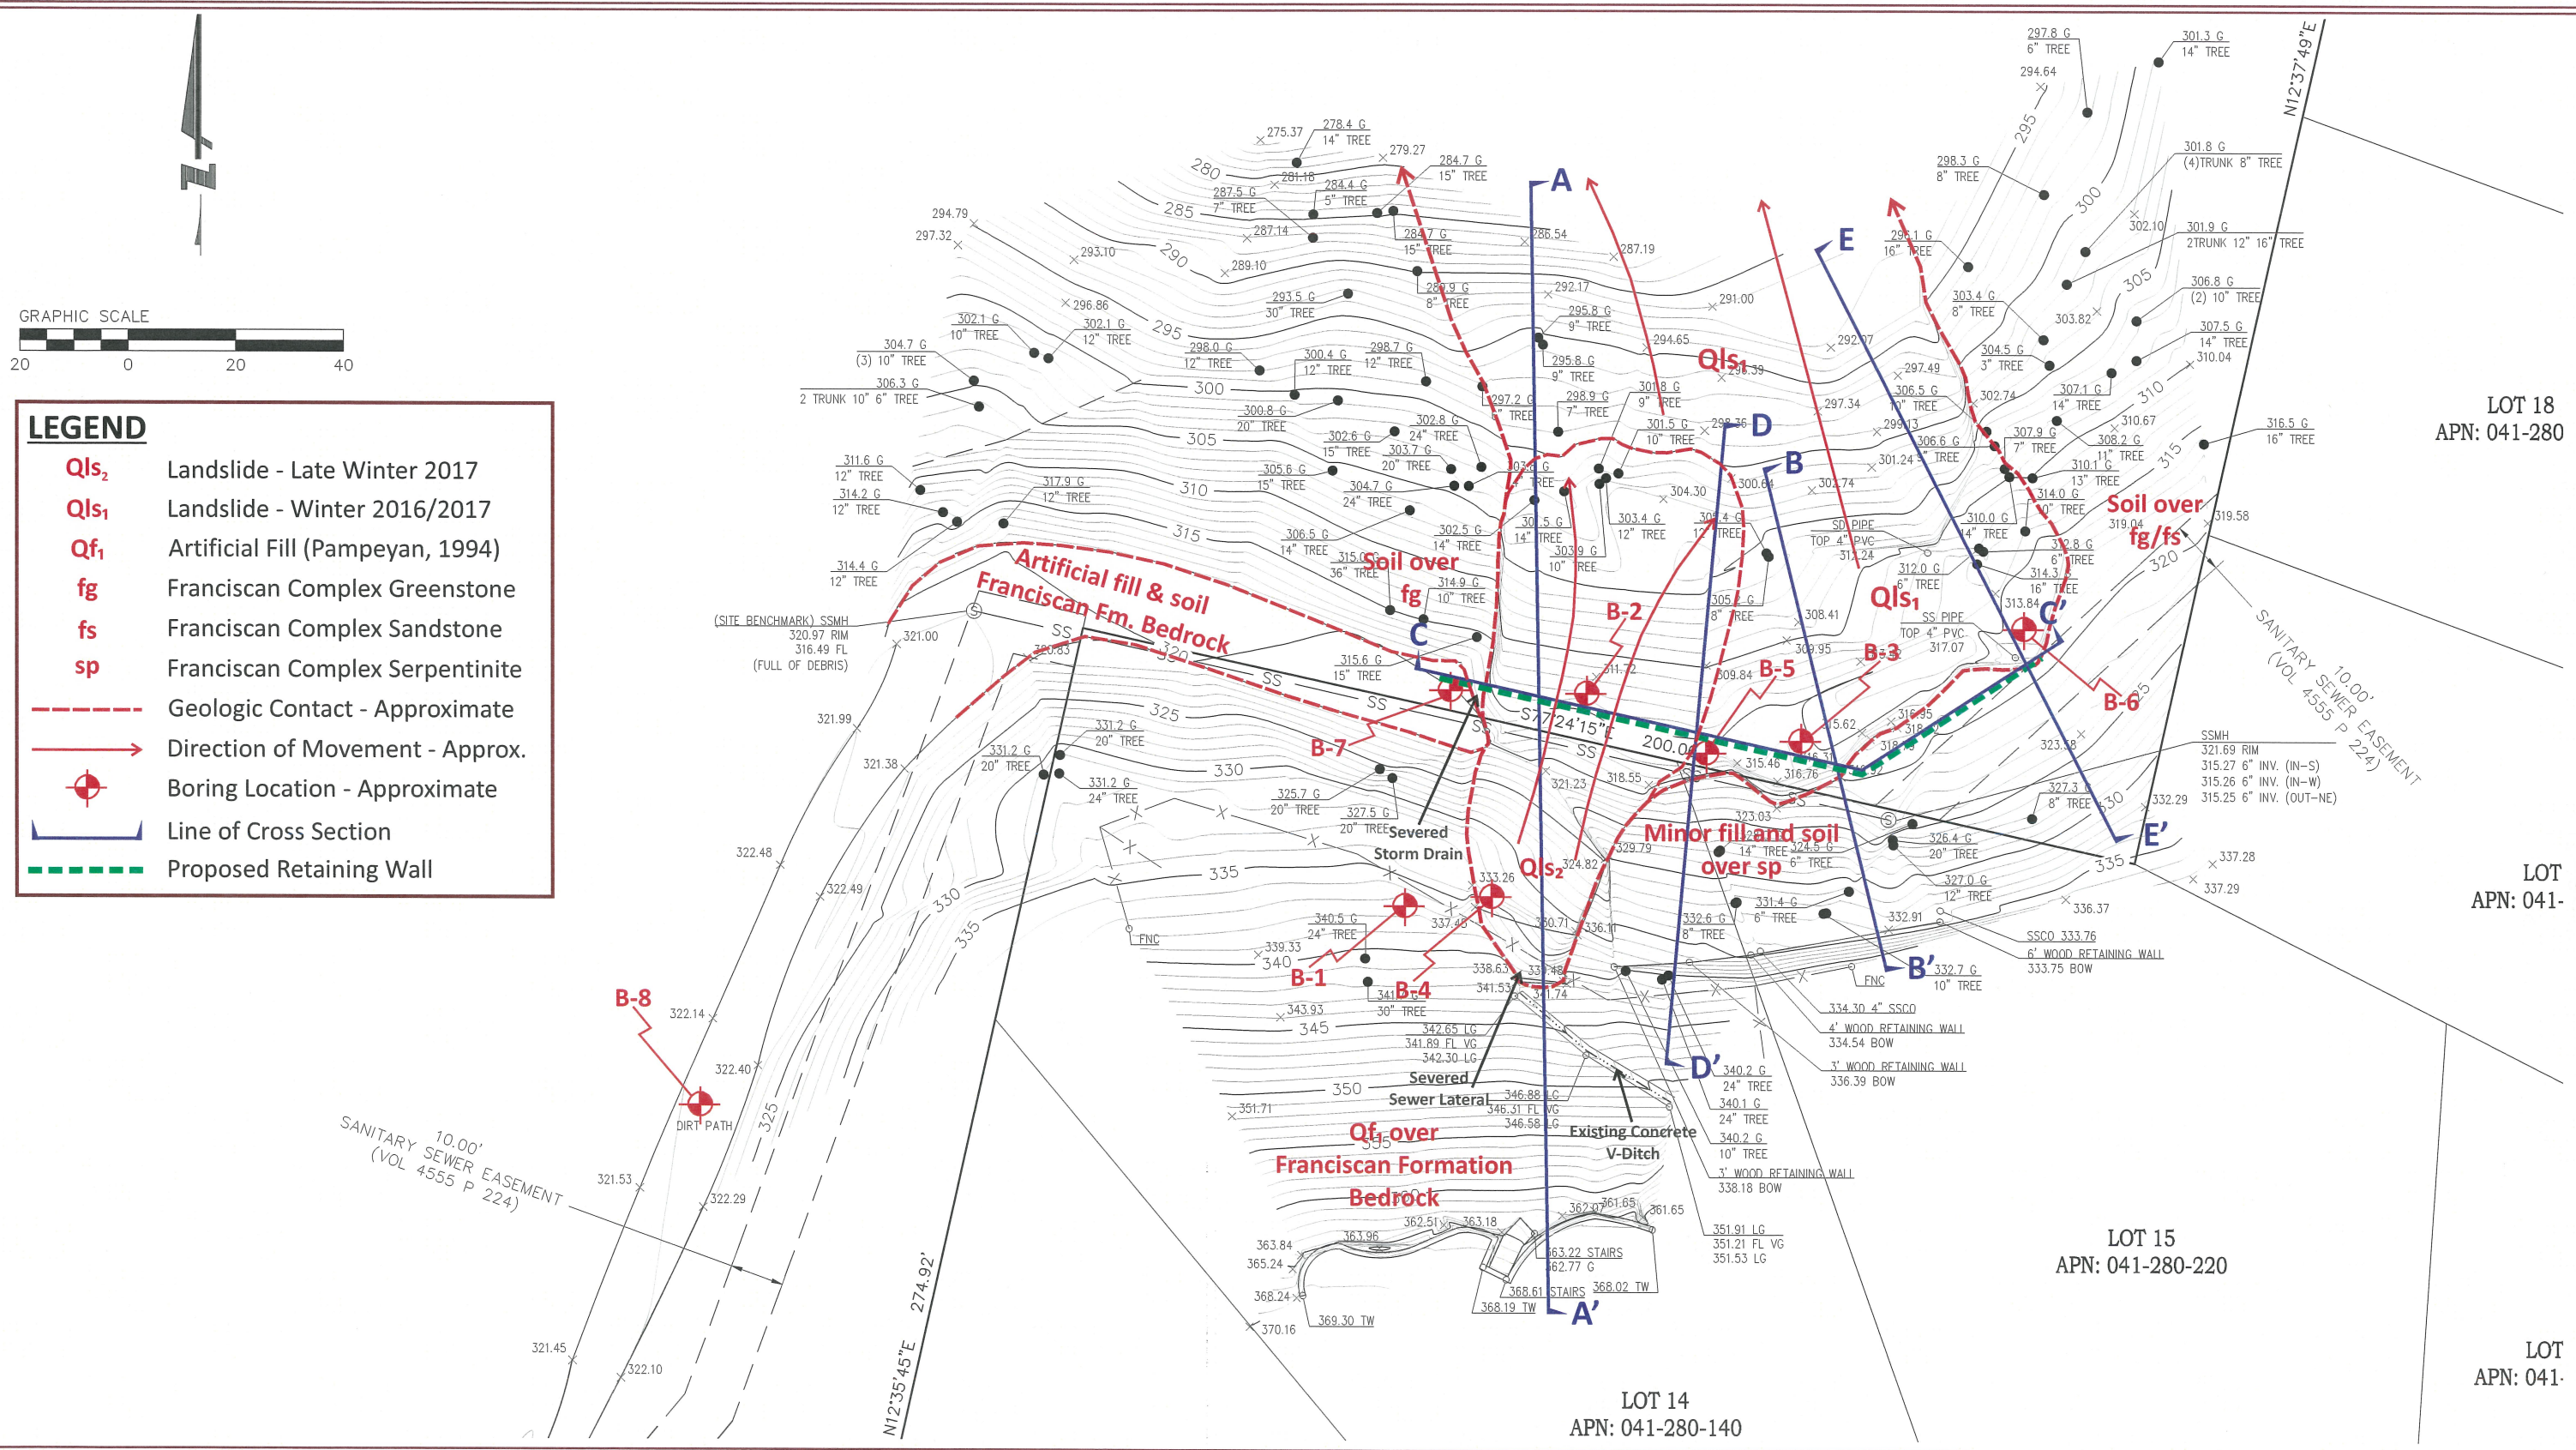
SITE PLAN			
JOB NO. BKFEN-34-00	SCALE: 1" ≈ 30'	DATE January 2018	PLATE 2

We noted a damaged corrugated metal storm drain pipe protruding from the west side of the scarp as shown on Plate 2, Site Plan. The pipe is believed to be connected to a catch basin at the back side of the access road where it collects drainage from the upslope area through a concrete lined V-ditch.

The damaged corrugated metal stormdrain pipe protruding from the west side of the mudslide still appeared to be producing water during our field exploration. Efforts should be made to investigate the origin of this runoff and divert it away from the mudslide area. As a minimum, a temporary flexible pipe should be connected to the severed storm drain pipe to divert any runoff away from the slide area and to the natural swale west of the slide area. Additionally, the severed storm drain pipe consists of corrugated metal and may be corroded and in need of replacement.

We note that the severed storm drain line should be repaired and re-routed such that it discharges onto an energy dissipater located off the mudslide area. BAGG will review the project plans and provide as needed consultation services to the design engineer to develop options for rerouting the severed storm drain line and other sources which could contribute to concentrated surface runoff in the backfill area.

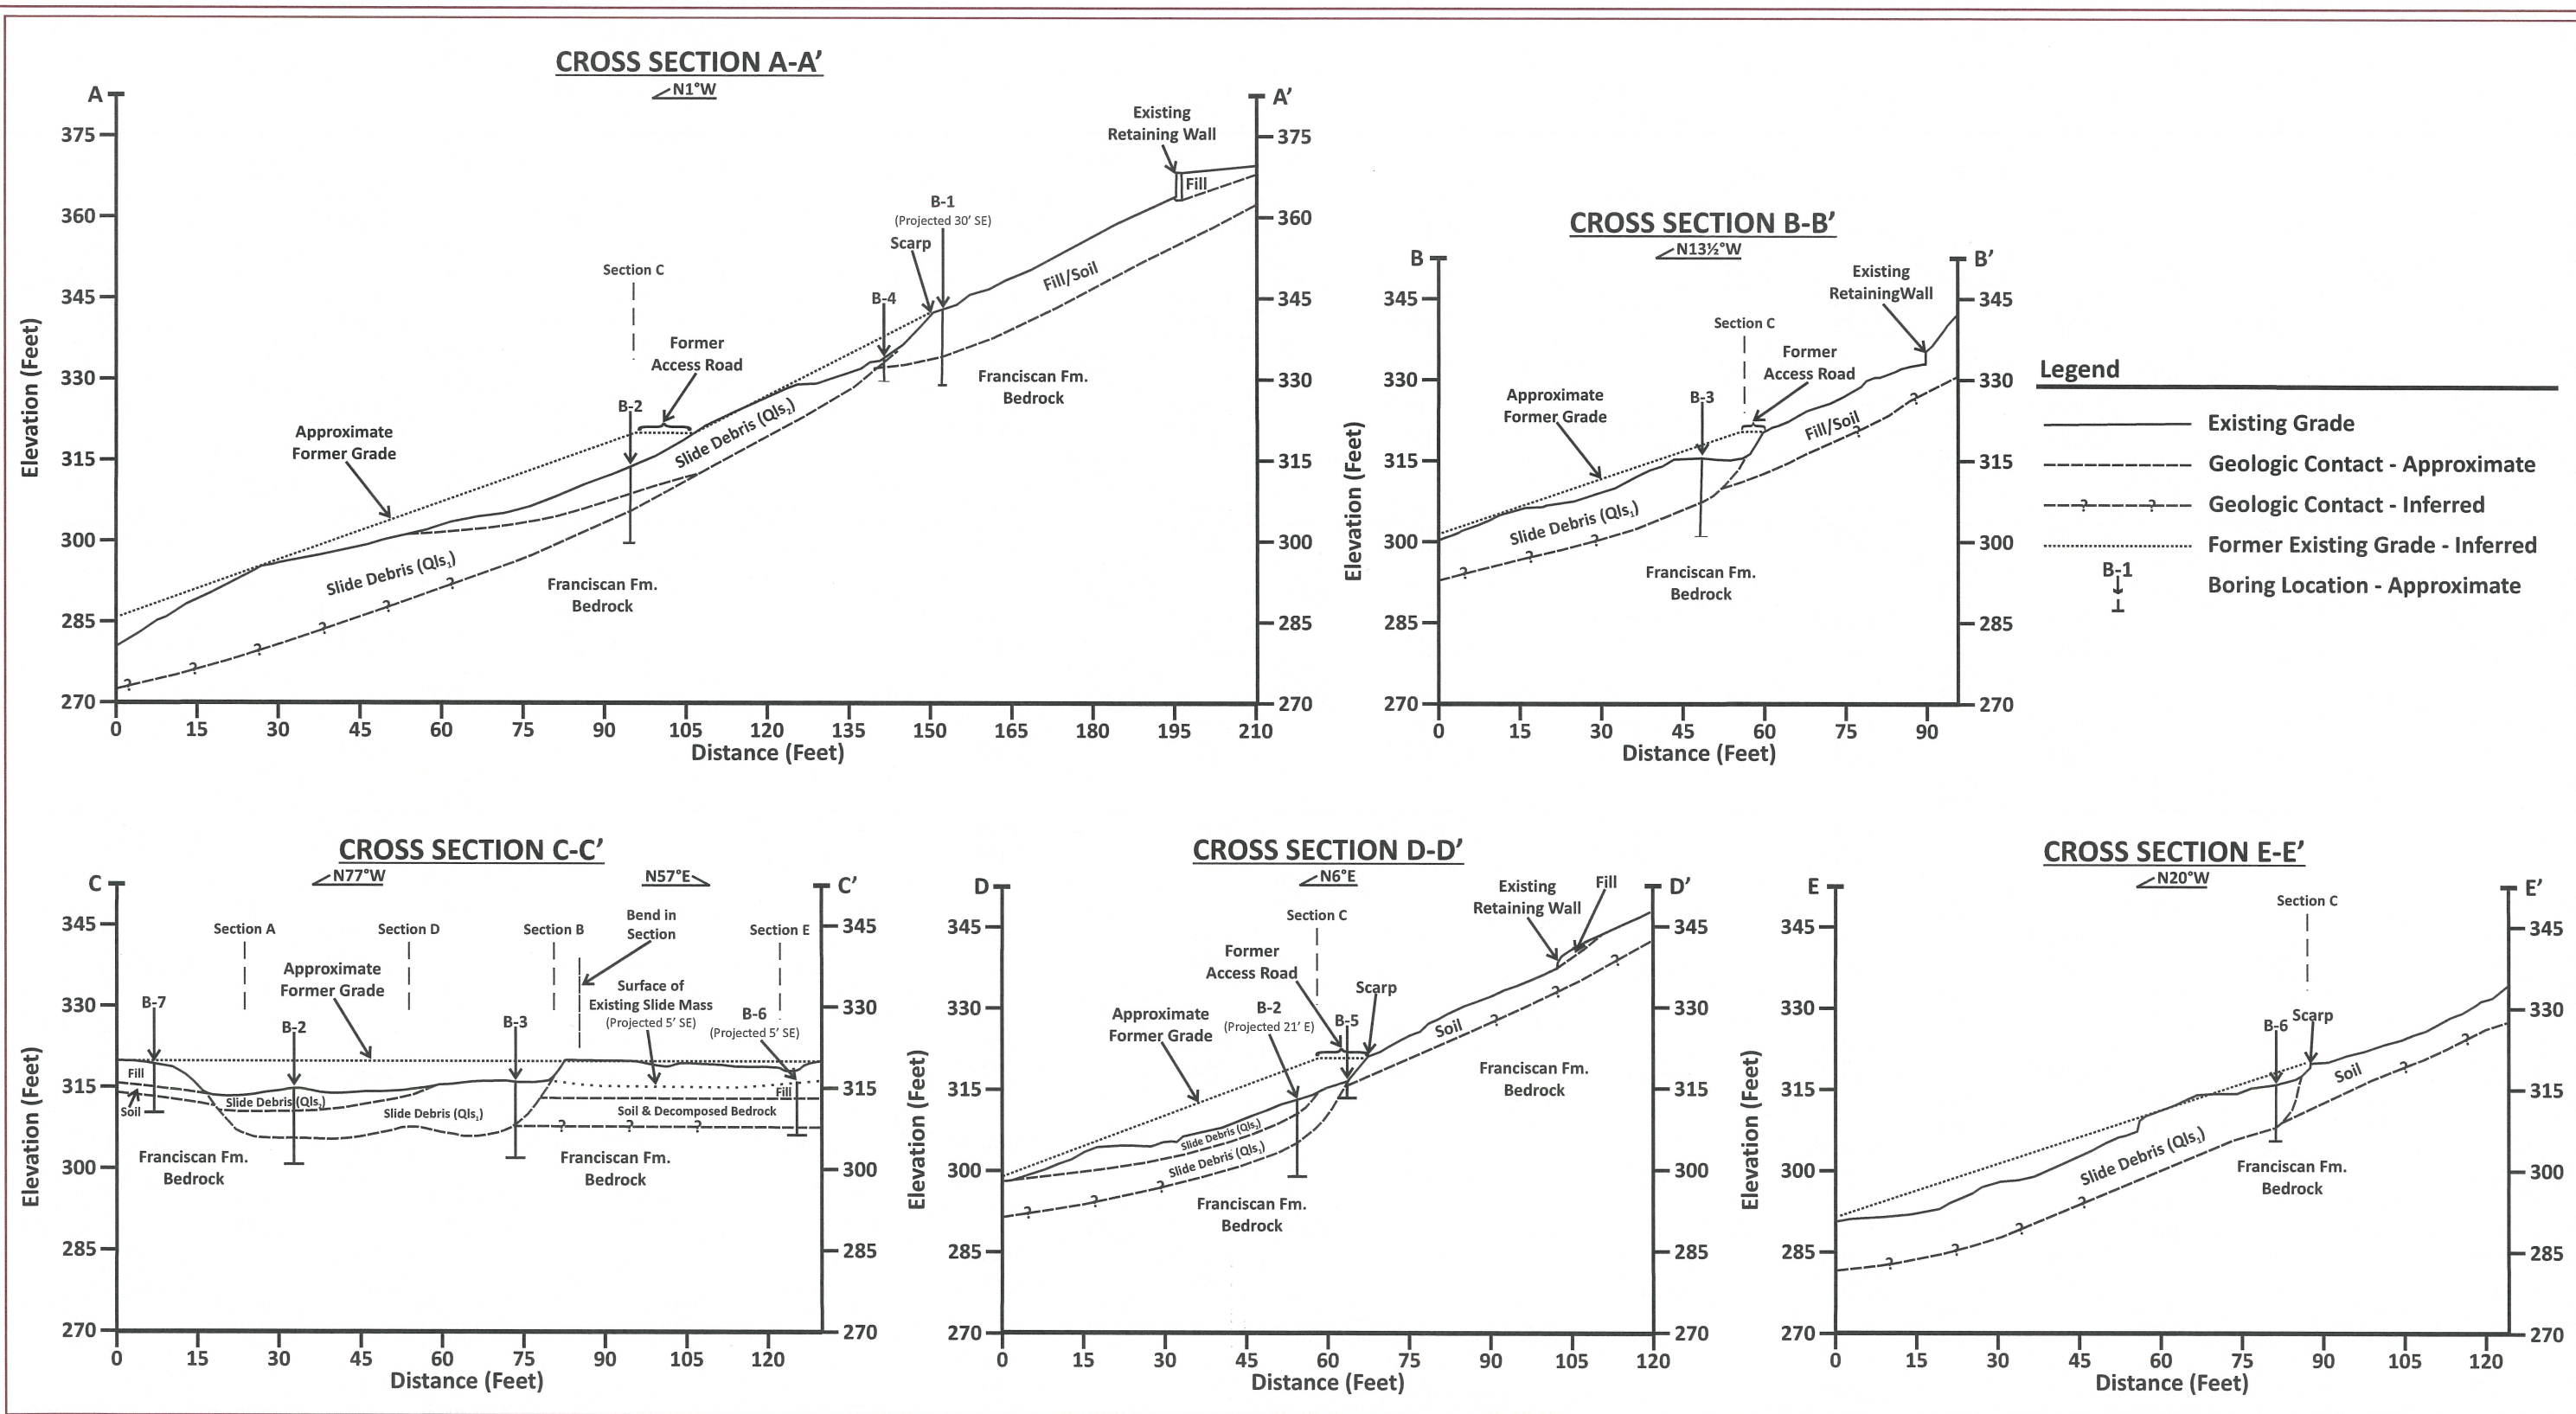
PLATE
3

Plate 3 shows cross-sections through various locations within the mudslide area. These cross-sections were developed based on an understanding of site geology and the results of our subsurface exploration. Cross-Section C-C' shows the approximate grade of the former access road and subsurface soil conditions along the approximate location of the proposed retaining wall. It is quite evident from this section that the soil conditions are quite variable across the proposed wall.
