# 751 Vista Drive Emerald Hills, CA Arborist Report 2024

October 10, 2024

Subject: Tree protection plan for 751 Vista Drive, Emerald Hills, CA 94062

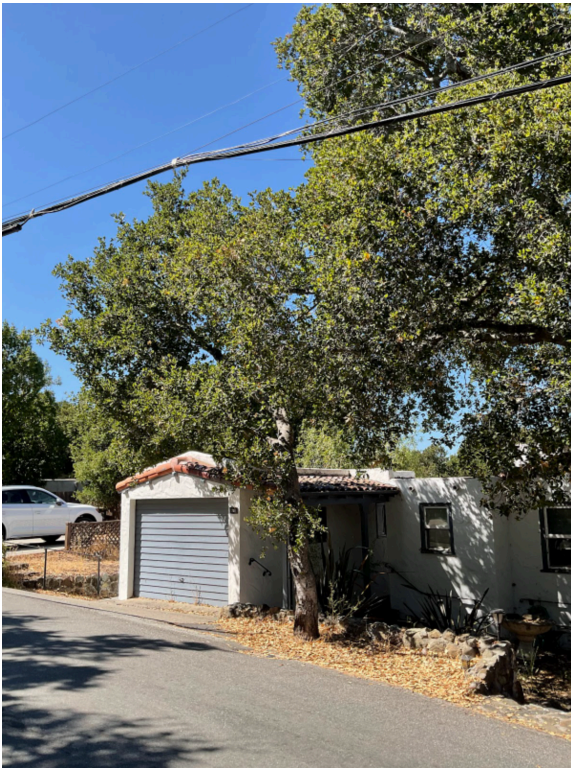
### Protected trees to be removed:

Tree tag #21 - coast live oak was assigned a Fair condition rating. The tree is located 3 feet from the road and is suppressed by dominant oak #22.

The proposed construction of a new driveway is expected to take place where the tree is located on the landscape.

- Tree #21 - coast live oak (protected), 15' wide canopy. Replacement trees needed: (3) or more trees, as determined by the Community Development Director, of the same species using at least five (5) gallon-size stock.

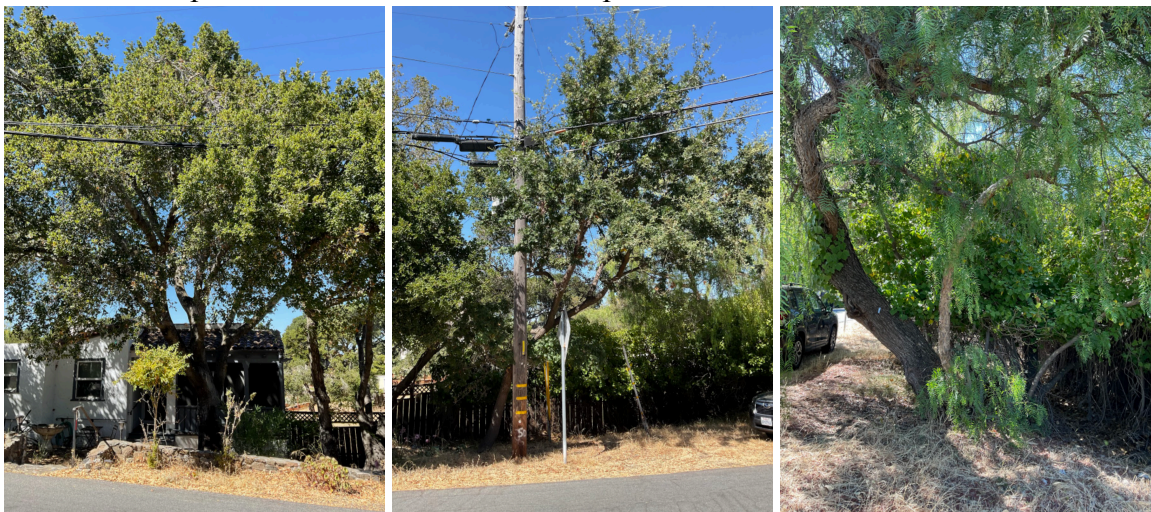
Installation of the new driveway is proposed within the dripline of protected trees #22 - #26. The proposed plan does a good job of placing the driveway where existing hardscapes and rock retaining walls are located. The existing hardscapes, rock walls, and home foundation have likely helped to discourage root growth in the area of proposed work. All excavation when within the dripline of the trees is required to be done by hand under the project arborist supervision. The grade for the driveway should match existing grades as close as possible or be higher up to reduce excavation depth. Impacts are expected to be minor to moderate. Grading and scarifying the soil will need to be done by hand under the Project Arborist supervision when working within the dripline of protected trees #22 - #26. Any exposed roots during the driveway work will need to be kept moist by covering roots in layers of wetted down burlap to help avoid root desiccation. Exposed roots will be required to be documented by the Project Arborist. Before the driveway work is to start, the tree protection zones are recommended to be heavily irrigated using 50 gallons of water. The top foot of the soil within the tree protection zone is recommended to be saturated.

**Showing trees #22 - #26 located at the front of the property.**

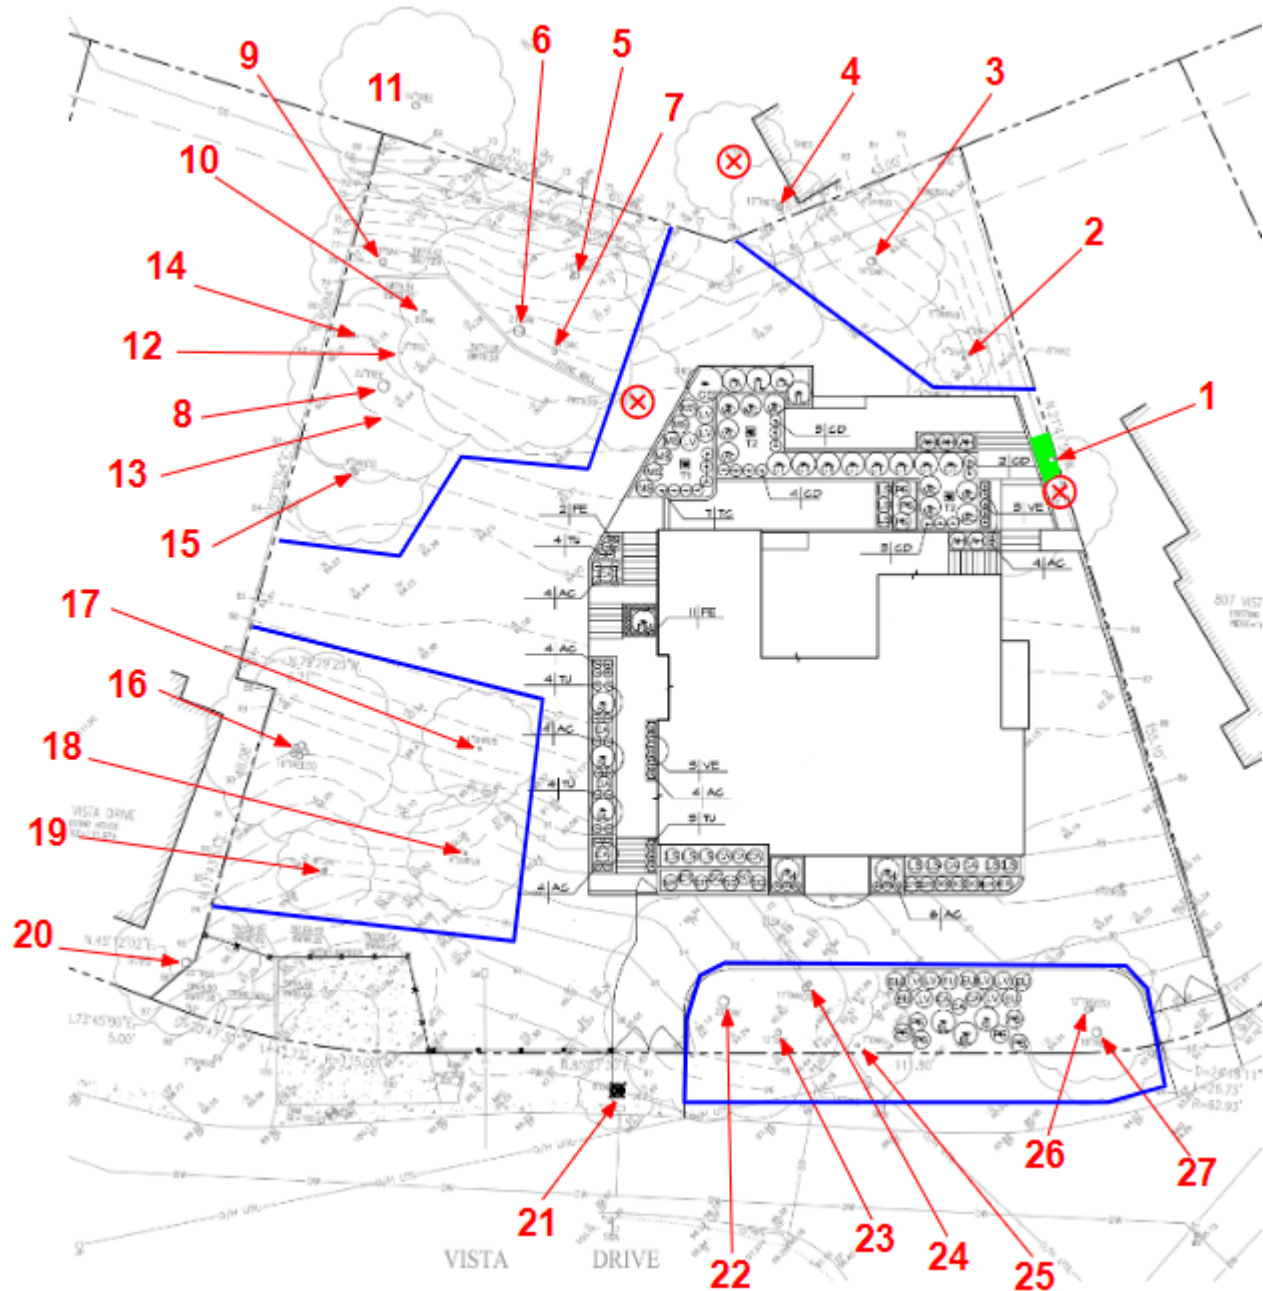
## TREE PROTECTION MAP

Approximate placement area of Type 1 Tree Protection Fencing shown outlined in **BLUE**.  
 Landscape Barrier Zone placement area for tree #1 shown in **GREEN**.
