# 1750 Cordilleras Rd

### Arborist Report 2024

Site: 1750 Cordilleras Rd  
Redwood City, CA 94062

Date: Jan 16, 2025

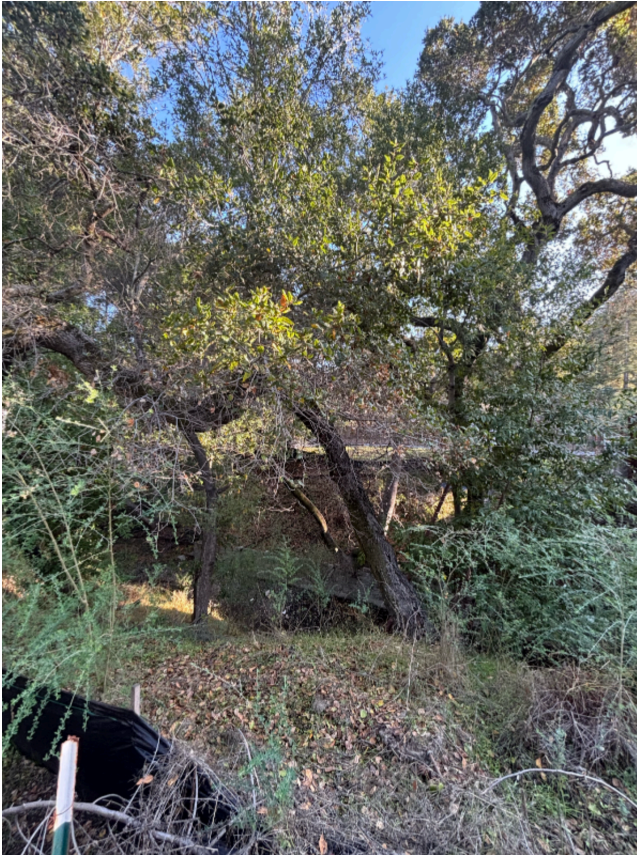
**Showing Tree #13**

Tree Tag #13, a Coast Live Oak (*Quercus agrifolia*), is nearly dead, exhibiting severe decline with a health rating of only 10%. The tree's poor condition poses a significant risk of failure, potentially endangering construction workers and nearby structures. Removal is warranted under Section 12,023(a)(1) and (a)(2) due to its health and safety implications.

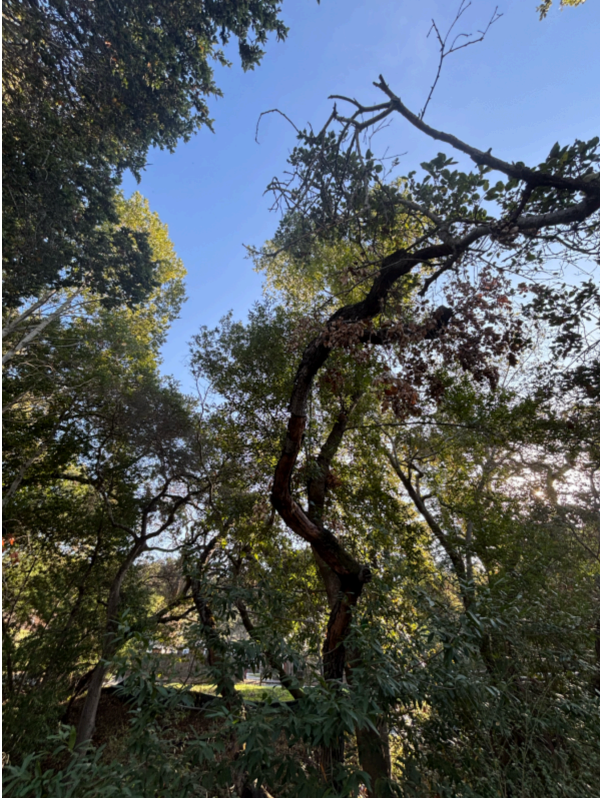
**Showing Tree #16**

Tree Tag #16, a Coast Live Oak (*Quercus agrifolia*), is entirely dead, with a condition rating of 0%. The tree poses a significant safety risk due to its potential for failure, especially as its structural integrity has been entirely compromised. Dead trees provide no ecological or structural benefits and represent a direct hazard to the construction zone. Its removal is justified under Section 12,023(a)(1), (a)(2), and (a)(5), as retaining a dead tree in close proximity to the construction area could jeopardize safety and impede project progress.

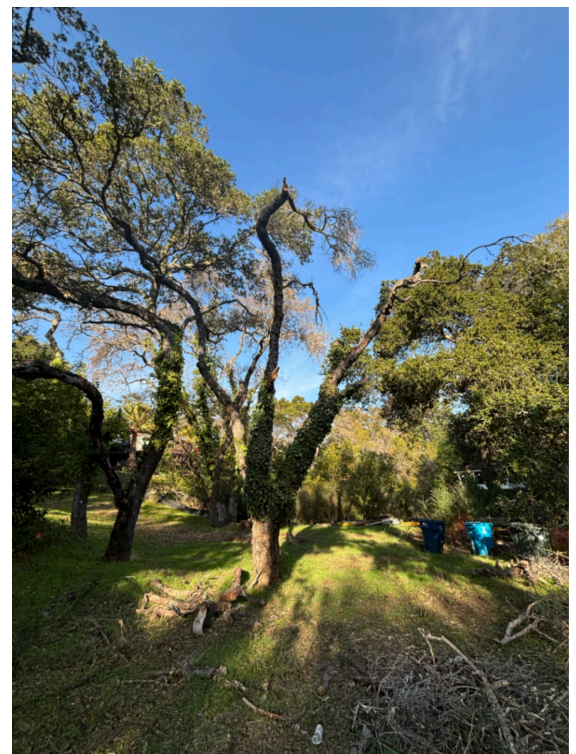
**Showing Tree #20**

Tree Tag #20, another Coast Live Oak, is completely dead with a 0% overall condition rating. This tree has no chance of recovery and its codominant structure at five feet further exacerbates the risk of collapse. Dead trees such as this are inherently hazardous and removal is essential under Section 12,023(a)(1), (a)(2), and (a)(5), as it could otherwise pose a threat to people and property.

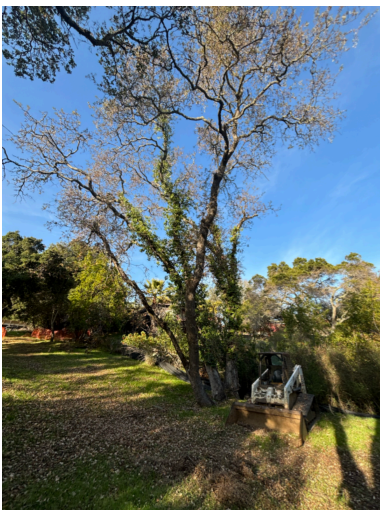
**Showing Tree Tags #21, #21b, and #21c**

Tree Tags #21, #21b, and #21c are Valley Oaks (*Quercus lobata*) that exhibit significant structural weaknesses, including decay at the root crown, a history of limb loss, and ivy growth enveloping their trunks. These trees have a fair health rating but poor structural integrity, making them unsuitable for long-term preservation. Their proximity to the proposed structure renders their removal necessary under Section 12,023(a)(6), as their retention would impede safe construction and reasonable use of the property.

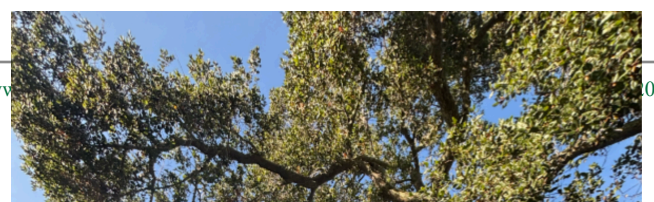
### Showing Tree #24

| Tree Tag # | Protected Tree | Preserve or Remove | Common Name/<br>Scientific Name | Trunk (in.) | Height (ft.) /<br>Canopy Spread (ft.) | Health Rating | Structural Rating | Form Rating | Suitability for Preservation | Overall Condition (0-100%) | Summary | Tree Picture #1 |
|---|---|---|---|---|---|---|---|---|---|---|---|---|
| 24 | Yes | (R) | Coast live oak<br><i>Quercus agrifolia</i> | 26 | 40/35 | Fair | Poor | Fair | Fair | 50% | Decay along limbs, close to driveway. | |

Tree Tags #22 through #25 are Coast Live Oaks with a range of structural and health issues, including trunk decay, dead limbs, and unbalanced canopies. These trees have overall condition ratings ranging from 30% to 50%. Their compromised structural stability, combined with their location within the proposed building footprint, poses a risk of failure and justifies removal under Section 12,023(a)(3) and (a)(6). For example, Tree Tag #23 leans heavily to the west with a history of limb loss and a one-sided canopy, creating a potential hazard to the site.

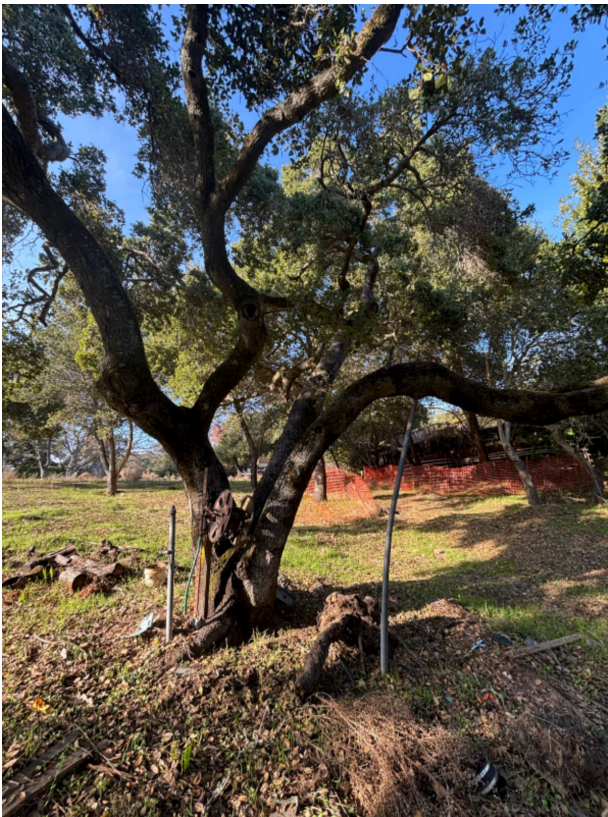
### Showing Tree #28

Tree Tag #27, a Coast Live Oak, and Tree Tag #28, a larger specimen, both exhibit codominant trunks with cavities and structural deficiencies. Although Tree Tag #28 is noted for its aesthetic value, its fair condition rating does not outweigh the risks associated with its location directly within the construction zone. The removal of these trees is necessary to ensure the safety and feasibility of the project under Section 12,023(a)(6).

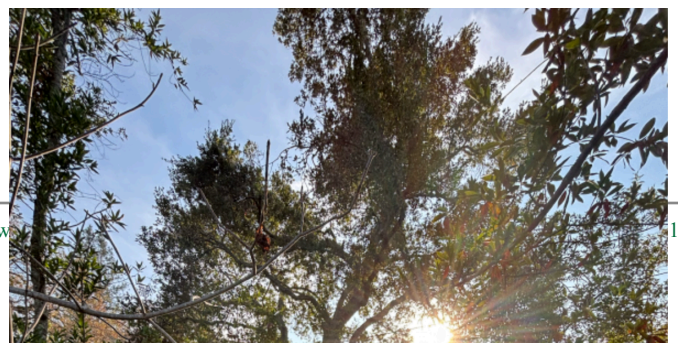
### Showing Tree #53

Several Blue Oaks (*Quercus douglasii*), including Tree Tags #38, #39, and #53, are completely dead with a 0% condition rating. Dead trees not only present an immediate safety hazard but also serve no ecological or aesthetic purpose. These trees must be removed under Section 12,023(a)(1) and (a)(5) to eliminate risks of collapse and ensure the safety of the construction zone.

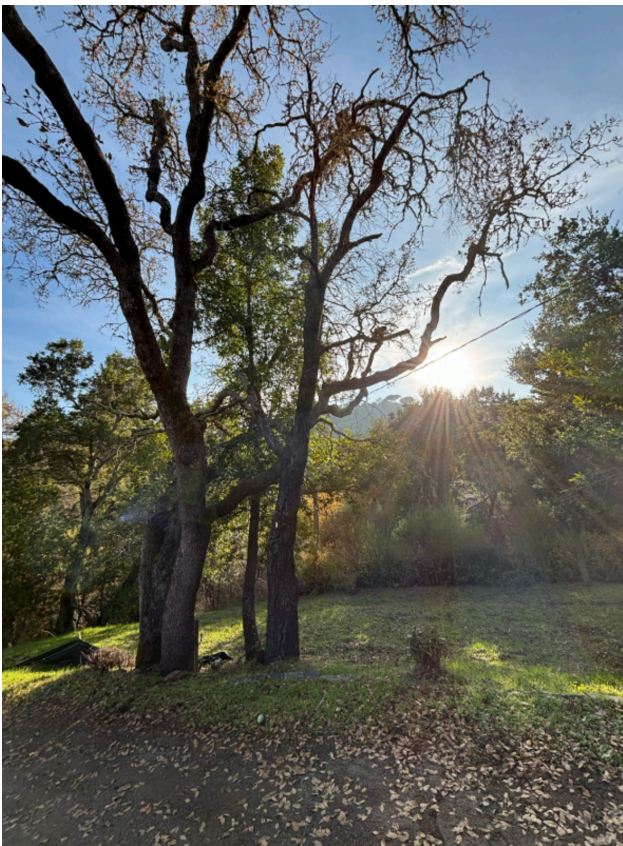
### Showing Tree #47

Coast Live Oak Tree Tags #41 and #47 also require removal as they are either failed or completely dead. Tree Tag #41 has already failed, and Tree Tag #47 is dead, making them unviable for retention. Both trees pose imminent safety risks to the site and fall within the criteria for removal under Section 12,023(a)(1), (a)(2), and (a)(5).

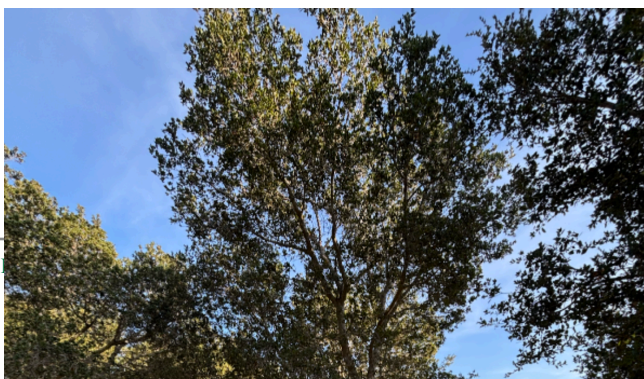
### Showing Tree #59

Tree Tag #59, another Coast Live Oak, has an overall condition rating of 60%. Although its health and structural ratings are fair, its form rating is poor due to its one-sided growth and suppression. The asymmetry and compromised form make it unsuitable for retention, especially given its location within the construction footprint. Retaining this tree would conflict with the objectives of the project and increase the likelihood of structural issues or failure in the future. Its removal is necessary under Section 12,023(a)(6) to ensure the safe and efficient use of the property.
