# SEAL COVE GEOLOGIC STUDY

## Seal Cove Neighborhood - Moss Beach Community, San Mateo California

**December 2025**

**SUBJECT: Seal Cove Geologic Study**  
**RE: Seal Cove Neighborhood**  
Moss Beach Community, San Mateo County, California

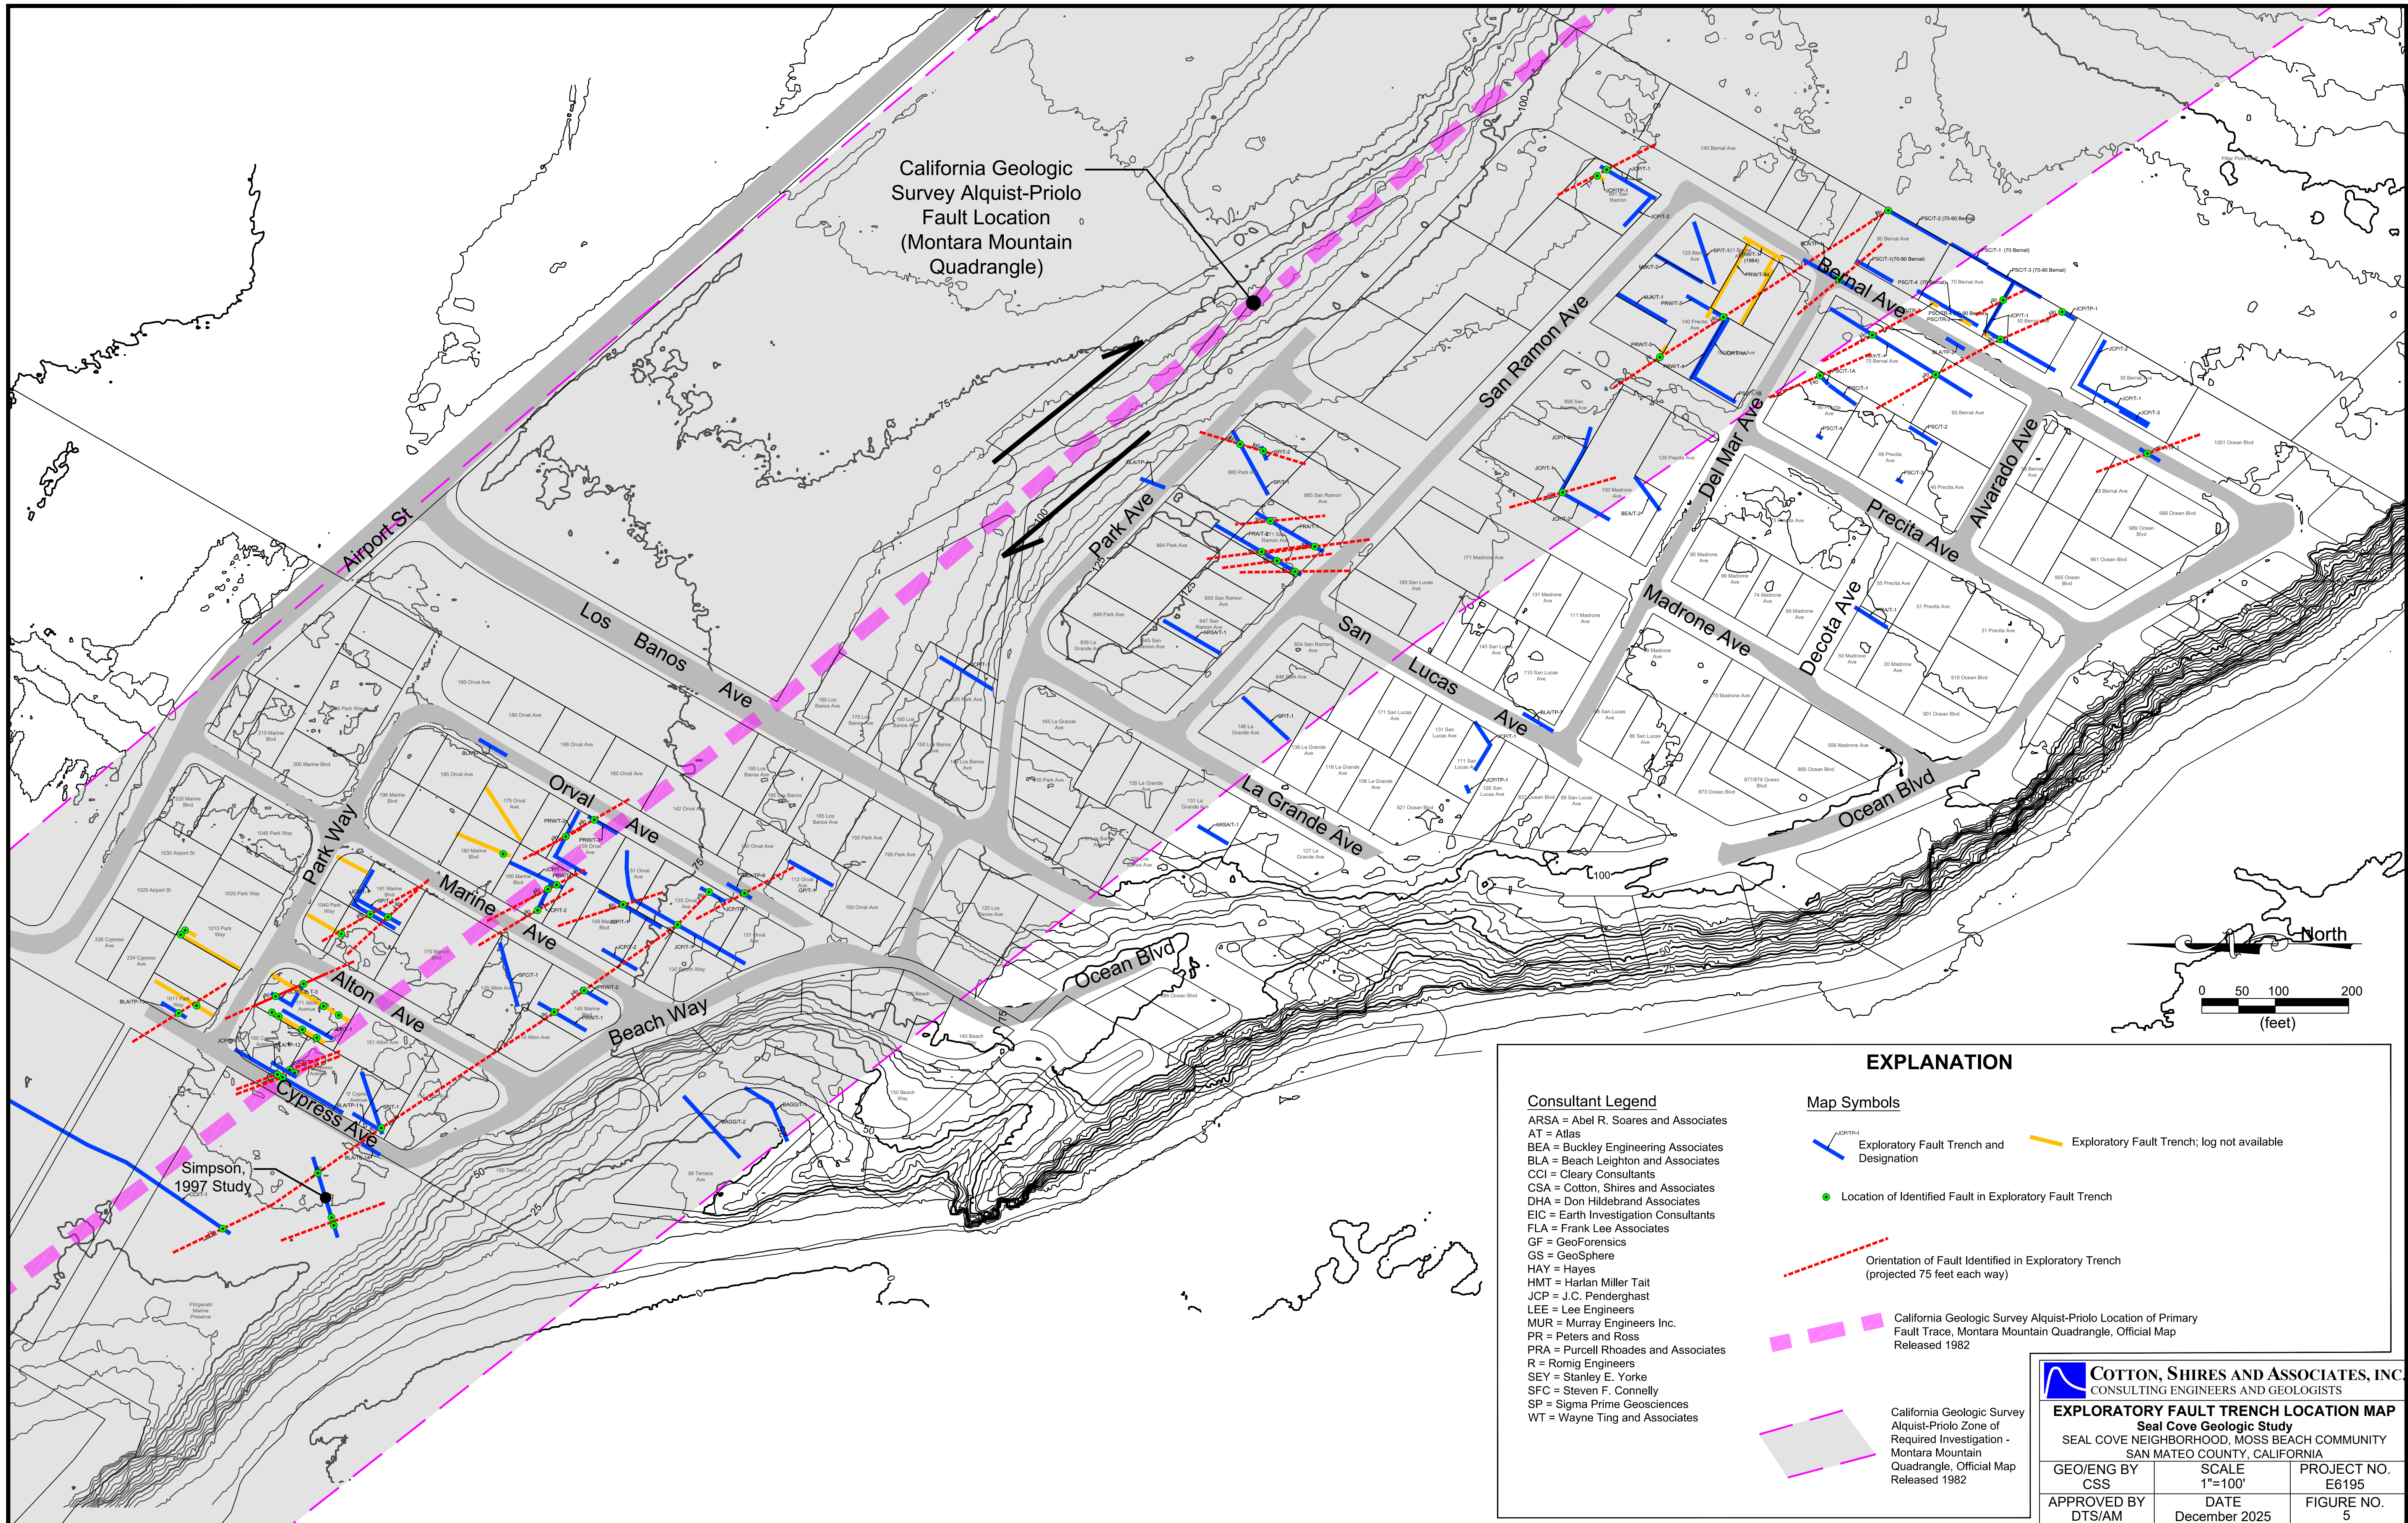
GEO/ENG BY CSS	SCALE 1"=100'	PROJECT NO. E6195
APPROVED BY DTS/AM	DATE December 2025	FIGURE NO. 5

The 1997 Simpson study concluded that the most recent fault rupture event and the penultimate fault rupture event were exposed in their exploratory fault trench. The location of the 1997 Simpson fault trench is shown on Figure 5 (at the north end of the study area). Simpson, utilized radiometric dating techniques, stratigraphic, and ethnostratigraphic (midden deposit) relationships to estimate the age of the most recent and penultimate fault rupture. Based on their analysis Simpson concluded that the most recent event occurred between 1270 AD and 1775 AD (250 to 755 years before present) and the penultimate event occurred between 620 AD and 1400 AD (625 to 1405 years before present). Finally, the Simpson study concluded that the most recent event was located near the western end of their trench (Figure 5), approximately 200 feet west of the projected east facing escarpment fault position. We note that the orientation of the most recent fault rupture event and the projection of the fault trace to the south align with the headscarp of the northern portion of the active landslide.

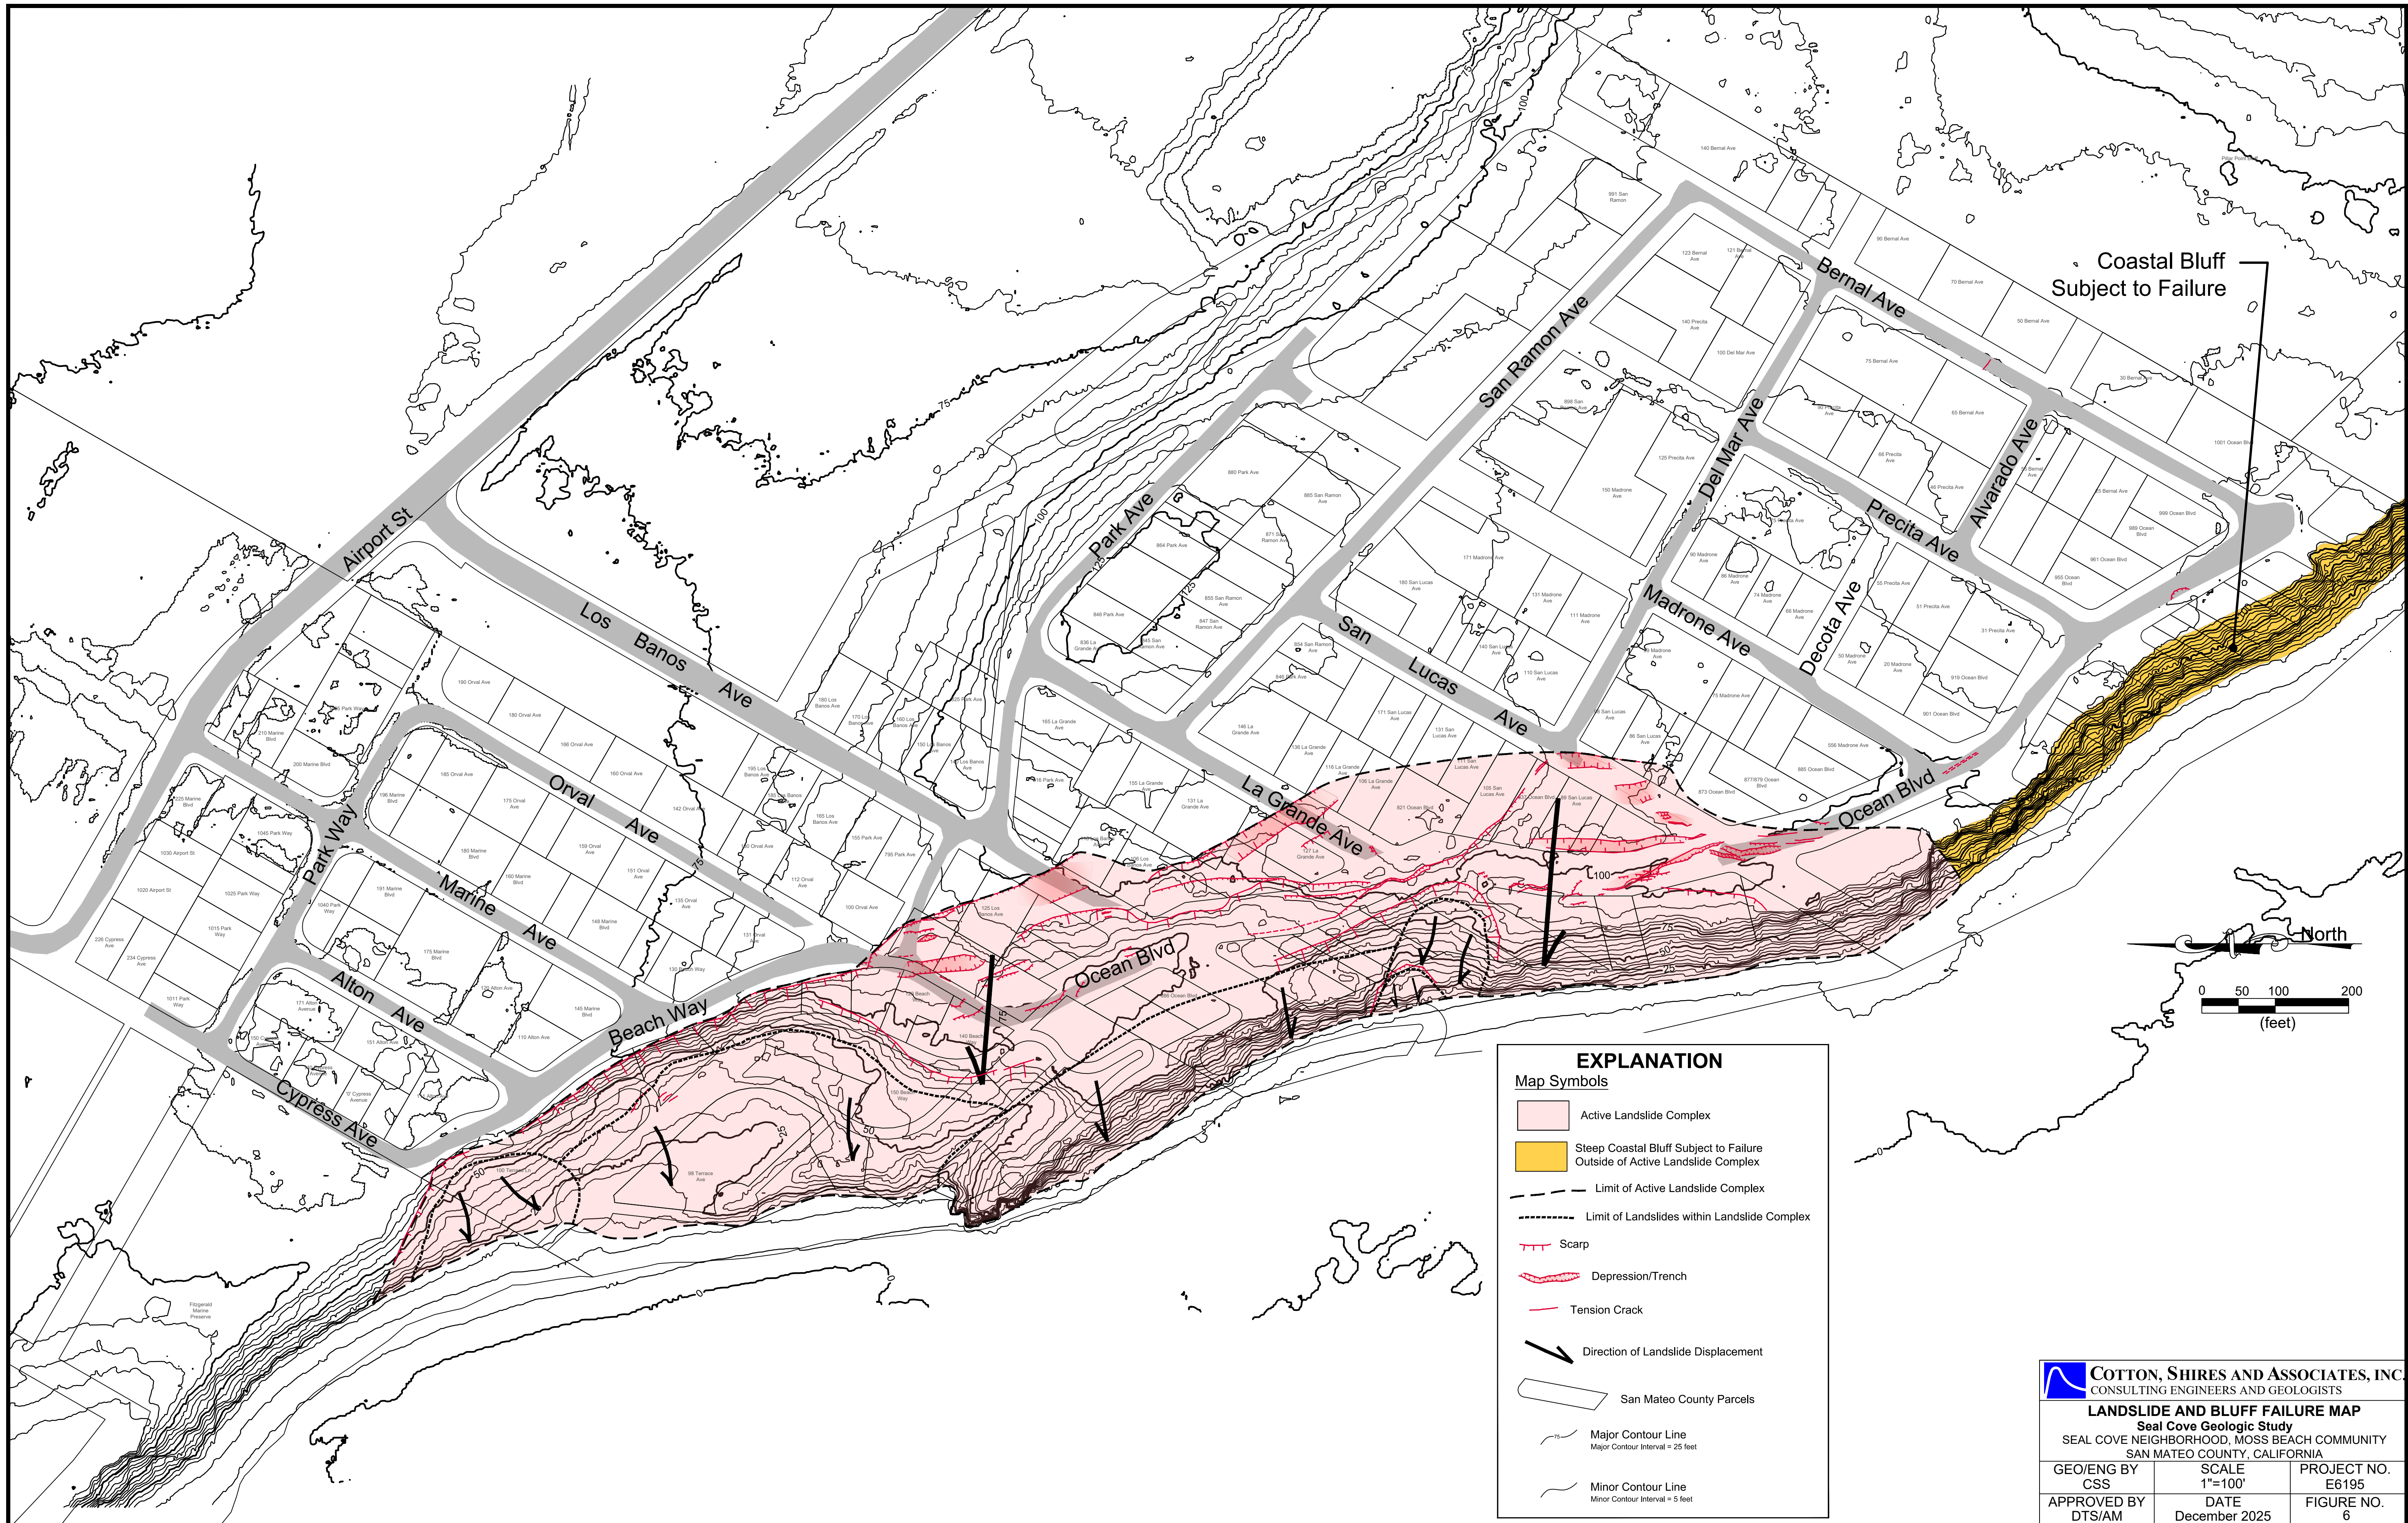
GEO/ENG BY CSS	SCALE 1"=100'	PROJECT NO. E6195
APPROVED BY DTS/AM	DATE December 2025	FIGURE NO. 6

The limits of the active landslide complex, based on our recent mapping, are shown on Figure 6. The active landslide complex in Seal Cove has caused road closures, abandoned homes, broken sewer lines, broken water mains, and caused various other issues affecting

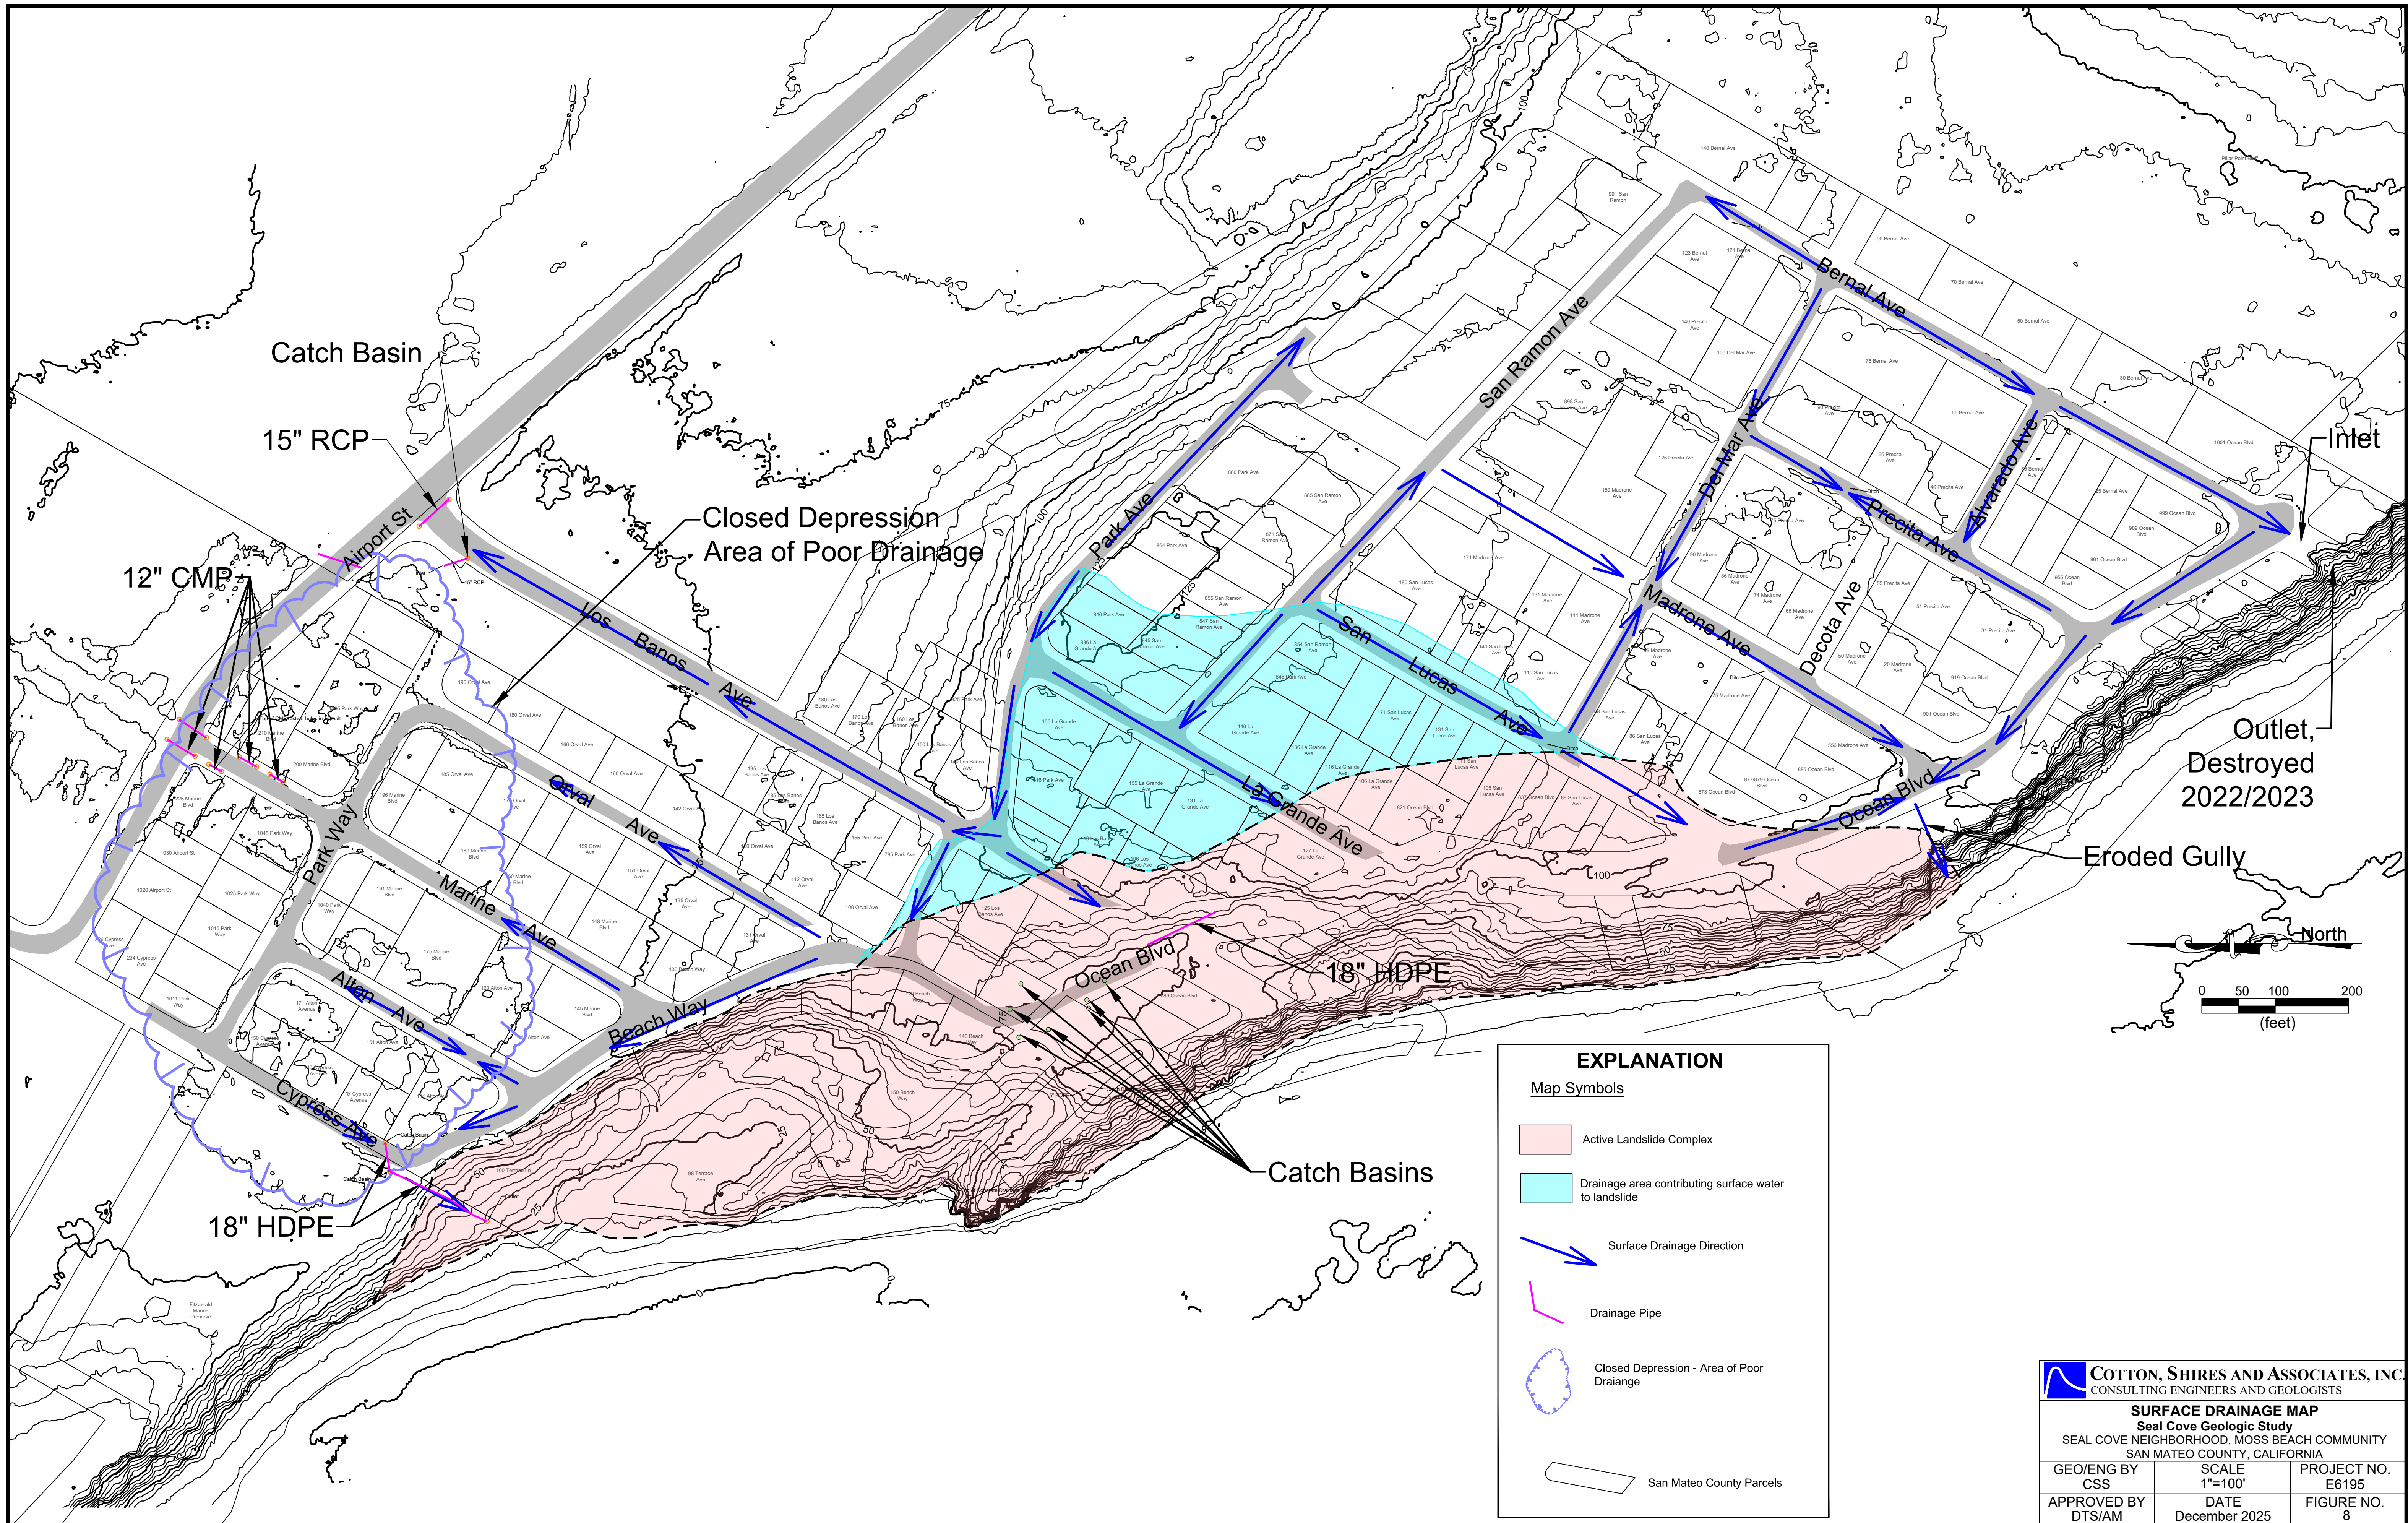
GEO/ENG BY CSS	SCALE 1"=100'	PROJECT NO. E6195
APPROVED BY DTS/AM	DATE December 2025	FIGURE NO. 8

We also observed multiple ditches throughout the neighborhood that were not included within the county's drainage map. Additionally, we observed areas of pooled water, partially blocked storm drain inlets on private property (overgrown with grass and debris), and gullied areas along the bluff face.

Many of the storm drain ditches divert water directly to the edge of the sea bluff, along Ocean Boulevard, where they drain directly over the edge and, in places, have created erosion gullies that have begun to recede towards the roadway. These gullies were observed near the intersection of Madrone Avenue and Ocean Boulevard, just west of the roadway near the mailboxes, as well as at the intersection of Bernal Avenue and Ocean Boulevard. Based on our review of historical aerial photos, it appears that the eroded gully existed prior to the development of the neighborhood. We were unable to locate the inlet and outlet marked on County maps, in the vicinity of the Bernal Avenue and Ocean Boulevard intersection. Based on our review of aerial photos from recent years, it appears that the outlet pipe was destroyed sometime during the 2022/23 winter. The area around this inlet is eroded and gullied.

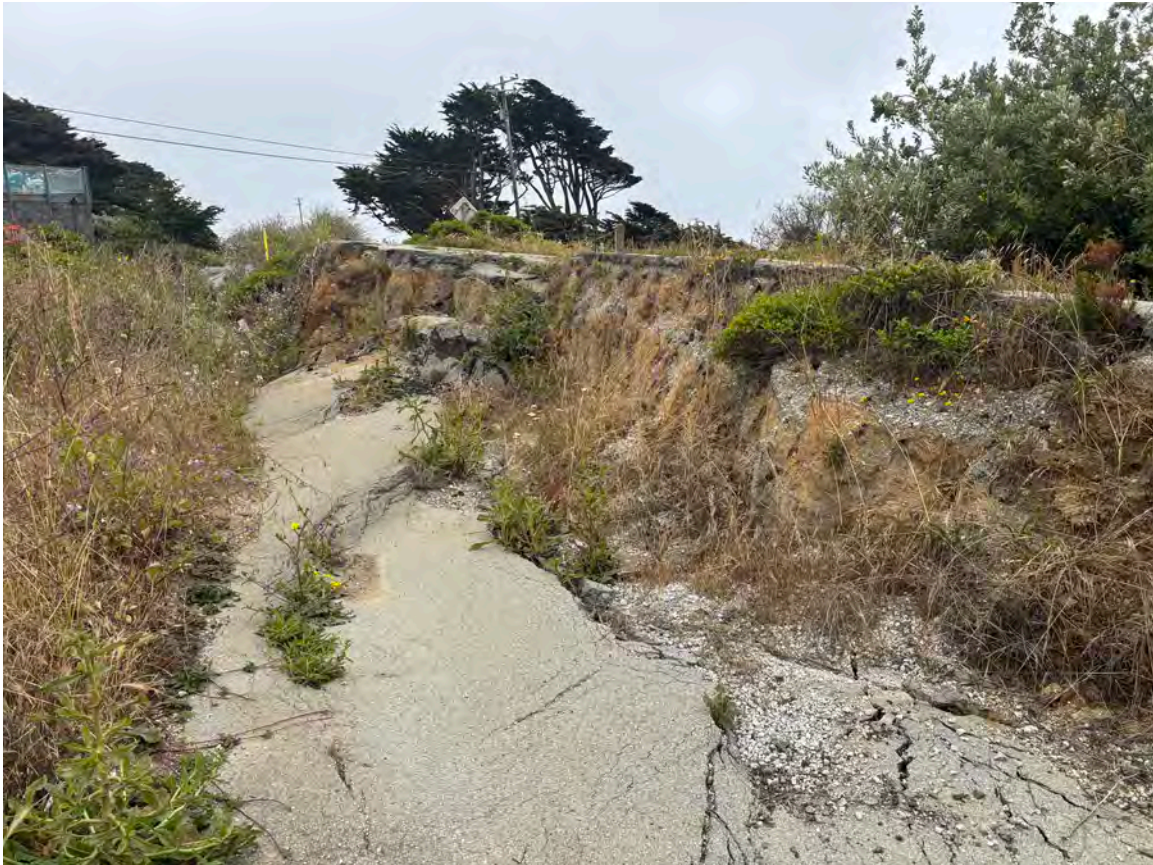
Prominent scarps along Ocean Boulevard range in height from 0.5 to 7 feet, and alternate in slope direction, sloping both inland and toward the bluff. As identified within the WCA 1980 study, the active landslide is characterized by progression from north to south and the mode of failure is a rotational failure along a concave-upward basal rupture surface.

**Photo 1: Scarp along Ocean Boulevard, between San Lucas Avenue and La Grande Avenue. Photo is taken facing toward the south. Height of scarp is 3-7 feet, with the downslope side facing inland (away from the sea bluff). Date of Photo: June 25, 2025**

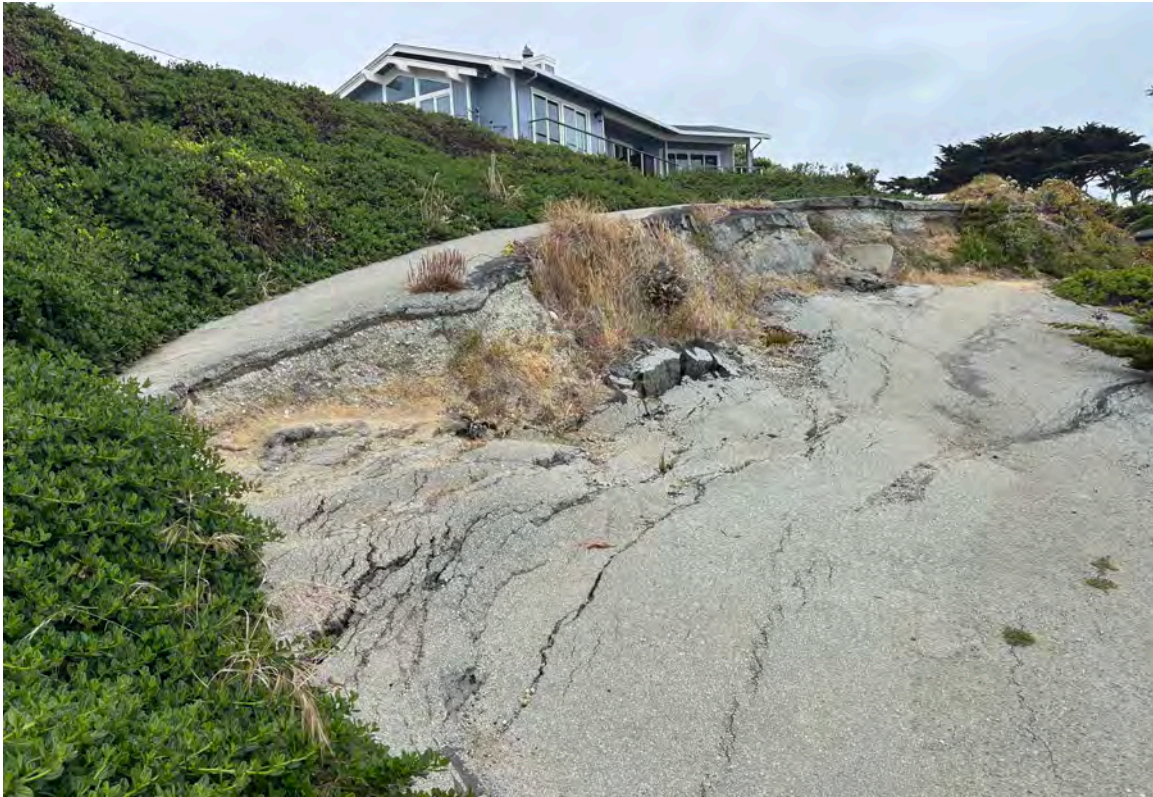
**Photo 2: Scarp at the intersection of La Grande Avenue and Ocean Boulevard. Photo is taken facing southeast. Height of the scarp is 4-6 feet, with the downslope side facing the sea bluff. The asphalt above the scarp is sloped inland. Date of photo: June 25, 2025**

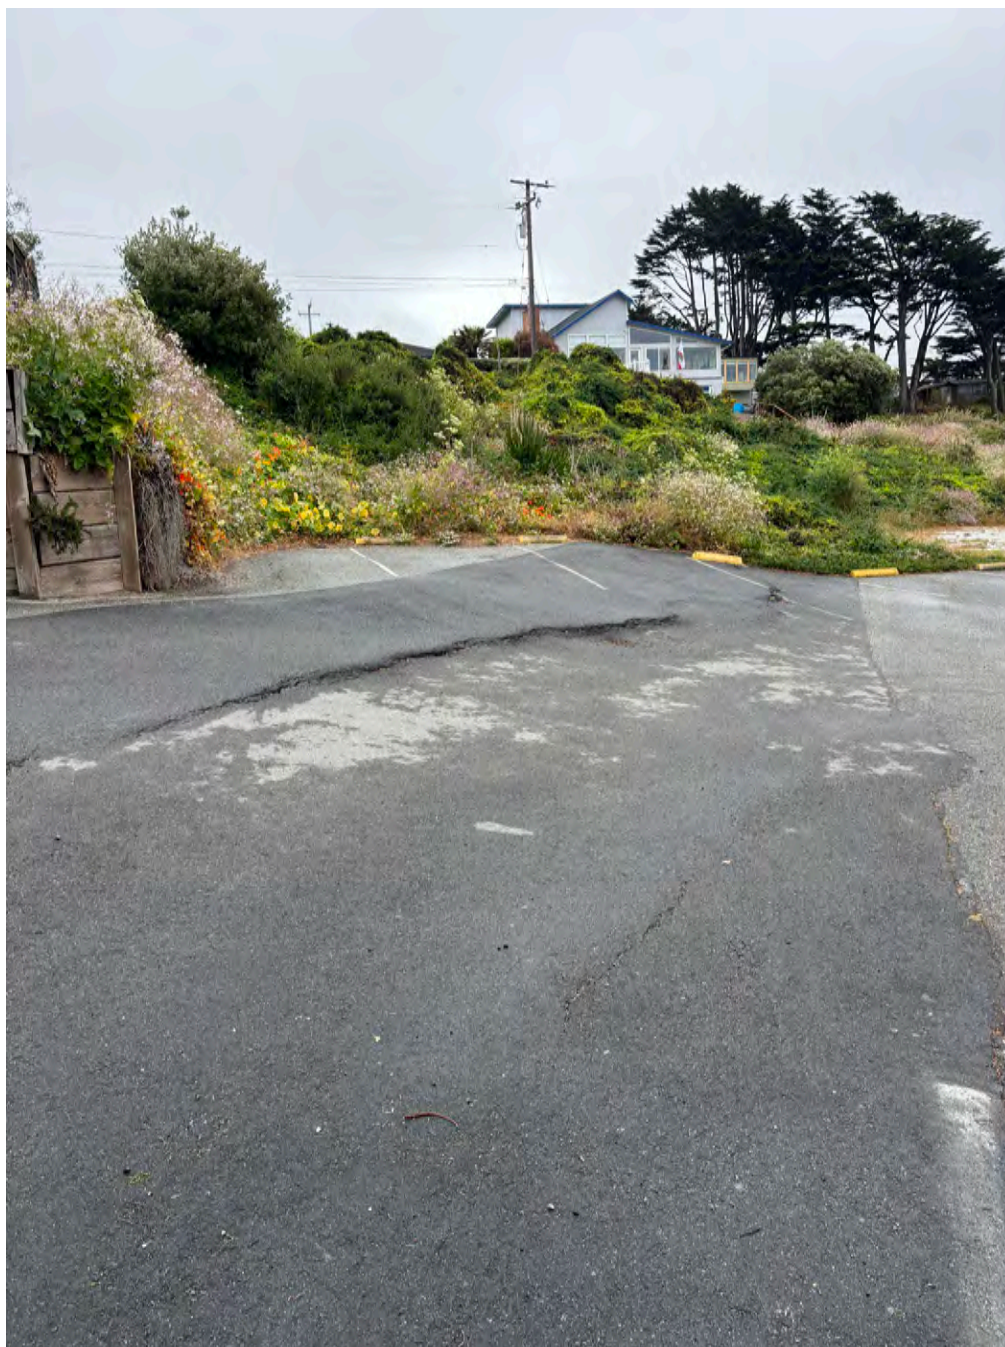
edge of the Moss Beach Distillery parking lot and forms a 10-foot-tall scarp that slopes towards the restaurant. This scarp continues through 125 and 116 Los Banos Avenue. Depressions, cracks, and minor scarps were observed within the Moss Beach Distillery parking lot. At 795 Park Avenue, we observed a power pole leaning towards the northwest at an angle of approximately 10 degrees. The adjacent pole to the northwest is located within the active landslide boundary near the scarp east of Moss Beach Distillery and displacement of the landslide is likely causing the observed tilt in the pole adjacent to 795 Park Avenue.

**Photo 3: Scarp in Moss Beach Distillery parking lot, east of the restaurant. Photo taken facing southeast. Date of photo: June 25, 2025.**

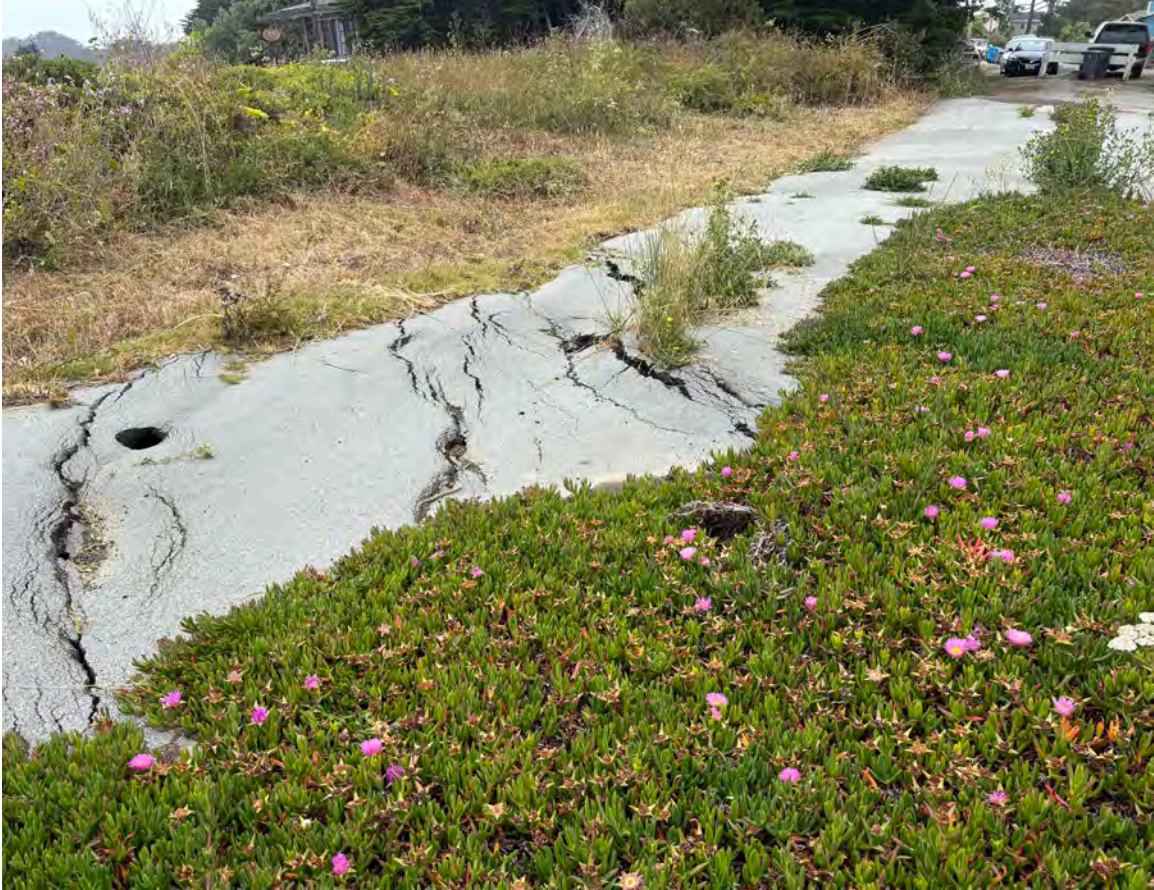
We understand that SMC has been notified of recent distress in the Seal Cove neighborhood, likely related to landslide movement, including in the vicinity of San Lucas Avenue between Ocean Boulevard and Del Mar Avenue. SMC staff observed recent distress, including “ . . . road subsidence and damage, multiple water main breaks, and property damage.” In addition, SMC staff noted that some of the reported “ . . . distress appears in areas within Hazard Zones 2 and 3, eastward of the 1980 mapped landslide.” We also understand that since the 1980 WCA report, a portion of Ocean Boulevard was closed around 2006 due to landslide movement between San Lucas Avenue to the south and Los Banos Avenue to the north.

**Photo 4: Graben, cracking, and sink hole (left) along San Lucas Avenue between Ocean Boulevard and Del Mar Avenue. Photo taken facing north. Date of photo: June 25, 2025.**

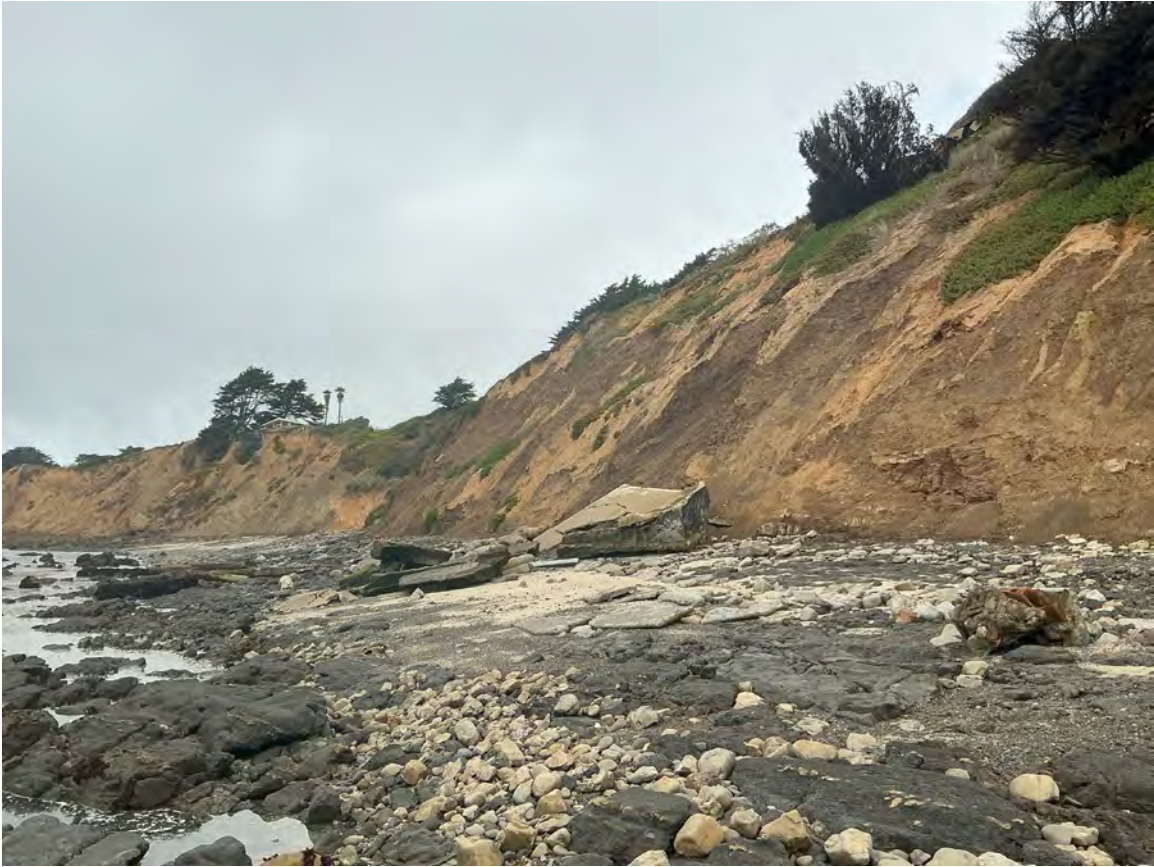
We observed several sites at the base of the coastal bluffs that contained remnants of infrastructure, originally situated on top of the bluffs, that were displaced during failures associated with bluff retreat (see Appendix D, Photo 5). The materials we noted included concrete foundations, wooden beams, concrete blocks, bricks, and metal.

**Photo 5: Collapsed foundation, originally atop the sea bluff, now along the beach between San Lucas Avenue and La Grande Avenue. Photo taken facing north. Date of photo: July 27, 2025.**
