**GEOTECHNICAL DESIGN REPORT**

**SLIP-OUT REPAIR NEAR 1780 HIGGINS CANYON ROAD**

**CE&G DOCUMENT: 0207545.001**

**SEPTEMBER 15, 2023**

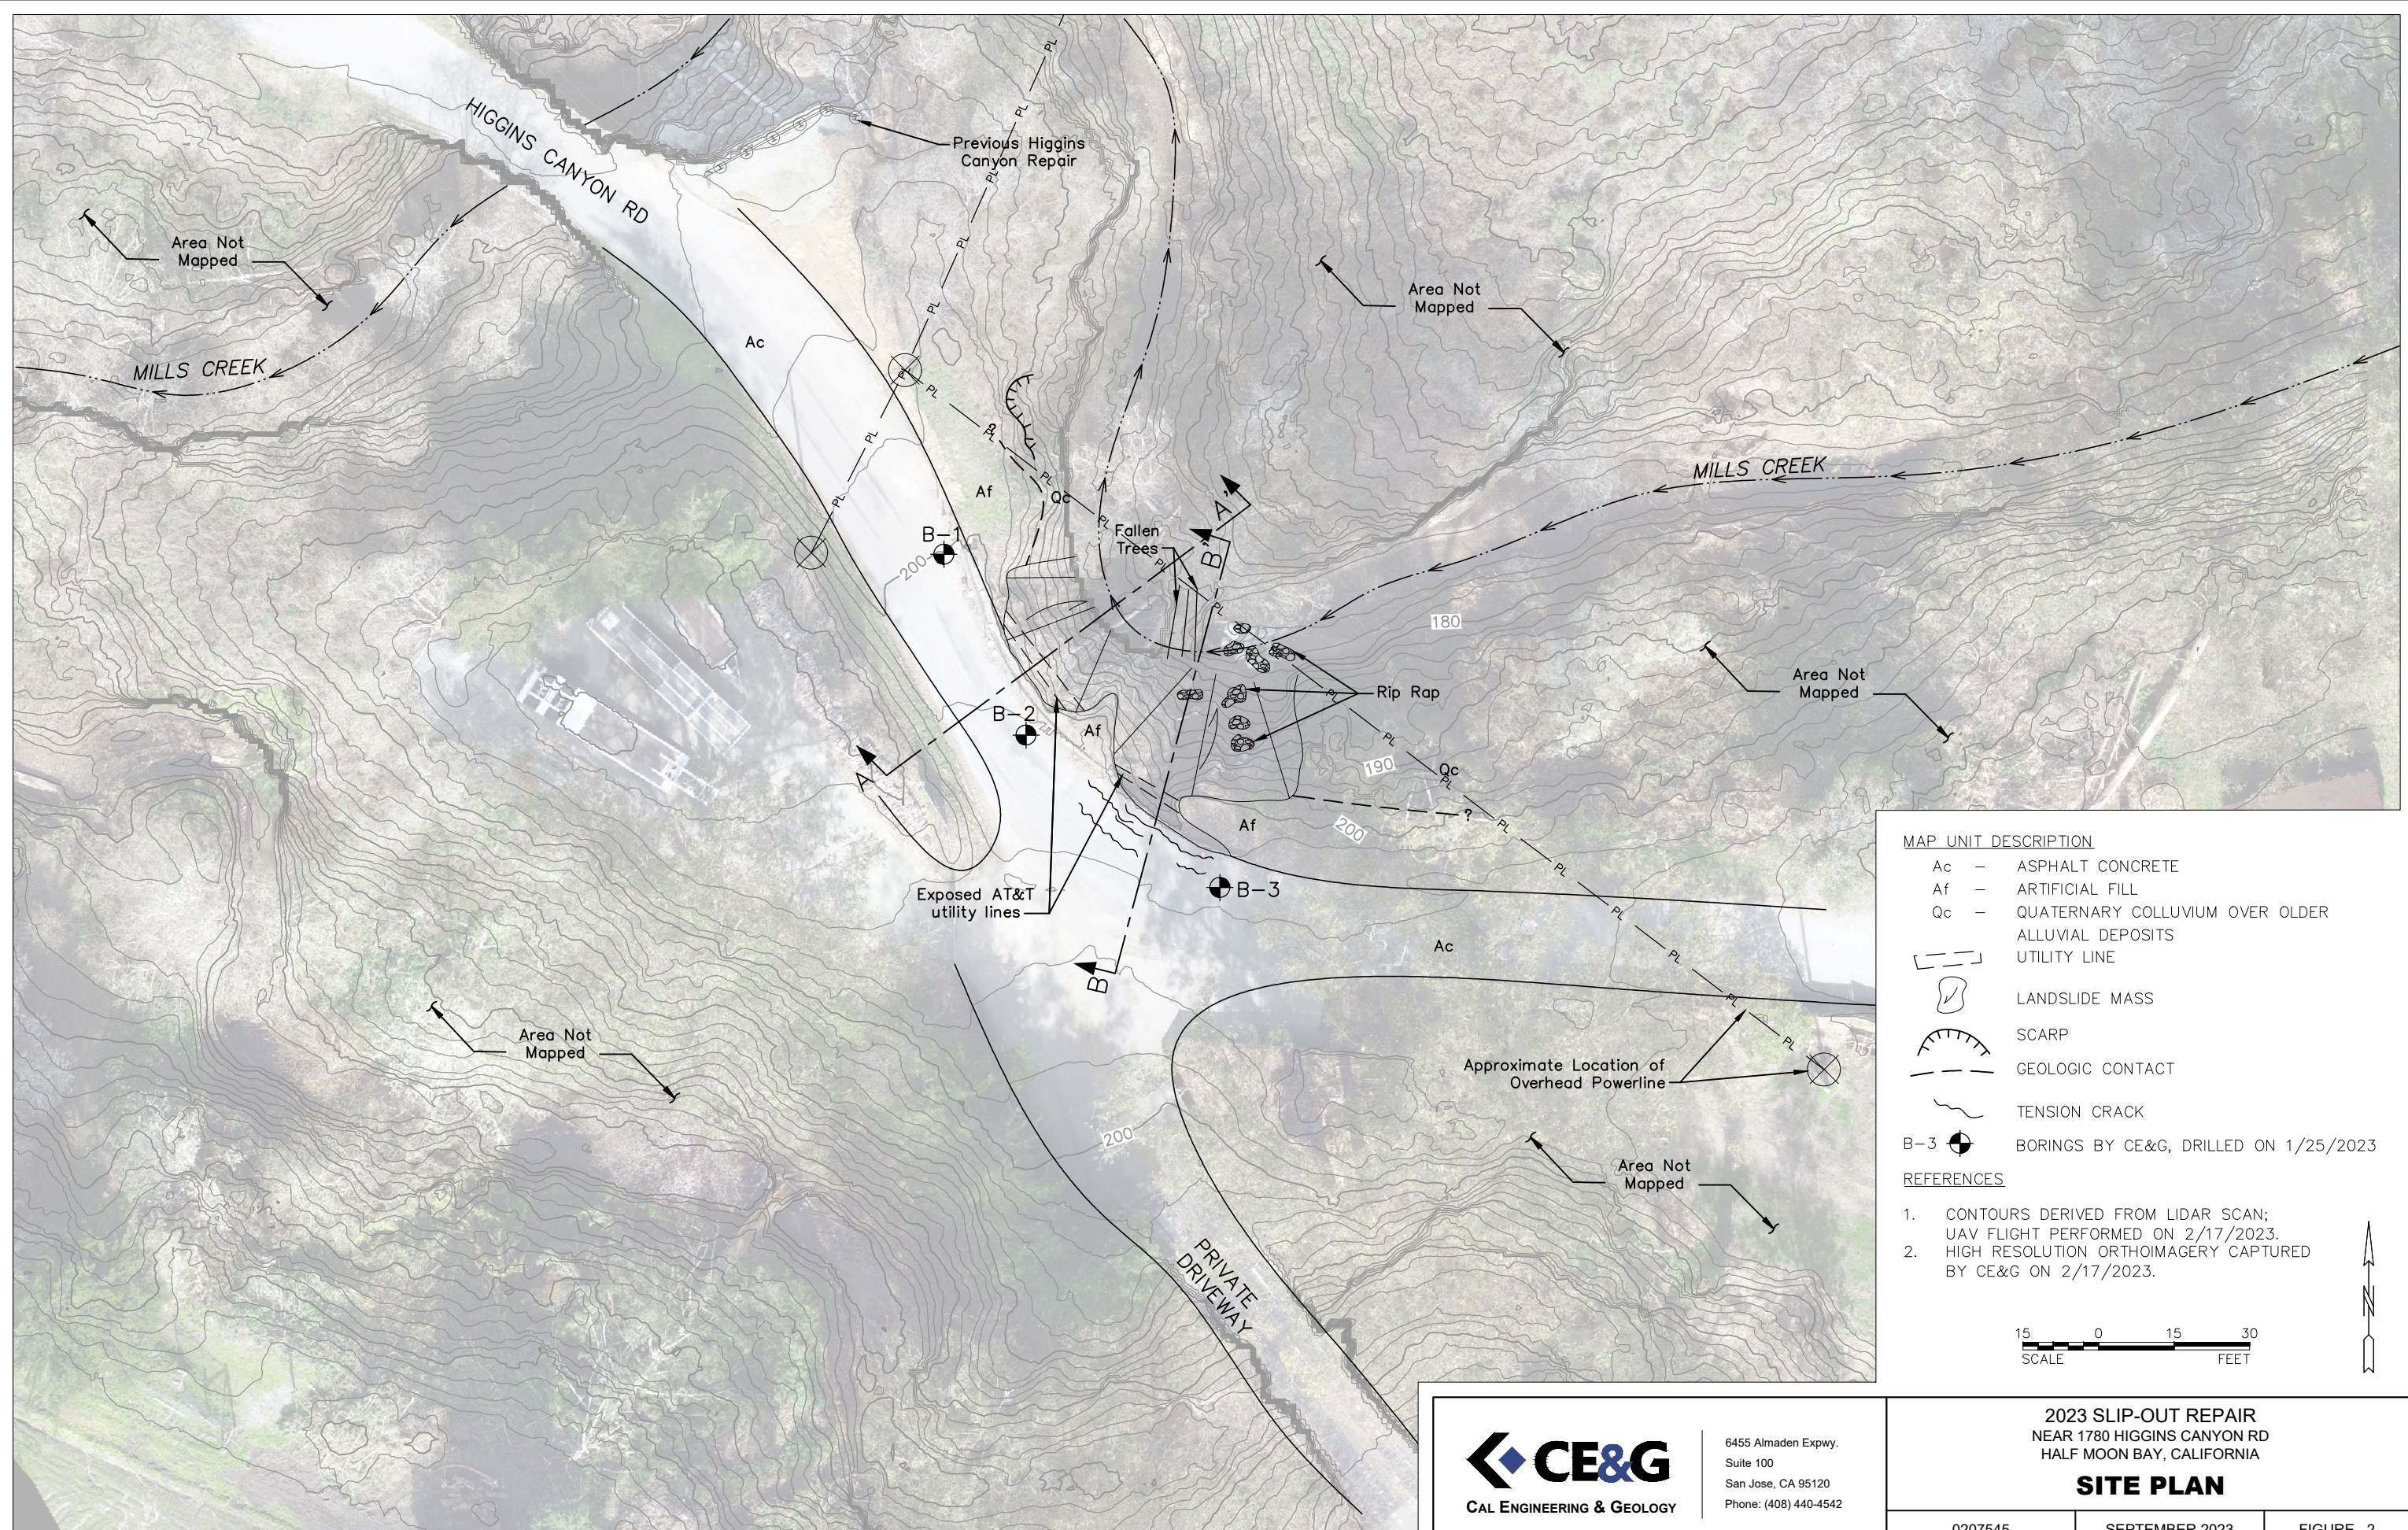
**SITE PLAN**

- Higgins Canyon Road in the site vicinity is asphalt-paved and ranges from approximately 18 to 21 feet wide.
- There are two slip-out scarps on the downslope side of Higgins Canyon Road. The scarps were previously separated by a narrow knob of road fill (see Figure 2); however, the lower portion of the knob has since failed, and the two scarps are now connected as one large scarp.
- The width of the overall failed area extends about 85 feet along Higgins Canyon Road. This area is located along a sharp outside bend in Mills Creek, which appears to have eroded the base of the slope, resulting in at least four separate slip-out events.
- The scarp has encroached into Higgins Canyon Road by about 12 to 18 inches. Most of the slide mass has been washed away by Mills Creek, except for some boulder-

sized riprap near the toe of the scarp. The scarp exposes shoulder fill and underlying alluvial soils. Bedrock was not observed within the scarp.

- Two utility lines consisting of a one-inch and four-inch plastic pipe were exposed in the upper portions of the scarp. Based on nearby utility markings by USA, the utility lines may belong to AT&T.
- Longitudinal tension cracking is present along the roadway margin.

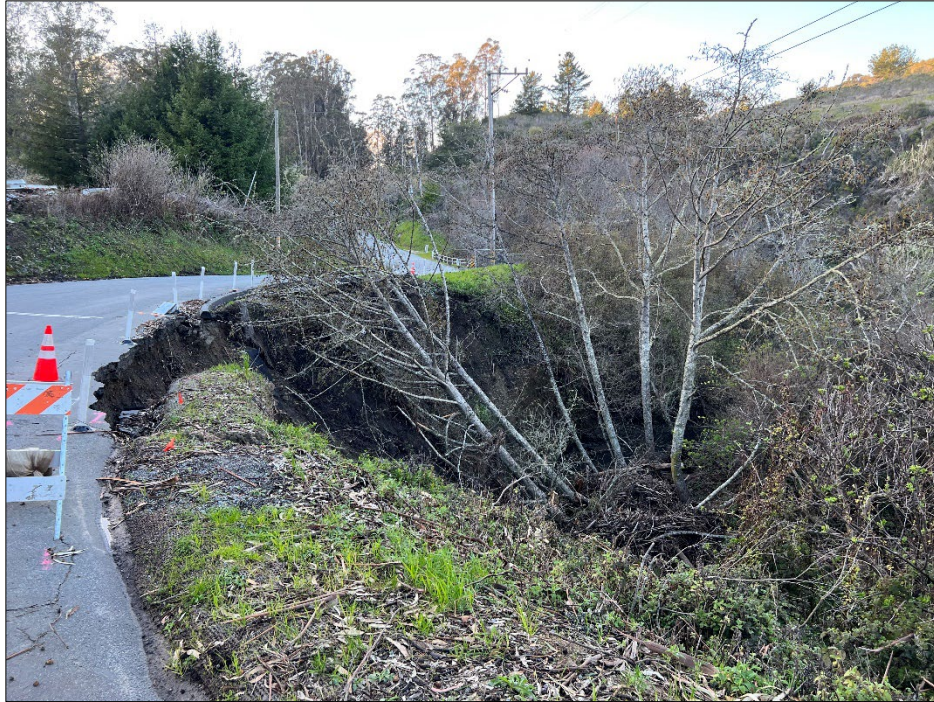
Photo 1: Northwest-facing view of the slip-out area. The photo was taken on March 8<sup>th</sup>, 2023.

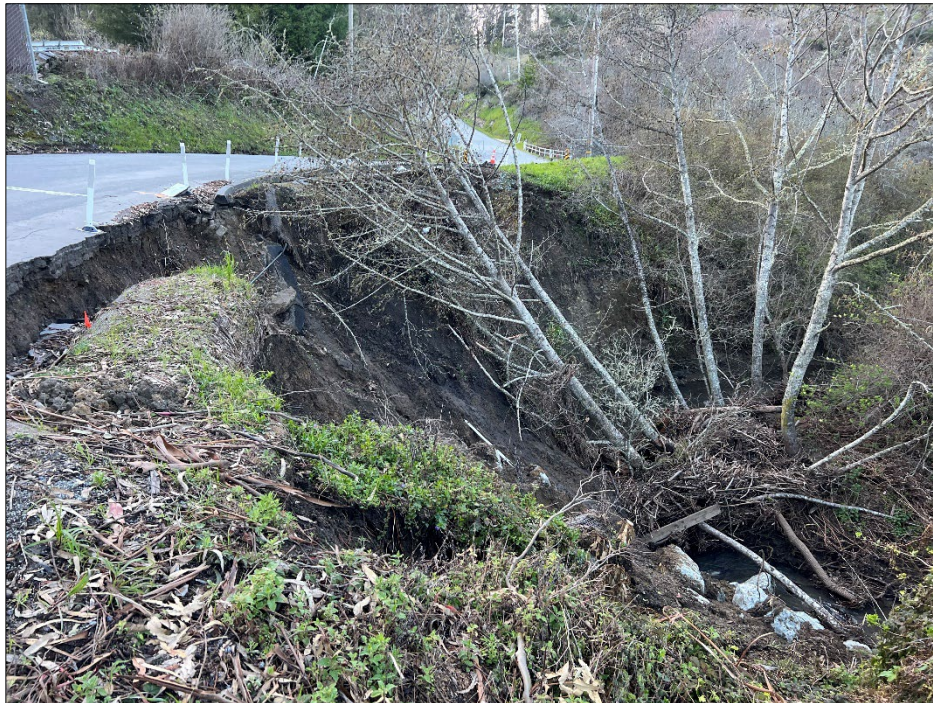
Photo 2: West-facing view of the slip-out area. The photo was taken on March 8<sup>th</sup>, 2023.

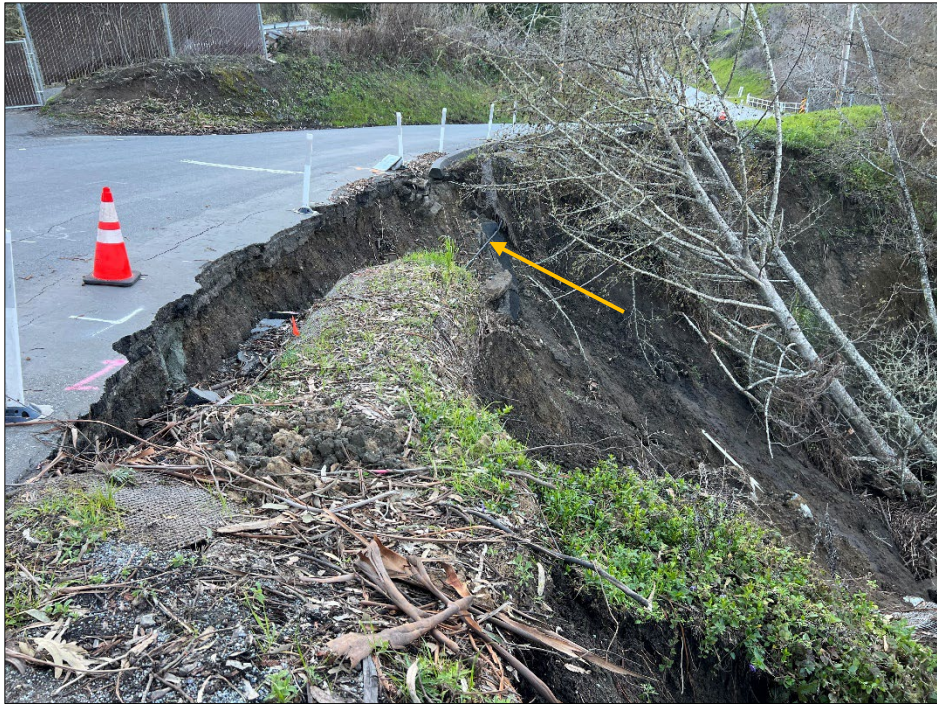
**Photo 3: West-facing view of the slip-out area. Note the two exposed utility lines in the scarp area (see yellow arrow). The photo was taken on March 8<sup>th</sup>, 2023.**

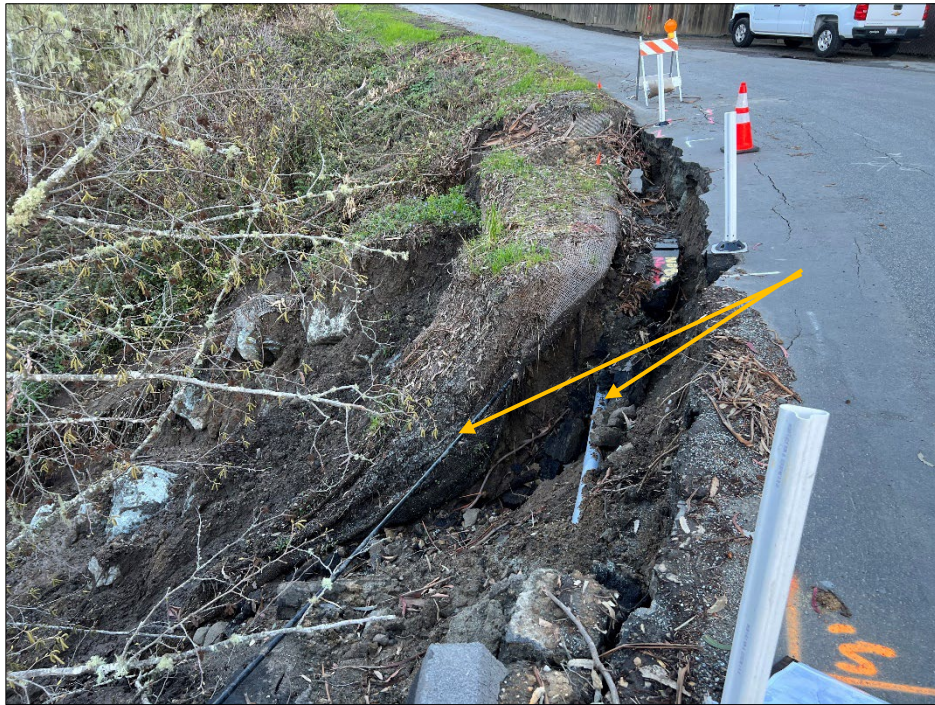
**Photo 4: East-facing view of the slip-out area. Note the two exposed utility lines in the scarp area. The photo was taken on March 8<sup>th</sup>, 2023.**

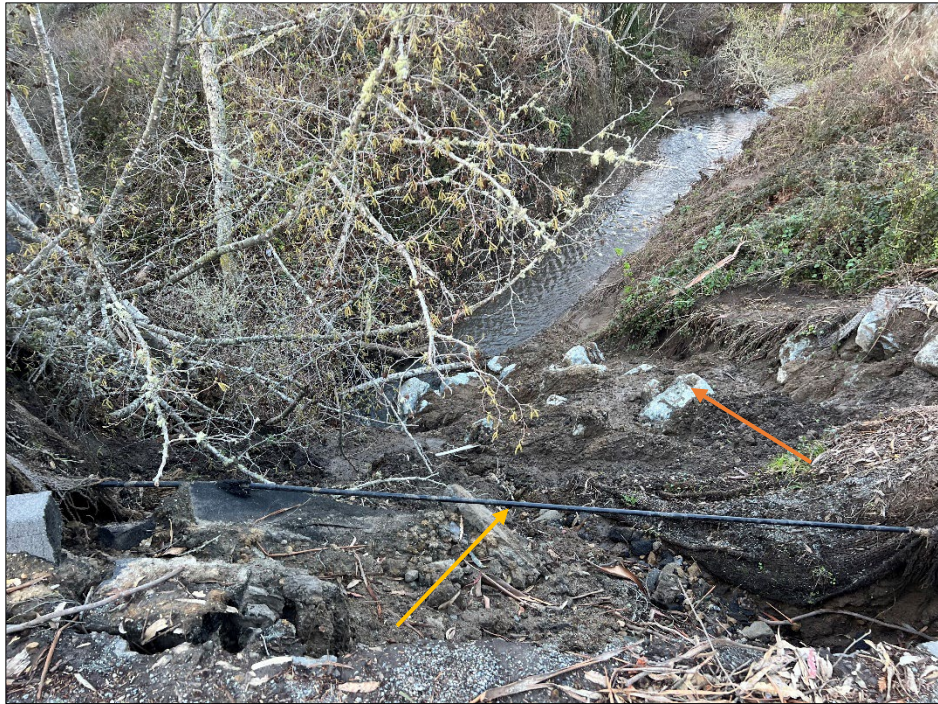
**Photo 5: Northeast-facing view of the slip-out area. Note the exposed utility line (see yellow arrow). Also note exposed riprap in slope fill (orange arrow). The photo was taken on March 8<sup>th</sup>, 2023.**

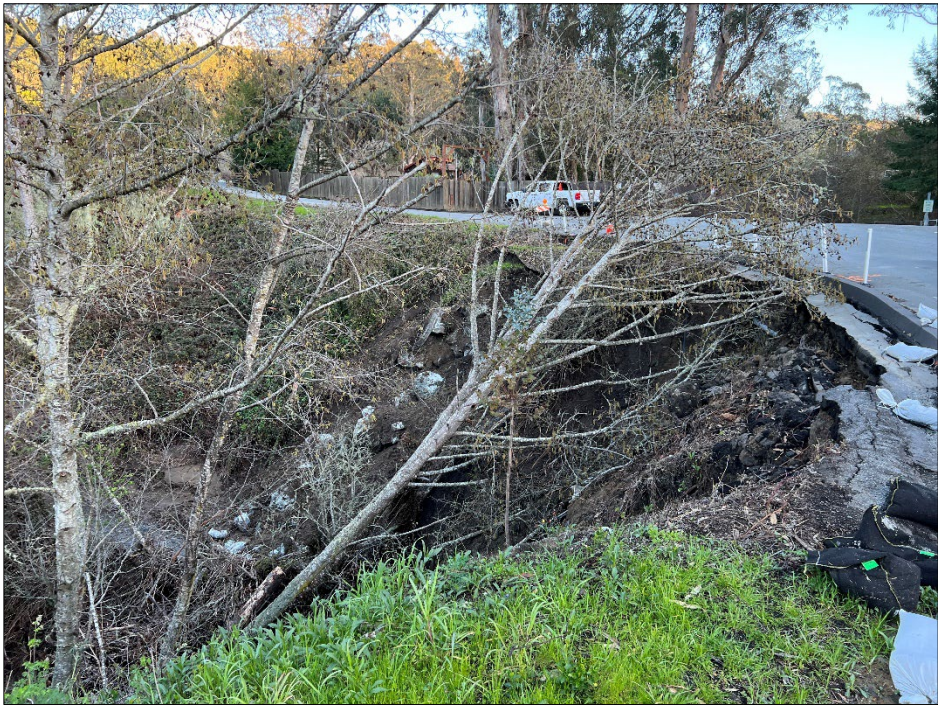
**Photo 6: Southeast-facing view of the slip-out area. The photo was taken on March 8<sup>th</sup>, 2023.**

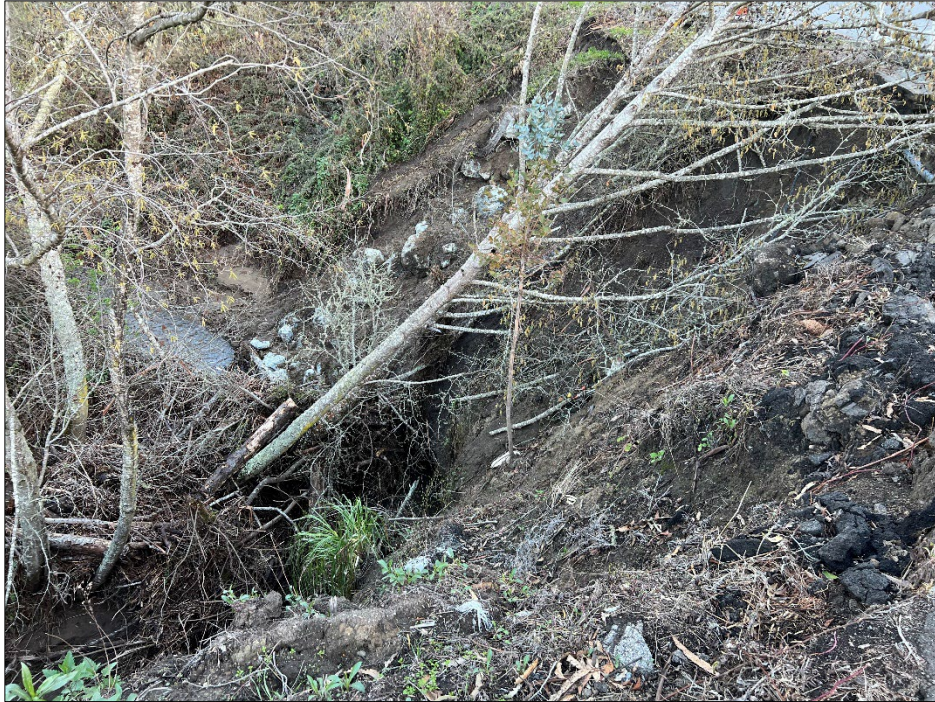
Photo 7: East-facing view of the slip-out area. The photo was taken on March 8<sup>th</sup>, 2023.

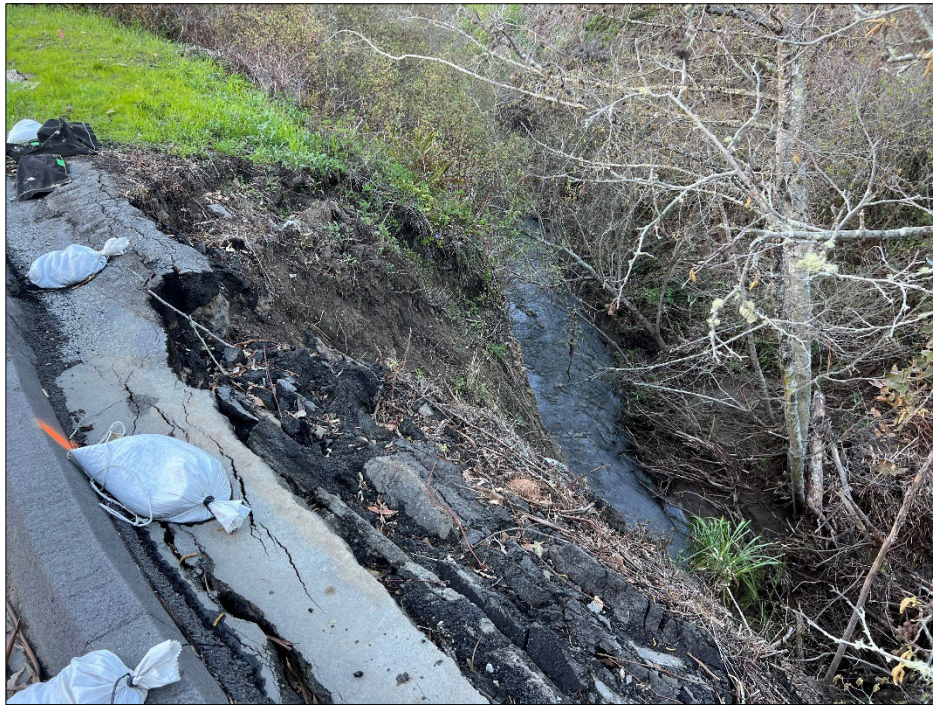
Photo 8: Northwest-facing view of the slip-out area. The photo was taken on March 8<sup>th</sup>, 2023.
