## ARBORIST REPORT

Nolan-Stevaux Residence  
Pescadero Creek Road, CA

**Tree Inventory & Recommended Tree Protection Measures at Pescadero Creek Road,  
County of San Mateo (APN 080-090-030)**

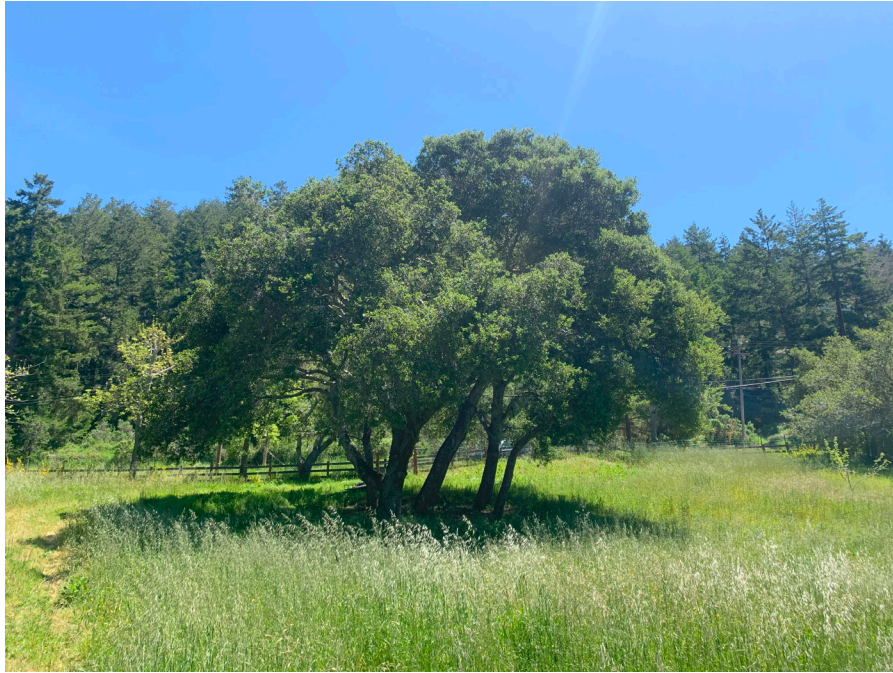
Oak grouping at the front portion of the lot

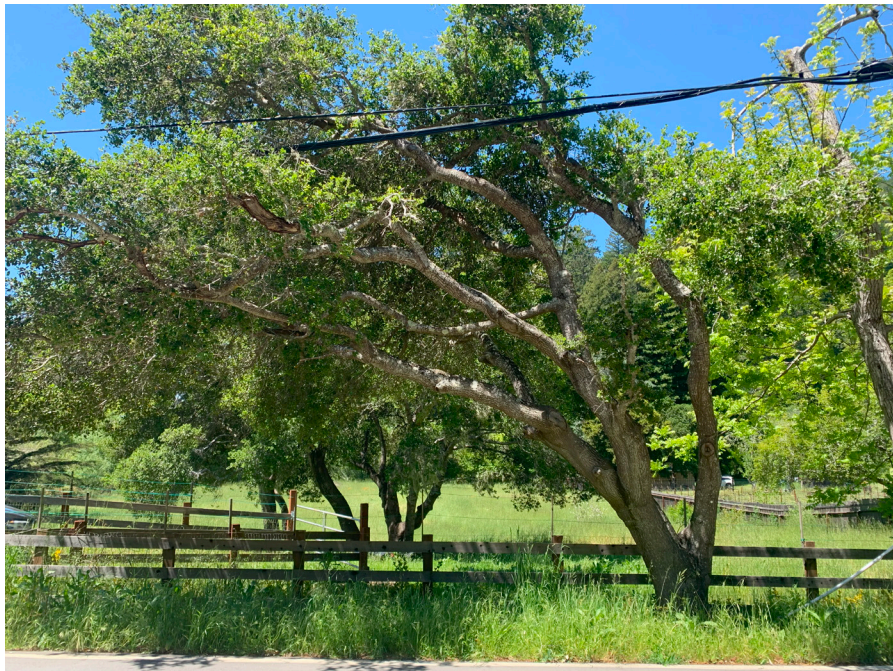
77	Coast Live Oak	19.5", 12.2"	3	3	4	30'	<p>Located along eastern property line, and <b>approximately 18 1/2' from proposed driveway; approximately 13' from proposed grading</b>. Included bark<sup>4</sup> below 3' branch union. Sapsucker evidence. Codominant at 6' above grade with included bark<sup>4</sup>. Under overhead wire. Major canopy growth to south, under and through overhead wire. Limbs extend over Pescadero Creek Rd – some showing damage due to vehicular conflicts.</p> <p><b>Prune limbs that show previous vehicular damage. Prune intertwined limbs (which are significant) to provide clearance.</b></p>		Minor	Save

Tree #77, Coast Live Oak along Pescadero Creek Rd

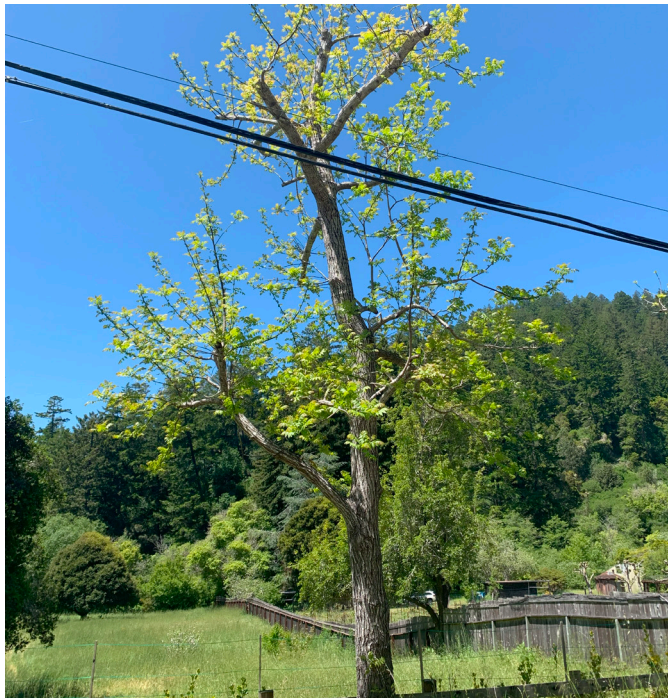
Tree #75, Walnut - Removal required due to conflict with driveway

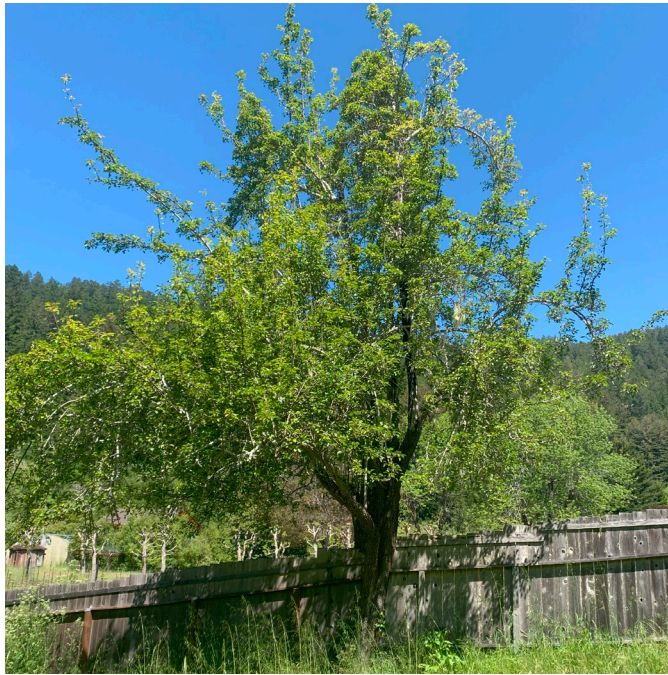
Tree #84, fruit tree at northern property line.

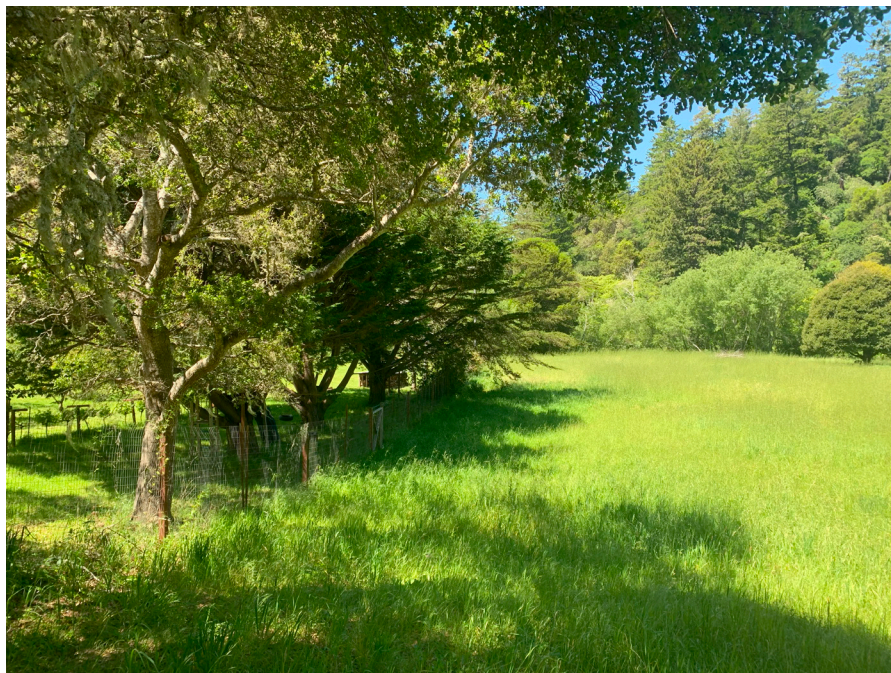
Trees along southern property line - canopies extend into subject property

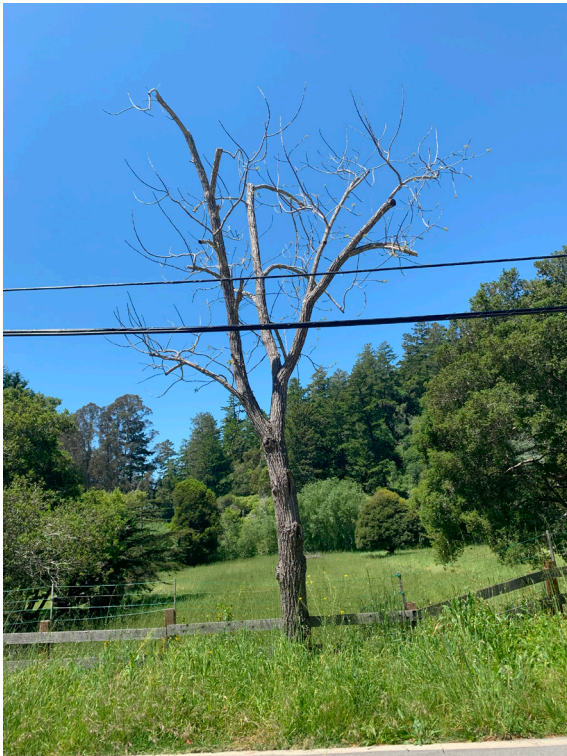
#	SPECIES	DIA	H	S	RV	C	OBSERVATIONS / RECOMMENDATIONS	H	IMPACT	SAVE / REMOVE
78	Walnut spp.	15.2"	1.5	2	1	12'	Located along eastern property line, ~40' from southeastern corner of lot. Topped, in severe decline.  <b>Removal recommended.</b>		None	Remove
79	Coast Live Oak	14"	3.5	3	4	20'	Part of central grove. Located approximately 25' from proposed driveway and 23' from proposed driveway contours. Crowded canopy grows north. Presence of Spanish moss <sup>5</sup> and sapsucker activity.		None	Save
80	Coast Live Oak	21.5"	3.5	3	4	30'	Part of central grove at eastern end of lot. Located approximately 40' from proposed driveway and 38' from proposed driveway contours. Majority of canopy grows to the south.		None	Save
81	Coast Live Oak	13.5"	3	2.5	3	15'	Part of central grove at eastern end of lot. Located approximately 34' from proposed driveway and proposed driveway contours. Crowded; central leader grows parallel to grade, southwest. Checkered bark along lower central leader.		None	Save

Tree #78, a walnut proposed for removal

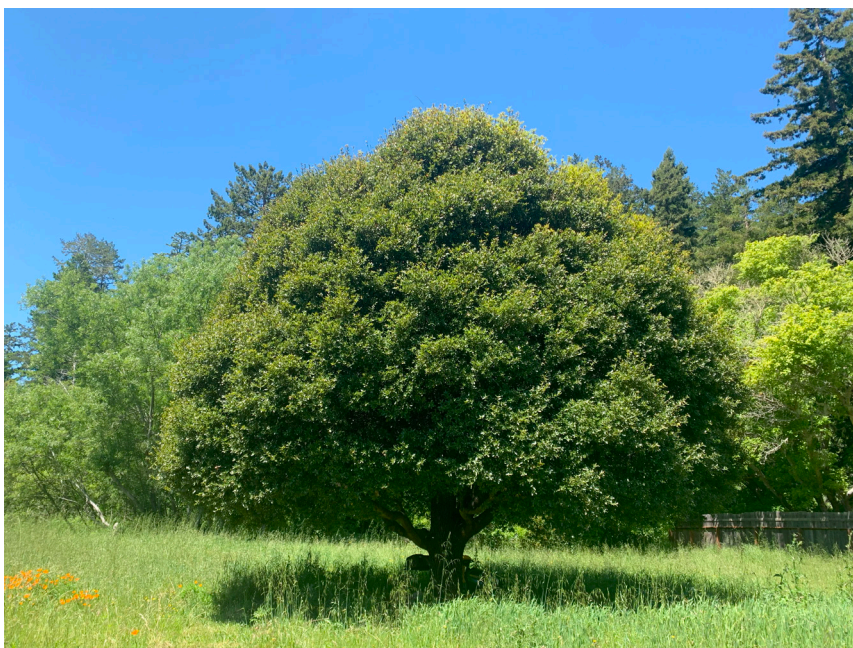
#	SPECIES	DIA	H	S	RV	C	OBSERVATIONS / RECOMMENDATIONS	H	IMPACT	SAVE / REMOVE
88	Canyon Live Oak	28"	4	3	4.5	40'	Located approximately 58' from proposed residence, and 17' from septic lines. Significant deadwood. Tri-dominant branch union 9' above grade with included bark <sup>4</sup> . Balanced structure.  <b>Retain Project Arborist to be on-site at the time of excavation required for leach fields. Prune deadwood.</b>		Moderate	Save
89 <sup>NT</sup>	Coast Live Oak	~20"	3	3	5	40'	Located offsite. Spanish moss <sup>5</sup> . Canopy extends 22' into subject lot.			Save
90 <sup>NT</sup>	Monterey Cypress	~42"	3	3	5	45'	Located offsite. Canopy extends 8' into subject lot.			Save
91 <sup>NT</sup>	Monterey Cypress	~40"	3	3	5	45'	Located offsite. Canopy extends 14' into subject lot.			Save
92 <sup>NT</sup>	Monterey Cypress	~40"	3	3	5	45'	Located offsite. Canopy extends 20' into subject lot.			Save

Tree #88, Canyon Oak with nearly symmetrical structure
