Mayne Tree Expert Company, Inc.

November 16, 2024

RE: 1815 CORDILLERAS RD., EMERALD HILLS (ARBORIST REPORT)

Tree Survey

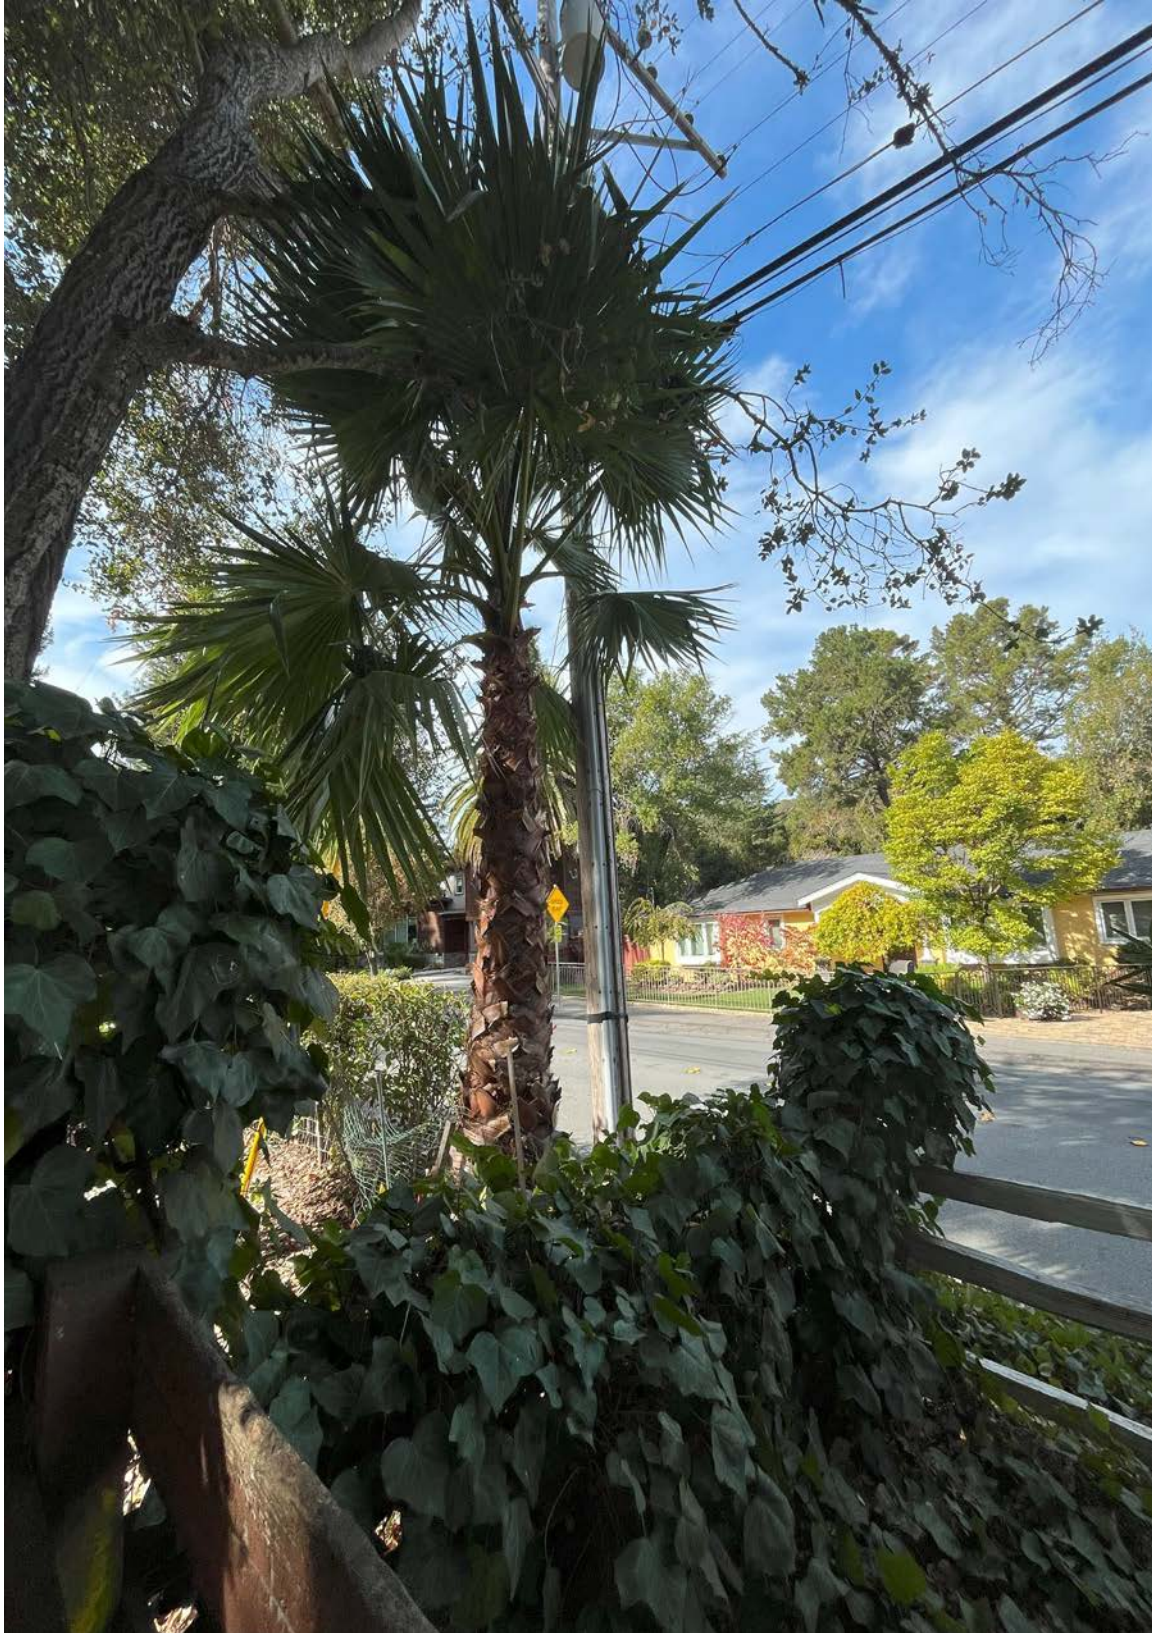
Tree #1

| Tree # | Species Common (<i>Scientific</i>) | Diameter (inches) | Condition (percent) | Height (feet) | Spread (feet) | Comments |
|---|---|---|---|---|---|--|
| 1 | Mexican Fan Palm | Est. 16.0 | 85 | 18 | 9 | Good form and vigor, no tag, located on neighboring property. |

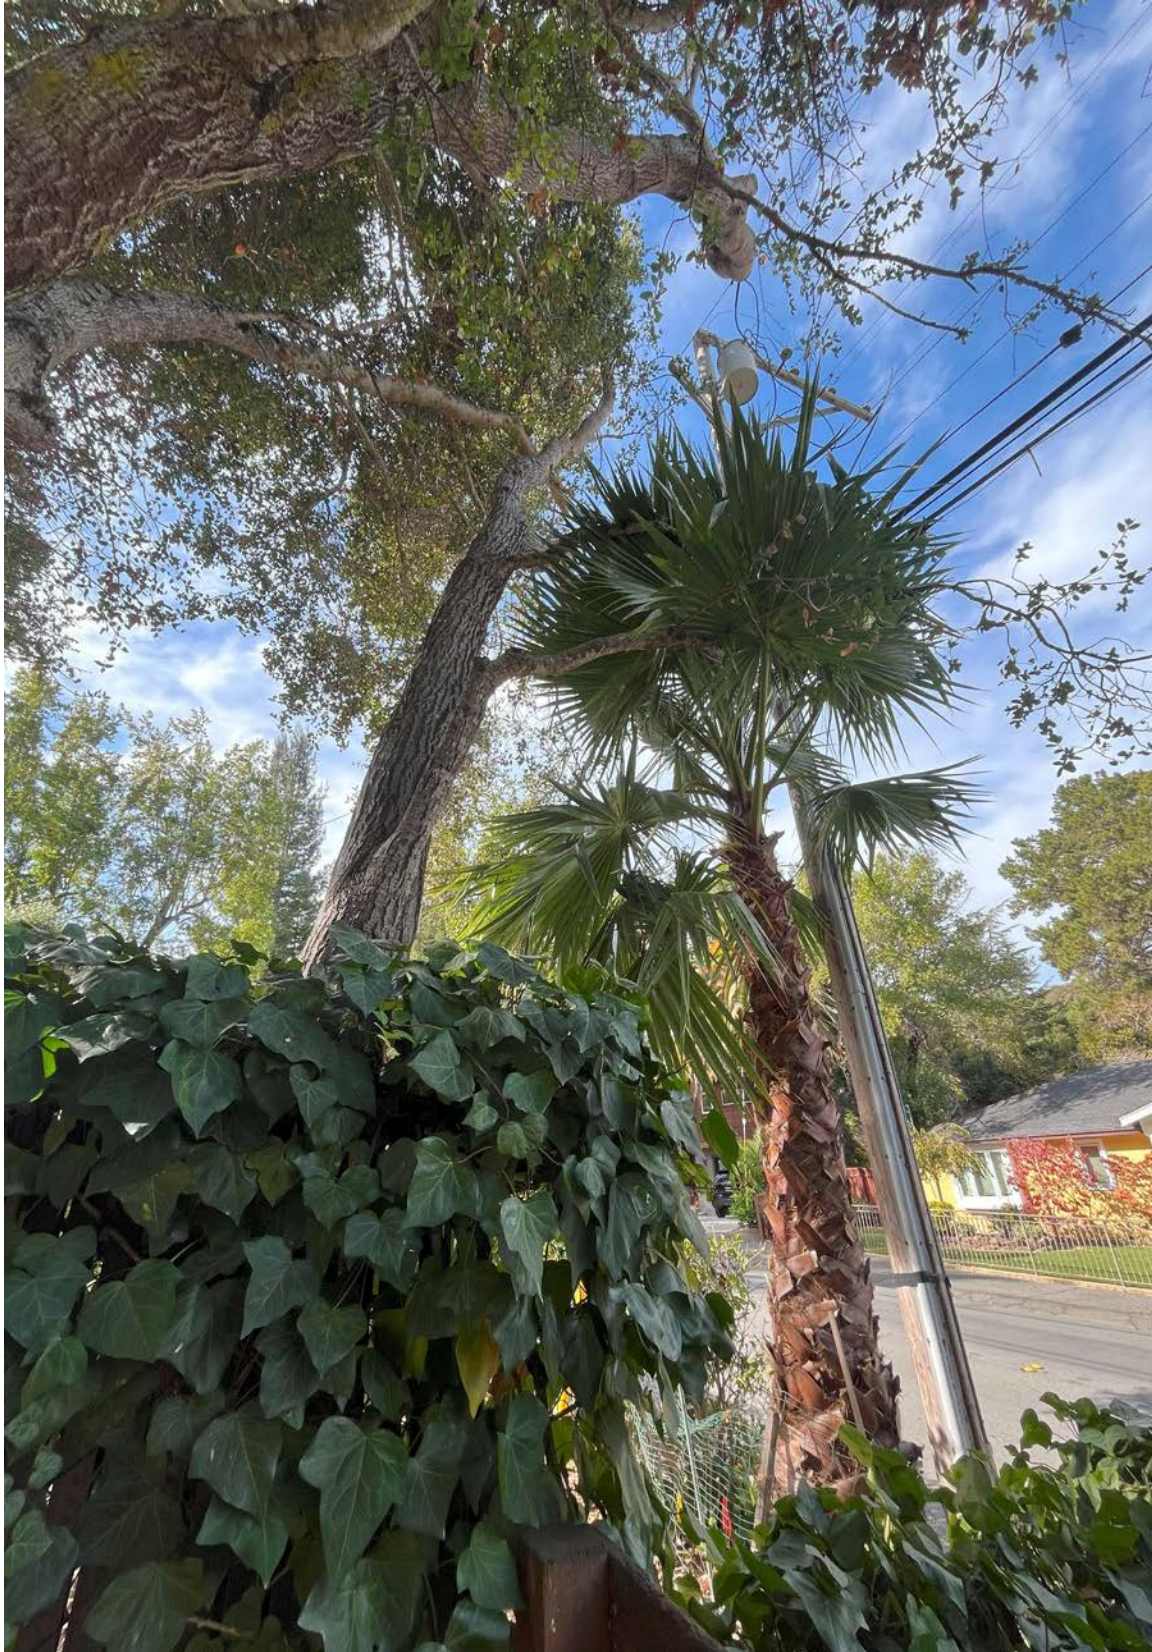
Tree #2

| Tree # | Species Common (<i>Scientific</i>) | Diameter (inches) | Condition (percent) | Height (feet) | Spread (feet) | Comments |
|---|---|---|---|---|---|--|
| 2 | Coast Live Oak | Est. 12.0 | 45 | 40 | 18 | Located on the neighboring property, no tag, leans to the west, side pruned by PG&E, poor form, good vigor, trunk in contact with the property line fence. |

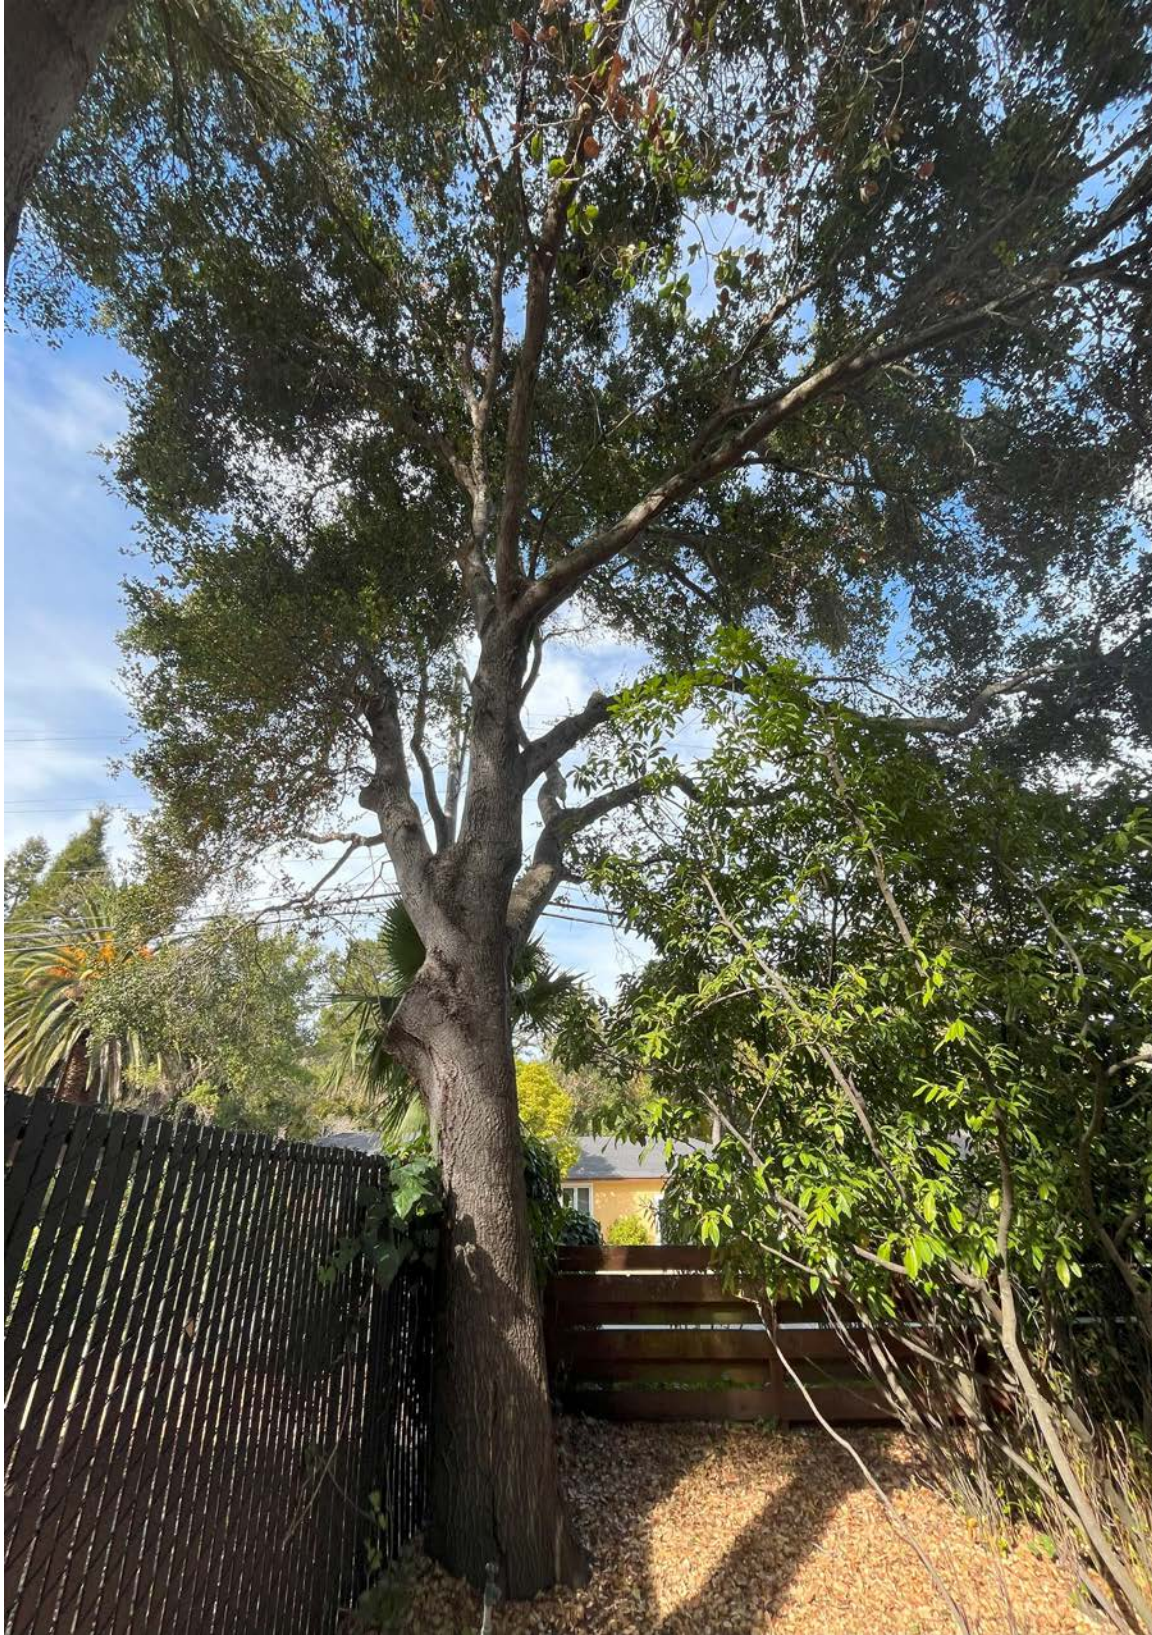
Tree #3

| Tree # | Species Common (<i>Scientific</i>) | Diameter (inches) | Condition (percent) | Height (feet) | Spread (feet) | Comments |
|---|---|---|---|---|---|--|
| 3 | Coast Live Oak | 27.8 | 55 | 50 | 39 | Located near the property line, partially covered root crown, three-stem at 12 feet high, PG&E routinely side prunes canopy, excess end weight, fair form and good vigor. |

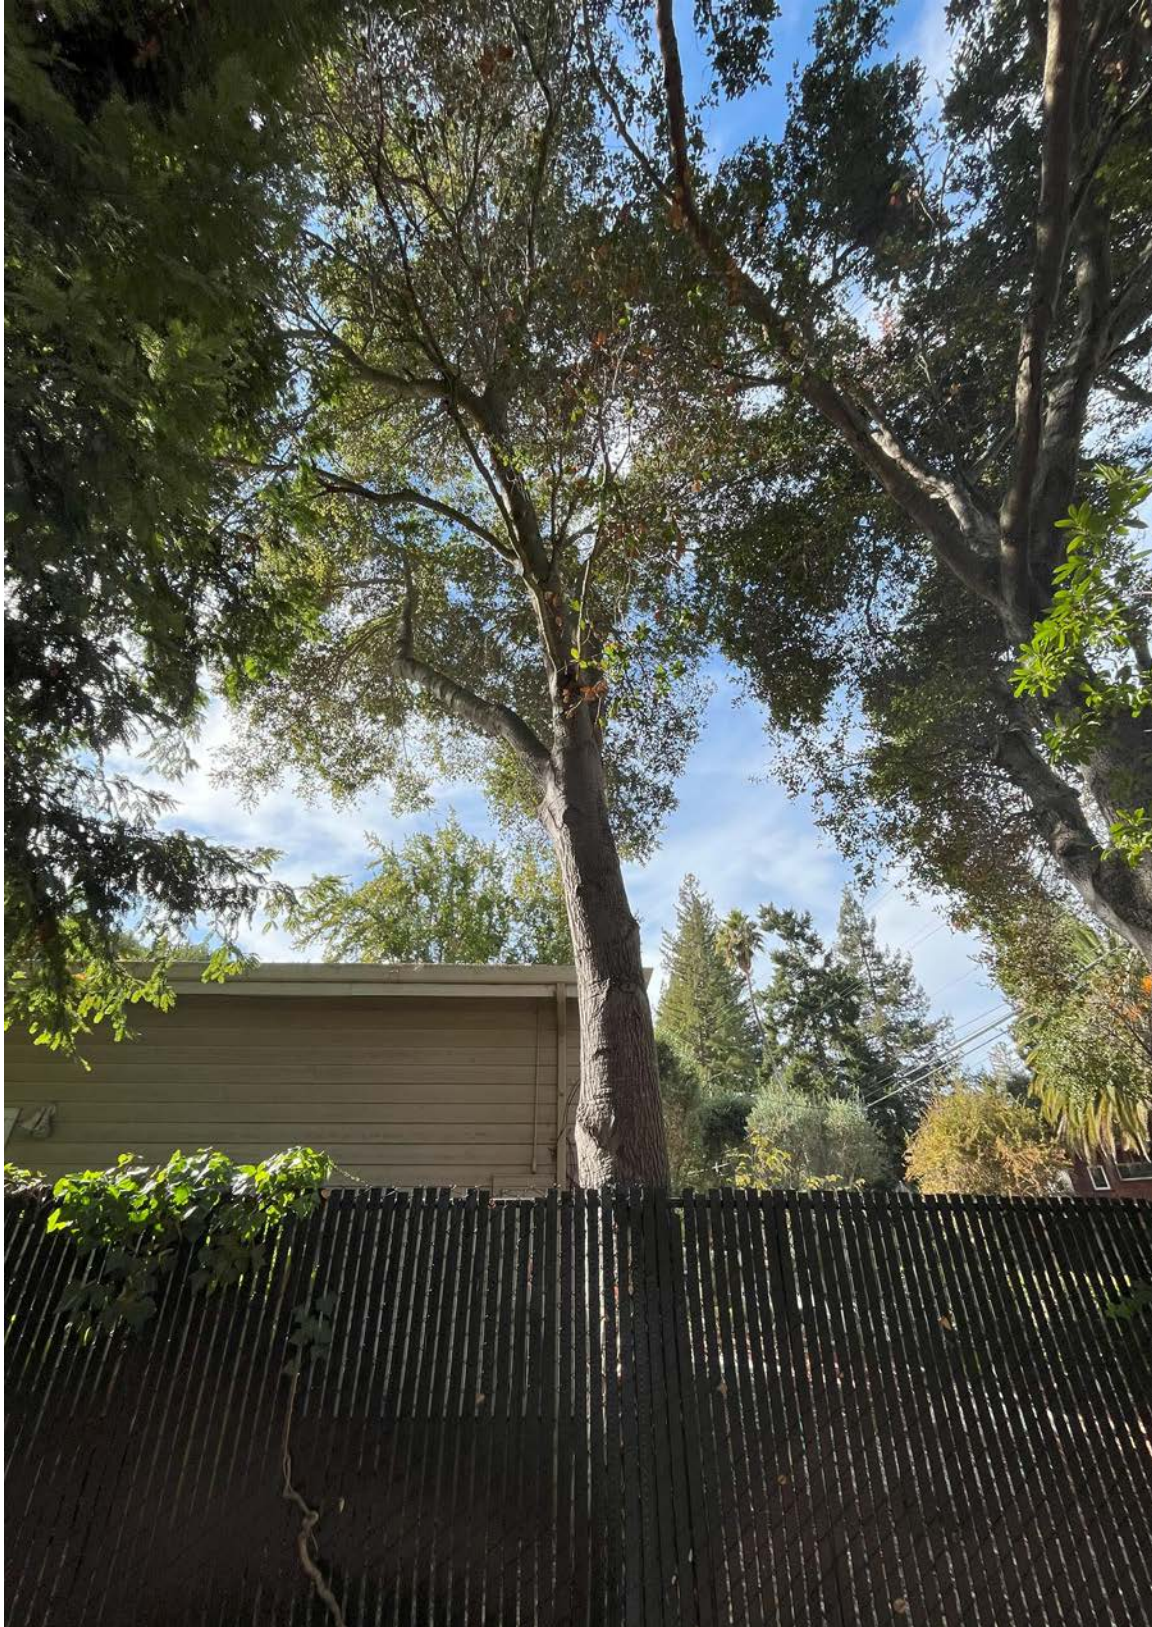
Tree #4

| Tree # | Species Common (<i>Scientific</i>) | Diameter (inches) | Condition (percent) | Height (feet) | Spread (feet) | Comments |
|---|---|---|---|---|---|--|
| 4 | Coast Live Oak | Est. 20.0 | 50 | 50 | 34 | Located on the neighboring property, no tag, trunk in contact with the property line fence, slight lean to the west, three-stem attachment at 20 feet high, moderate amount of interior deadwood, good vigor, and fair form. |

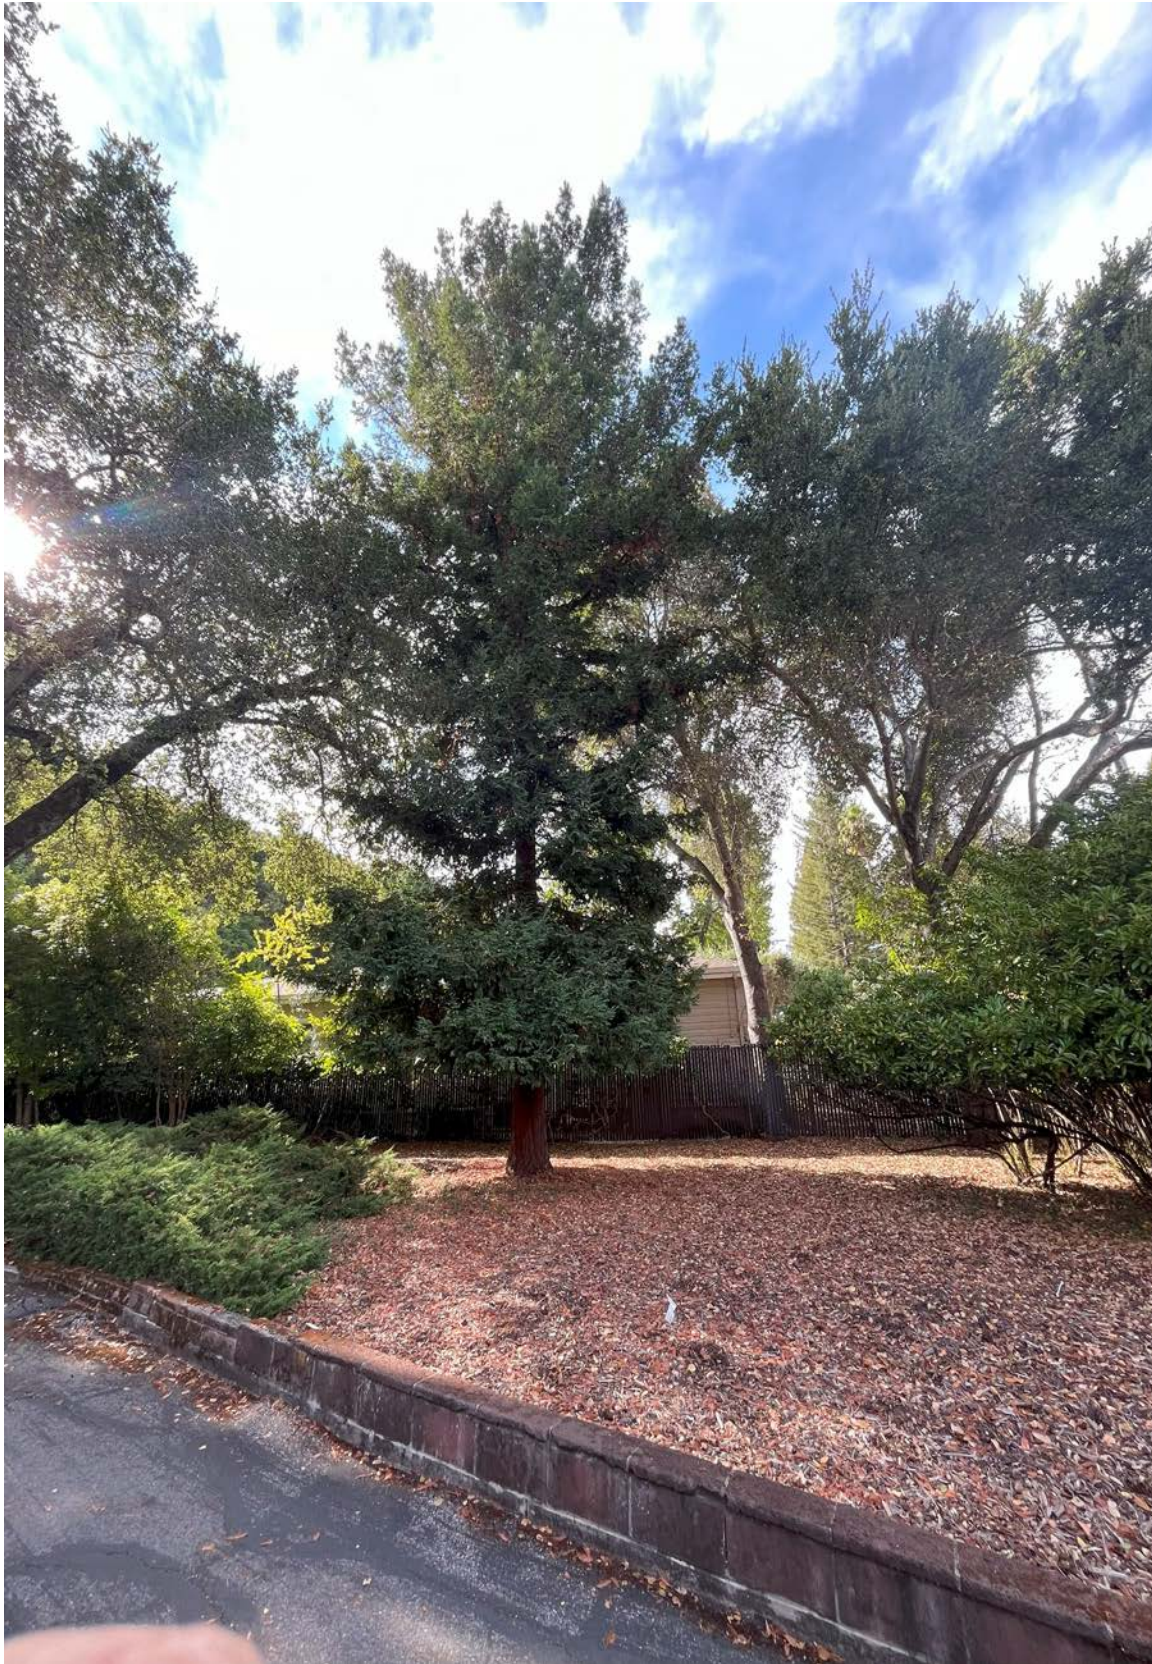
Tree #5

| Tree # | Species Common (<i>Scientific</i>) | Diameter (inches) | Condition (percent) | Height (feet) | Spread (feet) | Comments |
|---|---|---|---|---|---|--|
| 5 | Redwood | 22.1 | 85 | 70 | 36 | Partially covered root crown, good form, and vigor, branches touching internet line. |

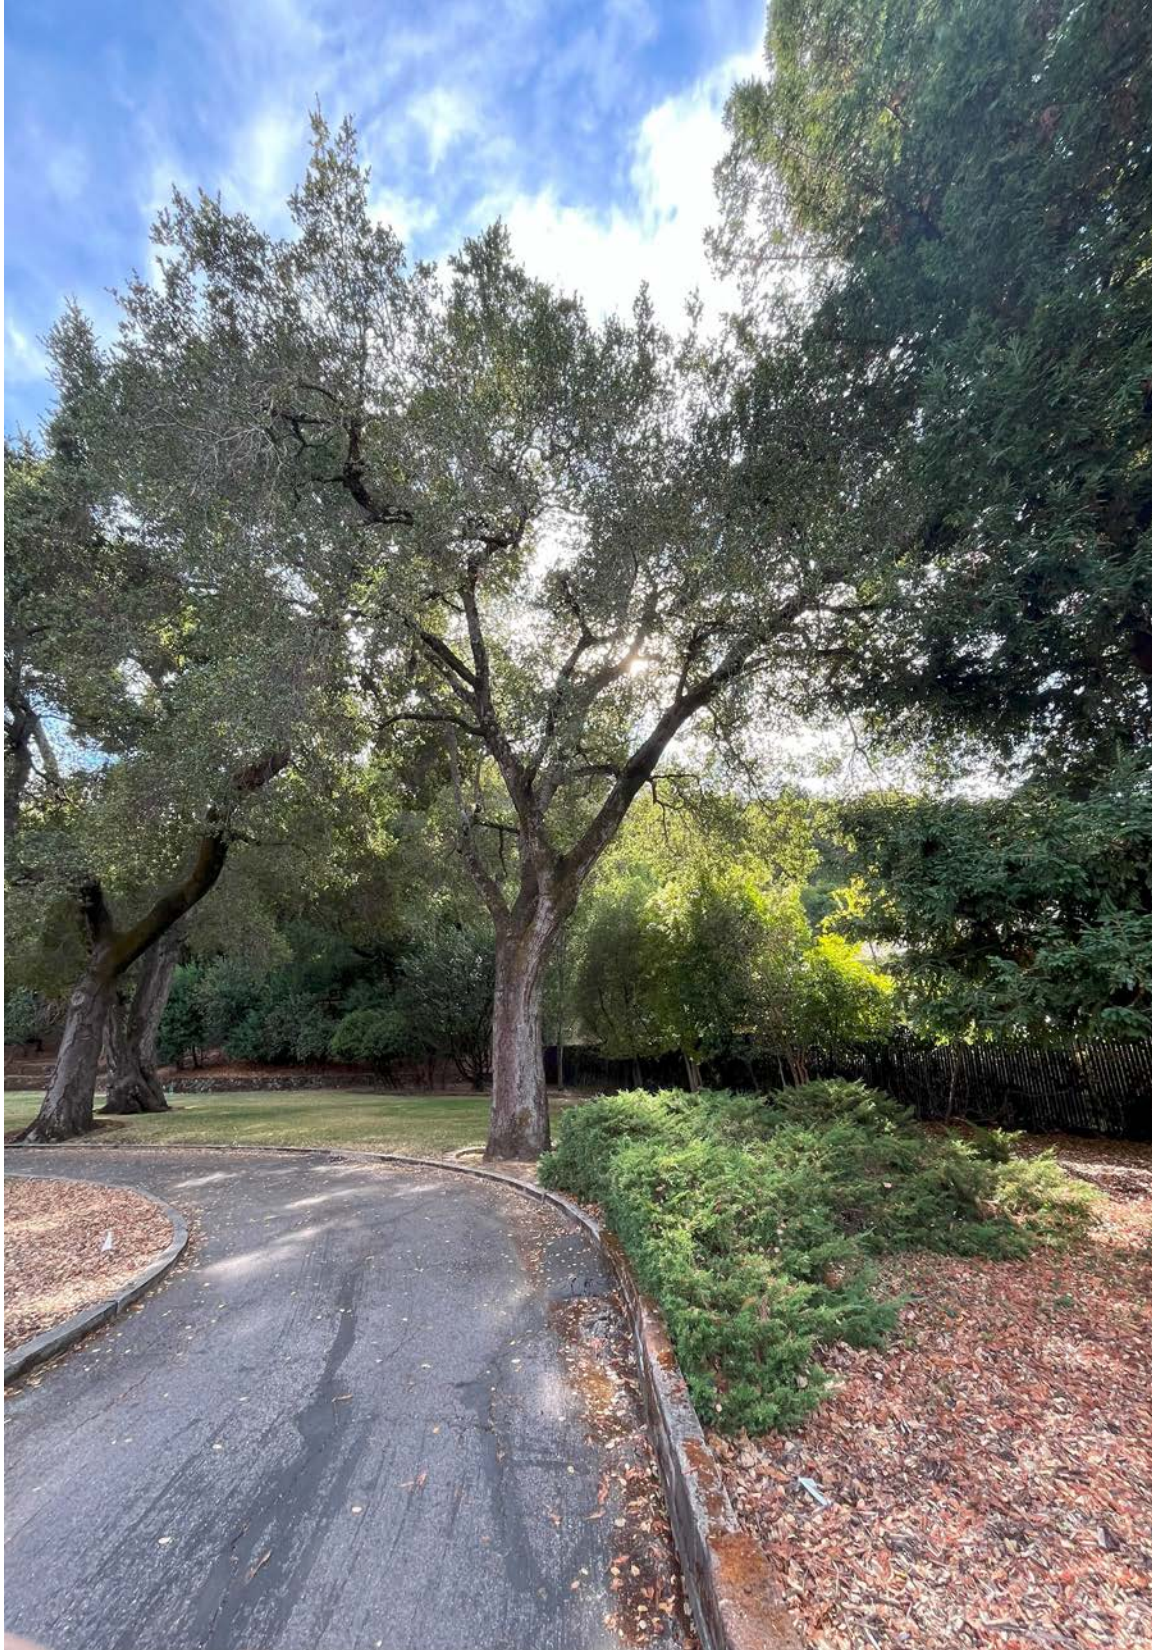
Tree #6

| Tree # | Species Common (<i>Scientific</i>) | Diameter (inches) | Condition (percent) | Height (feet) | Spread (feet) | Comments |
|---|---|---|---|---|---|--|
| 6 | Coast Live Oak | 35.3 | 60 | 55 | 48 | Partially covered root crown, three-stem attachment at 15 feet high, heavy lateral limbs, good vigor, and fair form. |

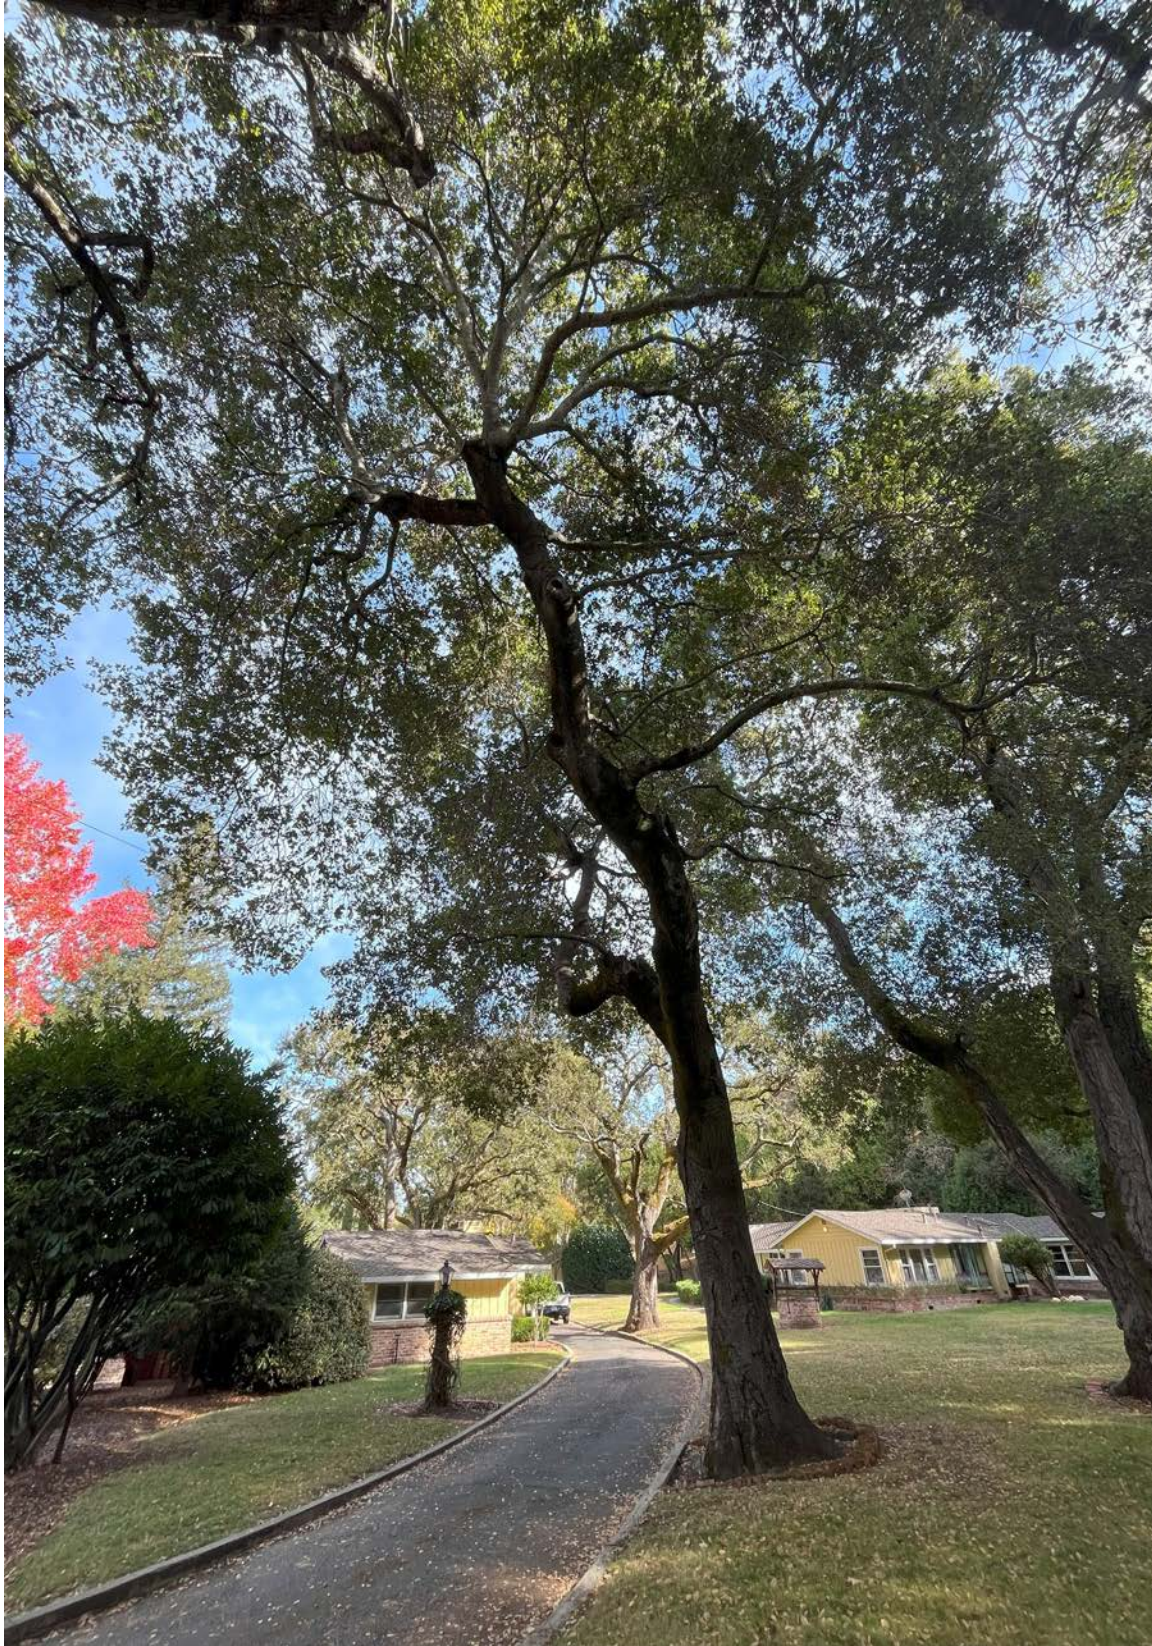
| Tree # | Species Common (<i>Scientific</i>) | Diameter (inches) | Condition (percent) | Height (feet) | Spread (feet) | Comments |
|---|---|---|---|---|---|---|
| 7 | Coast Live Oak | 35.6 | 60 | 55 | 39 | Large surface roots around the base, slight lean to the west-northwest, slight upwelling opposite the tree's lean, cavity at 20 feet high from previously failed leader, two stem attachment 18 feet high, good vigor, and poor form. |

Tree #7 is a Coast Live Oak located along the right front corner of the site. There are several large surface roots around the tree's base; it leans to the southwest slightly with a slight upwelling opposite the tree's lean and has a two-stem attachment 18 feet high. One of the stems has a large cavity from a previously failed leader around 20 feet high. Overall, this tree has good vigor and poor form.

I recommend routine tree maintenance, including weight reduction on the leaning side of the canopy and the leader with the large cavity.

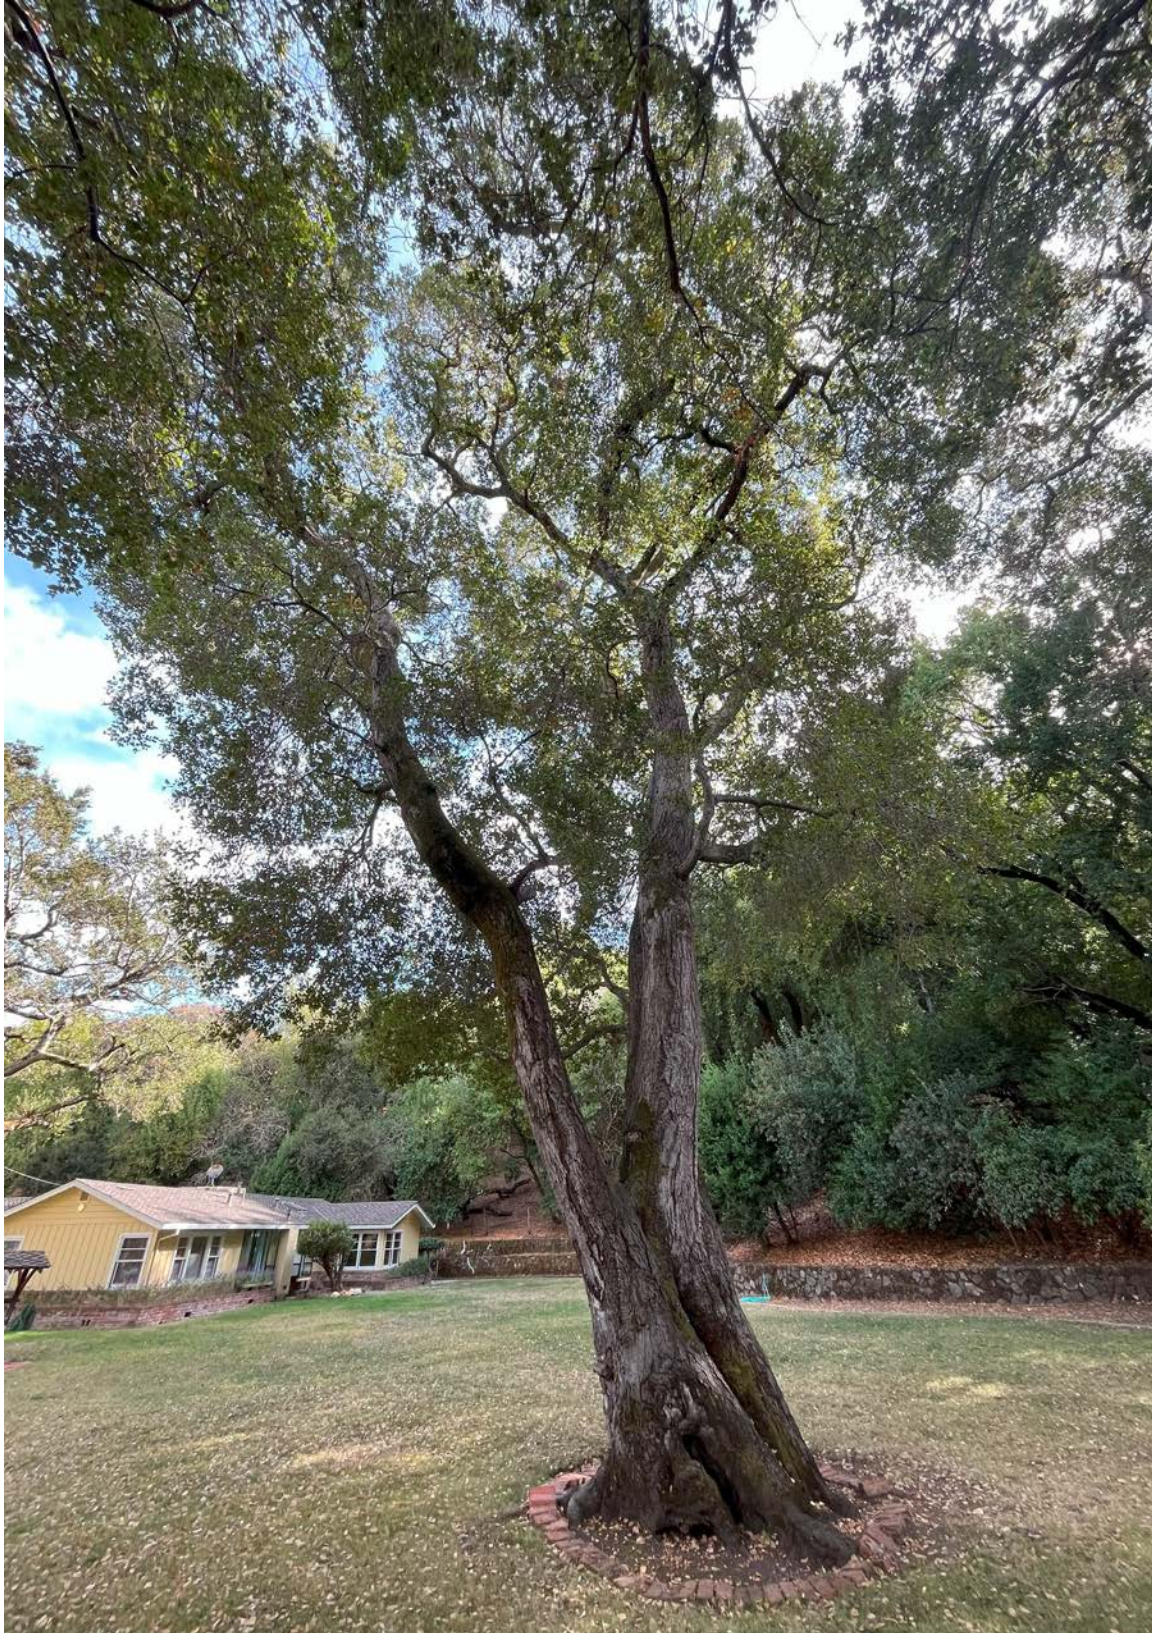
| Tree # | Species Common (<i>Scientific</i>) | Diameter (inches) | Condition (percent) | Height (feet) | Spread (feet) | Comments |
|---|---|---|---|---|---|---|
| 8 | Coast Live Oak | 62.6 | 45 | 70 | 49 | Decay at the base on northwest side, three-stem at 7 feet high with included bark, large heavy canopy with support cables, Sycamore Borer on the lower trunk, good vigor and poor form, probable hollow lower trunk. |

Tree #8 is a Coast Live Oak along the home's right side. The lower trunk of this tree appears to be partially hollow and has significant decay present. It has a three-stem attachment, including bark at 7 feet high, a large, heavy canopy with support cables, and a Sycamore borer on the lower trunk. Overall, this tree has good vigor but poor form.

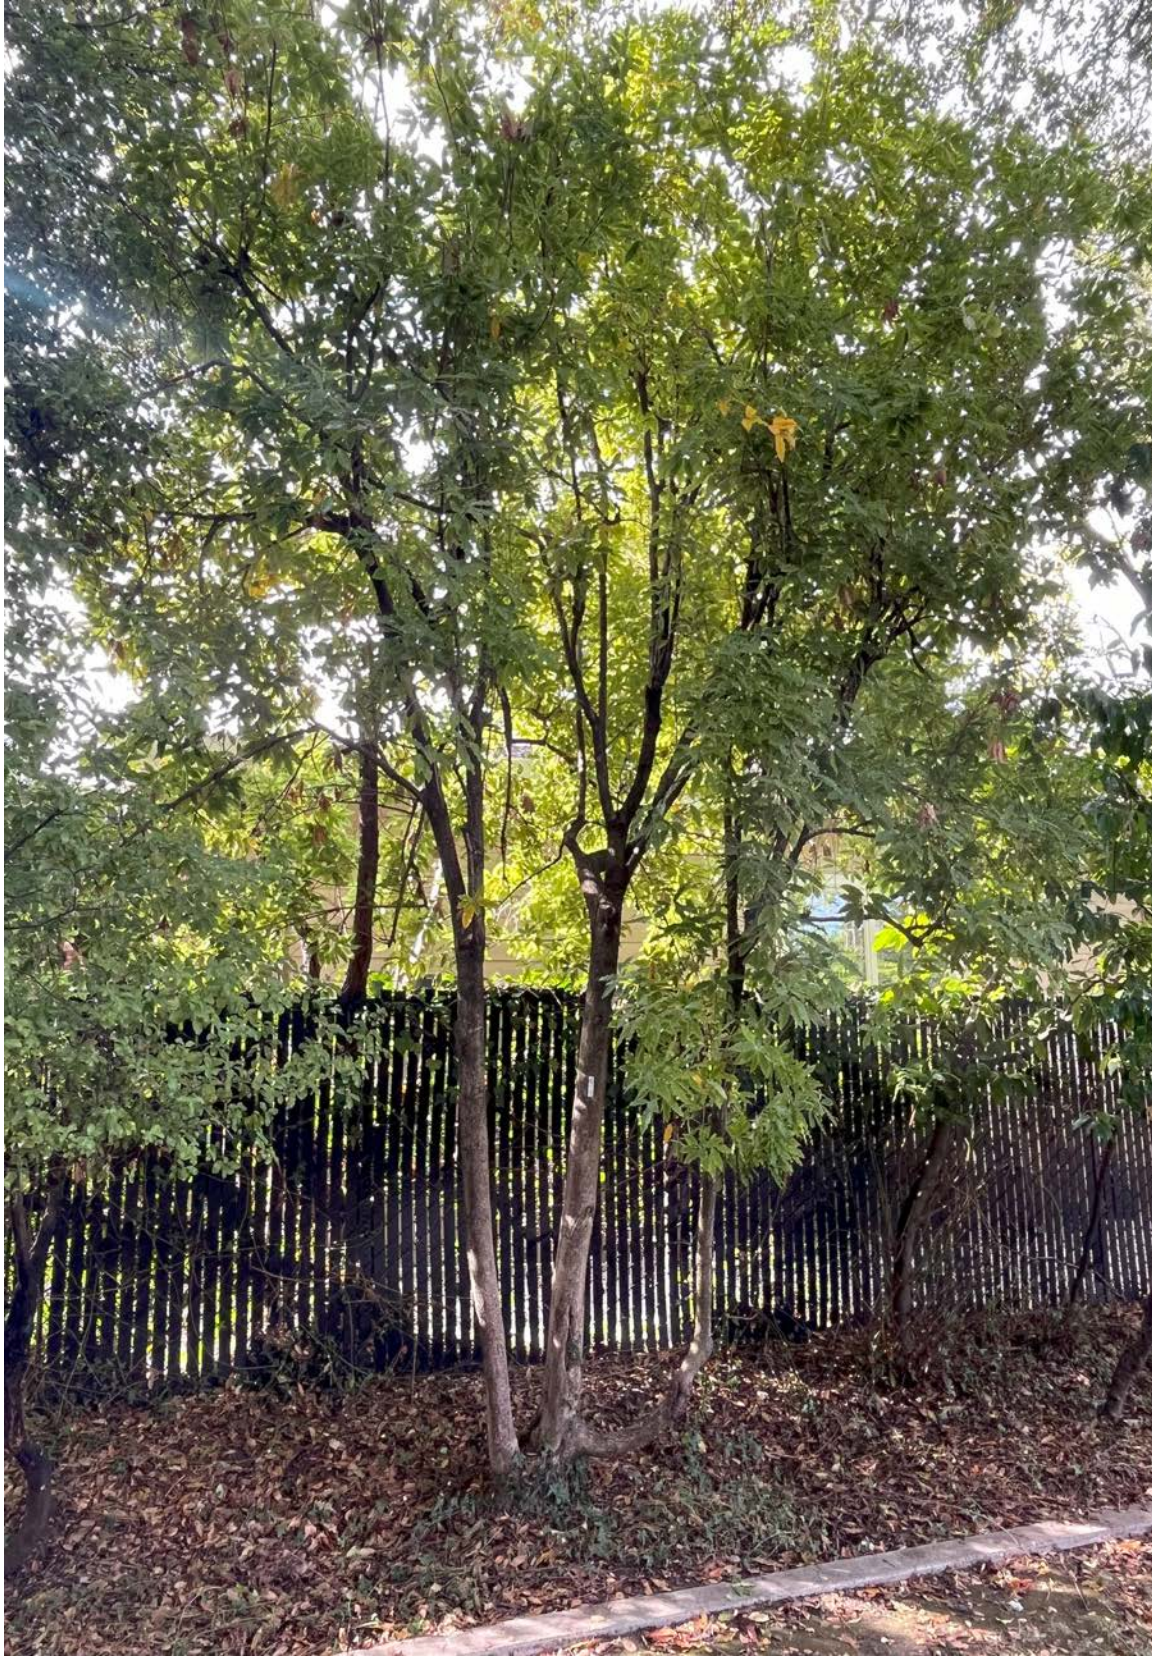
Tree #9

| Tree # | Species Common (<i>Scientific</i>) | Diameter (inches) | Condition (percent) | Height (feet) | Spread (feet) | Comments |
|---|---|---|---|---|---|---|
| 9 | <i>Pittosporum eugenioides</i> | Est. 8.0 | 45 | 20 | 15 | Root crown covered, three-stem at base, hedge tree, poor form, good vigor, cavity at base. |

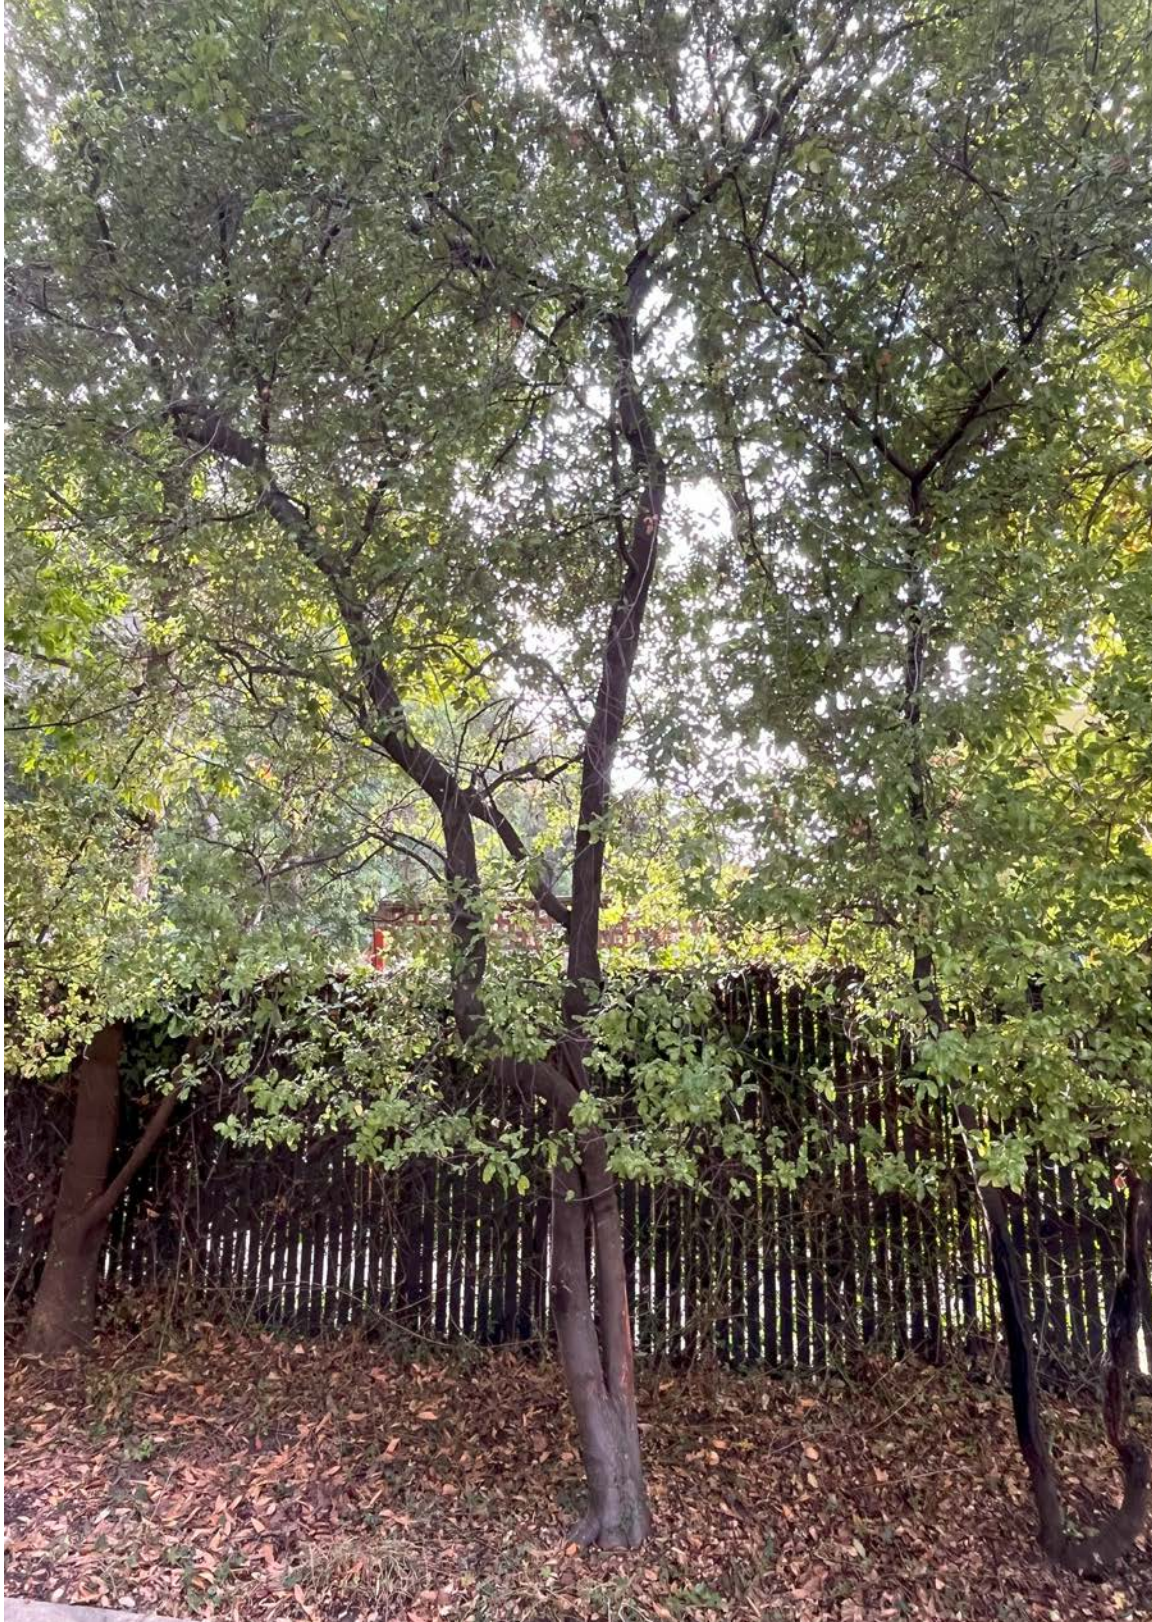
Tree #10

| Tree # | Species Common (<i>Scientific</i>) | Diameter (inches) | Condition (percent) | Height (feet) | Spread (feet) | Comments |
|---|---|---|---|---|---|---|
| 10 | <i>Pittosporum nigricans</i> | Est. 6.0 | 45 | 20 | 15 | Two stem with included bark at base, hedge tree, poor form and good vigor. . |

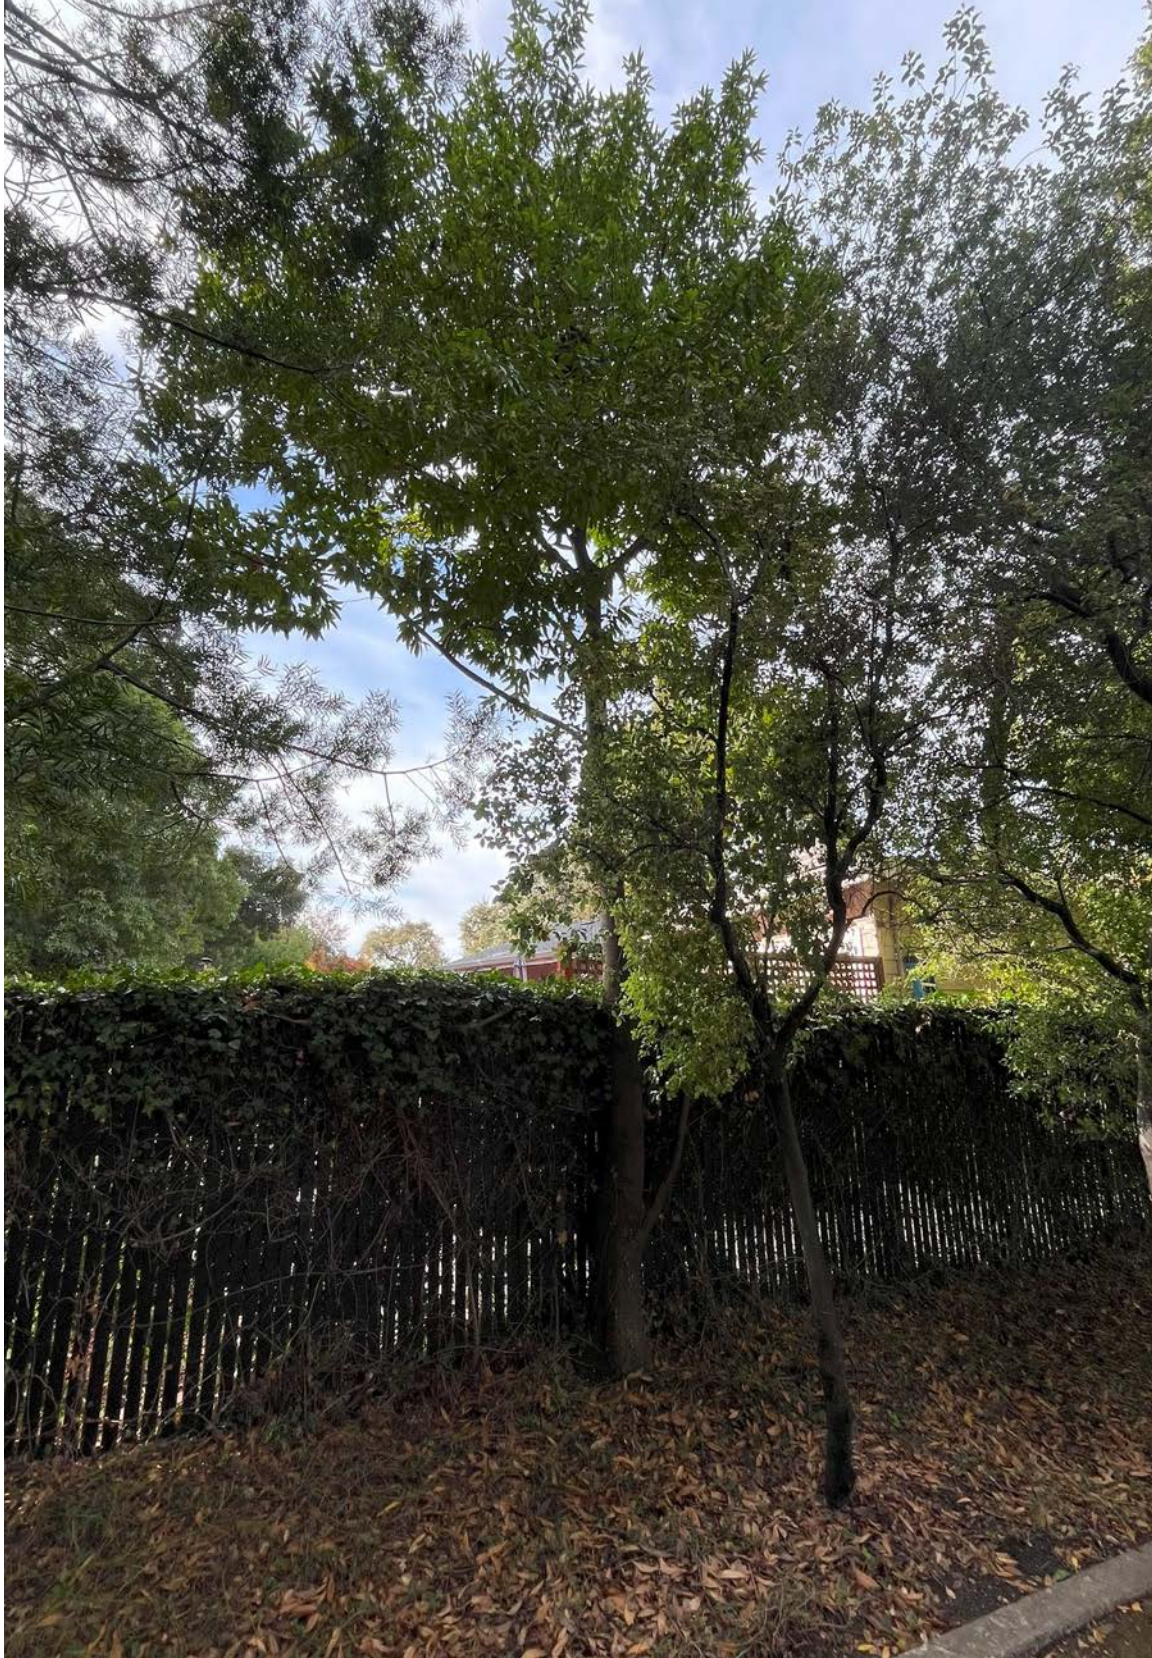
Tree #11

| Tree # | Species Common (<i>Scientific</i>) | Diameter (inches) | Condition (percent) | Height (feet) | Spread (feet) | Comments |
|---|---|---|---|---|---|---|
| 11 | California Bay Laurel | 8.5 | 55 | 25 | 15 | Root crown covered, full canopy with good vigor and fair form, located along the property line fence, trunk in contact with the fence. |
