Mayne Tree Expert Company, Inc.

November 16, 2024

RE: 1815 CORDILLERAS RD., EMERALD HILLS (ARBORIST REPORT)

Tree Survey

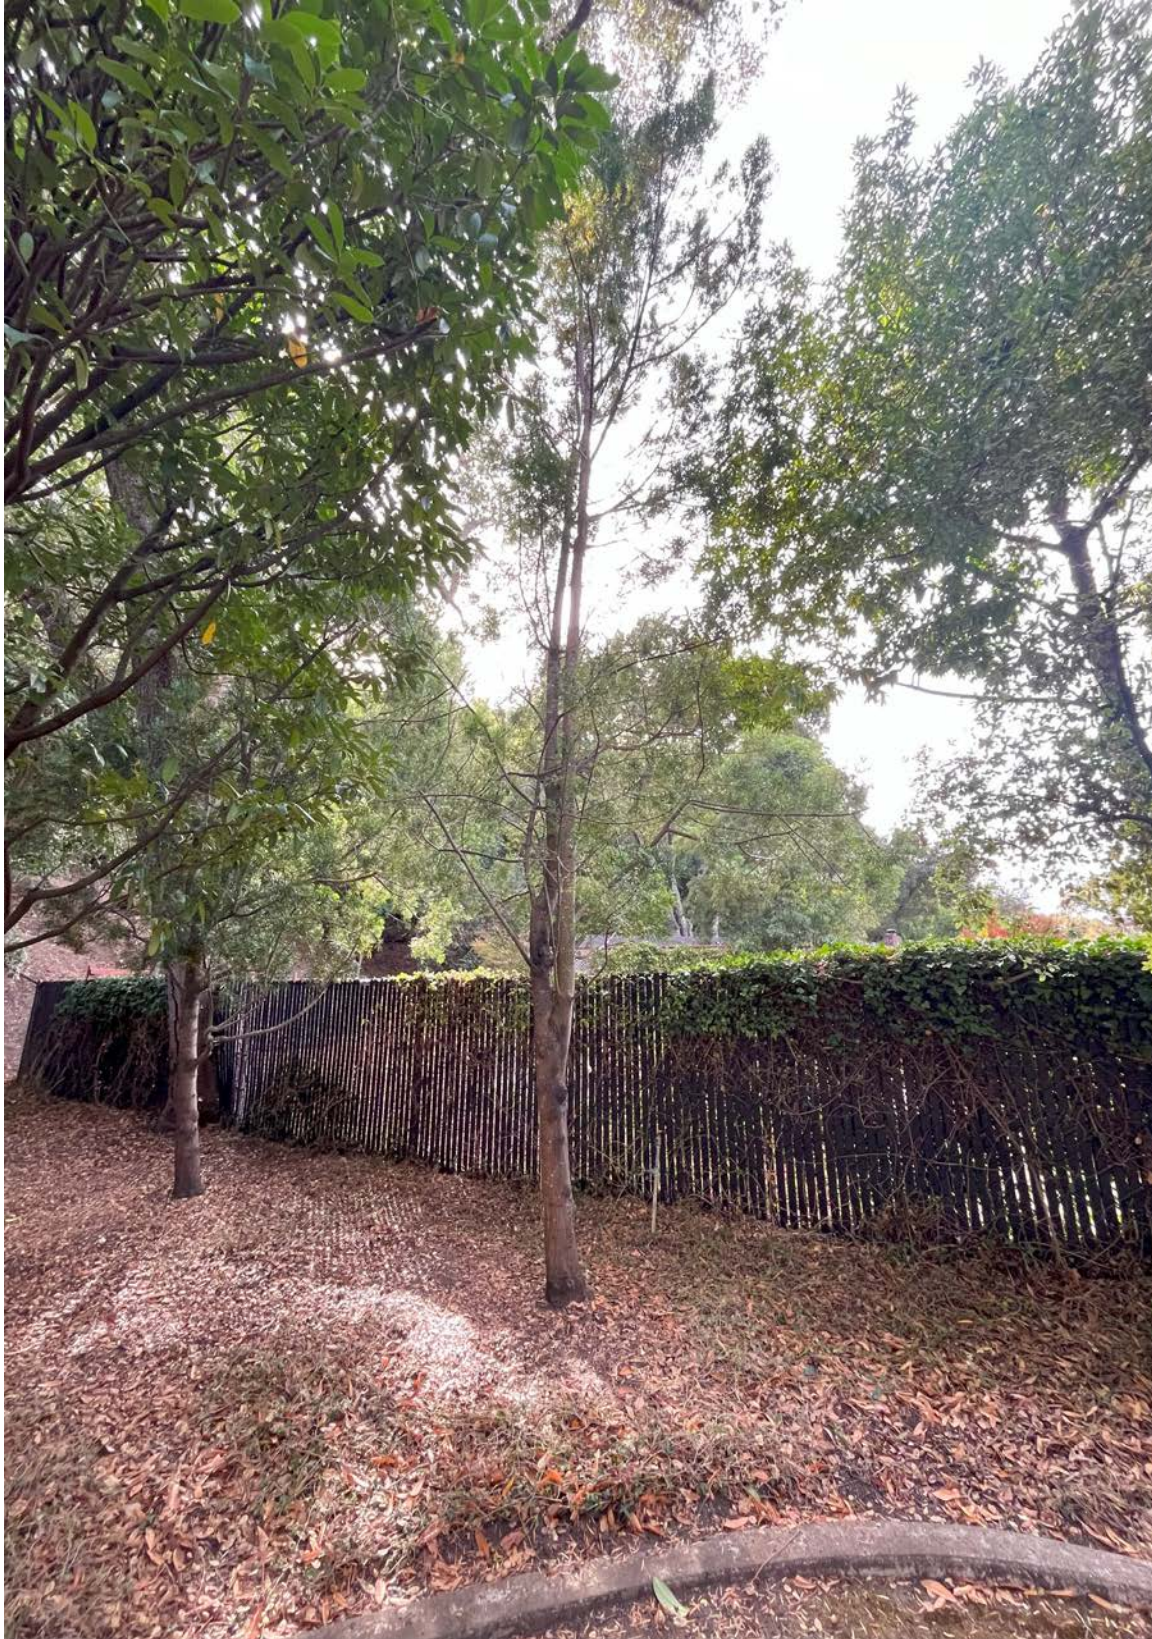
Tree #12

| Tree # | Species Common (<i>Scientific</i>) | Diameter (inches) | Condition (percent) | Height (feet) | Spread (feet) | Comments |
|---|---|---|---|---|---|---|
| 12 | Podocarpus | 7.1 | 40 | 25 | 9 | Codominant attachment with included bark at 5 feet high, moderate amount of interior deadwood, fair vigor and poor form. |

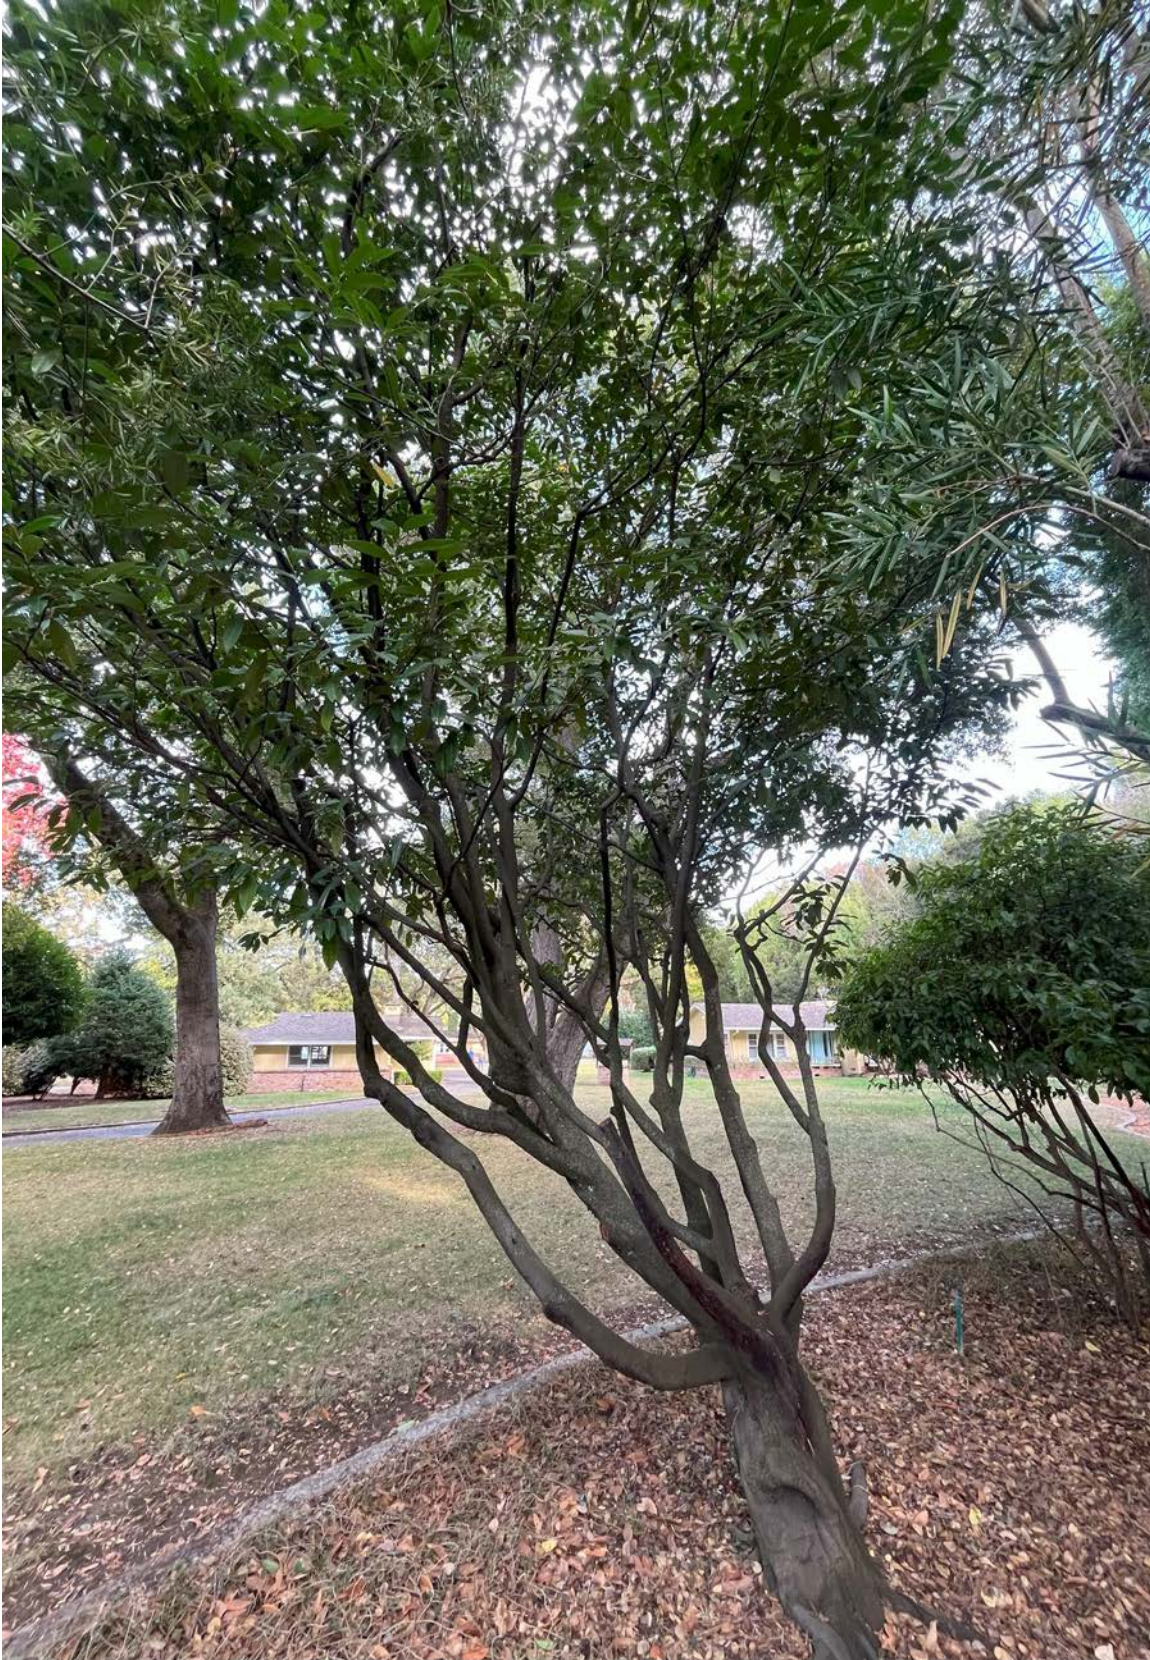
| Tree # | Species Common (<i>Scientific</i>) | Diameter (inches) | Condition (percent) | Height (feet) | Spread (feet) | Comments |
|---|---|---|---|---|---|---|
| 13 | English Laurel | 7.2 | 45 | 20 | 15 | Decay at 2 feet high on west side of trunk, multi-stem at 3 feet high, fair vigor and poor form. |

Tree #13 is an English Laurel tree located along the right side of the property. This tree leans to the north, has decay at its base on the west side of the trunk, and has a multi-stem attachment at 3 feet high. Overall, this tree has fair vigor and poor form.

I recommend routine tree maintenance that should include shaping the tree to maintain a balanced form.

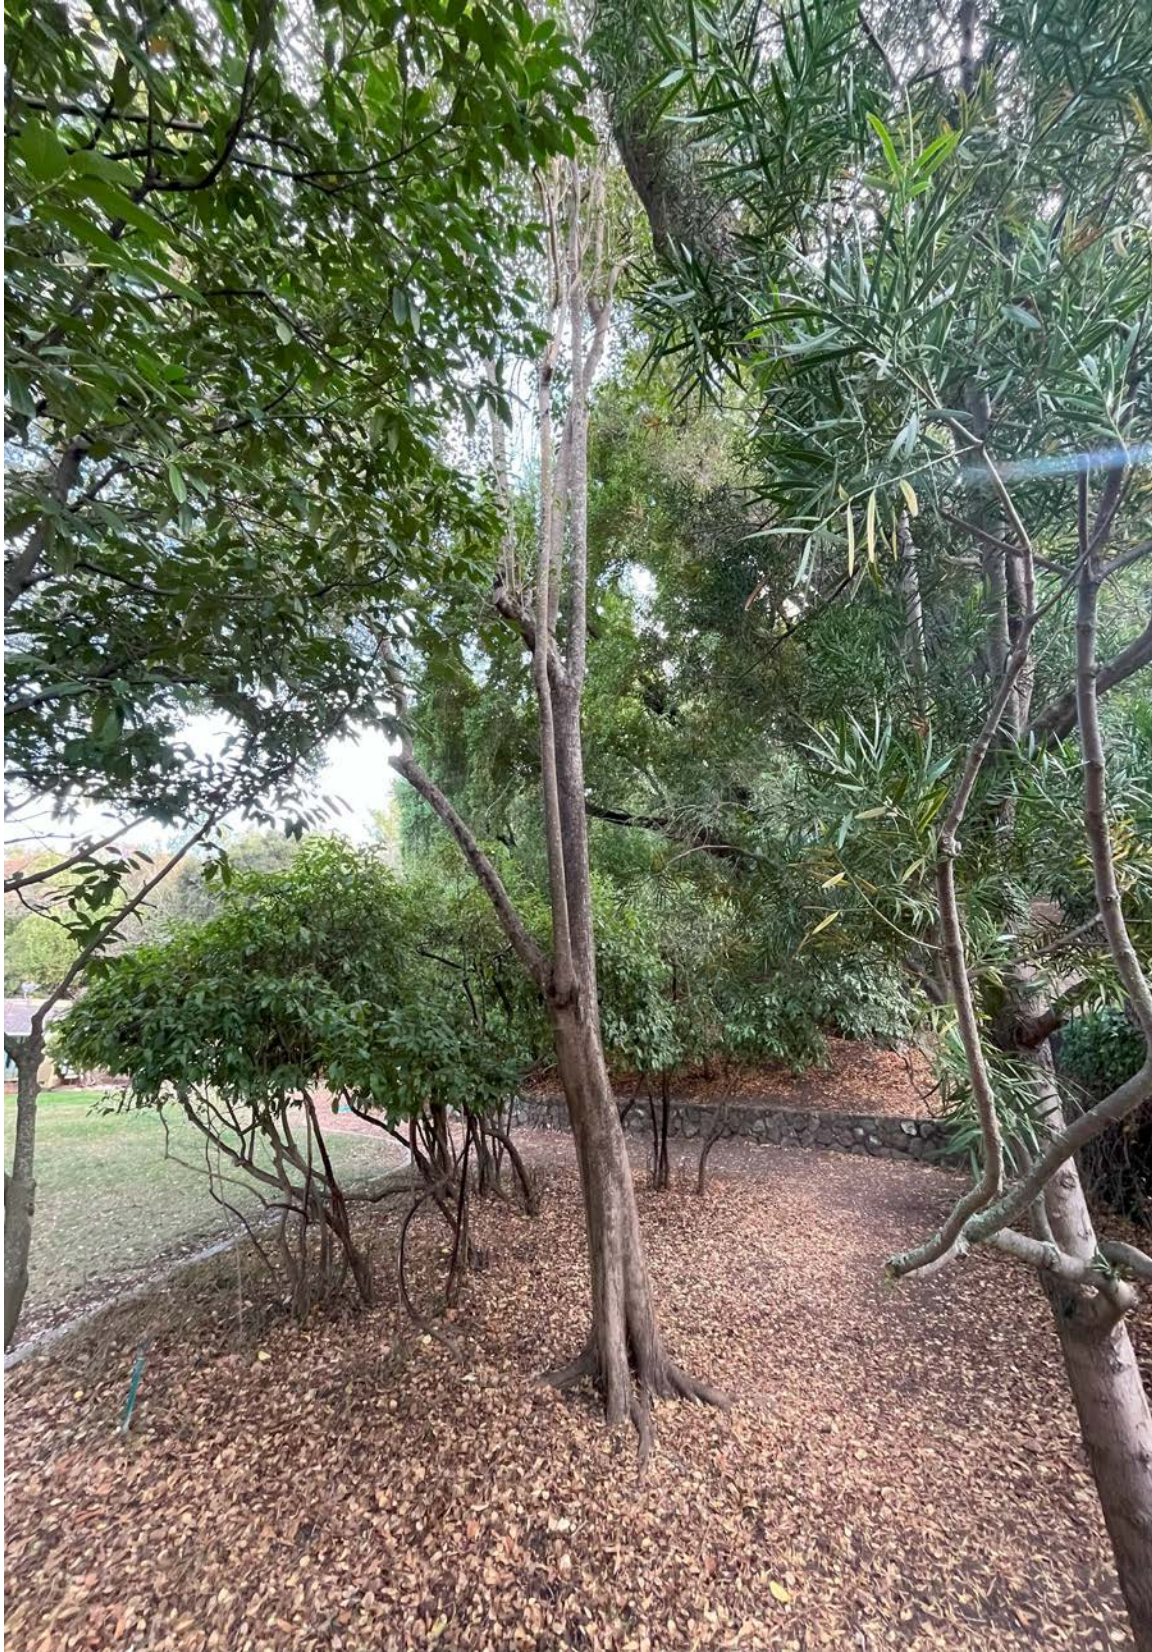
| Tree # | Species Common (<i>Scientific</i>) | Diameter (inches) | Condition (percent) | Height (feet) | Spread (feet) | Comments |
|---|---|---|---|---|---|--|
| 14 | Japanese Privet | 12.9 | 40 | 45 | 18 | Decay at base on northeast side, multi-stem at 15 feet high, good vigor and poor form. |

Tree #14 is a Japanese Privet tree located along the right side of the property. This tree has decay at its base on the north side of the trunk and has a multi-stem attachment at 15 feet high. Overall, this tree has good vigor and poor form.

I recommend removing this tree as it is an undesirable volunteer species with poor form and decay at its base.

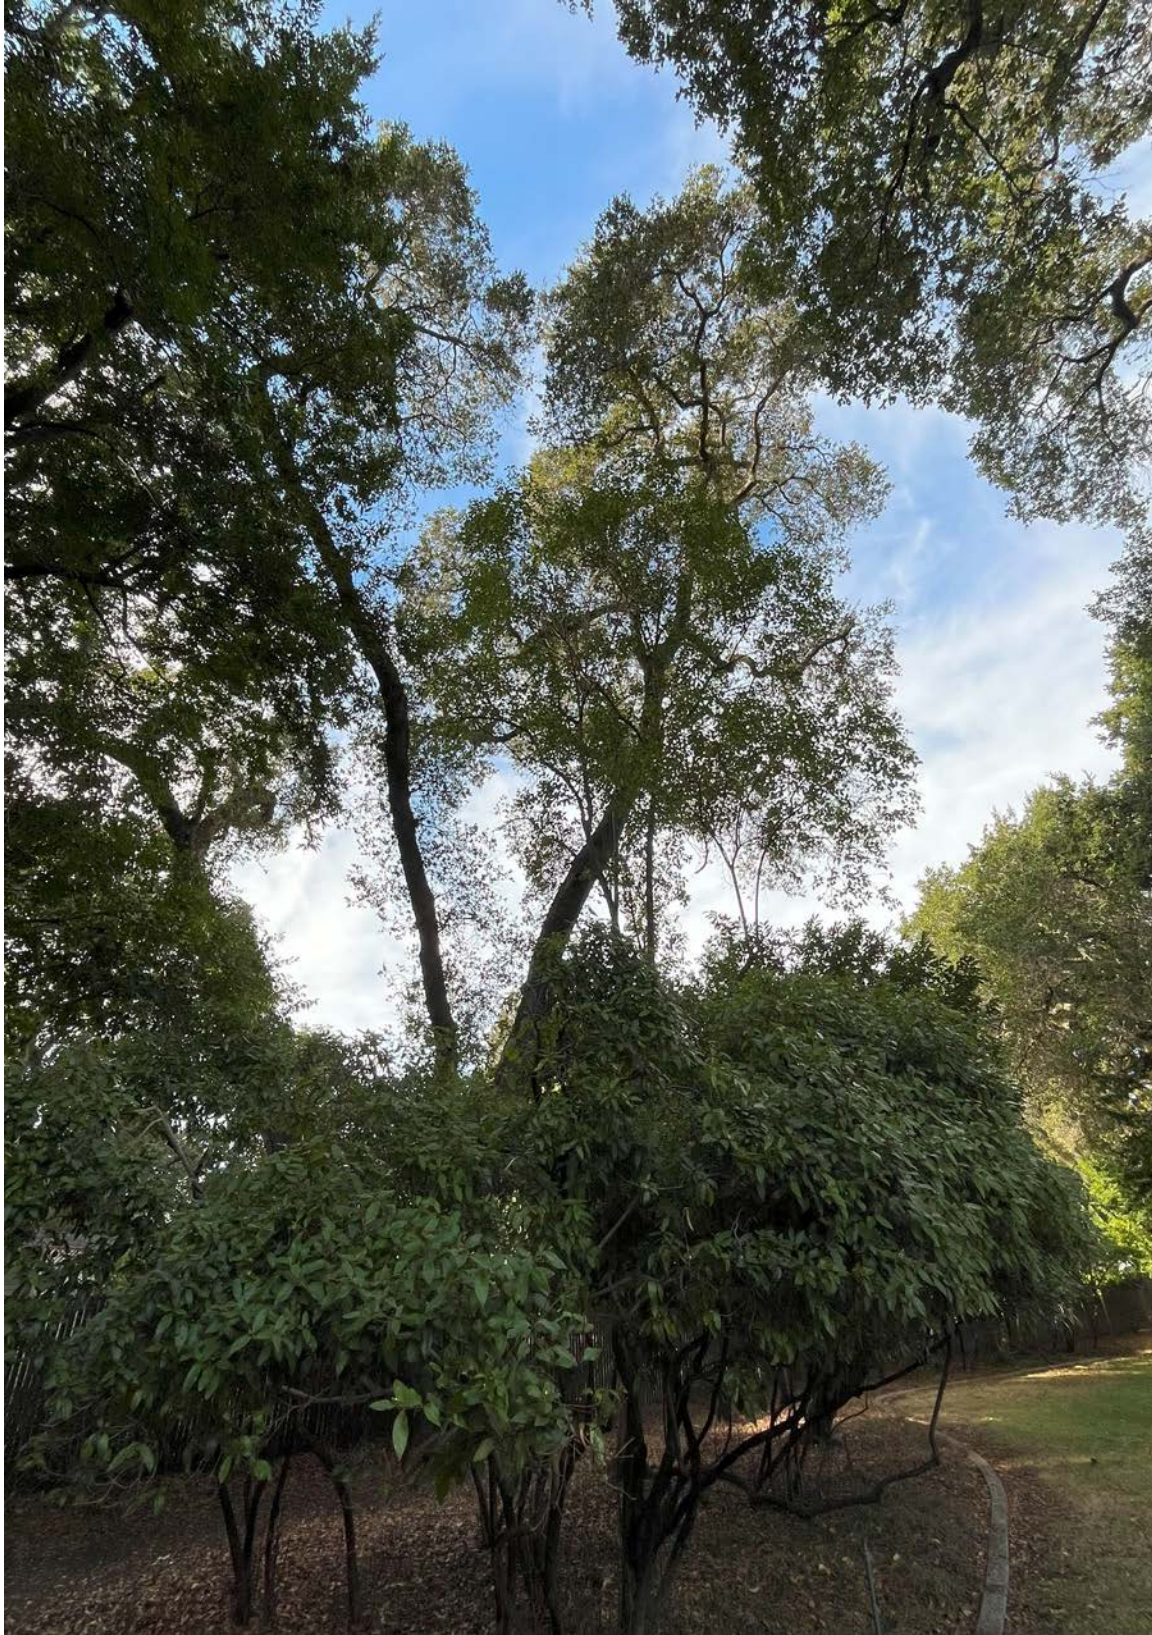
Tree #15

| Tree # | Species Common (<i>Scientific</i>) | Diameter (inches) | Condition (percent) | Height (feet) | Spread (feet) | Comments |
|---|---|---|---|---|---|--|
| 15 | Coast Live Oak | Est. 45.0 | 55 | 80 | 60 | Two-stem at base, straddling the property line, the two stems lean in opposite directions, Sycamore borer on the lower trunk, abundance of trunk sprouts, poor form and moderate vigor. |

I recommend routine tree maintenance, including thinning out the trunk sprouts on the stem over the client's property and reducing the end weight in the same location.

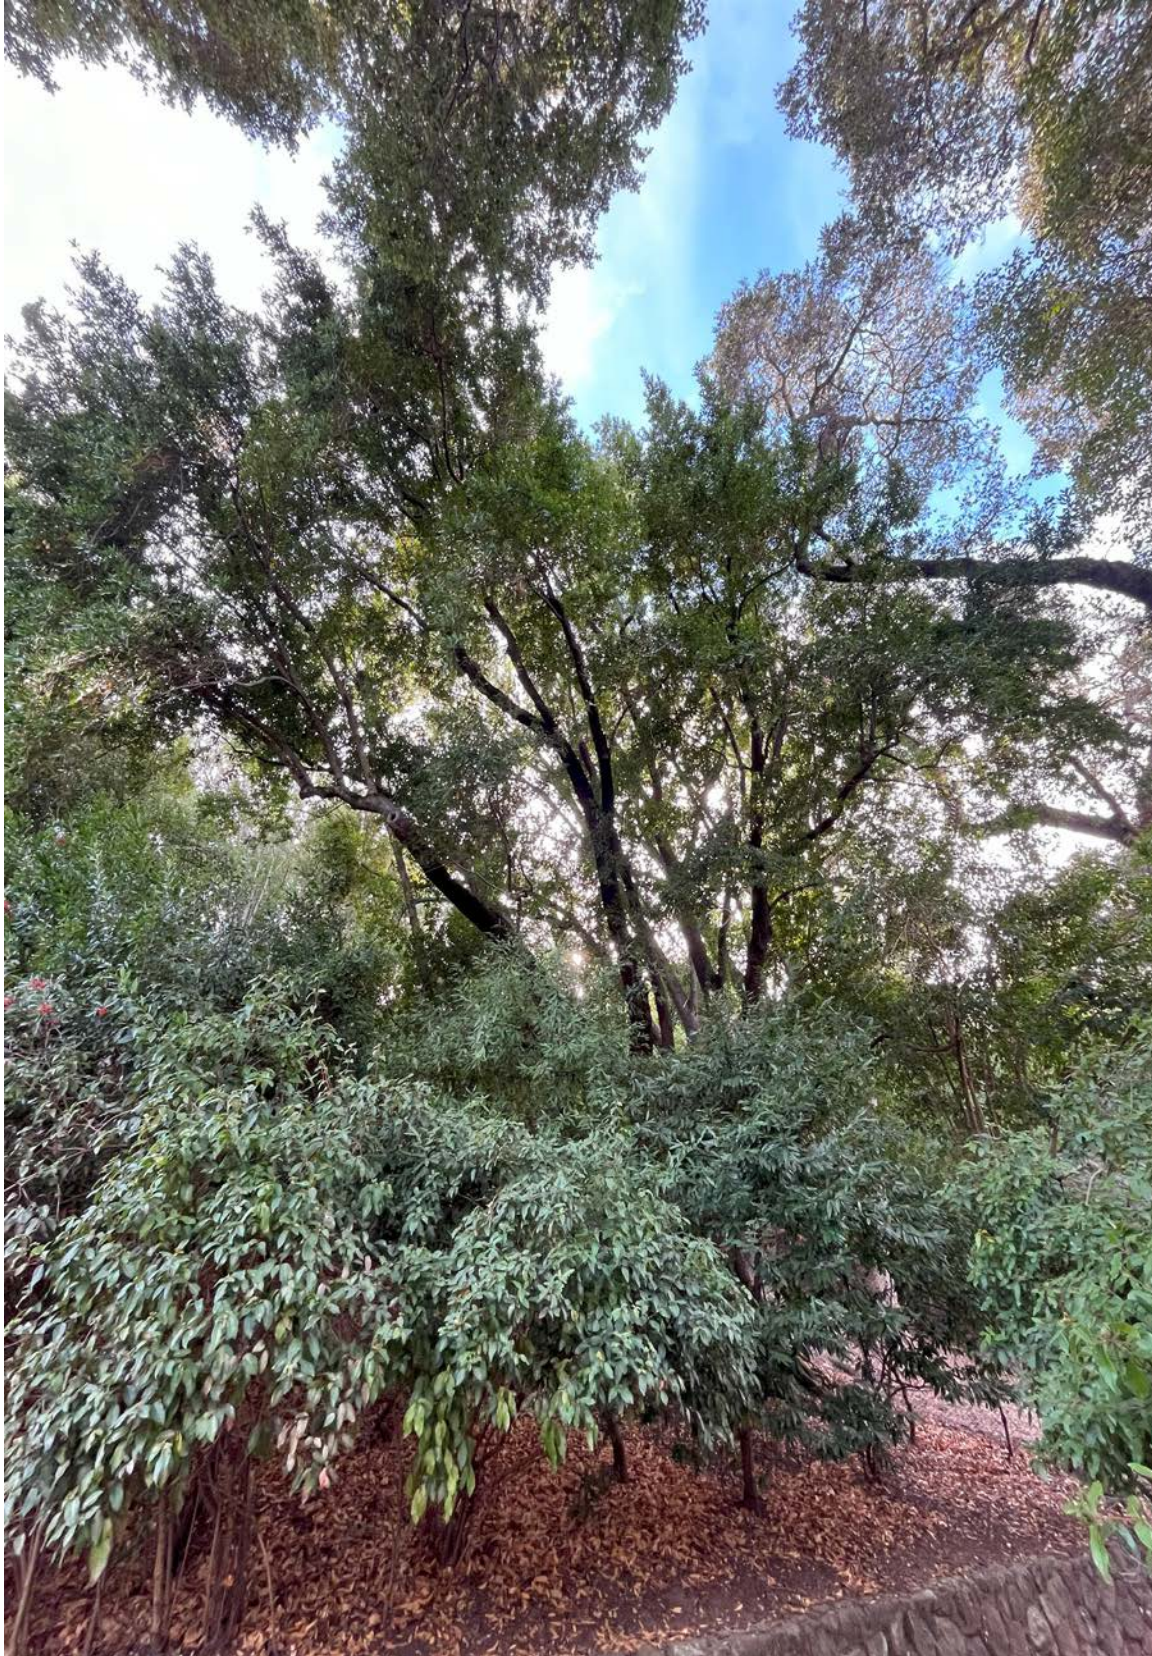
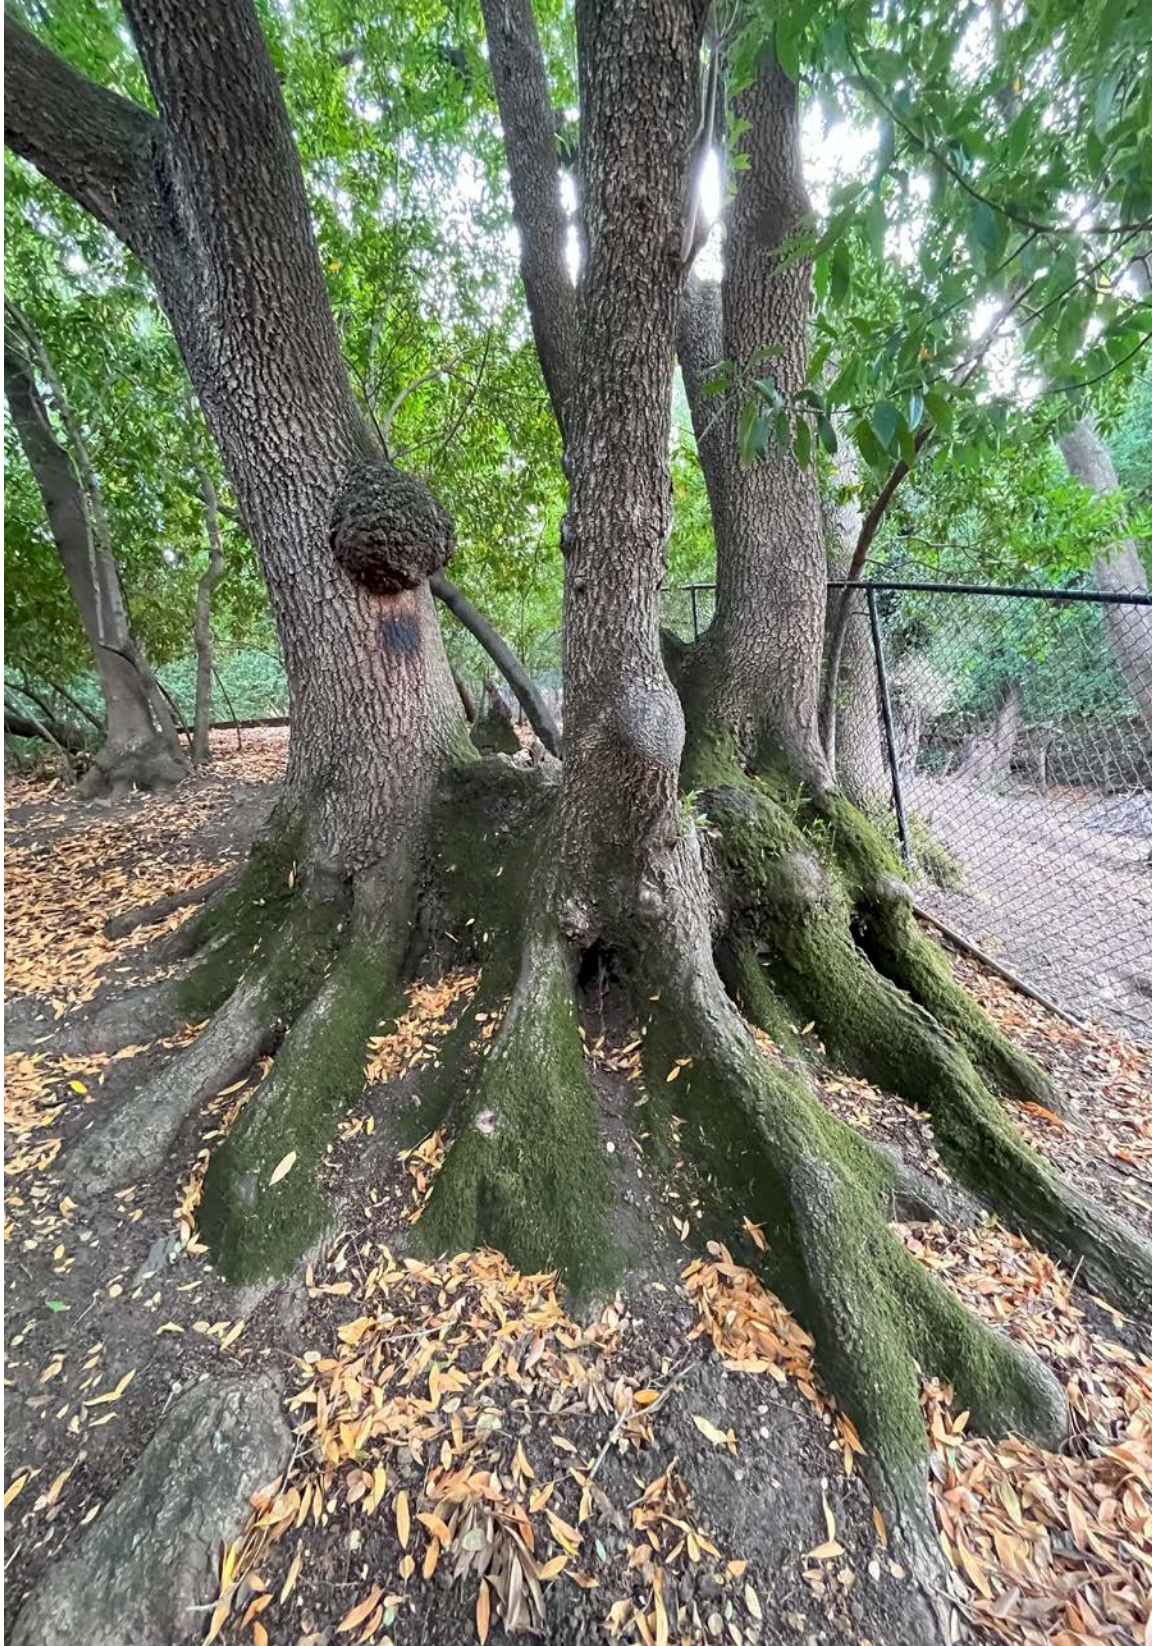
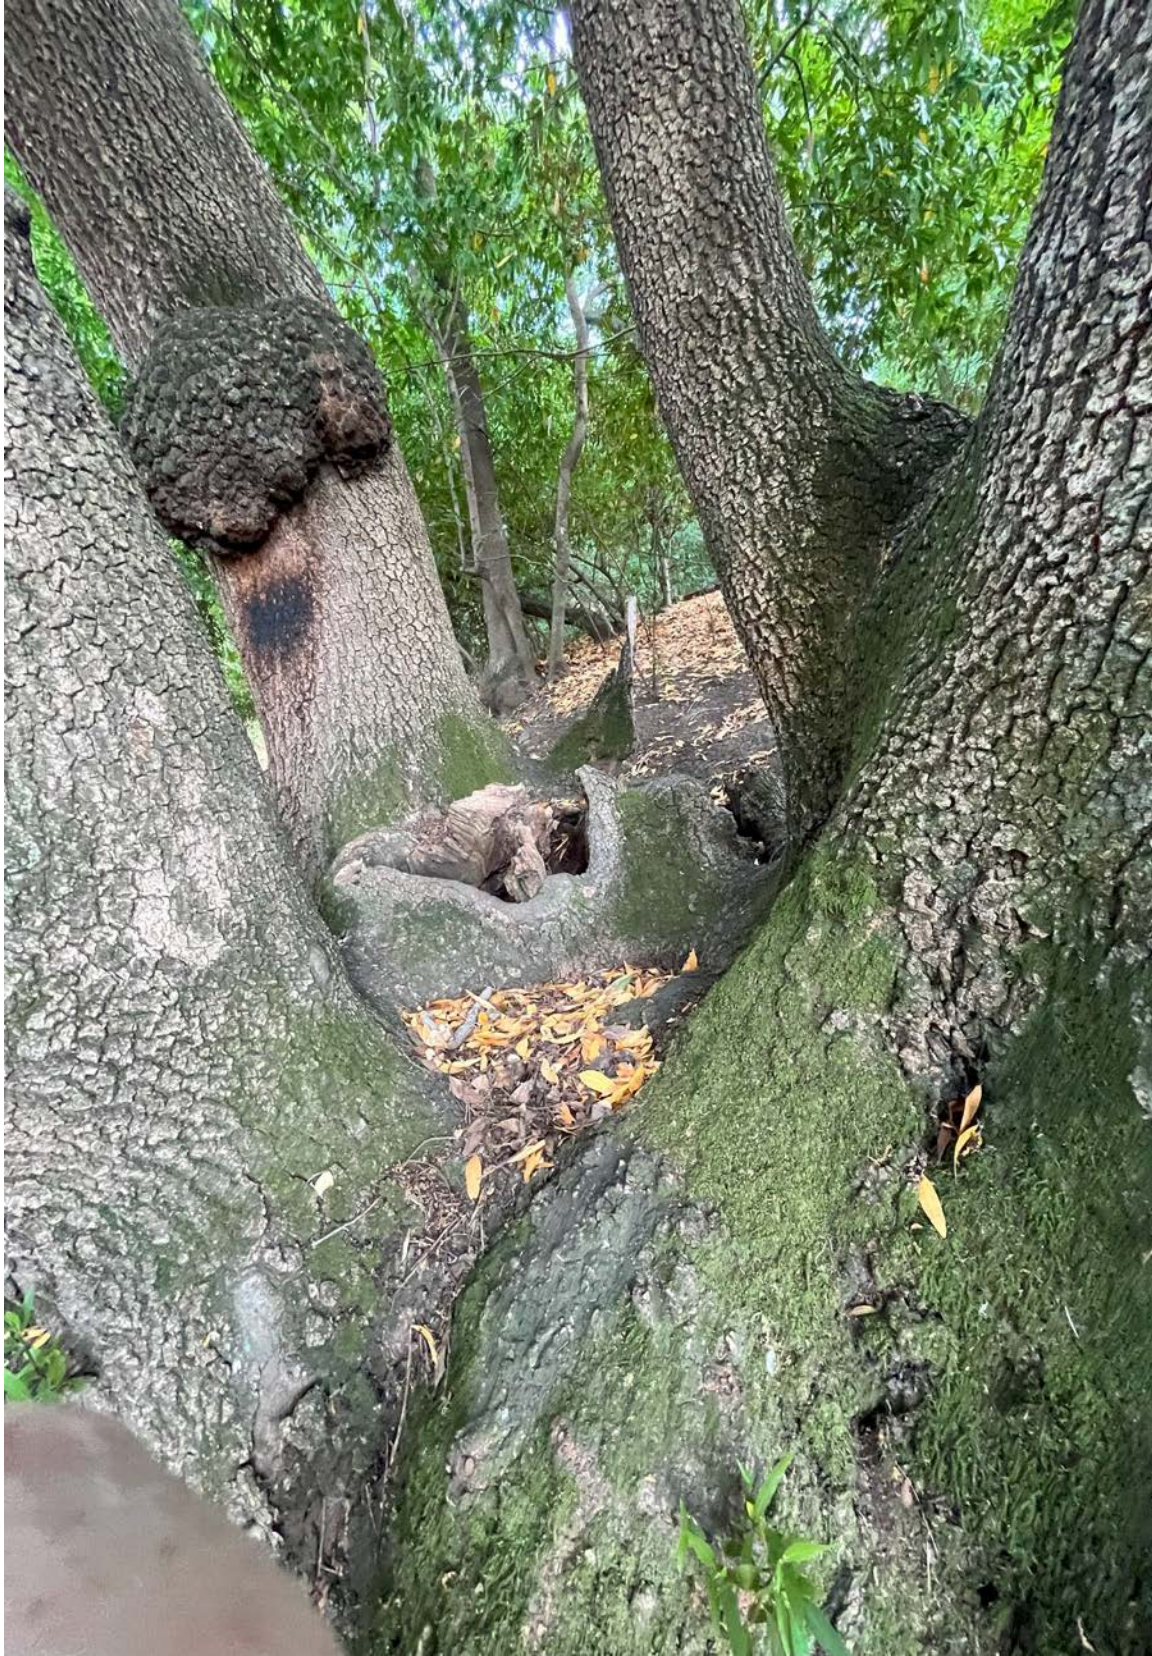
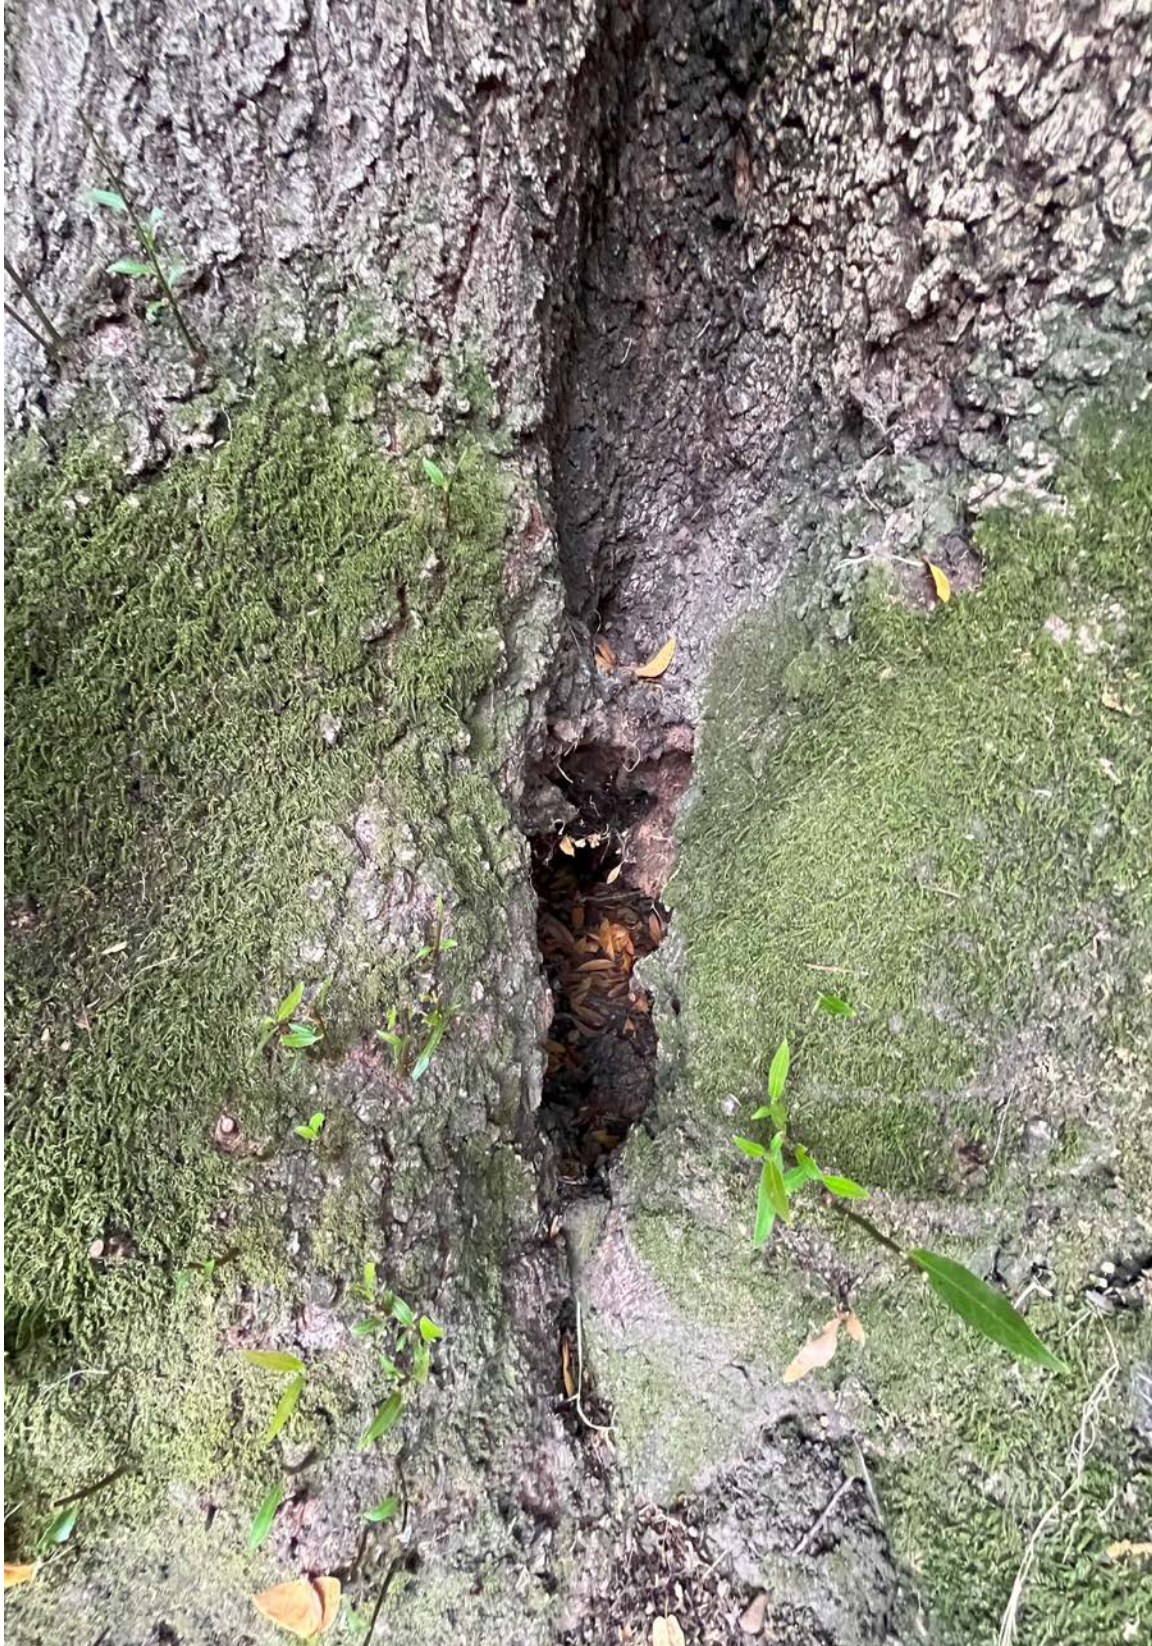
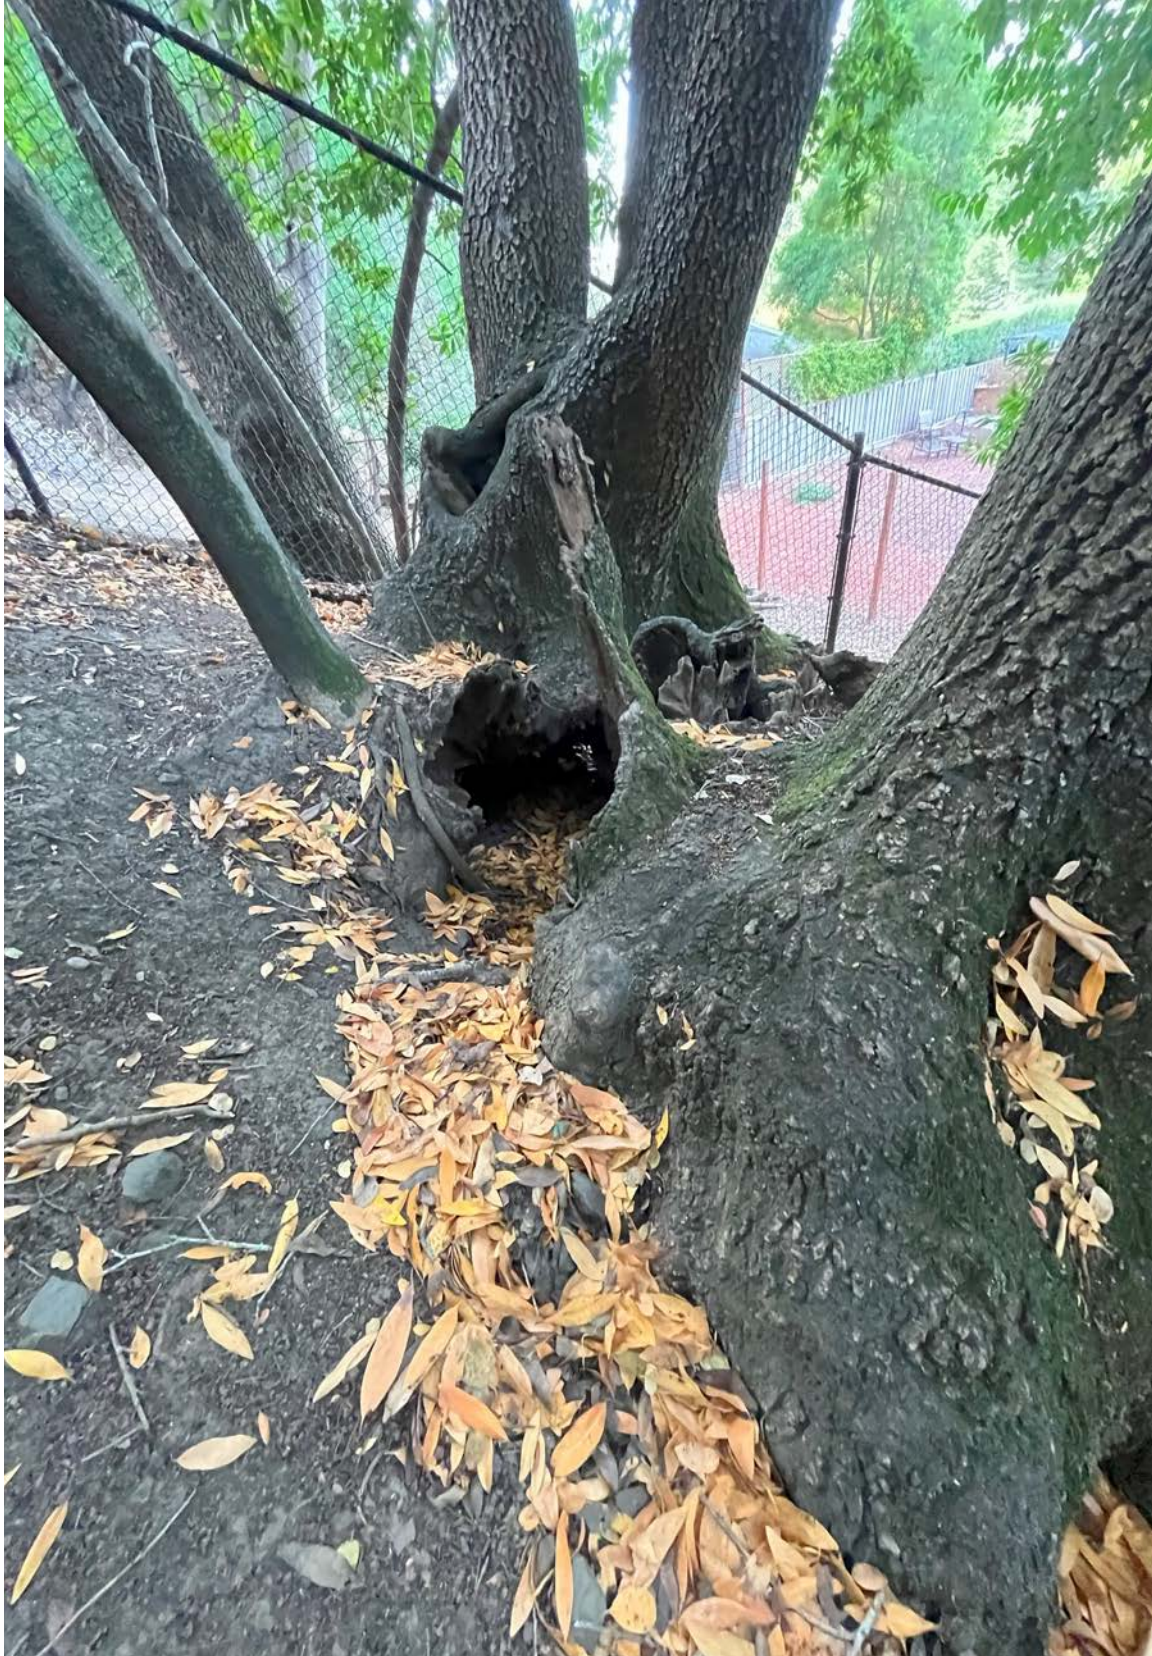
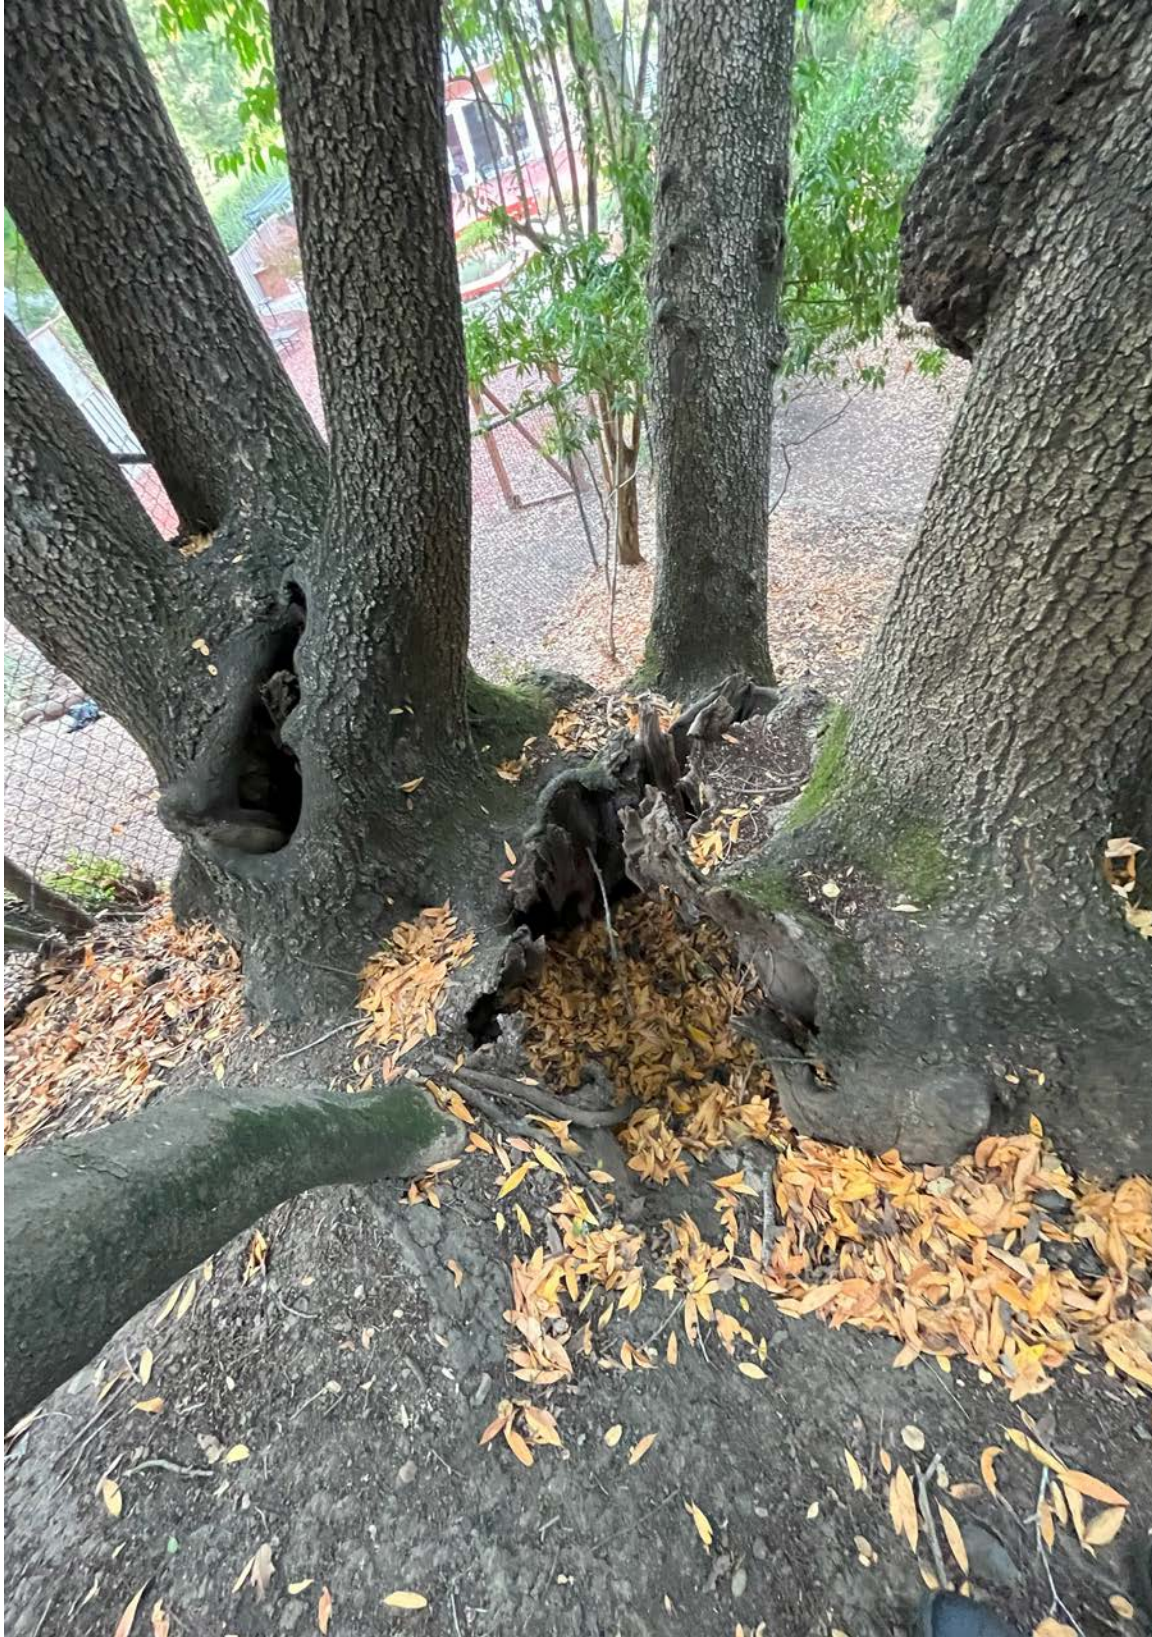
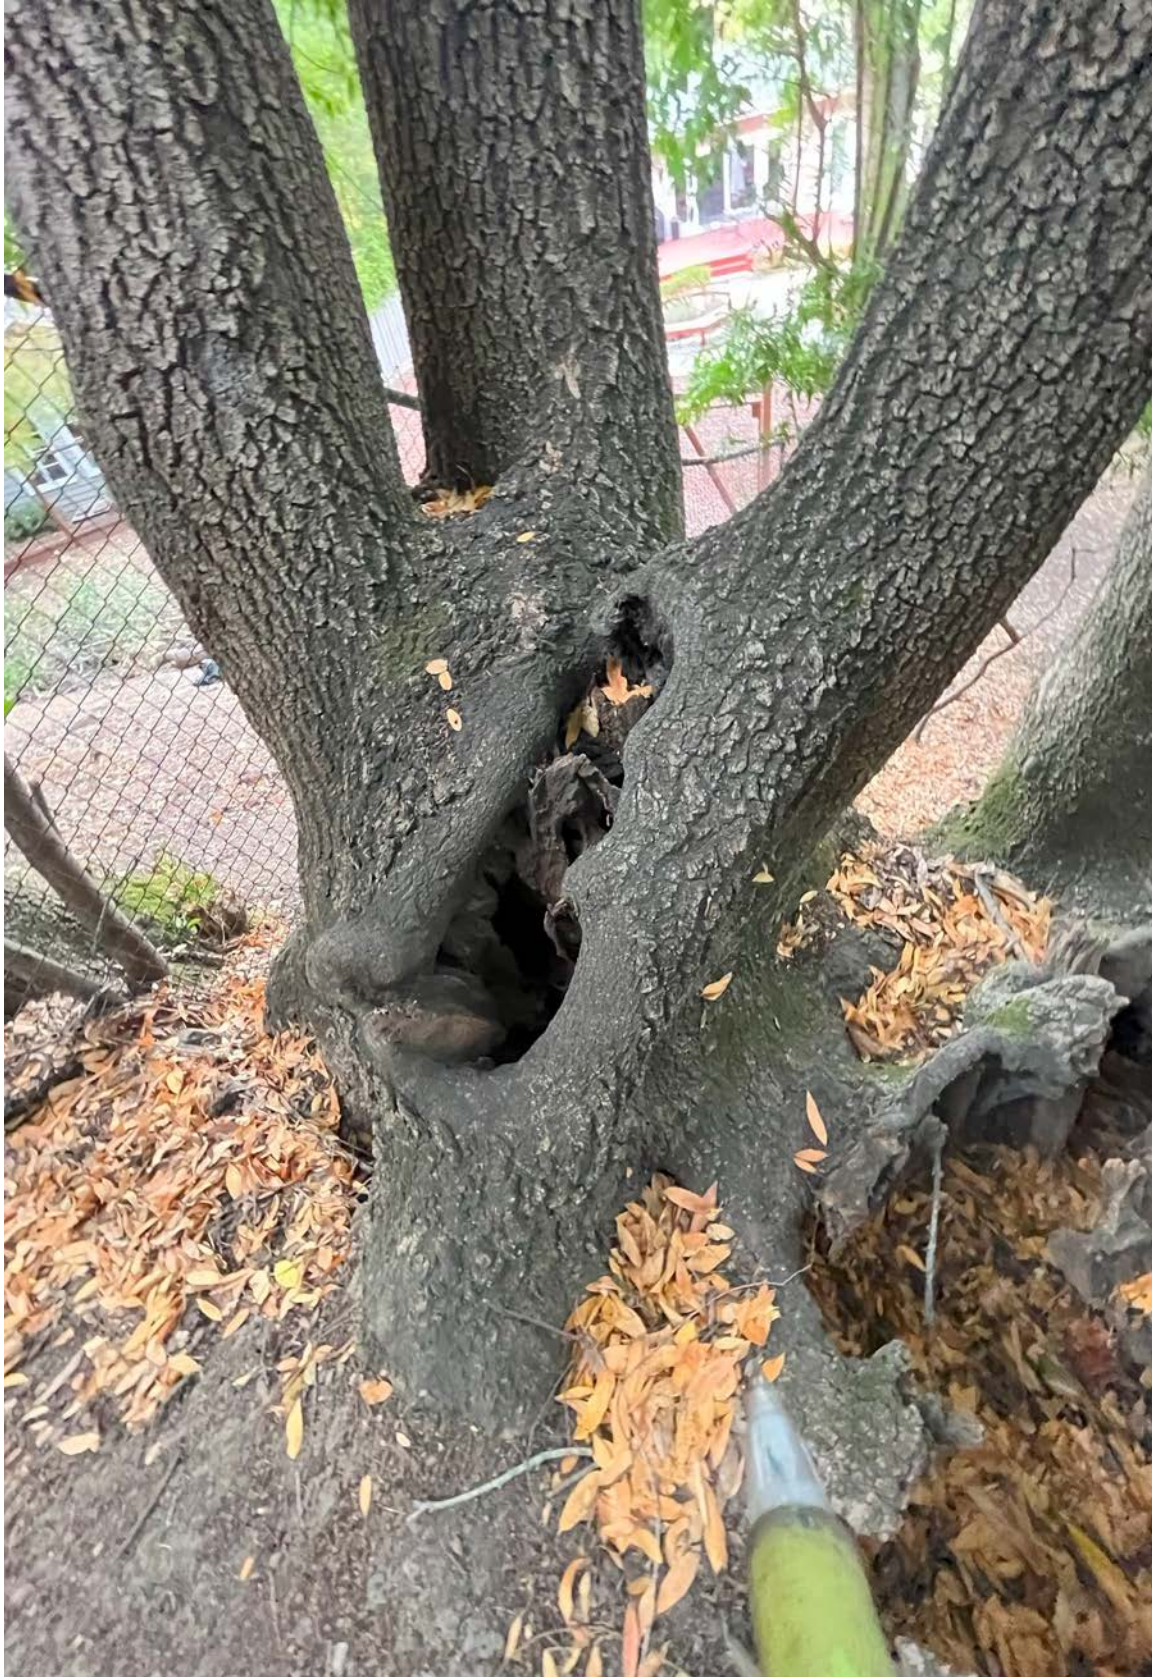
| Tree # | Species Common (<i>Scientific</i>) | Diameter (inches) | Condition (percent) | Height (feet) | Spread (feet) | Comments |
|---|---|---|---|---|---|--|
| 16 | California Bay Laurel | Est. 65.0 | 40 | 70 | 65 | Six stems at base, lower trunk completely hollow with extensive decay, heavy lateral limbs, on leaning leaders, poor form and good vigor. |

Tree #16 is a California Bay Laurel tree located on the hillside along the right rear corner of the site. This tree has a total of 6 stems originating from a significantly decayed lower trunk affected by Ganoderma sap. This is a common issue with old large Bay trees. The weakly attached large leaders have a high potential for failure due to this type of weakened attachment. Overall, this tree has good vigor and very poor form.

I recommend routine tree maintenance, including significant weight reduction of the leaning leaders and reshaping of the canopy to promote a balanced form.
