Mayne Tree Expert Company, Inc.

November 16, 2024

RE: 1815 CORDILLERAS RD., EMERALD HILLS (ARBORIST REPORT)

Tree Survey

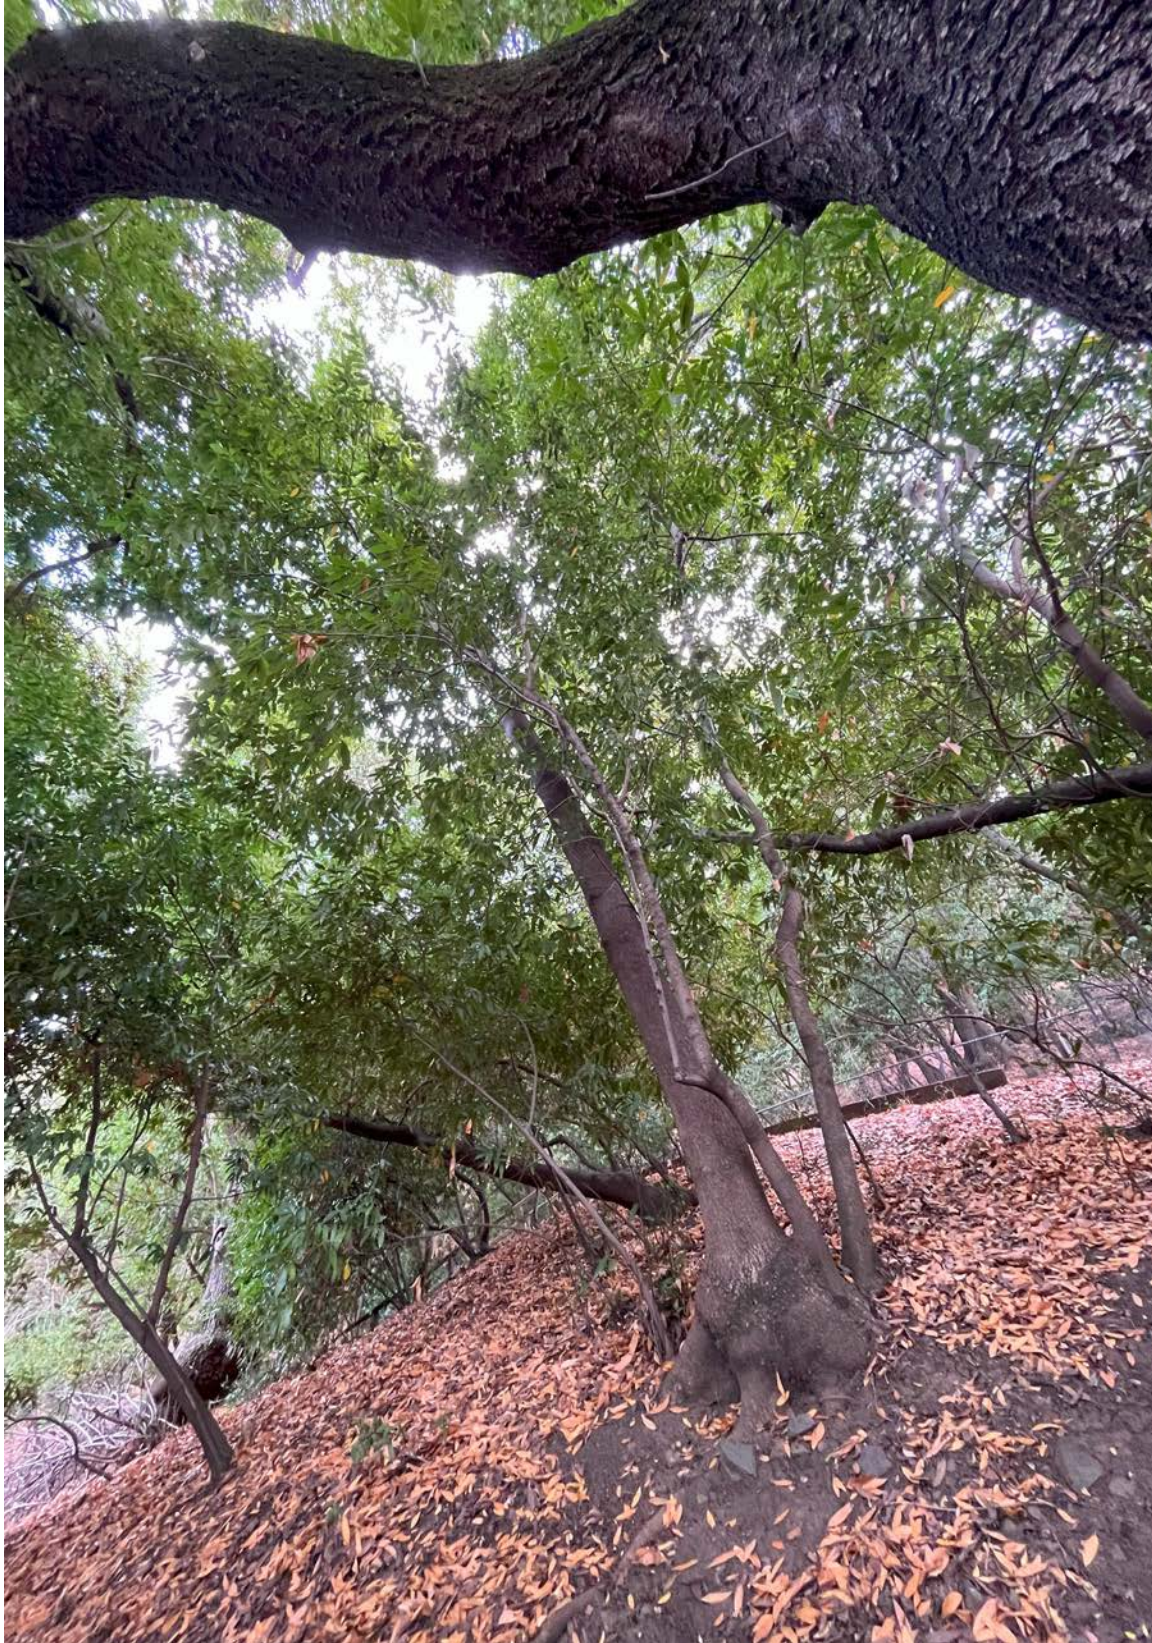
Tree #17

| Tree # | Species Common (<i>Scientific</i>) | Diameter (inches) | Condition (percent) | Height (feet) | Spread (feet) | Comments |
|---|---|---|---|---|---|--|
| 17 | California Bay Laurel | 10.4 | 45 | 40 | 21 | Three-stem at base, partially covered root crown, leans east, poor form, fair vigor. |

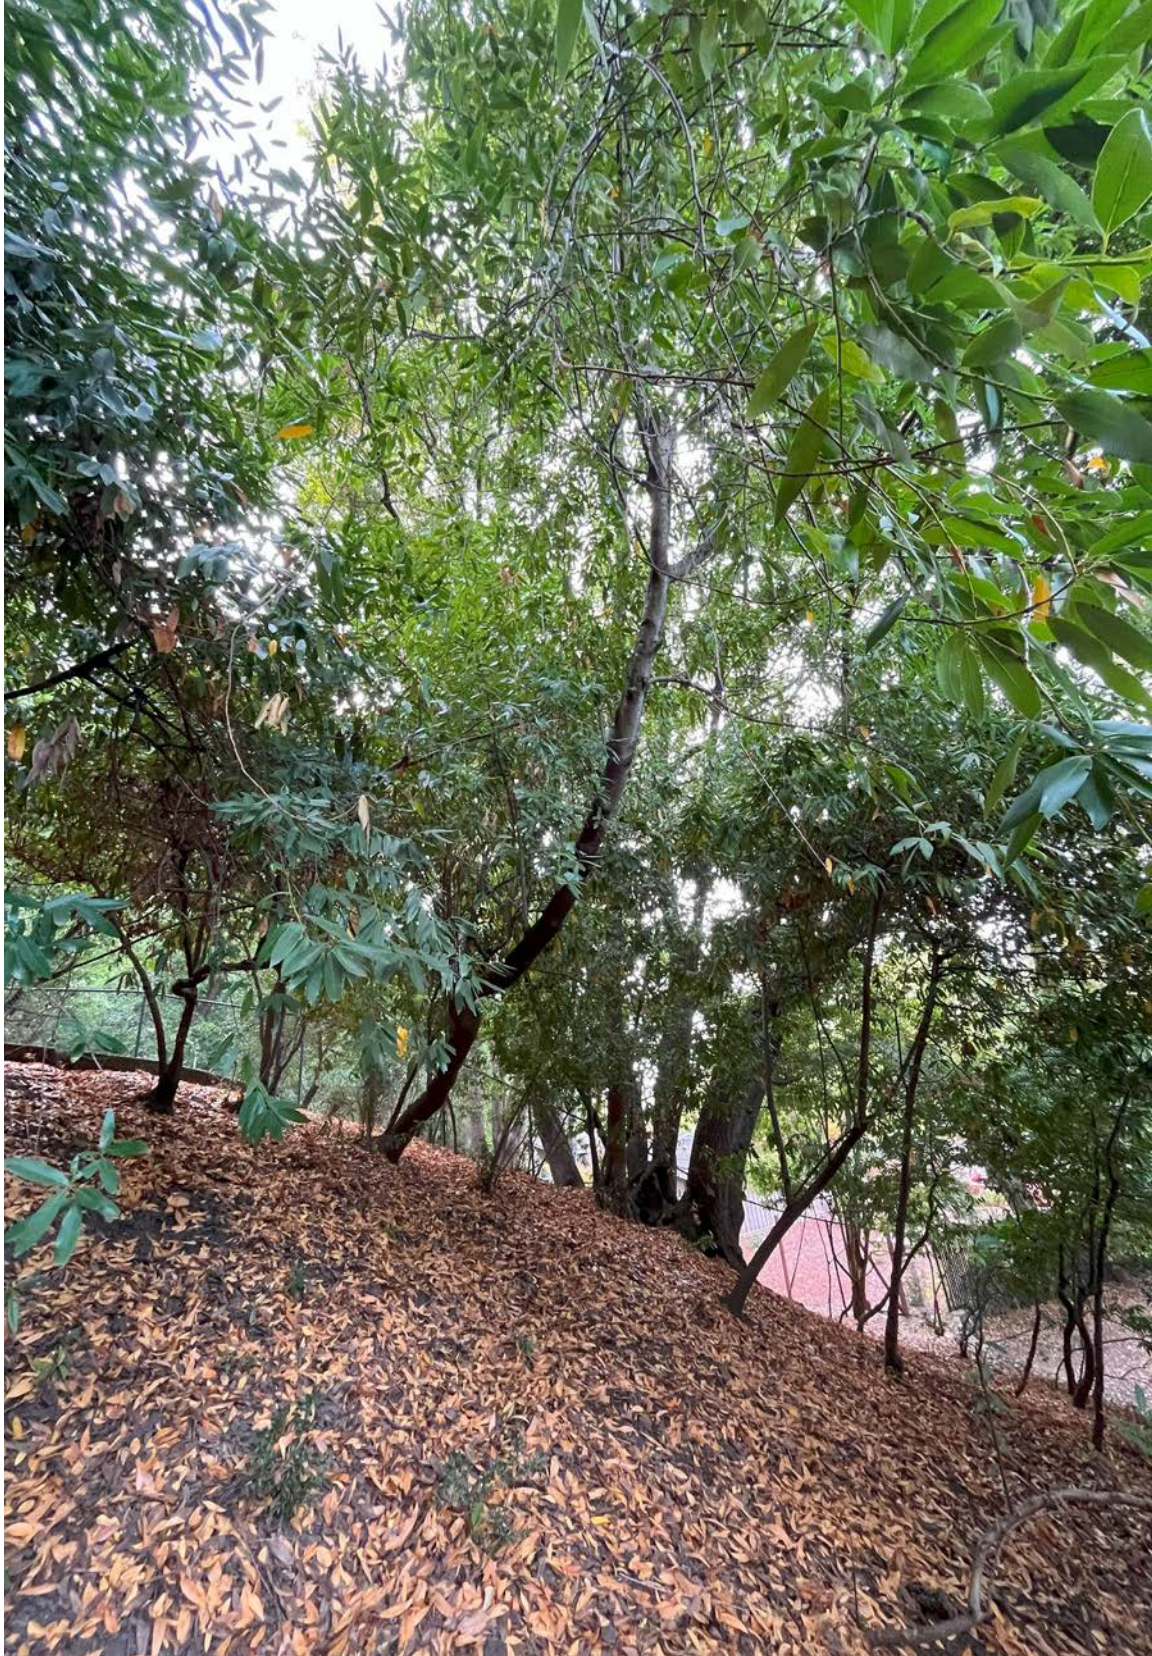
Tree #18

| Tree # | Species Common (<i>Scientific</i>) | Diameter (inches) | Condition (percent) | Height (feet) | Spread (feet) | Comments |
|---|---|---|---|---|---|--|
| 18 | California Bay Laurel | 7.1 | 40 | 25 | 24 | Significantly lean to the east, stag headed crown, poor form and fair vigor. |

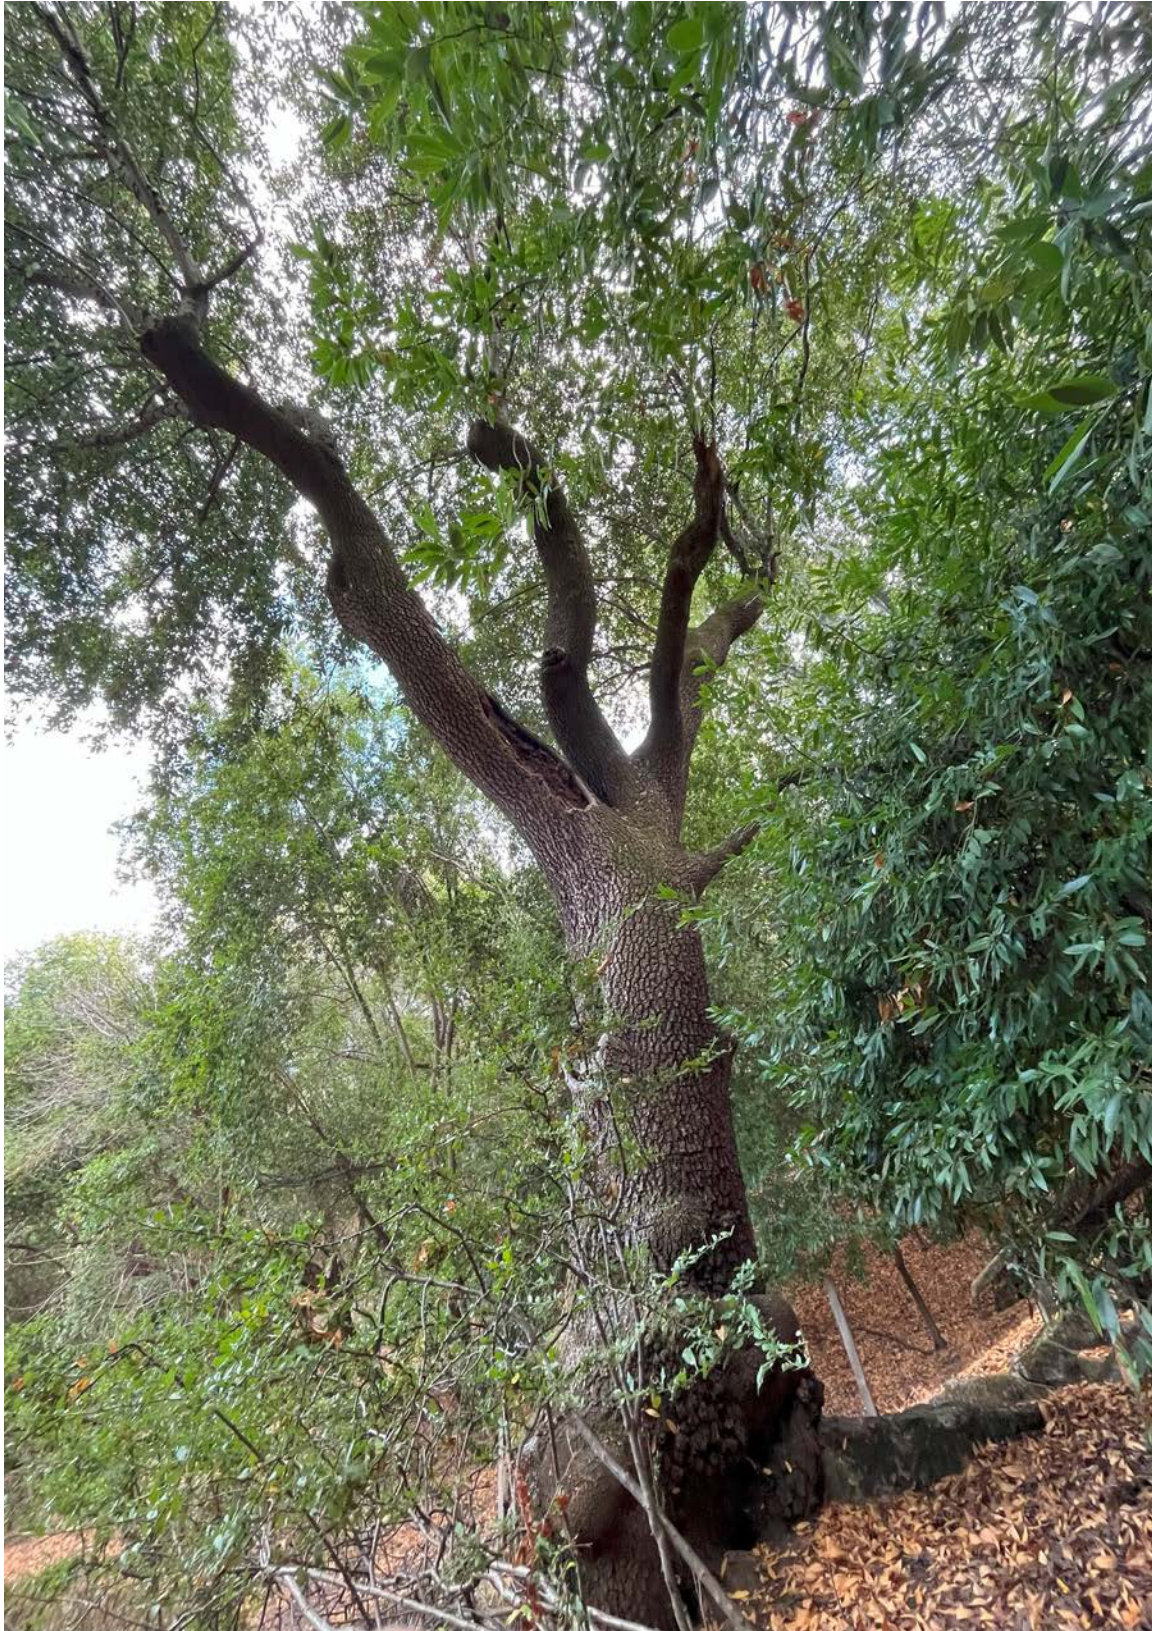
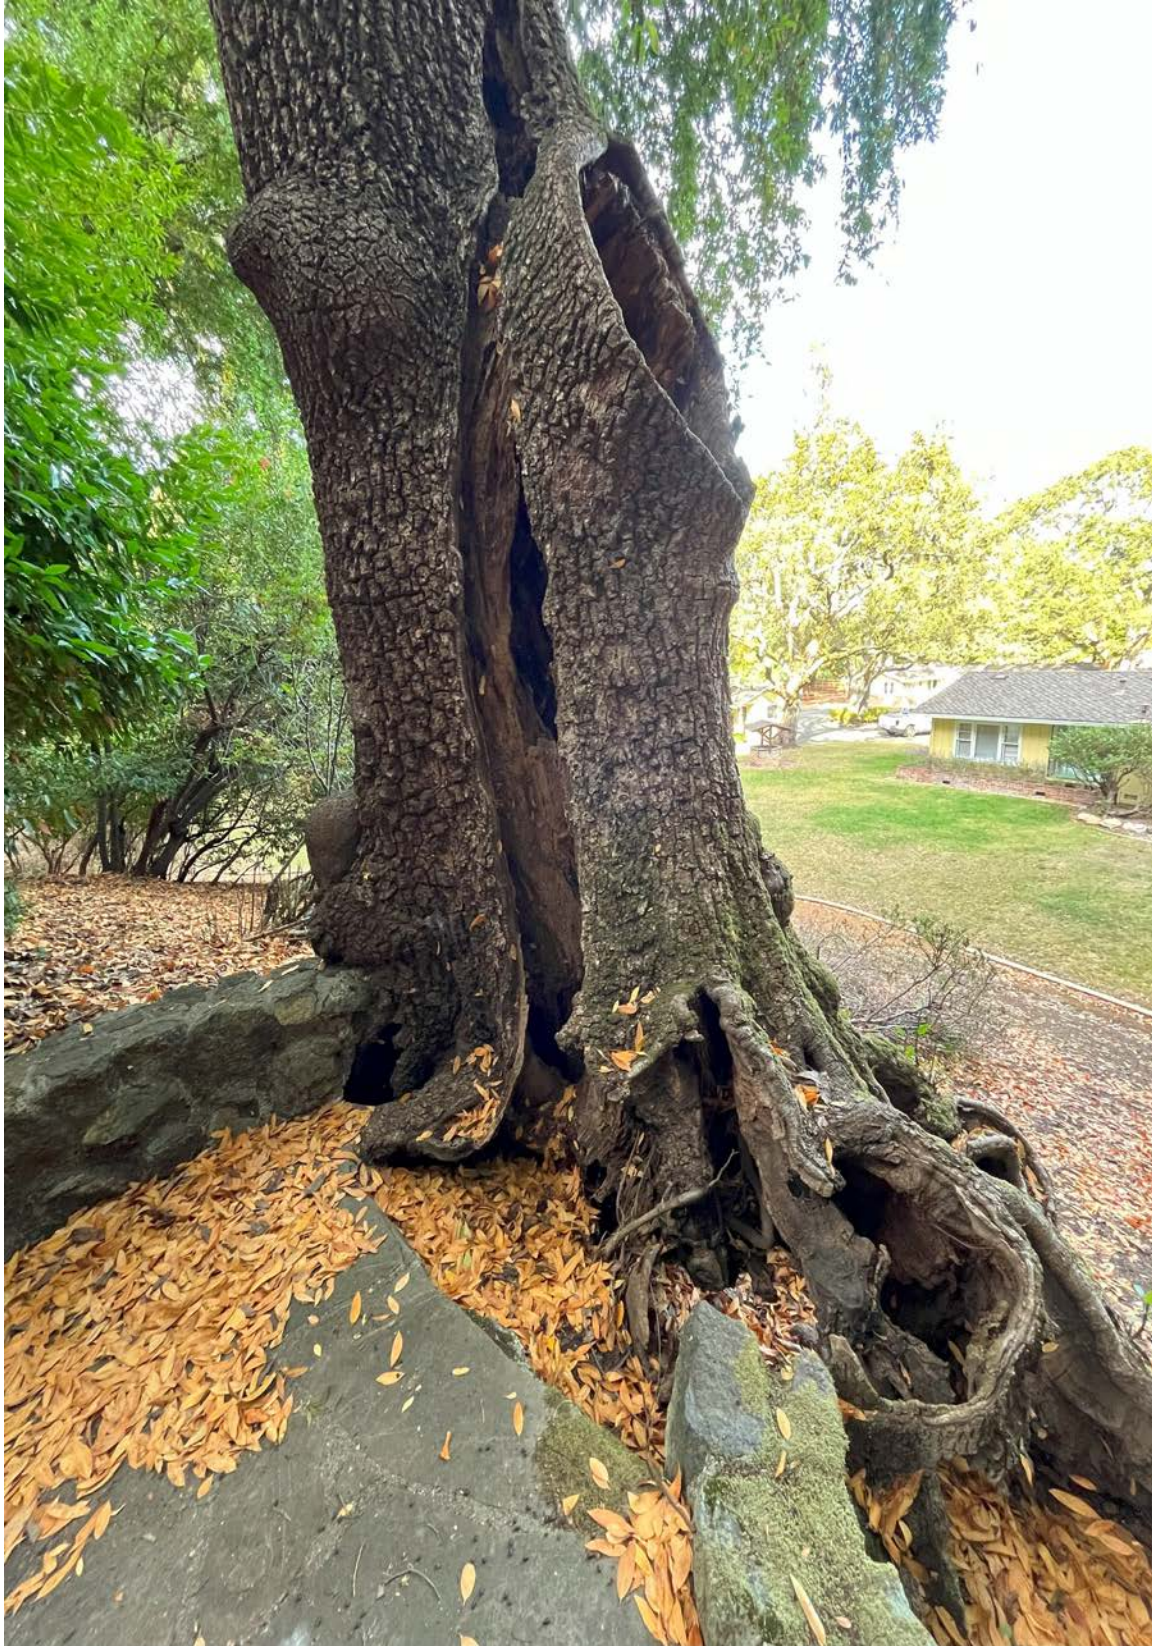
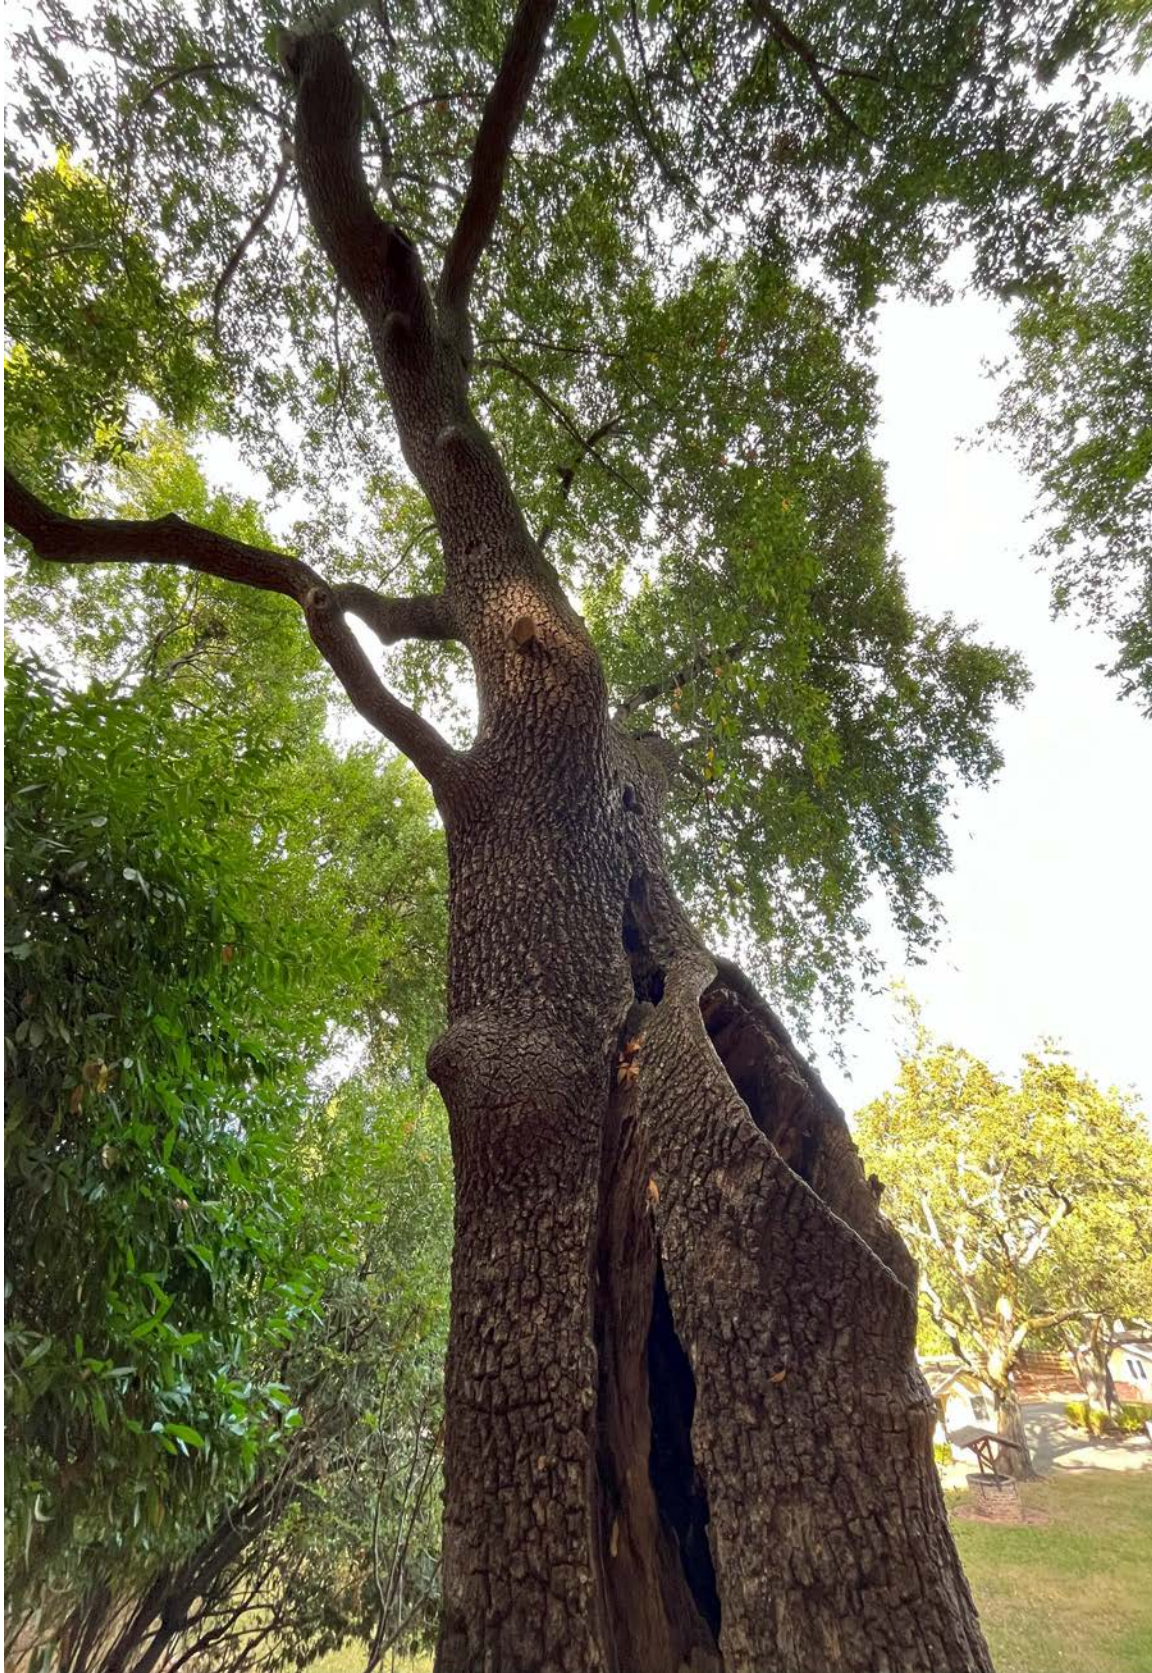
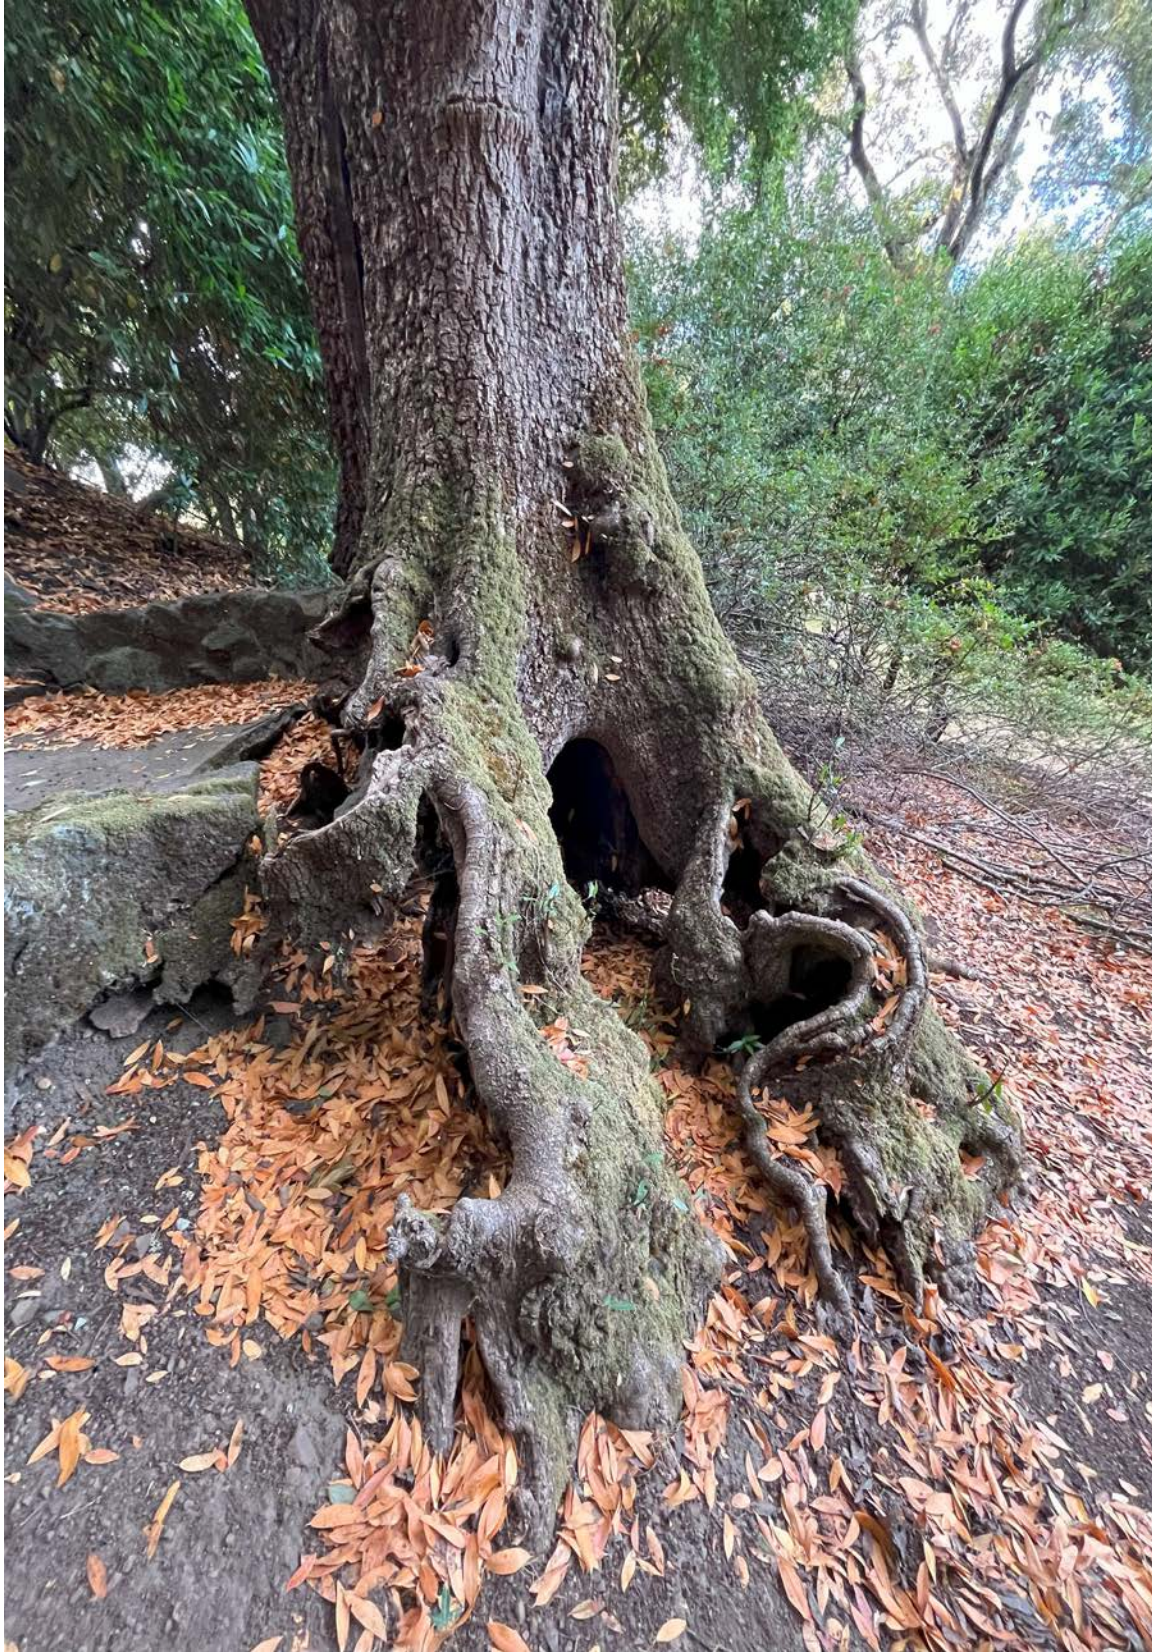
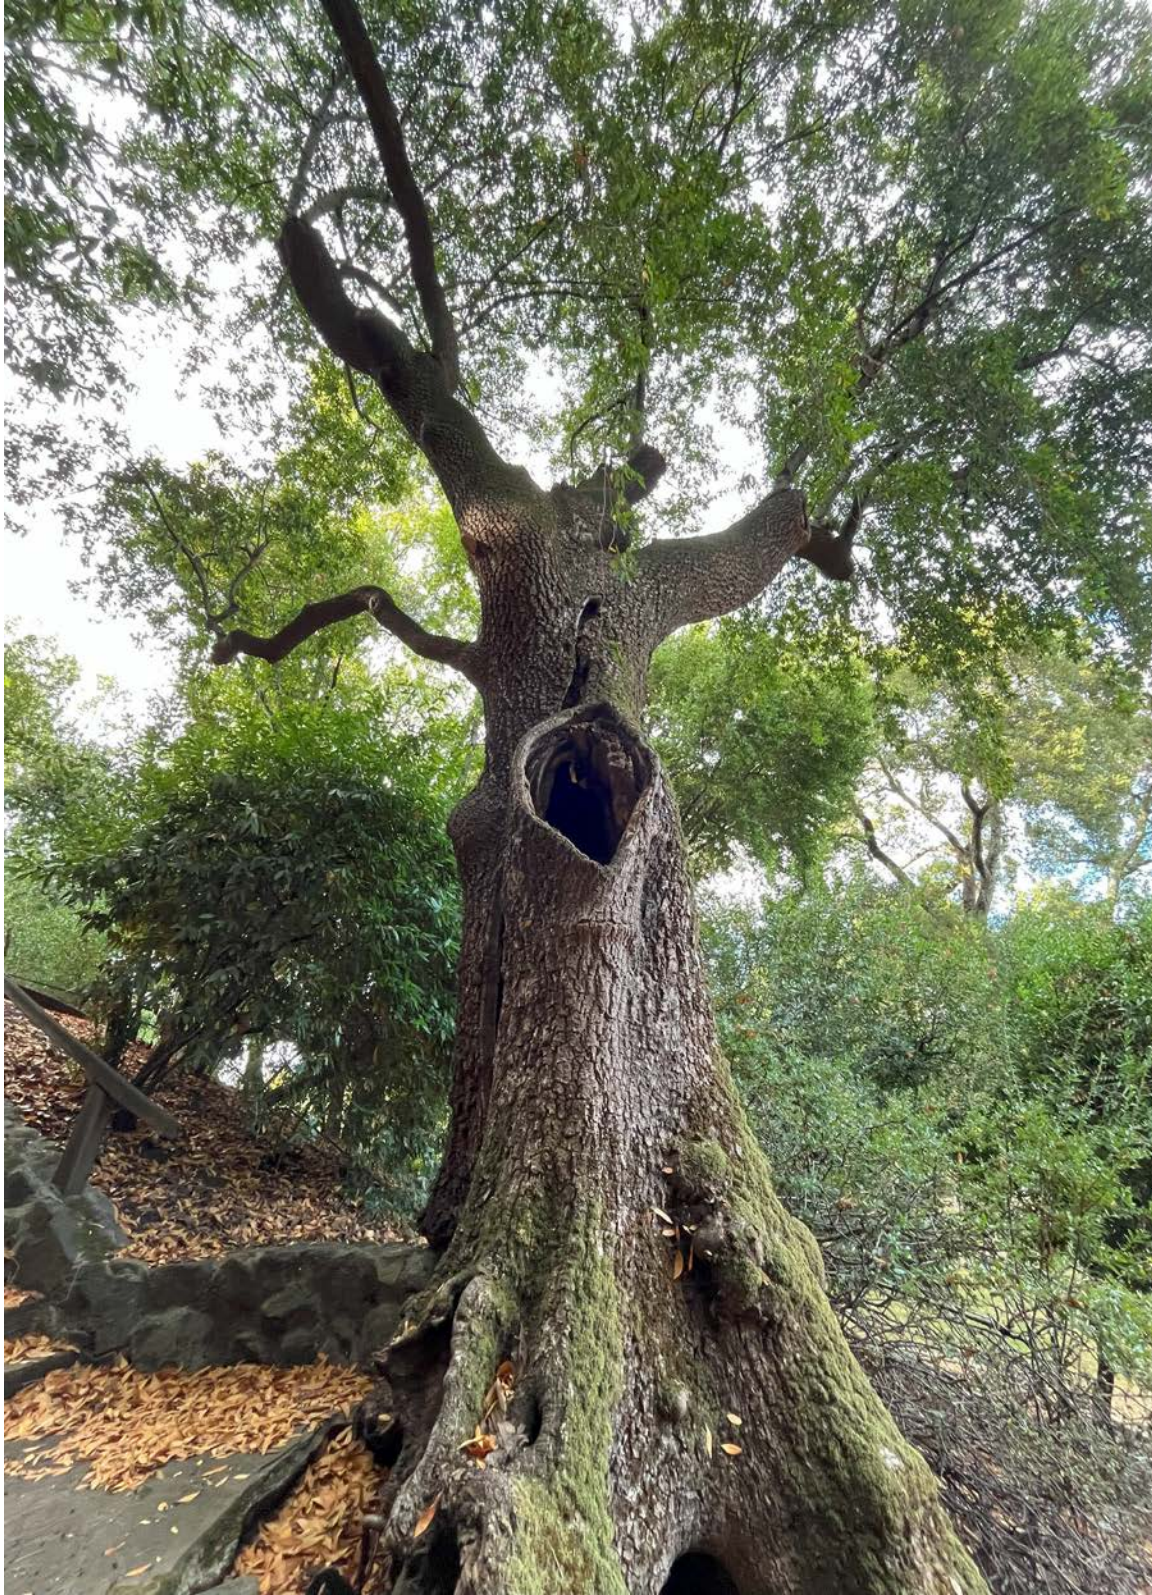
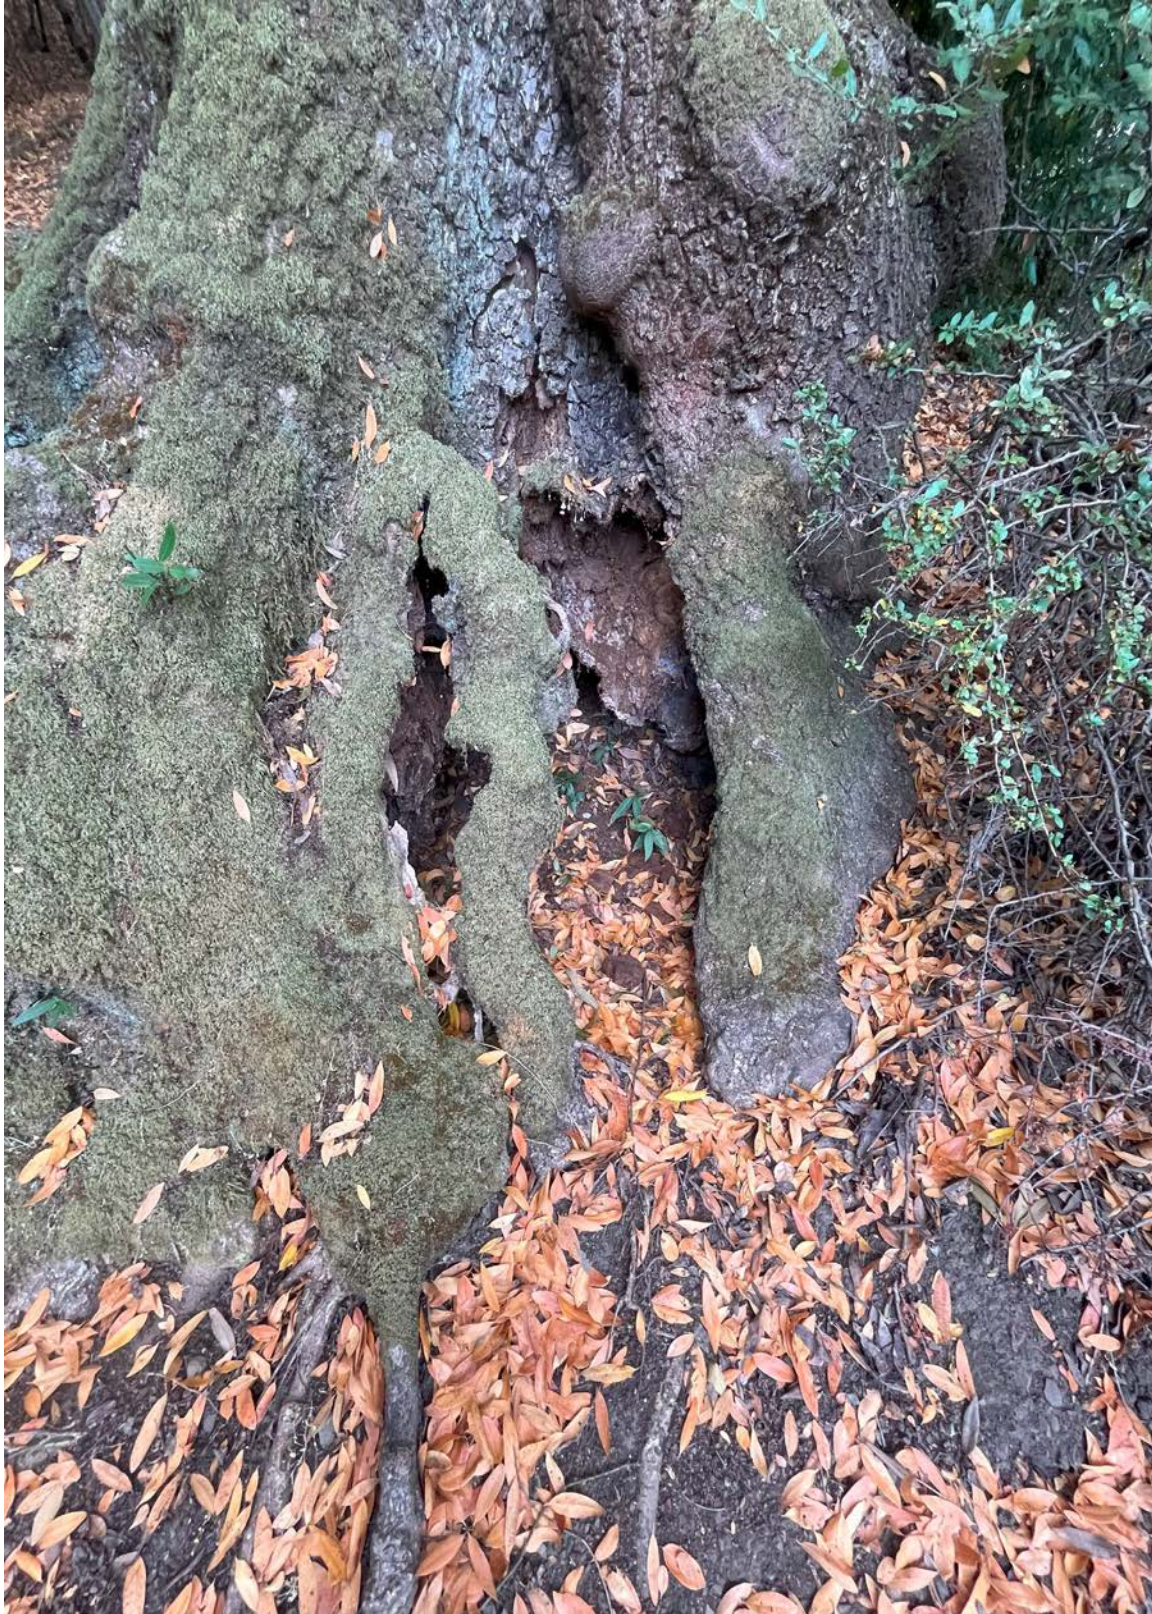
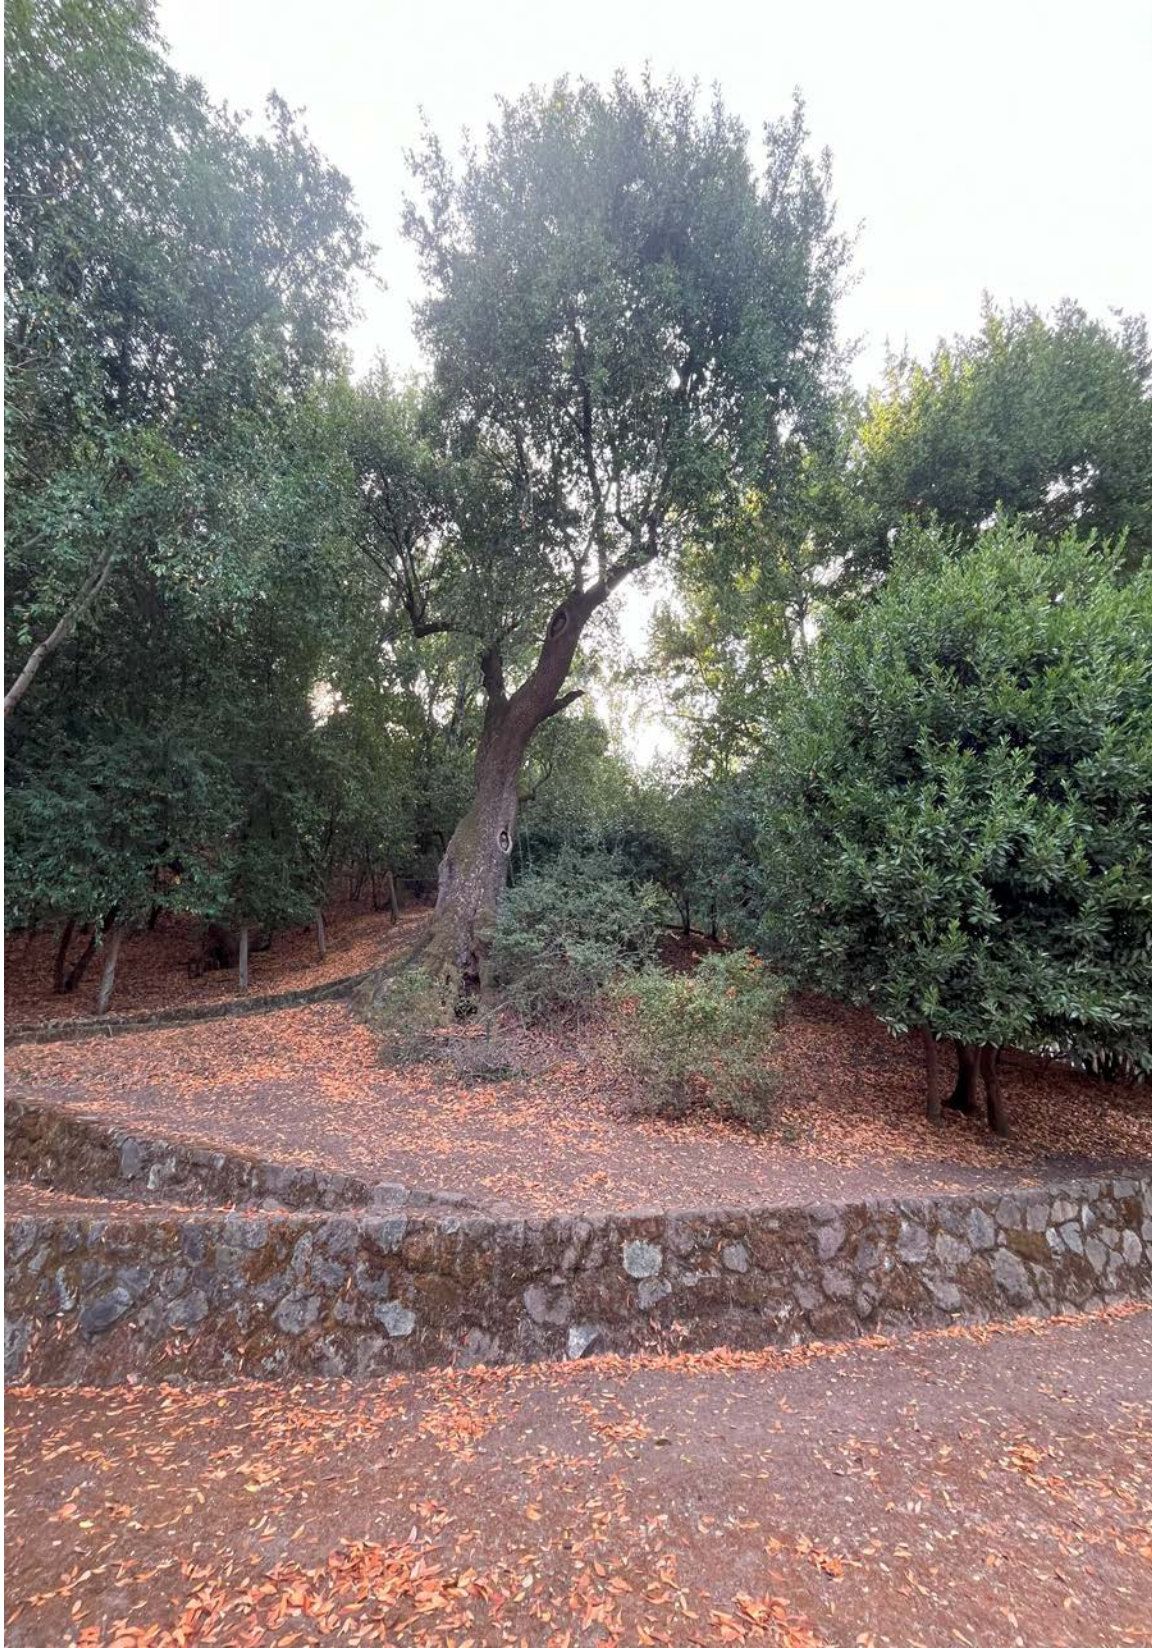
| Tree # | Species Common (<i>Scientific</i>) | Diameter (inches) | Condition (percent) | Height (feet) | Spread (feet) | Comments |
|---|---|---|---|---|---|--|
| 19 | California Bay Laurel | 57.8 | 35 | 50 | 39 | Partially covered root crown, lower trunk is completely hollow, four-stem at 15 feet high, significant decay at 15 feet high, topped in past at 30 feet high, abundance of weakly attached sprouts at old cuts, poor form, and good vigor. |

Tree #19 is a California Bay laurel tree located along the right rear corner of the property on the hillside near a stairway. The lower trunk of this tree has extensive decay and is hollow. The upper canopy was topped at 30 feet in the past, with many weakly attached sprouts. Overall, this tree has poor form and fair vigor.

I recommend removing this tree as it has poor form and extensive decay and is a potential hazard.

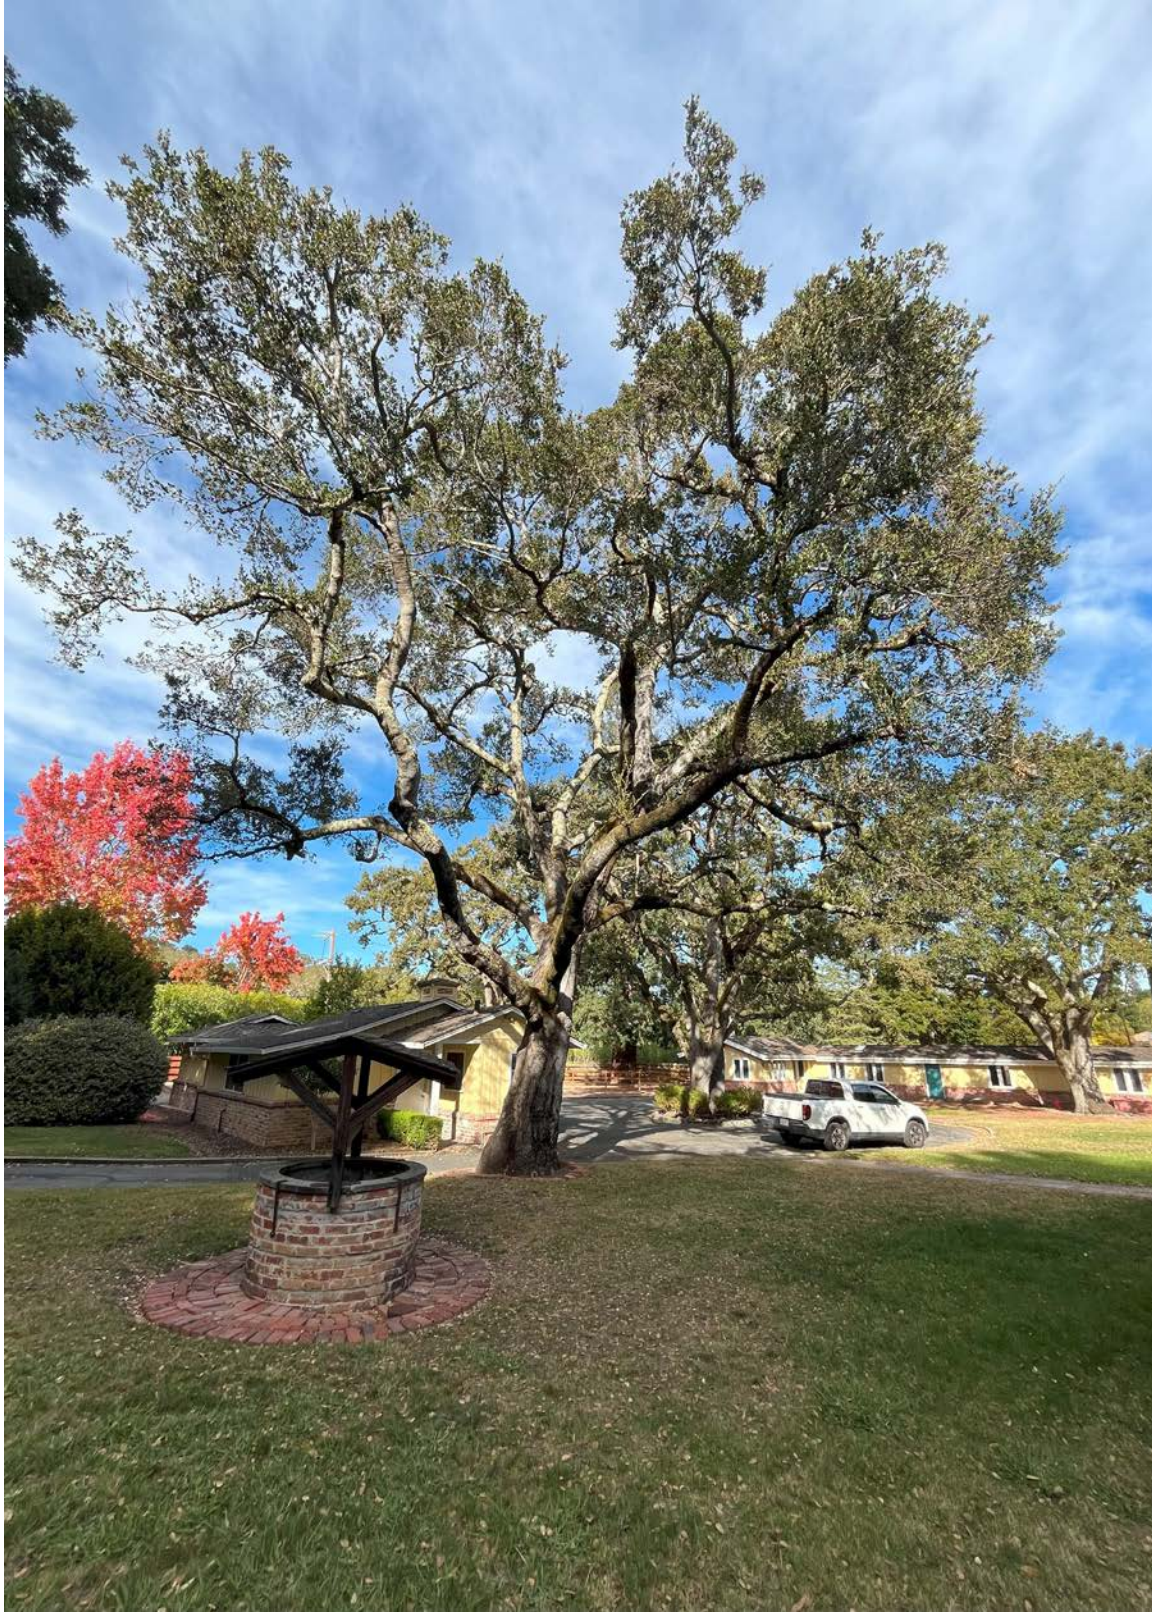
Tree #20

| Tree # | Species Common (<i>Scientific</i>) | Diameter (inches) | Condition (percent) | Height (feet) | Spread (feet) | Comments |
|---|---|---|---|---|---|--|
| 20 | Coast Live Oak | 39.9 | 60 | 40 | 39 | Partially covered root crown, Sycamore Borer on lower trunk, recently pruned, good vigor and fair form. |

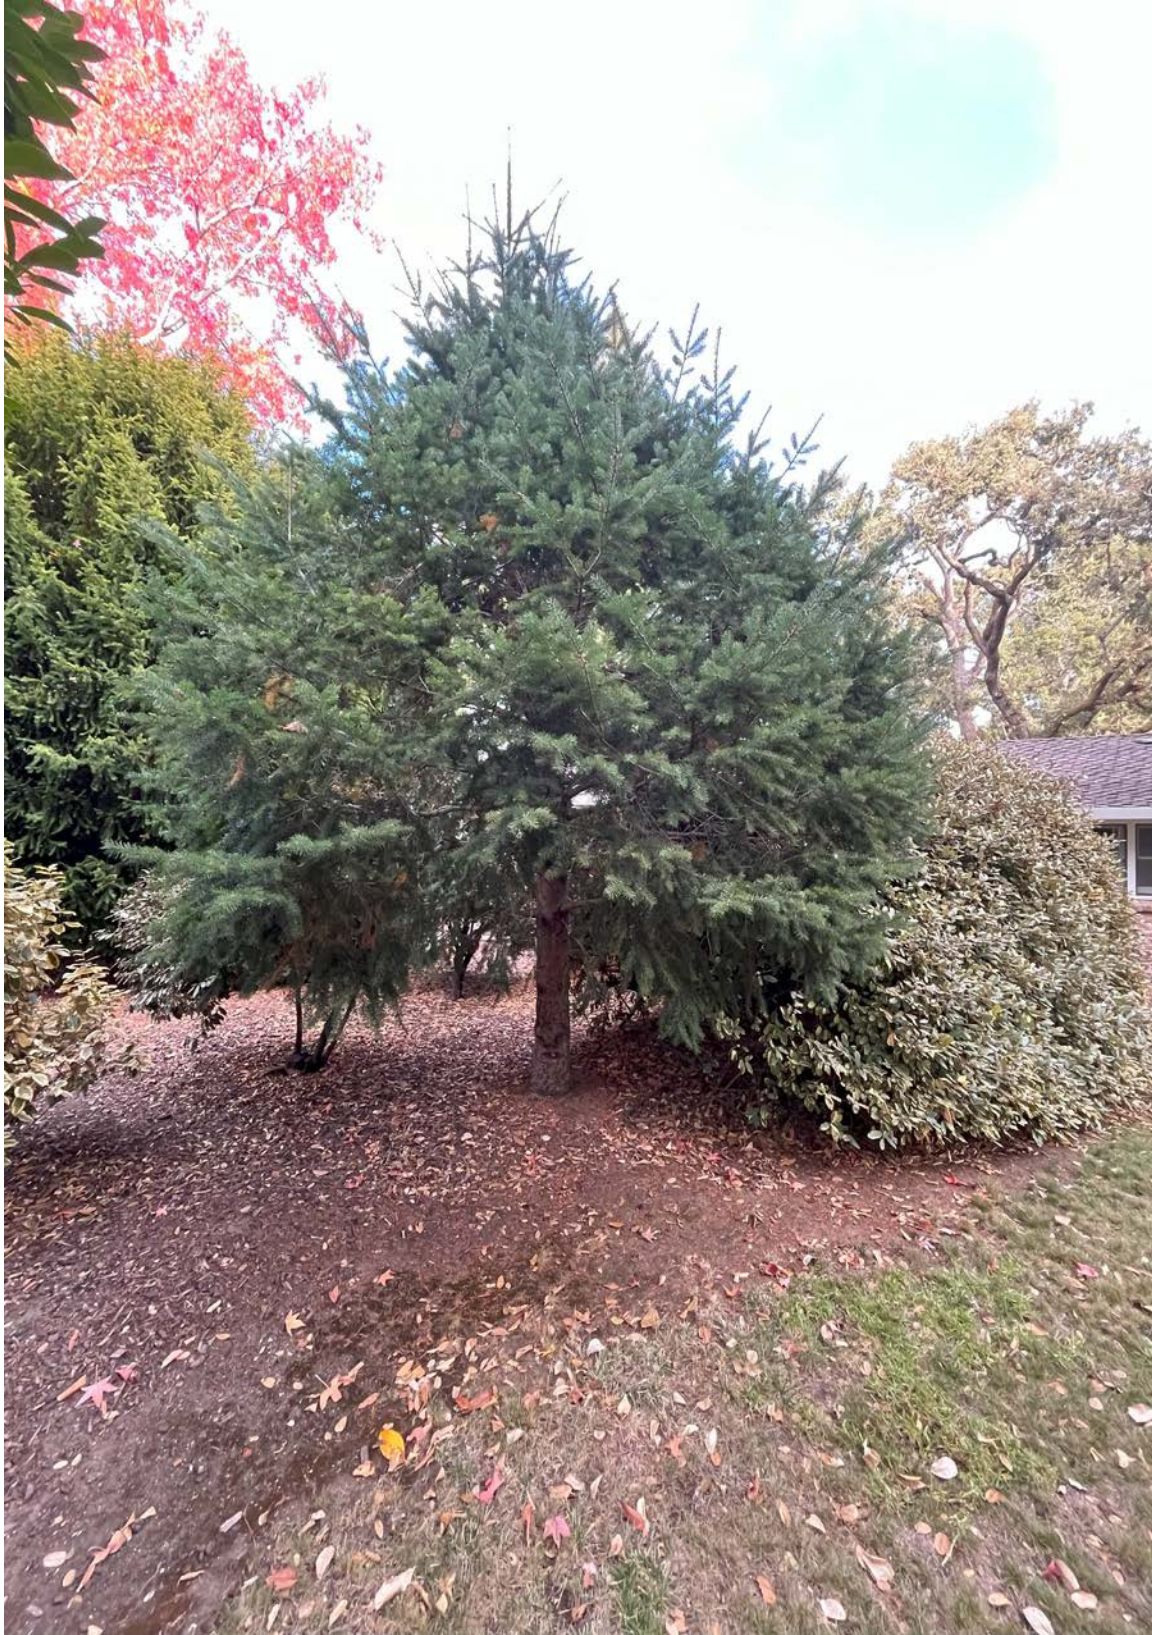
Tree #21

| Tree # | Species Common (<i>Scientific</i>) | Diameter (inches) | Condition (percent) | Height (feet) | Spread (feet) | Comments |
|---|---|---|---|---|---|--|
| 21 | Douglas Fir | 7.6 | 50 | 15 | 12 | Partially covered root crown, multi-stem top at 9 feet high, good vigor and fair form. |

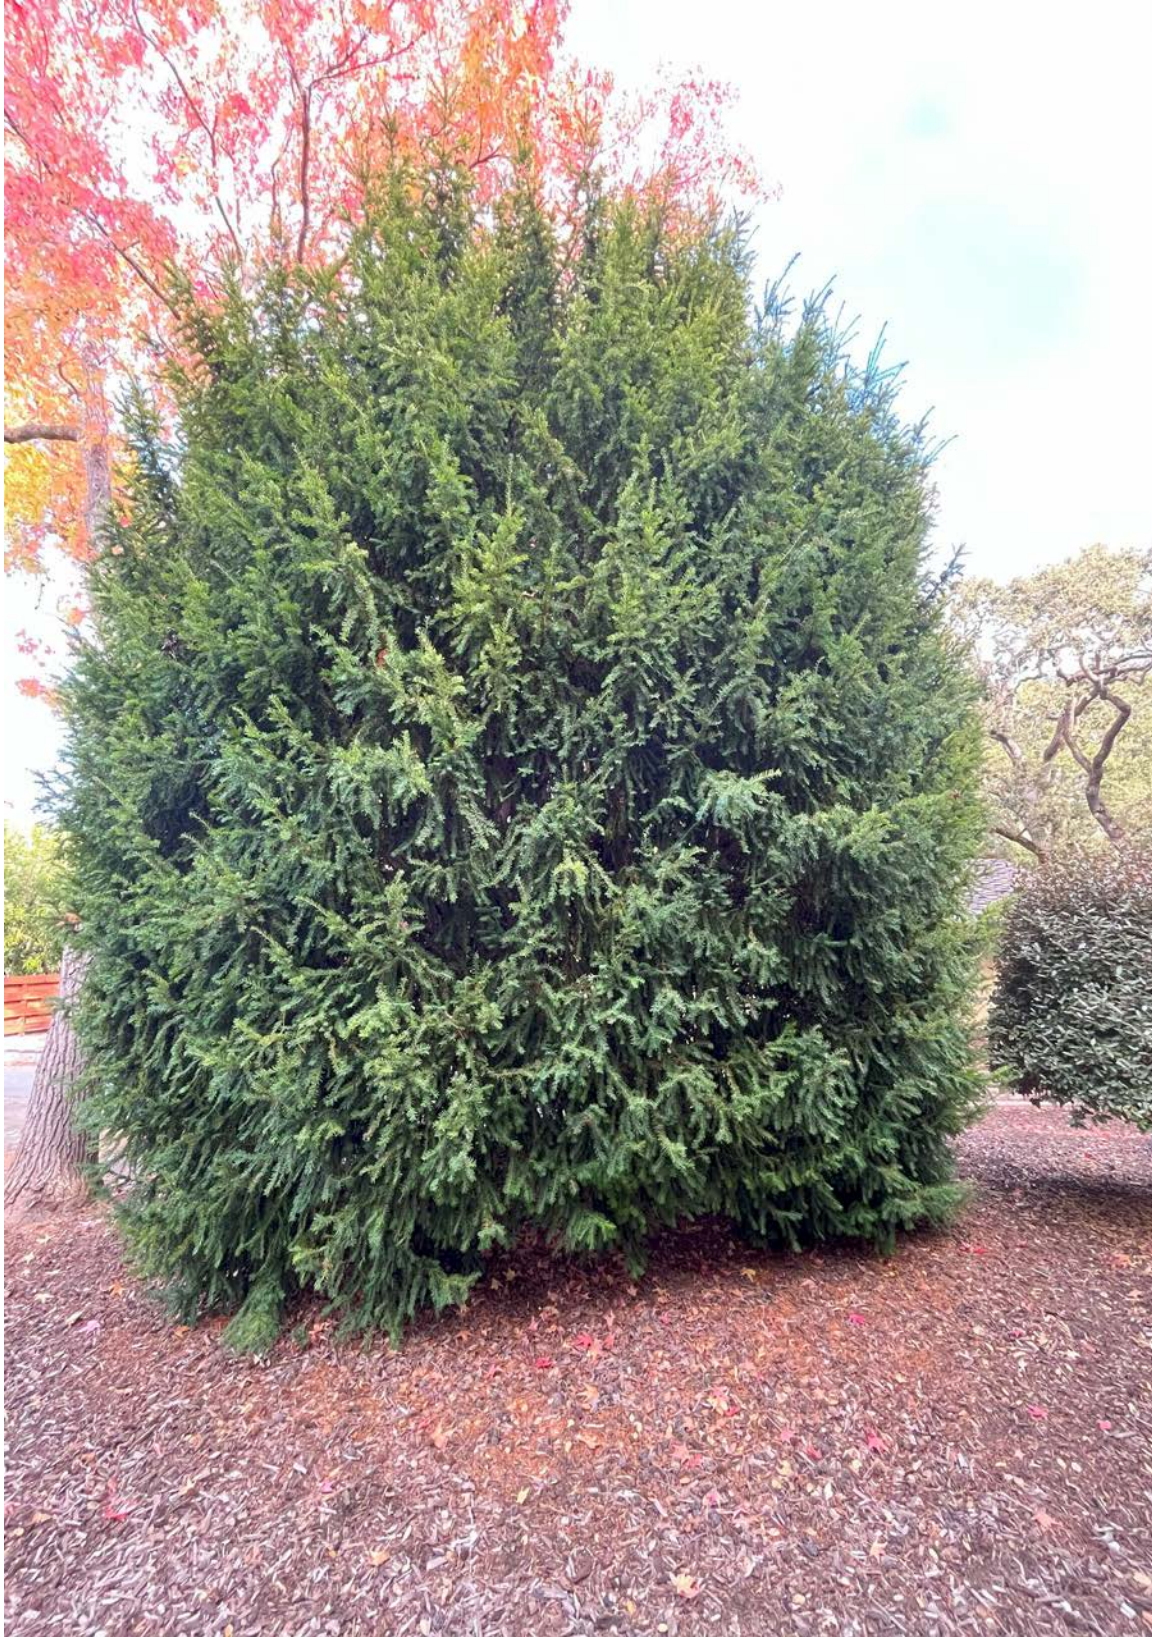
Tree #22

| Tree # | Species Common (<i>Scientific</i>) | Diameter (inches) | Condition (percent) | Height (feet) | Spread (feet) | Comments |
|---|---|---|---|---|---|---|
| 22 | English Yew | Est. 18.0 | 80 | 25 | 18 | Six-stem at base, root crown covered, good vigor and form. |
