Mayne Tree Expert Company, Inc.

November 16, 2024

RE: 1815 CORDILLERAS RD., EMERALD HILLS (ARBORIST REPORT)

Tree Survey

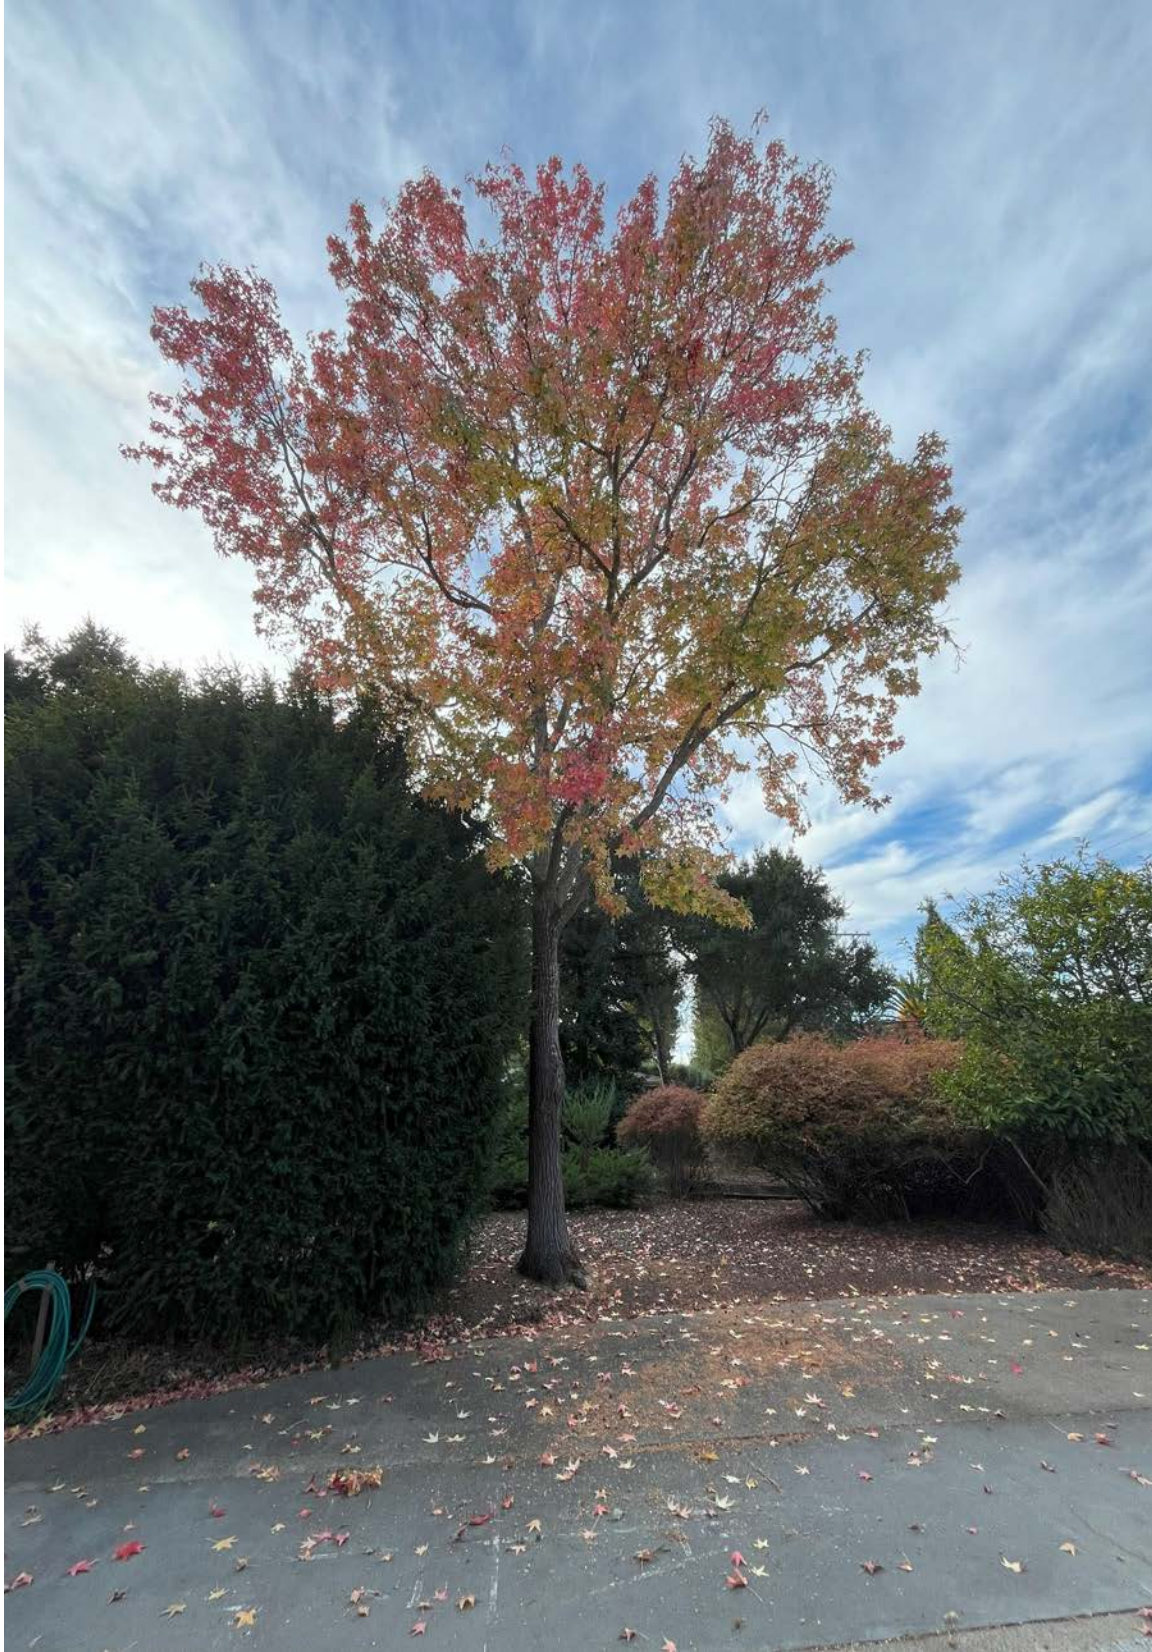
Tree #23

| Tree # | Species Common (<i>Scientific</i>) | Diameter (inches) | Condition (percent) | Height (feet) | Spread (feet) | Comments |
|---|---|---|---|---|---|---|
| 23 | Liquidambar | 16.7 | 55 | 40 | 24 | Slight lean east, fair form and vigor. |

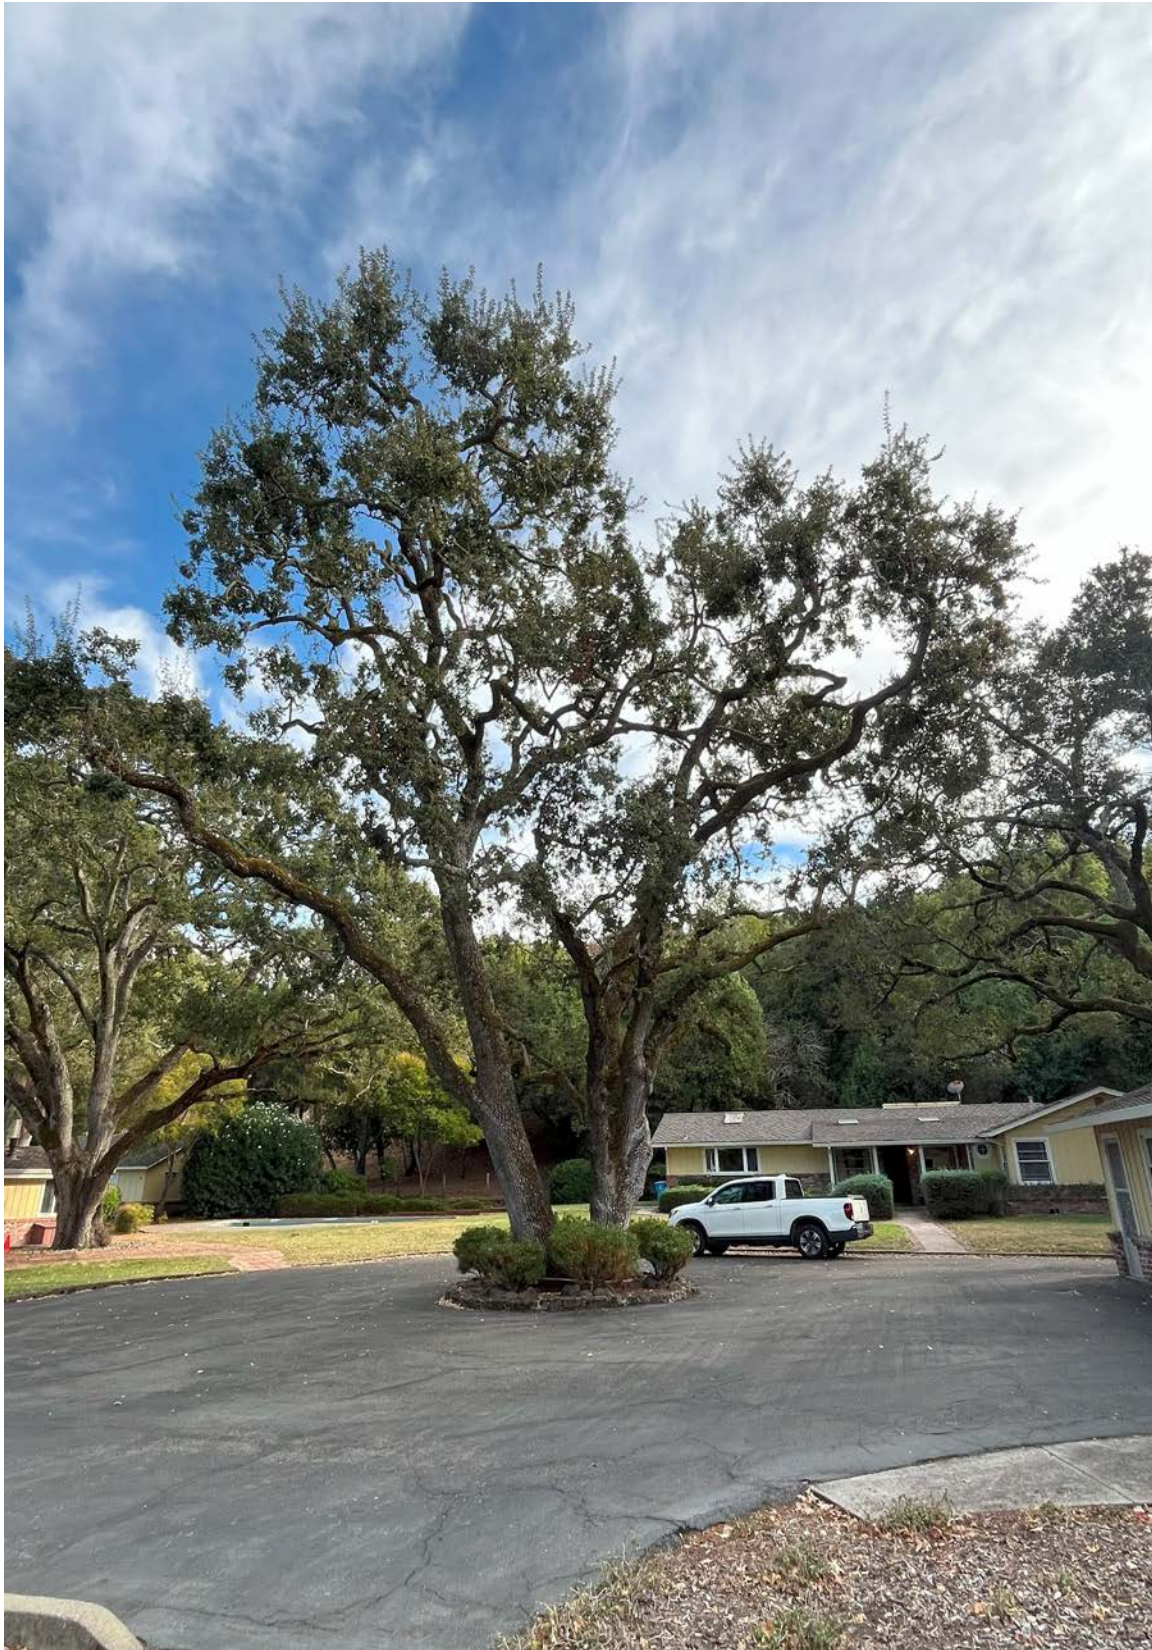
Tree #24

| Tree # | Species Common (<i>Scientific</i>) | Diameter (inches) | Condition (percent) | Height (feet) | Spread (feet) | Comments |
|---|---|---|---|---|---|---|
| 24 | Valley Oak | 30.9, 31.1 | 50 | 50 | 45 | Root crown covered, surrounded by brick tree well, 90% of root zone is covered by asphalt, two-stem at base, recently pruned, fair vigor and form. |

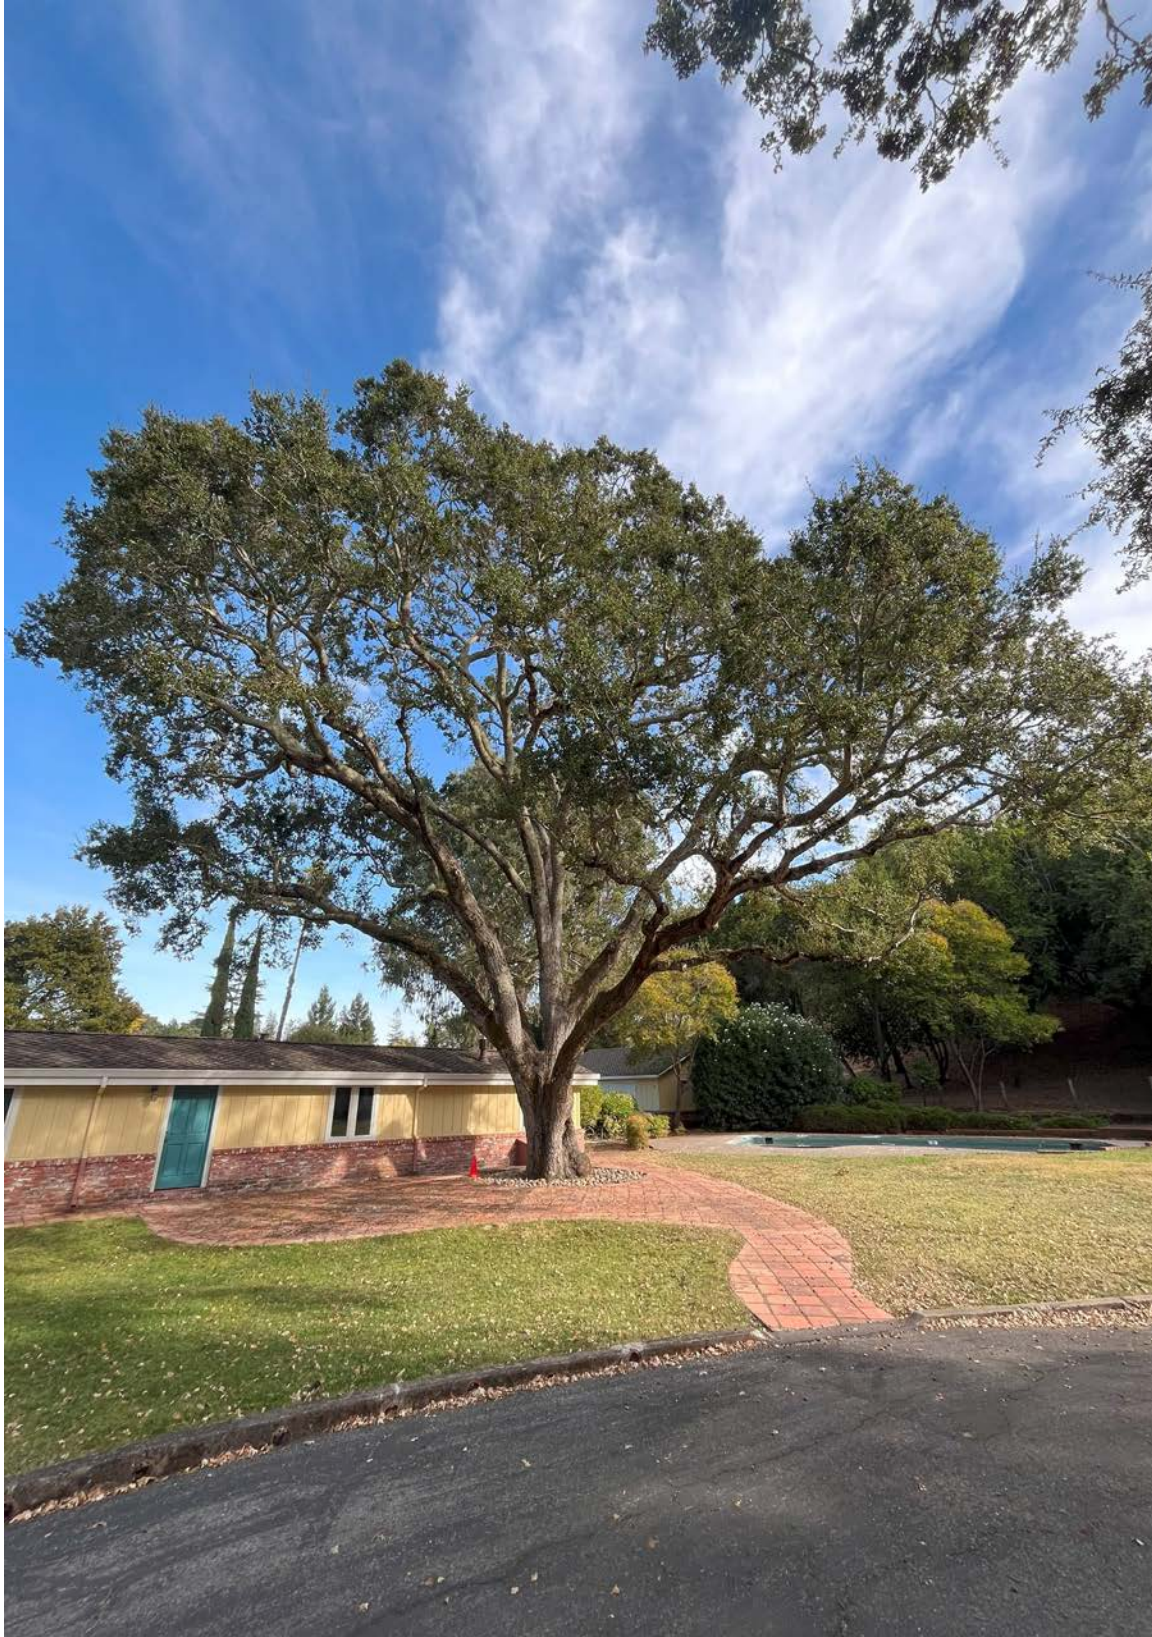
Tree #25

| Tree # | Species Common (<i>Scientific</i>) | Diameter (inches) | Condition (percent) | Height (feet) | Spread (feet) | Comments |
|---|---|---|---|---|---|---|
| 25 | Coast Live Oak | 57.3 | 60 | 50 | 55 | Root crown covered, three-stem at 10 feet high recently pruned fair vigor and form. |

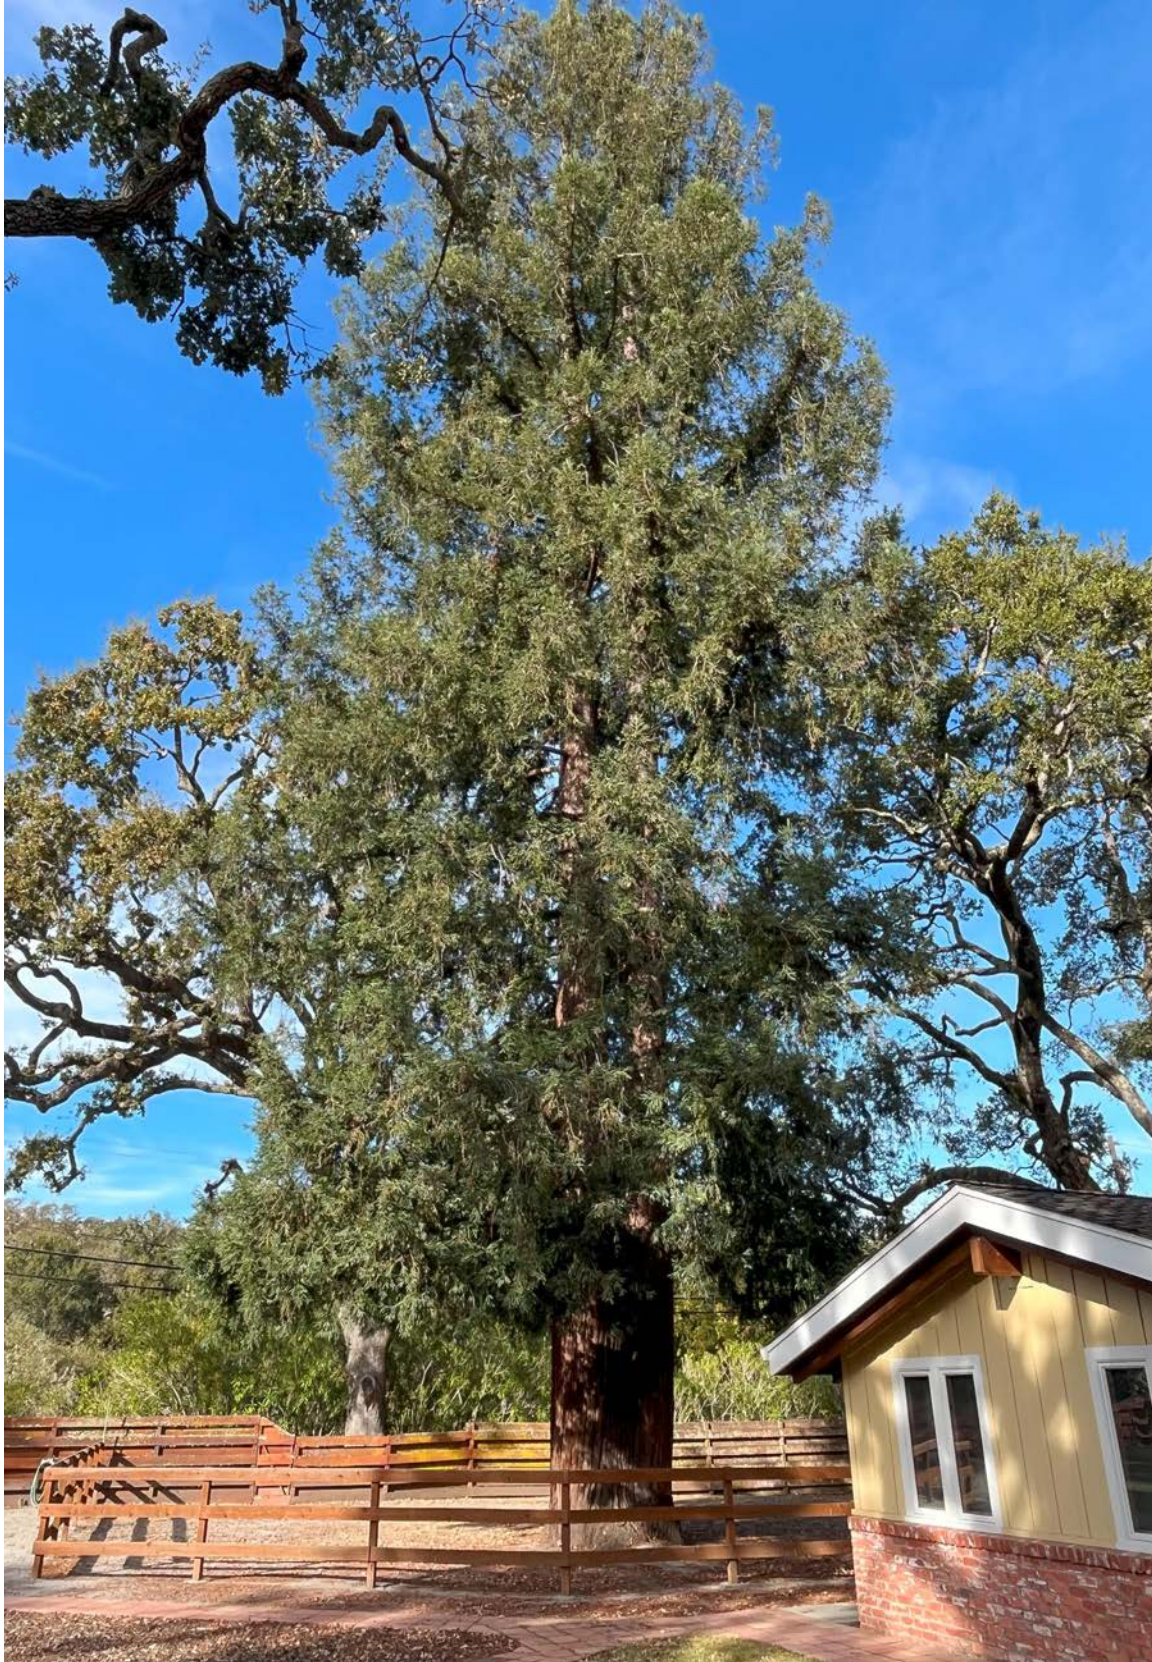
Tree #26

| Tree # | Species Common (<i>Scientific</i>) | Diameter (inches) | Condition (percent) | Height (feet) | Spread (feet) | Comments |
|---|---|---|---|---|---|---|
| 26 | Redwood | 34.7 | 65 | 110 | 39 | Partially covered root crown, codominant attachment with included bark at 9 feet high, recently pruned, poor form and fair vigor. |

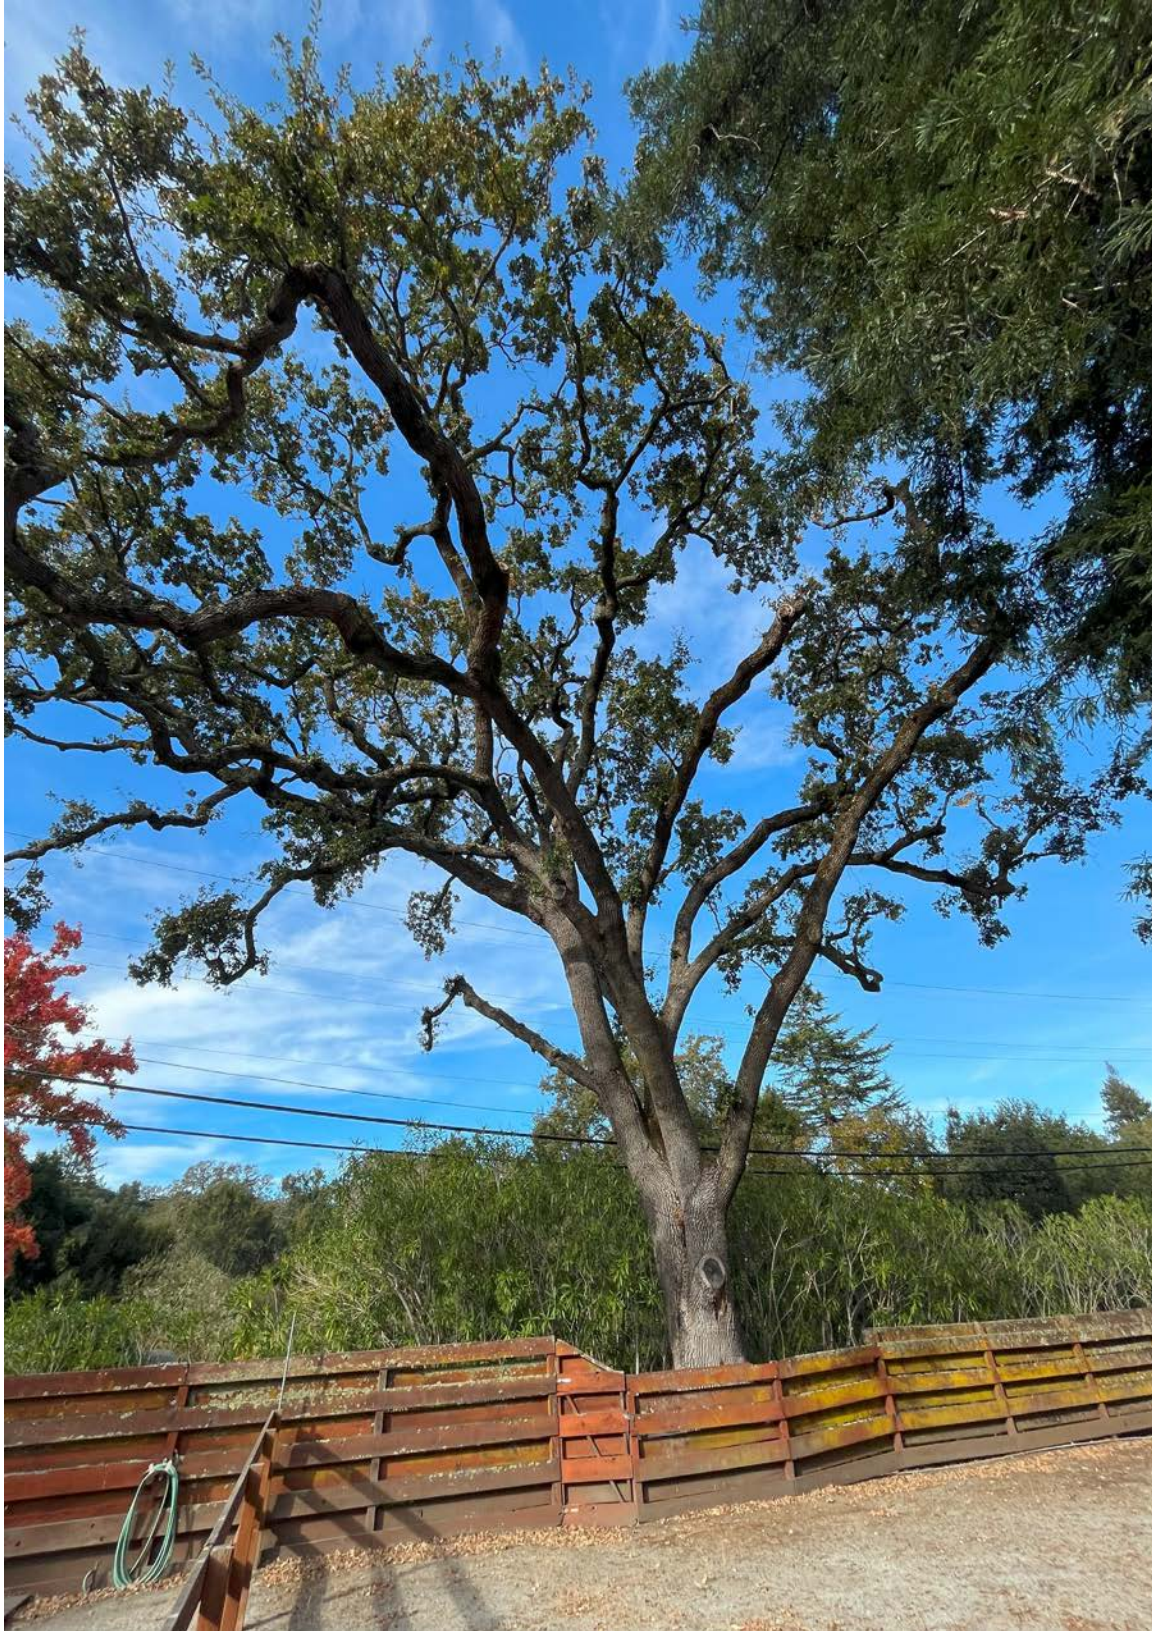
Tree #27

| Tree # | Species Common (<i>Scientific</i>) | Diameter (inches) | Condition (percent) | Height (feet) | Spread (feet) | Comments |
|---|---|---|---|---|---|---|
| 27 | Valley Oak | Est. 49.0 | 50 | 50 | 54 | Partially covered root crown, two-stem with included bark at 8 feet high, canopy grows over high voltage lines, heavy lateral limbs, good vigor and fair form. |

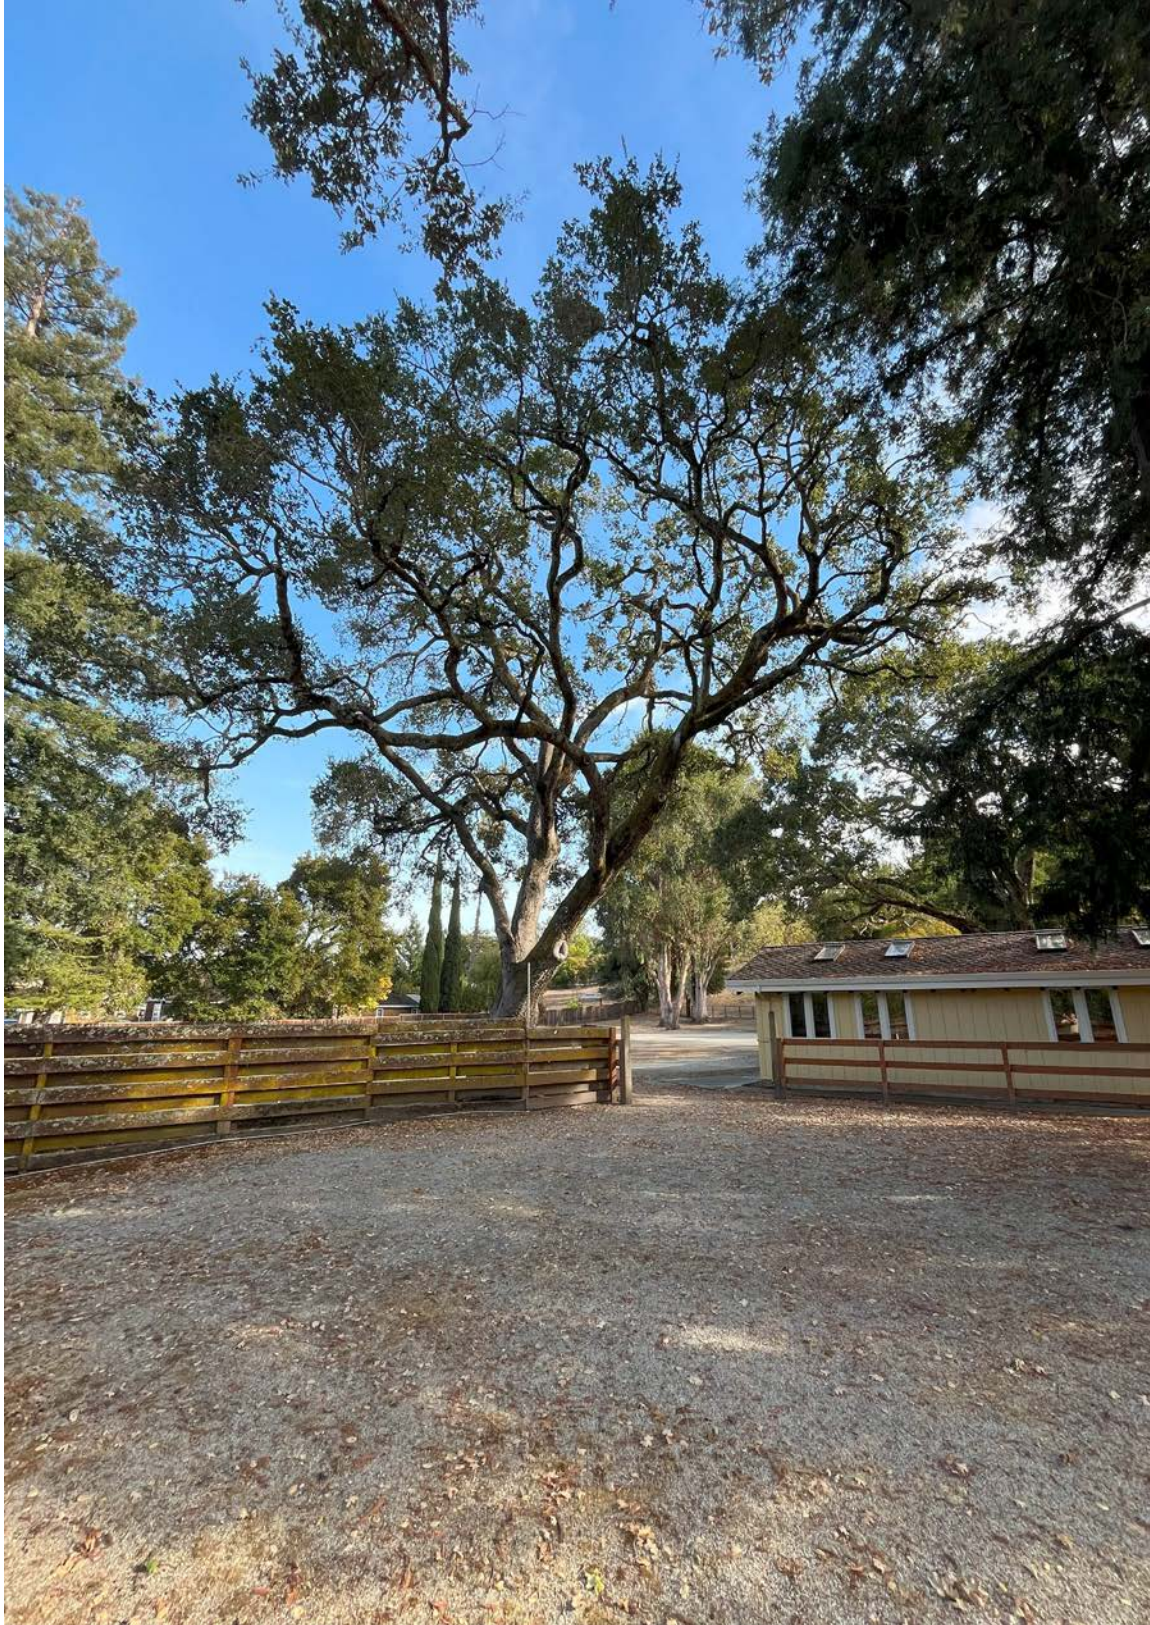
Tree #28

| Tree # | Species Common (<i>Scientific</i>) | Diameter (inches) | Condition (percent) | Height (feet) | Spread (feet) | Comments |
|---|---|---|---|---|---|---|
| 28 | Coast Live Oak | 47.1 | 50 | 40 | 55 | Cavity with Ganoderma Conk at base on the southeast side, Sycamore Borer on the lower trunk, cavity at 8 feet on east side of trunk, three-stem at 7 feet high, recently pruned good vigor and poor form. |

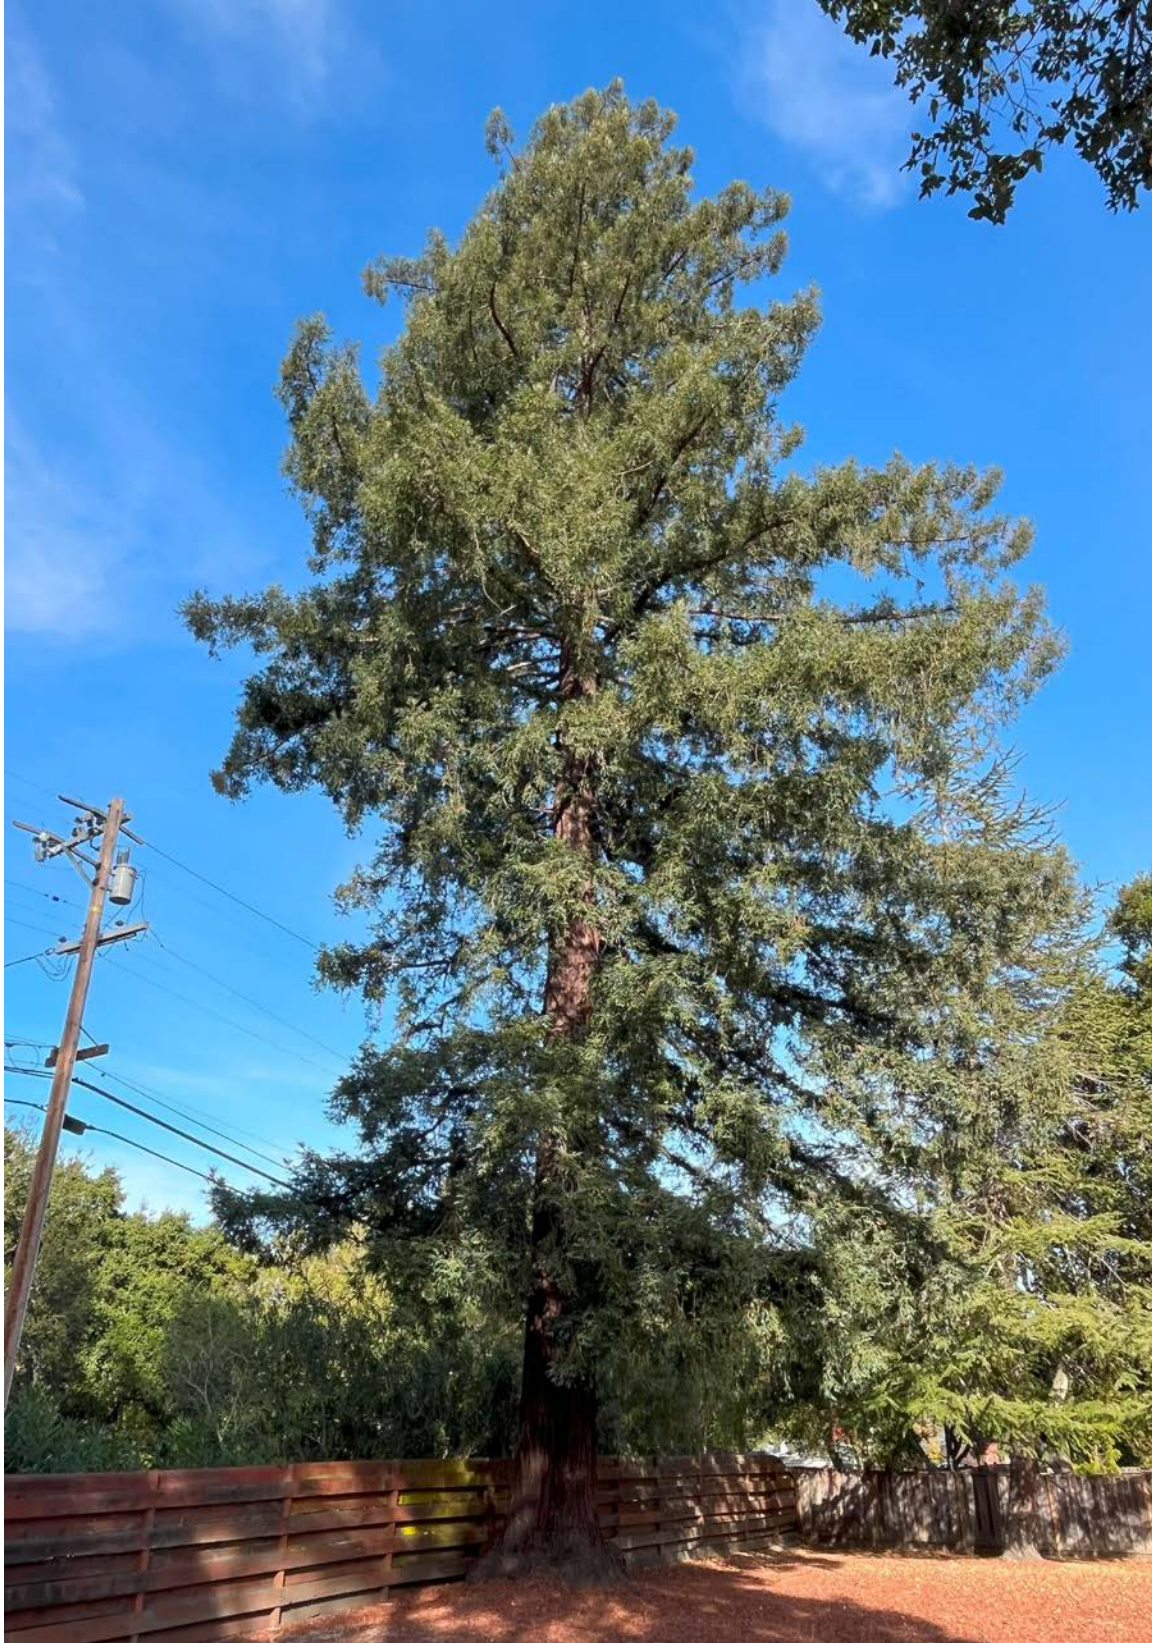
Tree #29

| Tree # | Species Common (<i>Scientific</i>) | Diameter (inches) | Condition (percent) | Height (feet) | Spread (feet) | Comments |
|---|---|---|---|---|---|---|
| 29 | Redwood | 57.3 | 85 | 100 | 39 | Partially covered root crown, canopy overhangs power lines, good vigor and form. |

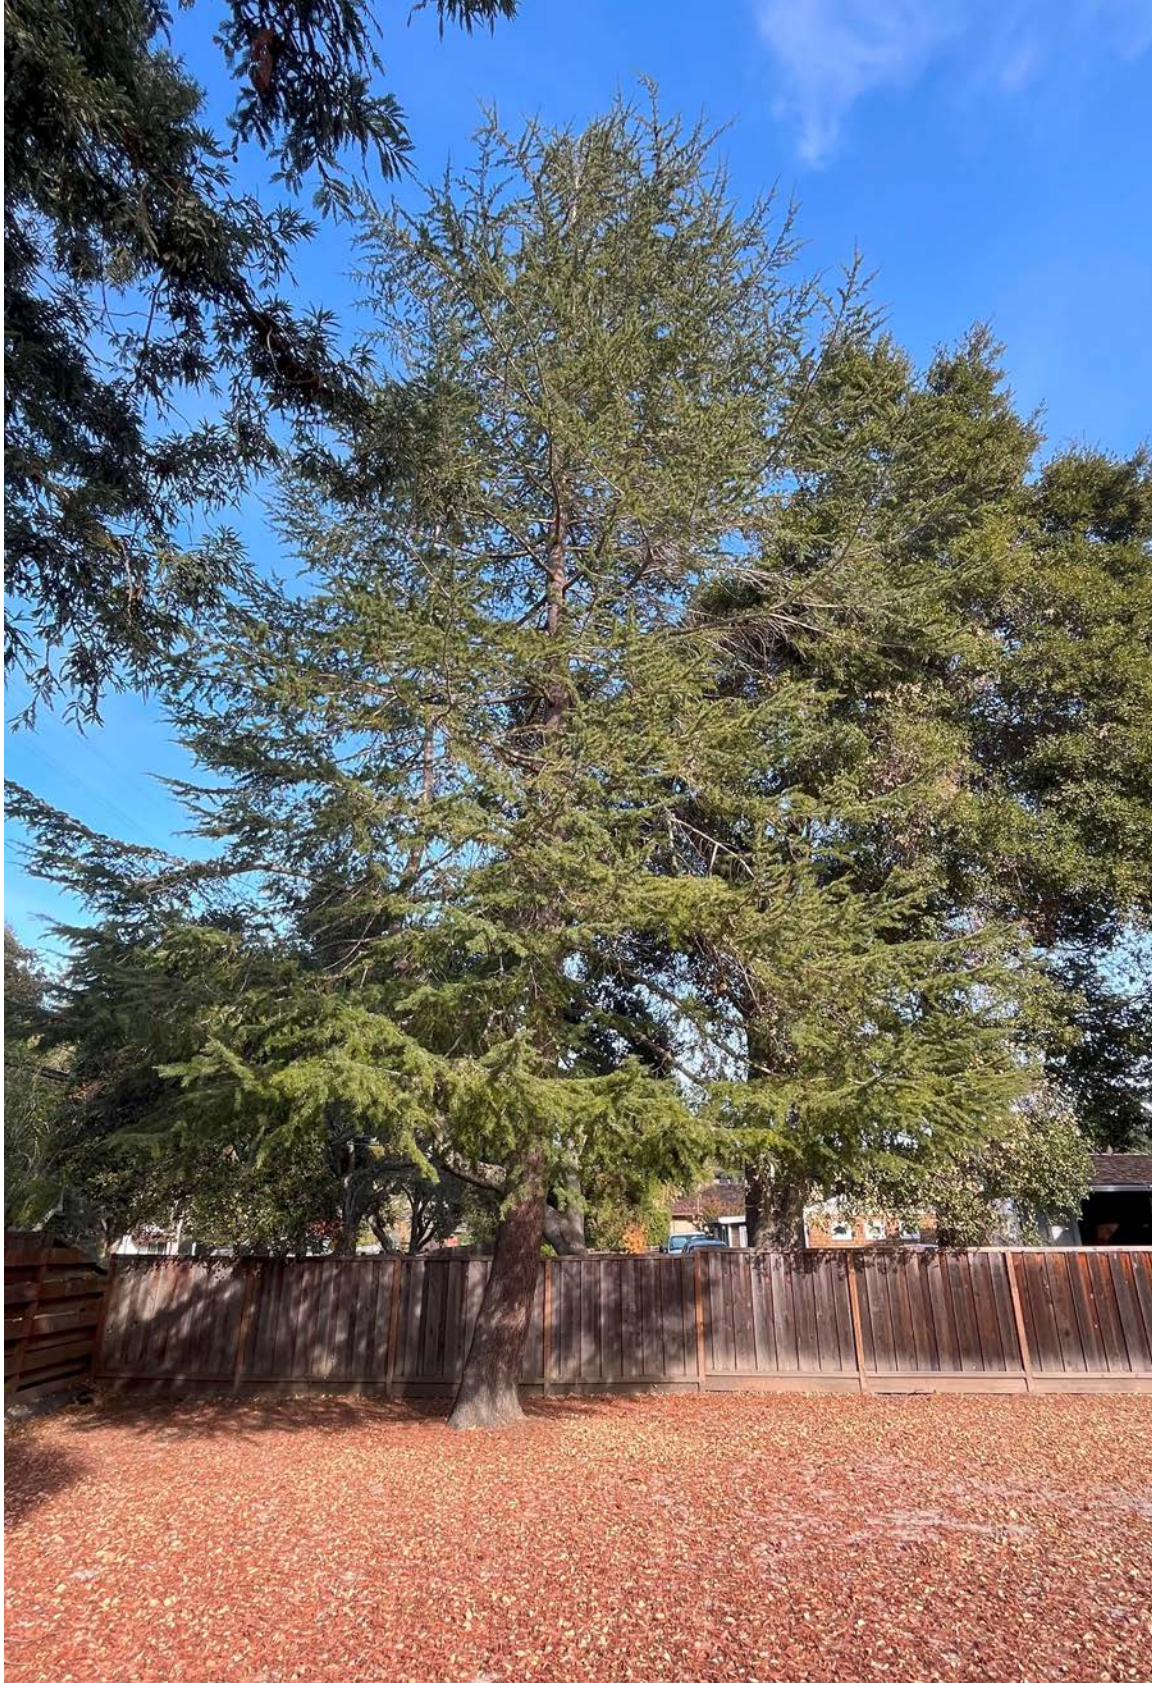
Tree #30

| Tree # | Species Common (<i>Scientific</i>) | Diameter (inches) | Condition (percent) | Height (feet) | Spread (feet) | Comments |
|---|---|---|---|---|---|---|
| 30 | Deodara Cedar | 24.9 | 65 | 75 | 36 | Moderate amount of interior deadwood, single large upright leader to the north, good vigor and fair form. |

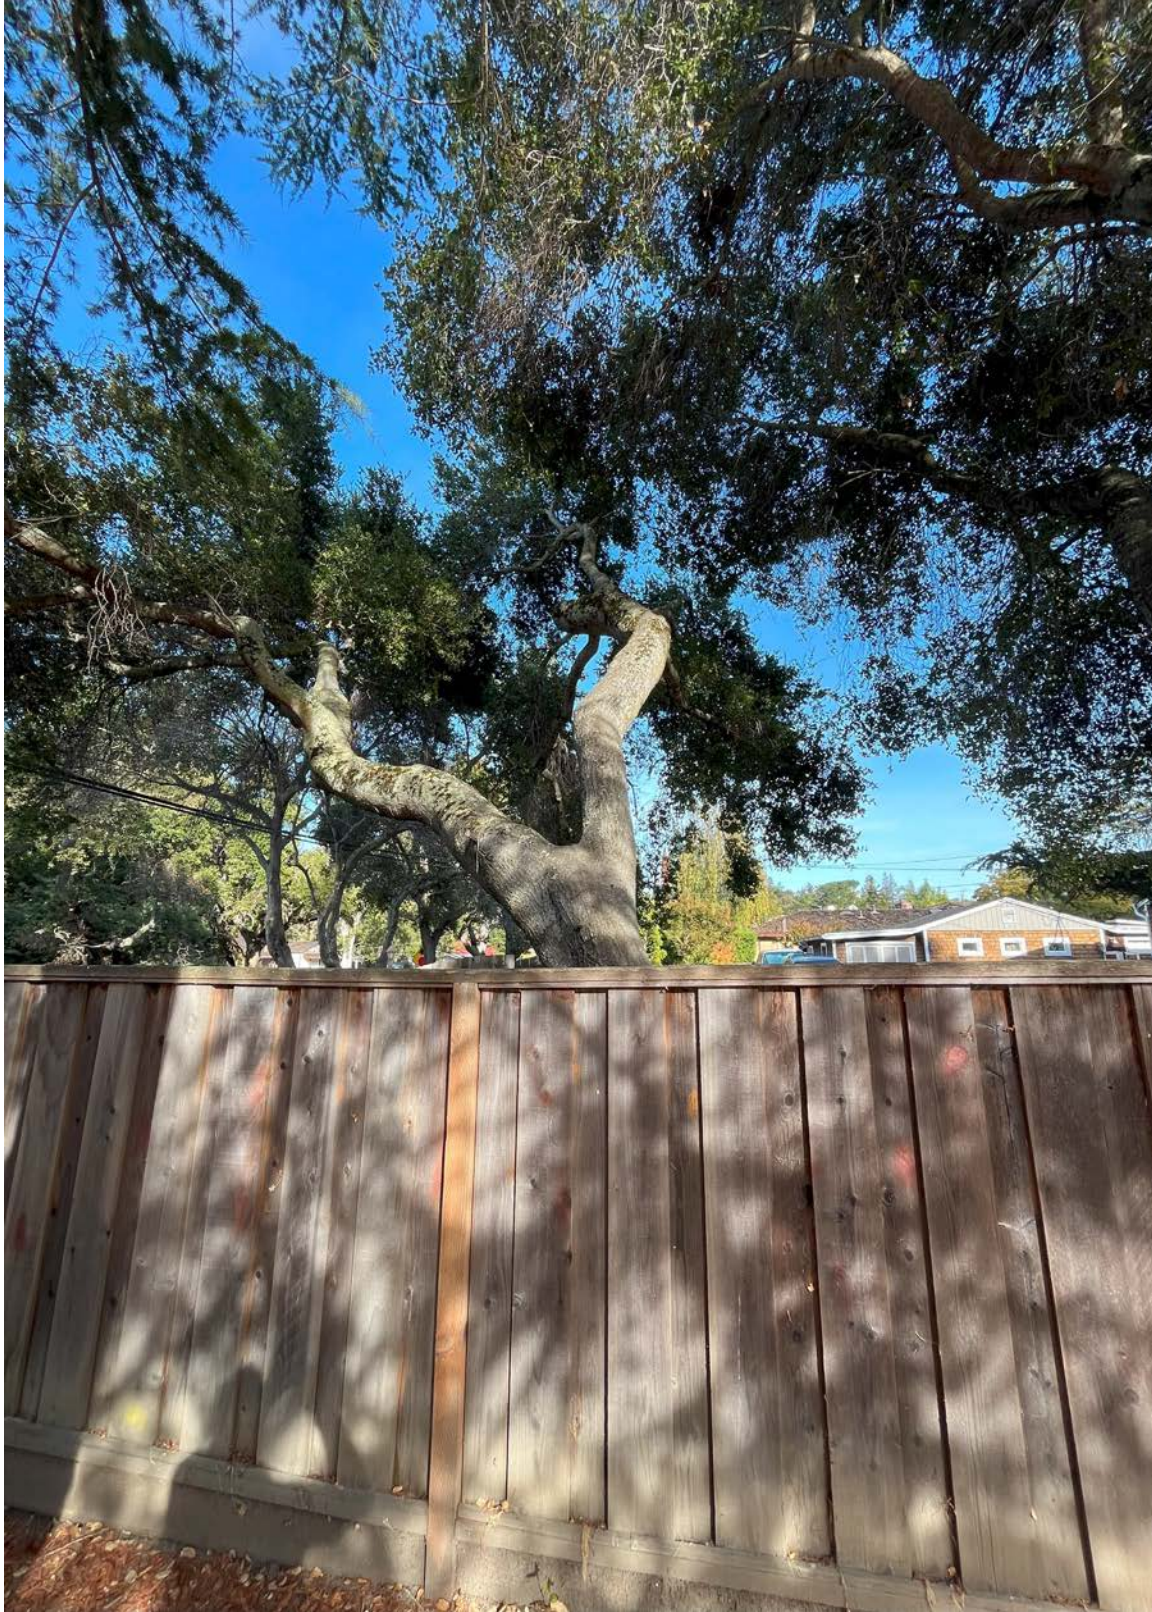
Tree #31

| Tree # | Species Common (<i>Scientific</i>) | Diameter (inches) | Condition (percent) | Height (feet) | Spread (feet) | Comments |
|---|---|---|---|---|---|---|
| 31 | Coast Live Oak | Est. 18.0 | 45 | 35 | 42 | Located on the neighboring property, no tag, two-stem at 7 feet high, leans significantly to the northeast, poor form and fair vigor. |

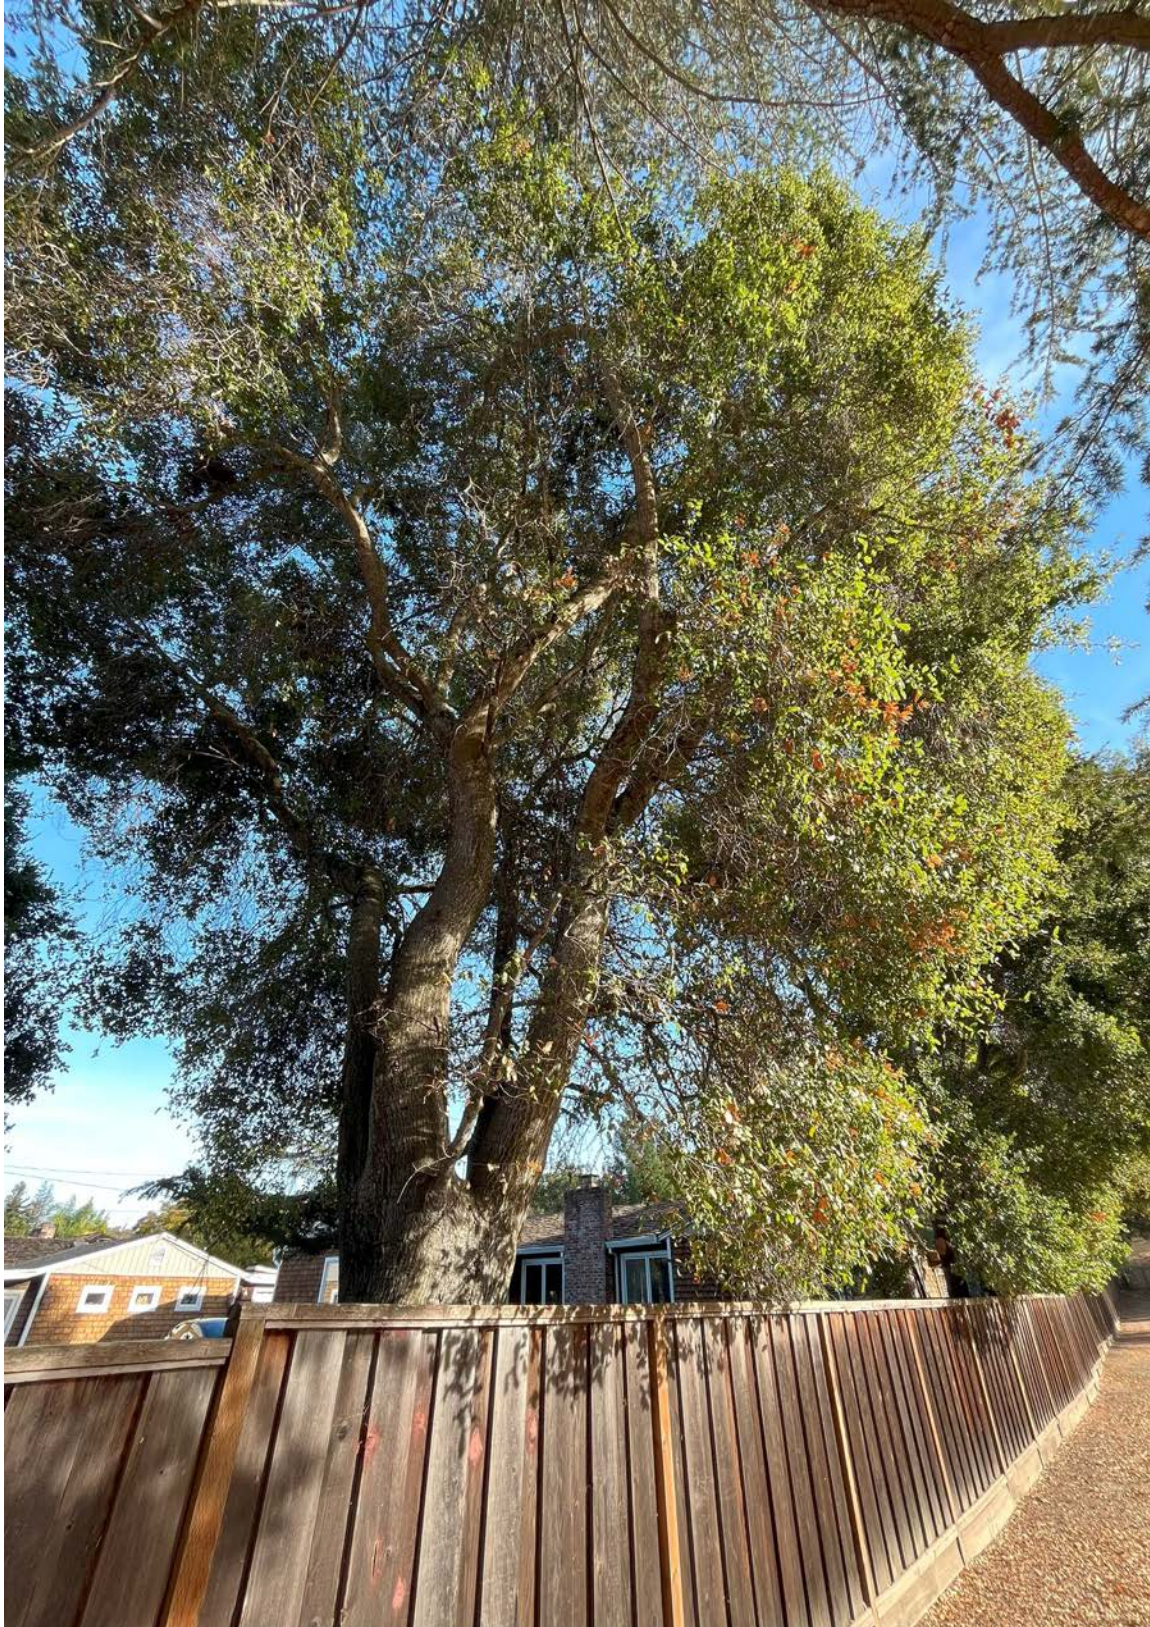
Tree #32

| Tree # | Species Common (<i>Scientific</i>) | Diameter (inches) | Condition (percent) | Height (feet) | Spread (feet) | Comments |
|---|---|---|---|---|---|---|
| 32 | Coast Live Oak | Est. 30.0 | 50 | 50 | 36 | Located on the neighboring property, no tag, three-stem attachment at 7 feet high, abundance of interior deadwood, good vigor and poor form. |

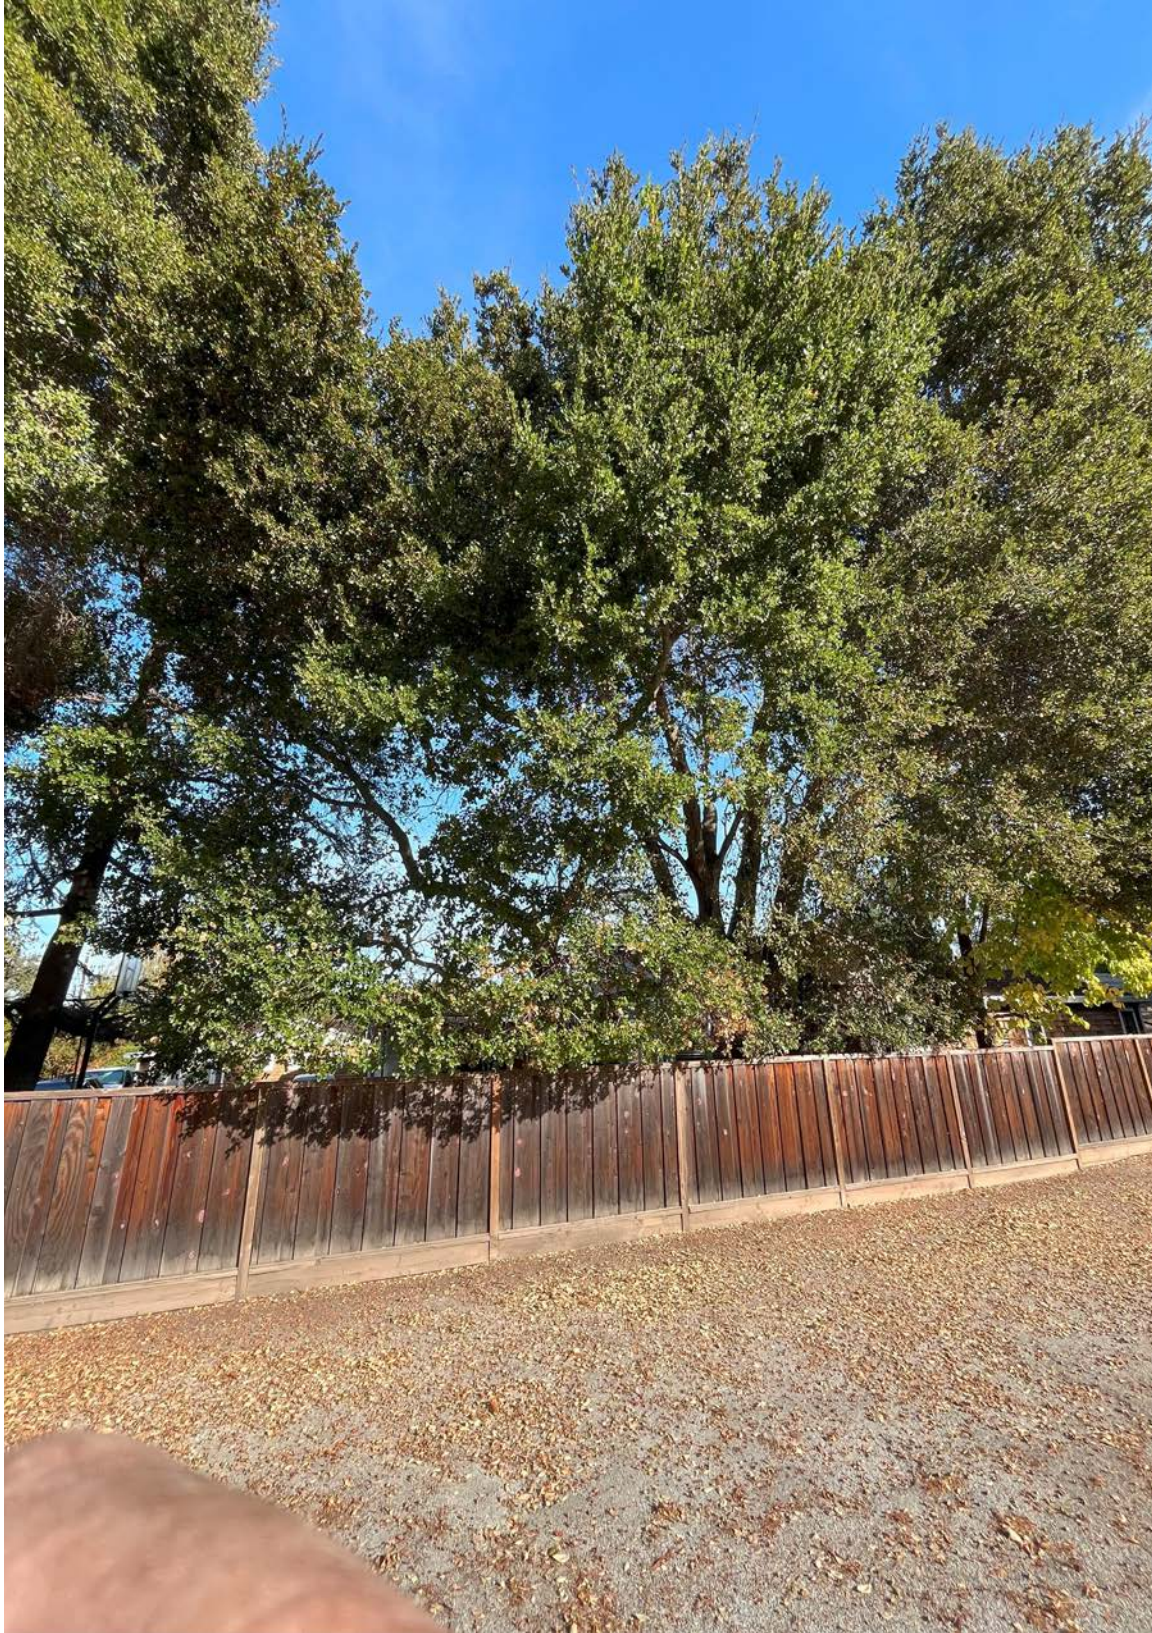
Tree #33

| Tree # | Species Common (<i>Scientific</i>) | Diameter (inches) | Condition (percent) | Height (feet) | Spread (feet) | Comments |
|---|---|---|---|---|---|---|
| 33 | Coast Live Oak | Est. 13.0 | 50 | 30 | 18 | Located on the neighboring property, no tag, two-stem attachment at 10 feet high, moderate amount of interior deadwood, poor form and good vigor. |
