Mayne Tree Expert Company, Inc.

November 16, 2024

RE: 1815 CORDILLERAS RD., EMERALD HILLS (ARBORIST REPORT)

Tree Survey

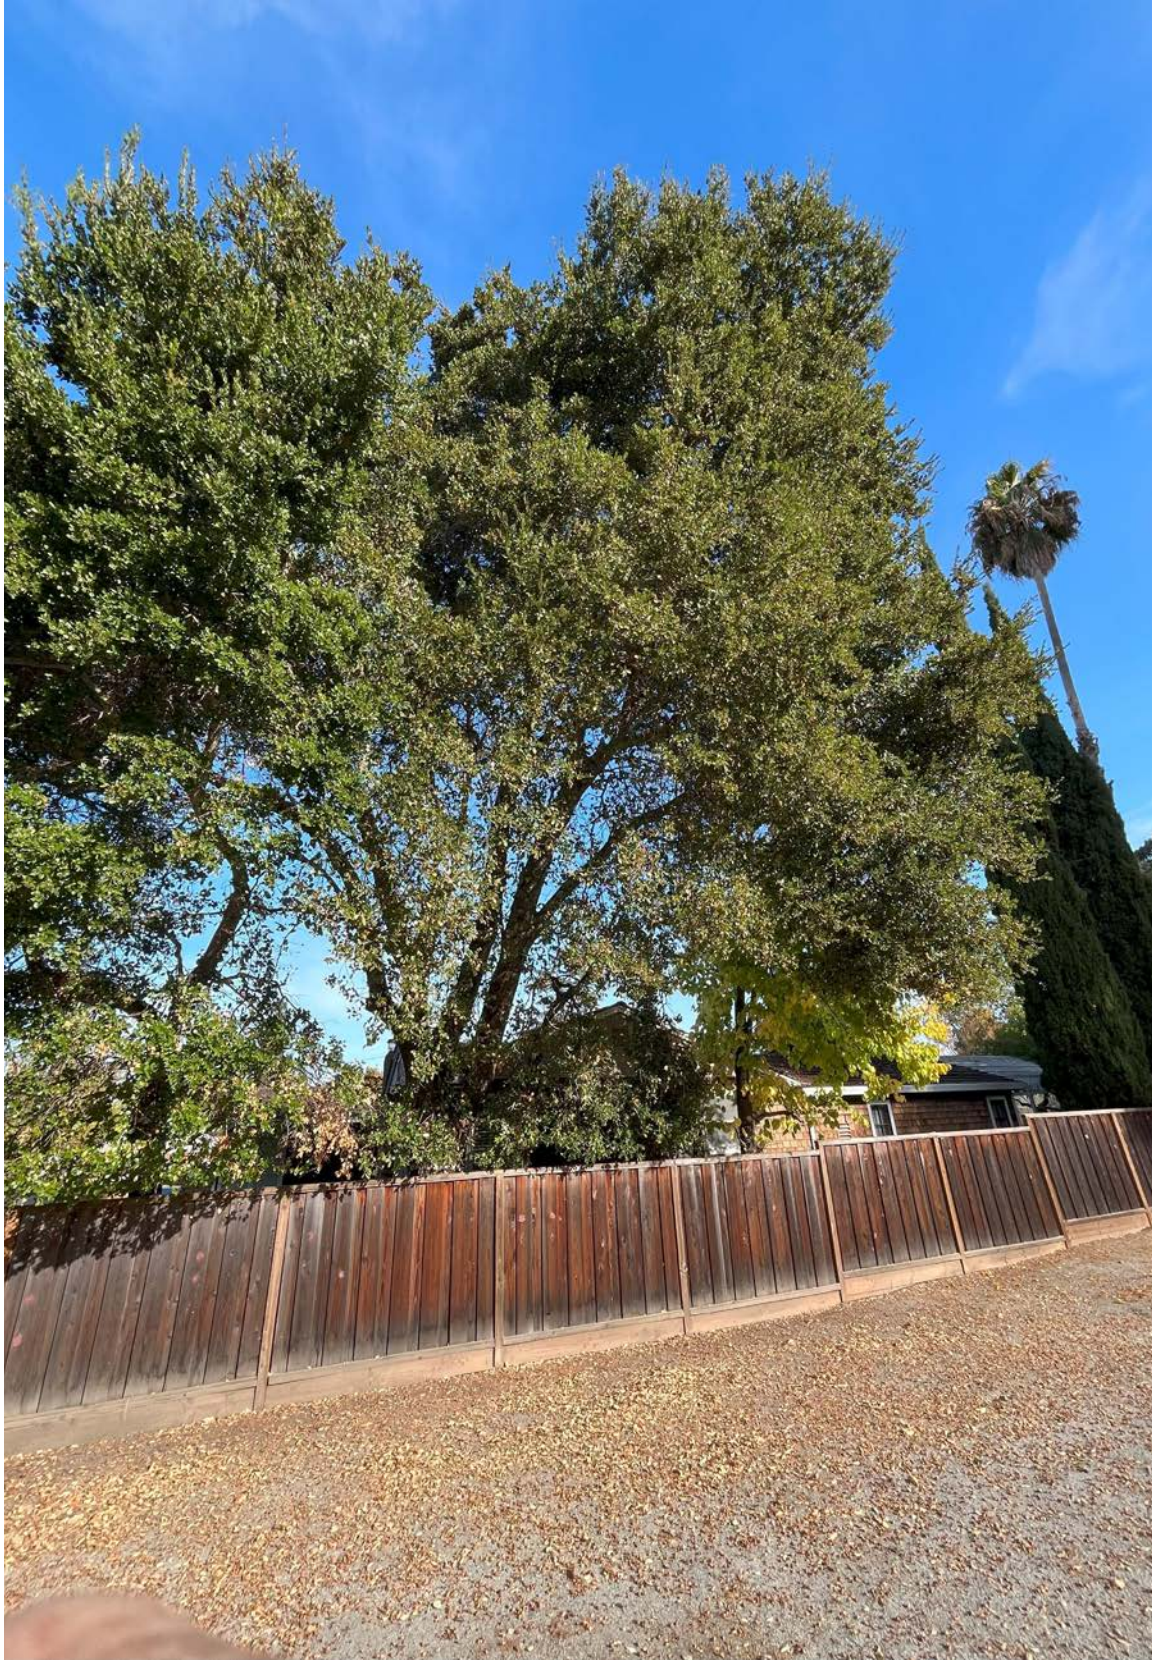
Tree #34

| Tree # | Species Common (<i>Scientific</i>) | Diameter (inches) | Condition (percent) | Height (feet) | Spread (feet) | Comments |
|---|---|---|---|---|---|---|
| 34 | Coast Live Oak | Est. 28.0 | 50 | 40 | 39 | Located on the neighboring property, no tag, multi-stem attachment at 10 feet high, poor form and good vigor. |

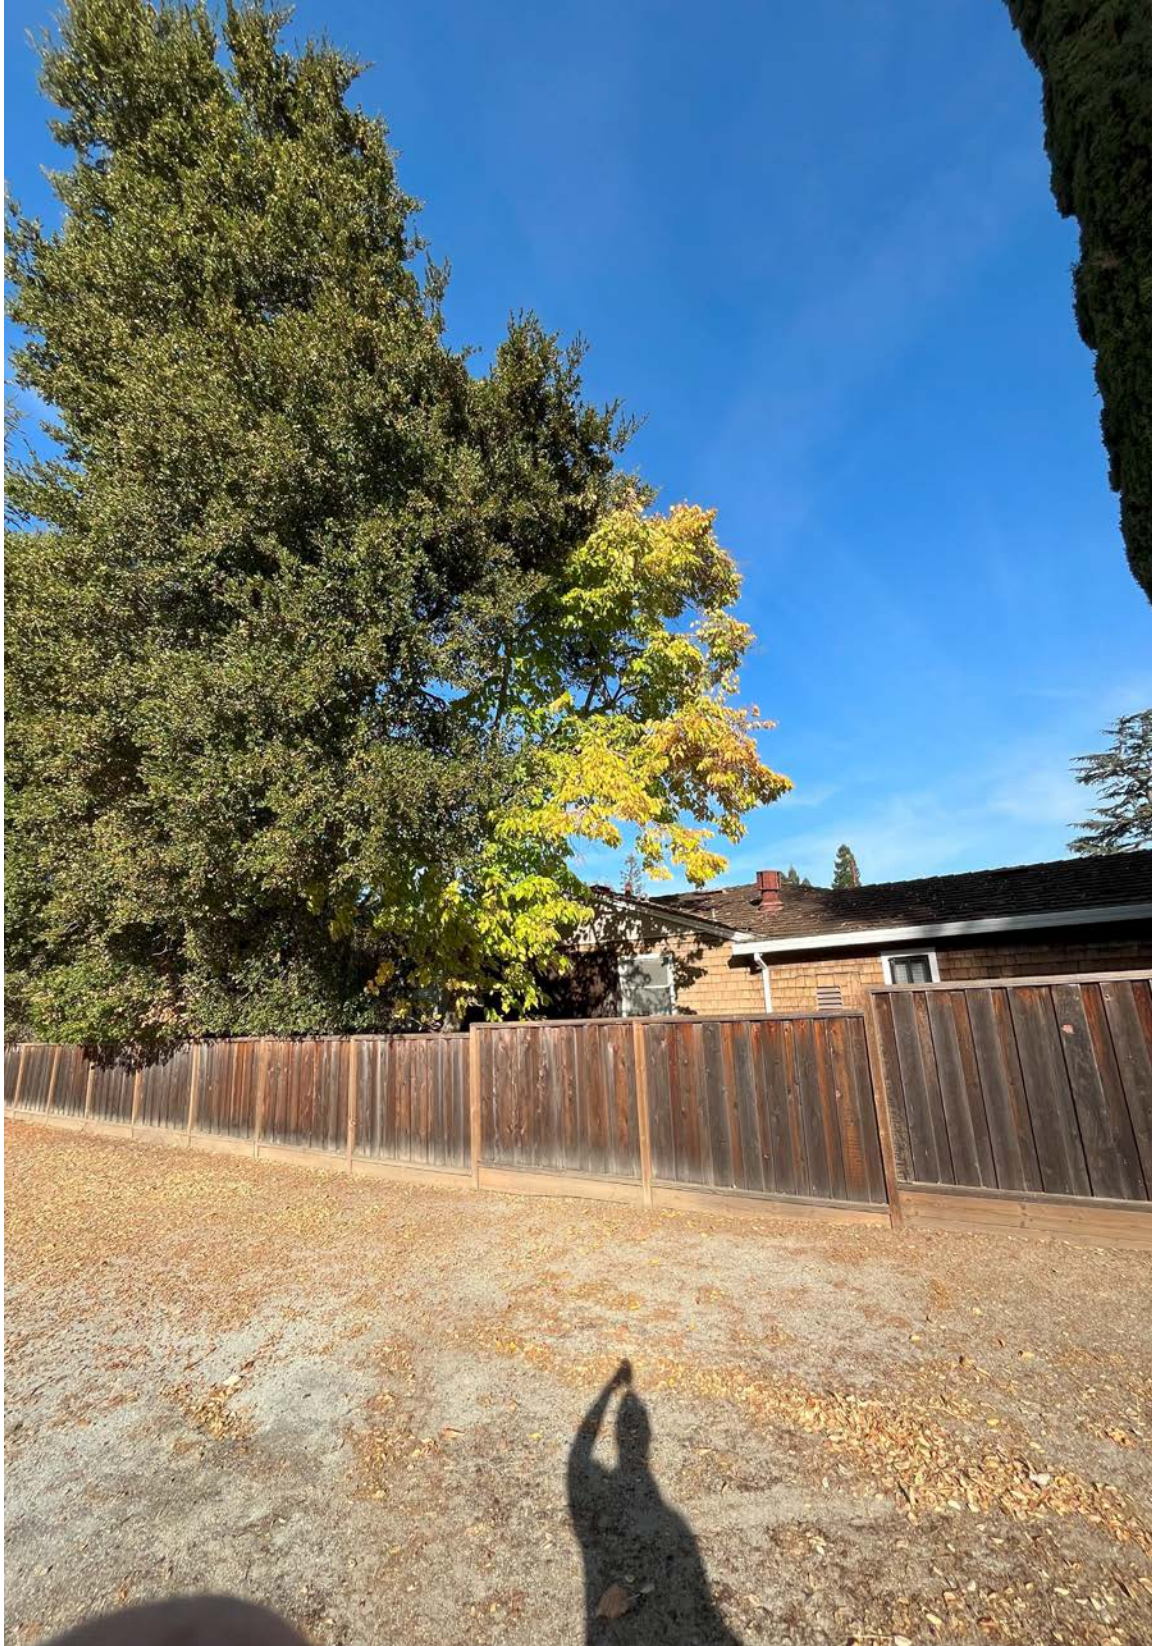
Tree #35

| Tree # | Species Common (<i>Scientific</i>) | Diameter (inches) | Condition (percent) | Height (feet) | Spread (feet) | Comments |
|---|---|---|---|---|---|---|
| 35 | Linden | Est. 8.0 | 50 | 25 | 18 | Located on the neighboring property, no tag, leans south, fair form and vigor, multi-stem top at 15 feet high. |

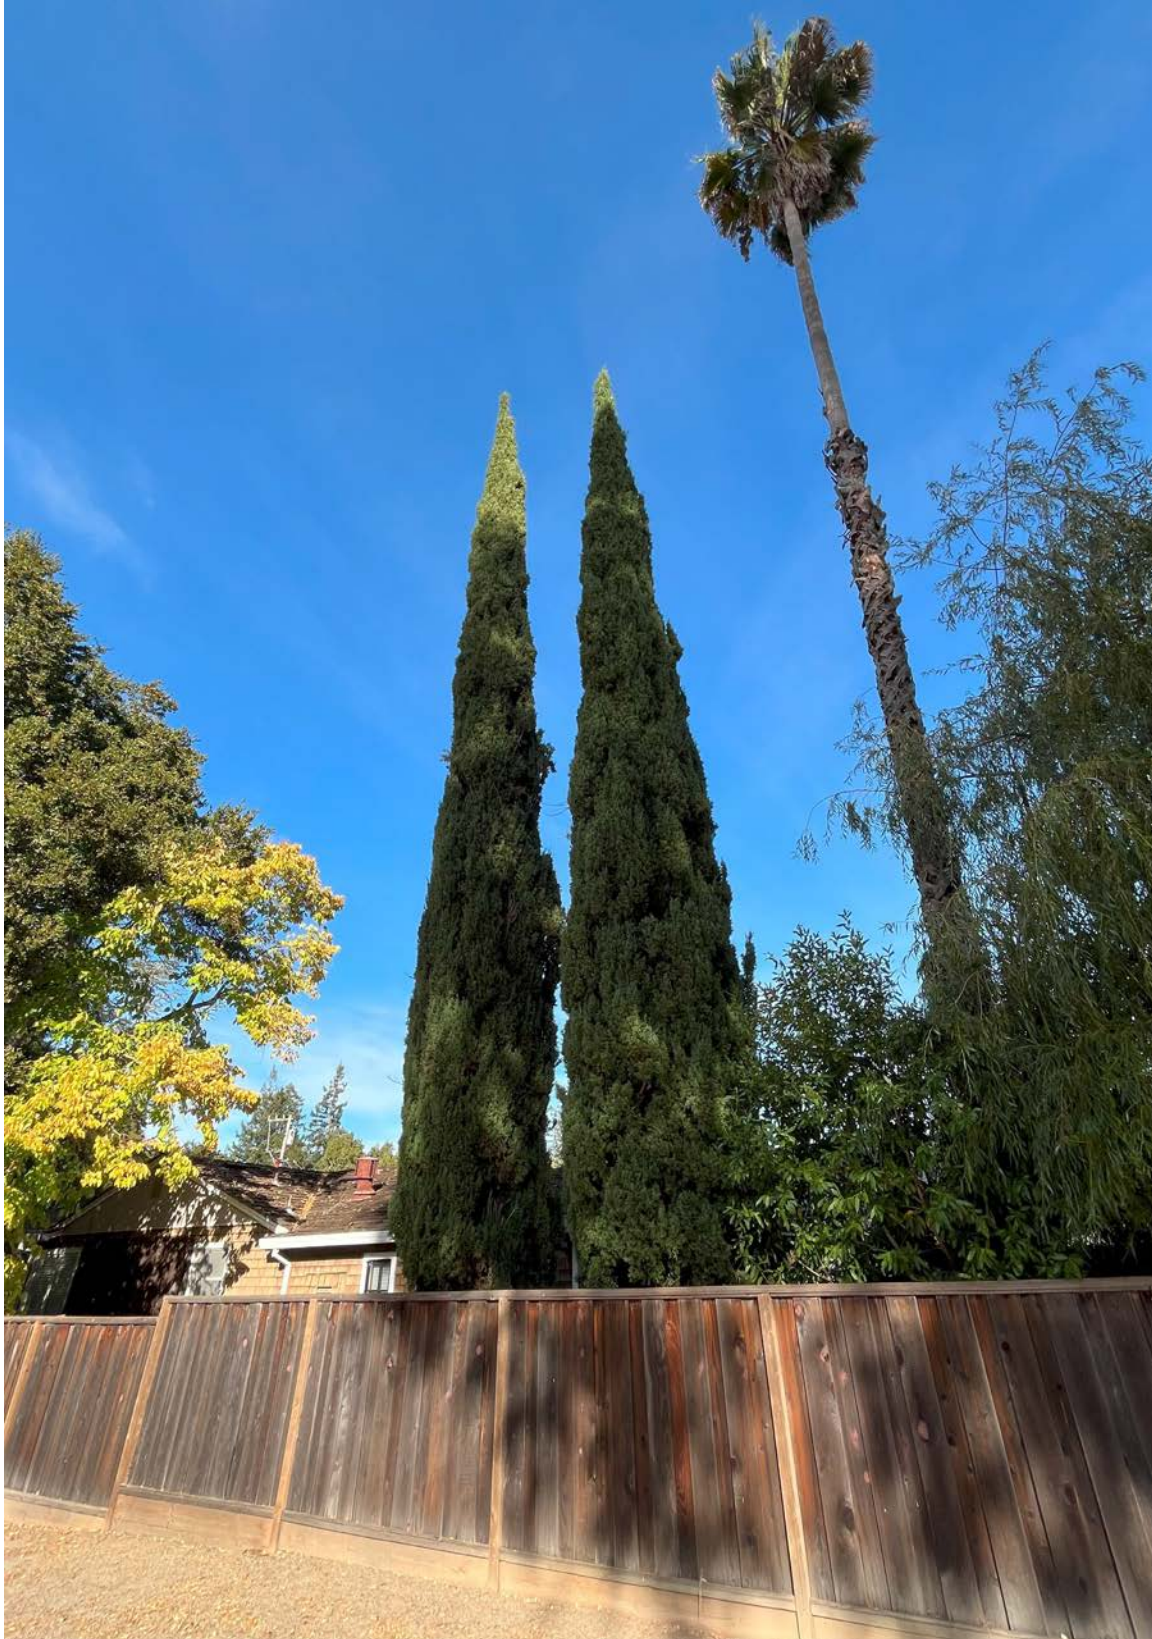
Tree #36 & #37

| Tree # | Species Common (<i>Scientific</i>) | Diameter (inches) | Condition (percent) | Height (feet) | Spread (feet) | Comments |
|---|---|---|---|---|---|---|
| 36 | Italian Cypress | Est. 15.0 | 70 | 40 | 9 | Located on the neighboring property, no tag, good form and vigor. |
| 37 | Italian Cypress | Est. 14.0 | 70 | 40 | 9 | Located on the neighboring property, no tag, good form and vigor. |

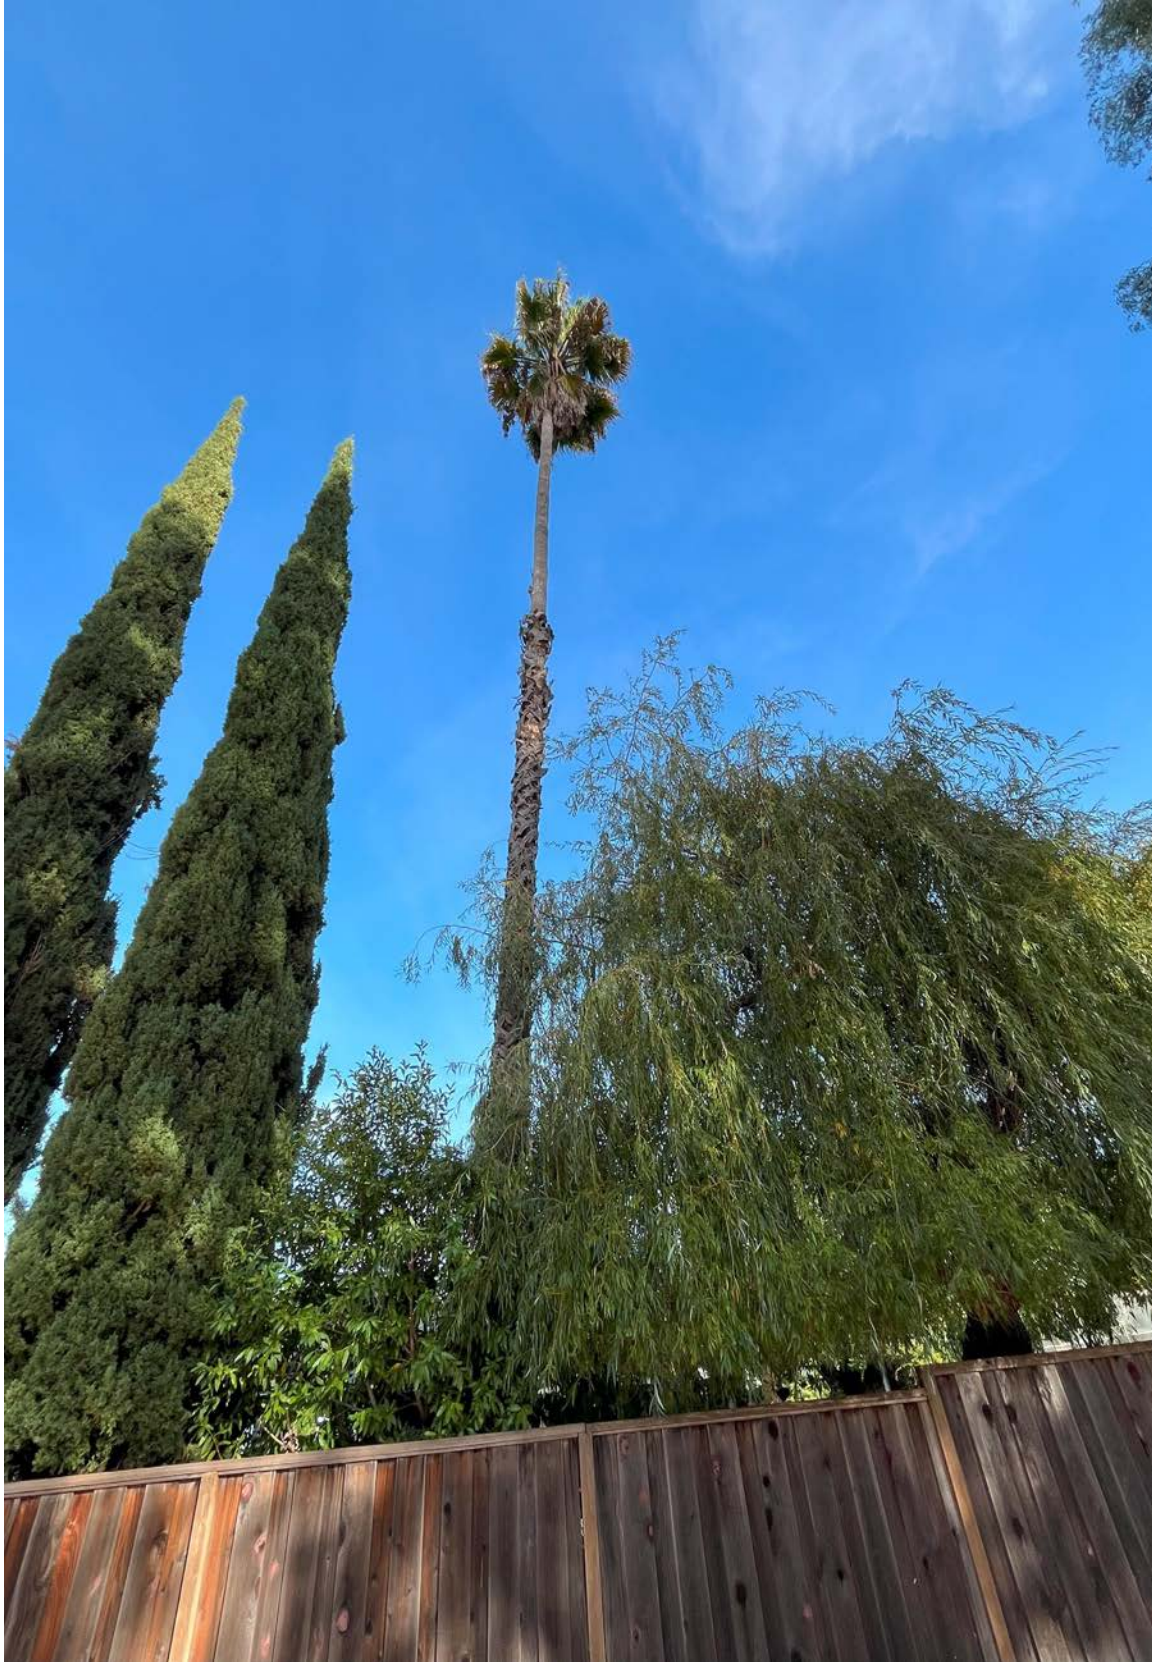
Tree #38

| Tree # | Species Common (<i>Scientific</i>) | Diameter (inches) | Condition (percent) | Height (feet) | Spread (feet) | Comments |
|---|---|---|---|---|---|---|
| 38 | Mexican Fan Palm | Est. 18.0 | 80 | 60 | 12 | Located on the neighboring property, no tag, good form and vigor. |

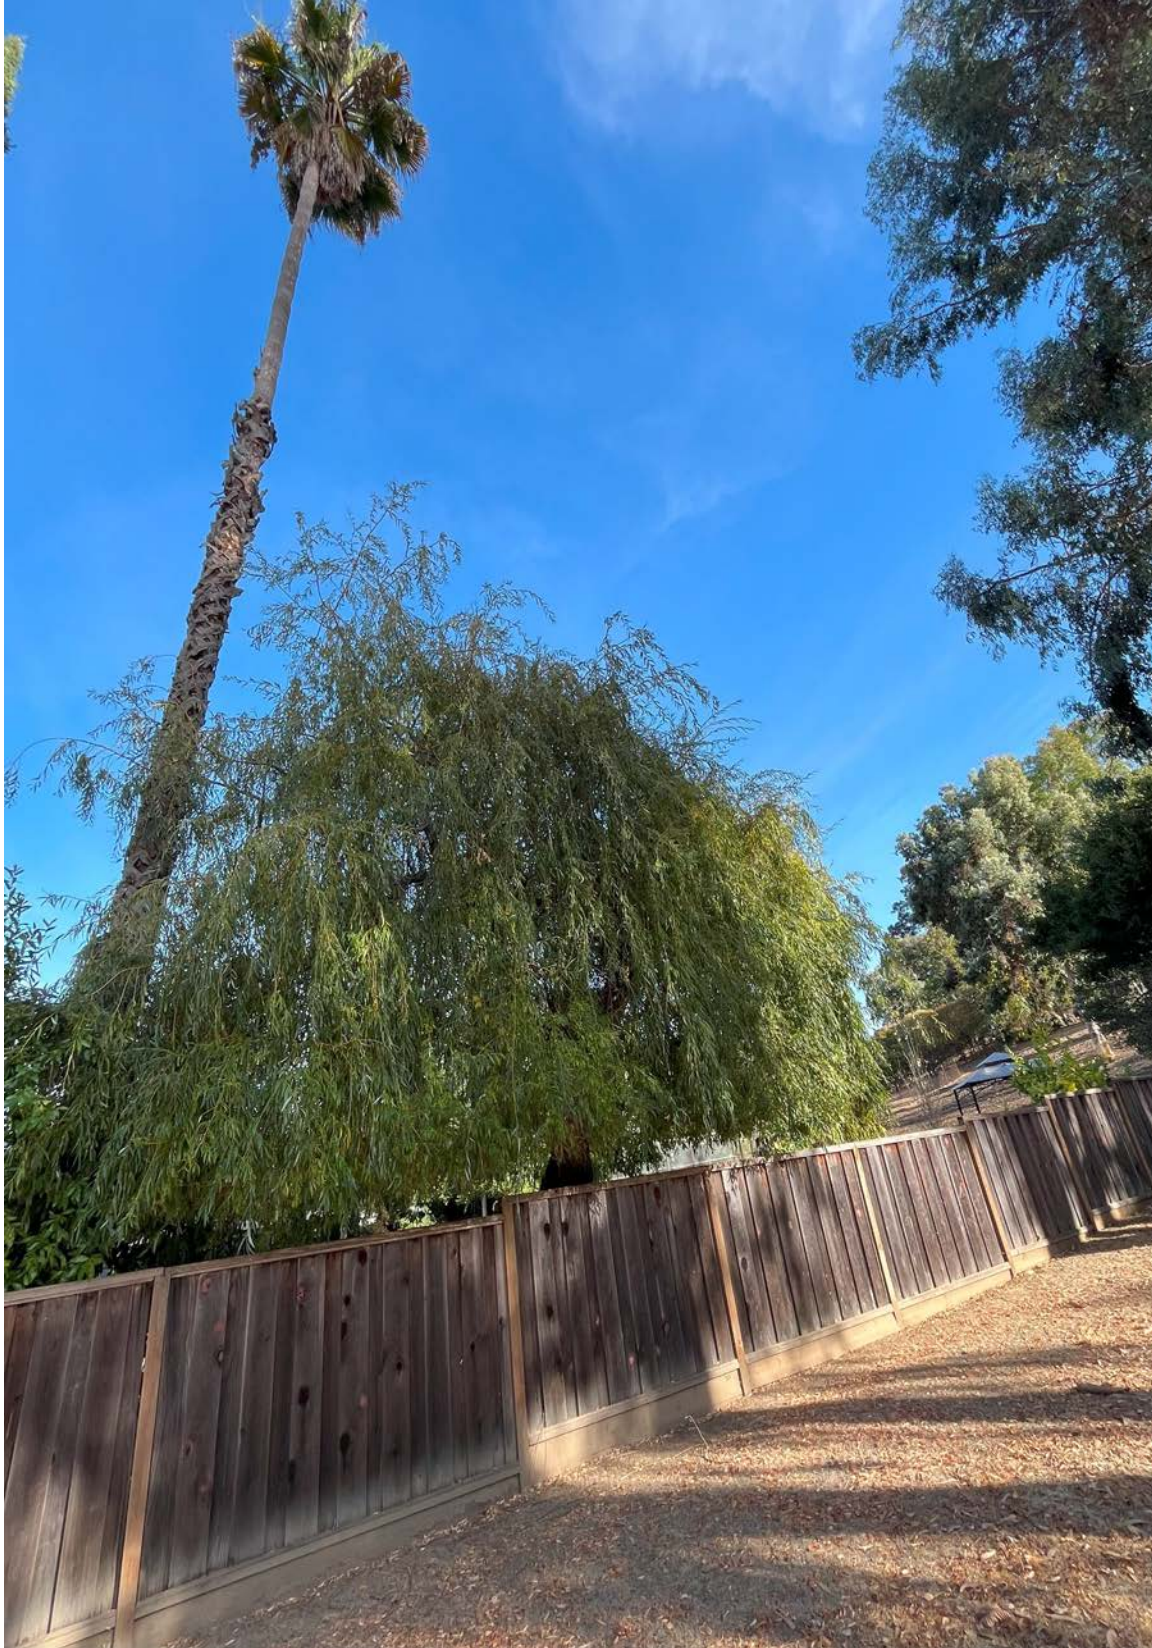
Tree #39

| Tree # | Species Common (<i>Scientific</i>) | Diameter (inches) | Condition (percent) | Height (feet) | Spread (feet) | Comments |
|---|---|---|---|---|---|---|
| 39 | Willow | Est. 16.0 | 50 | 20 | 24 | Located on the neighboring property, multi-stem top at 8 feet high, good vigor and poor form. |

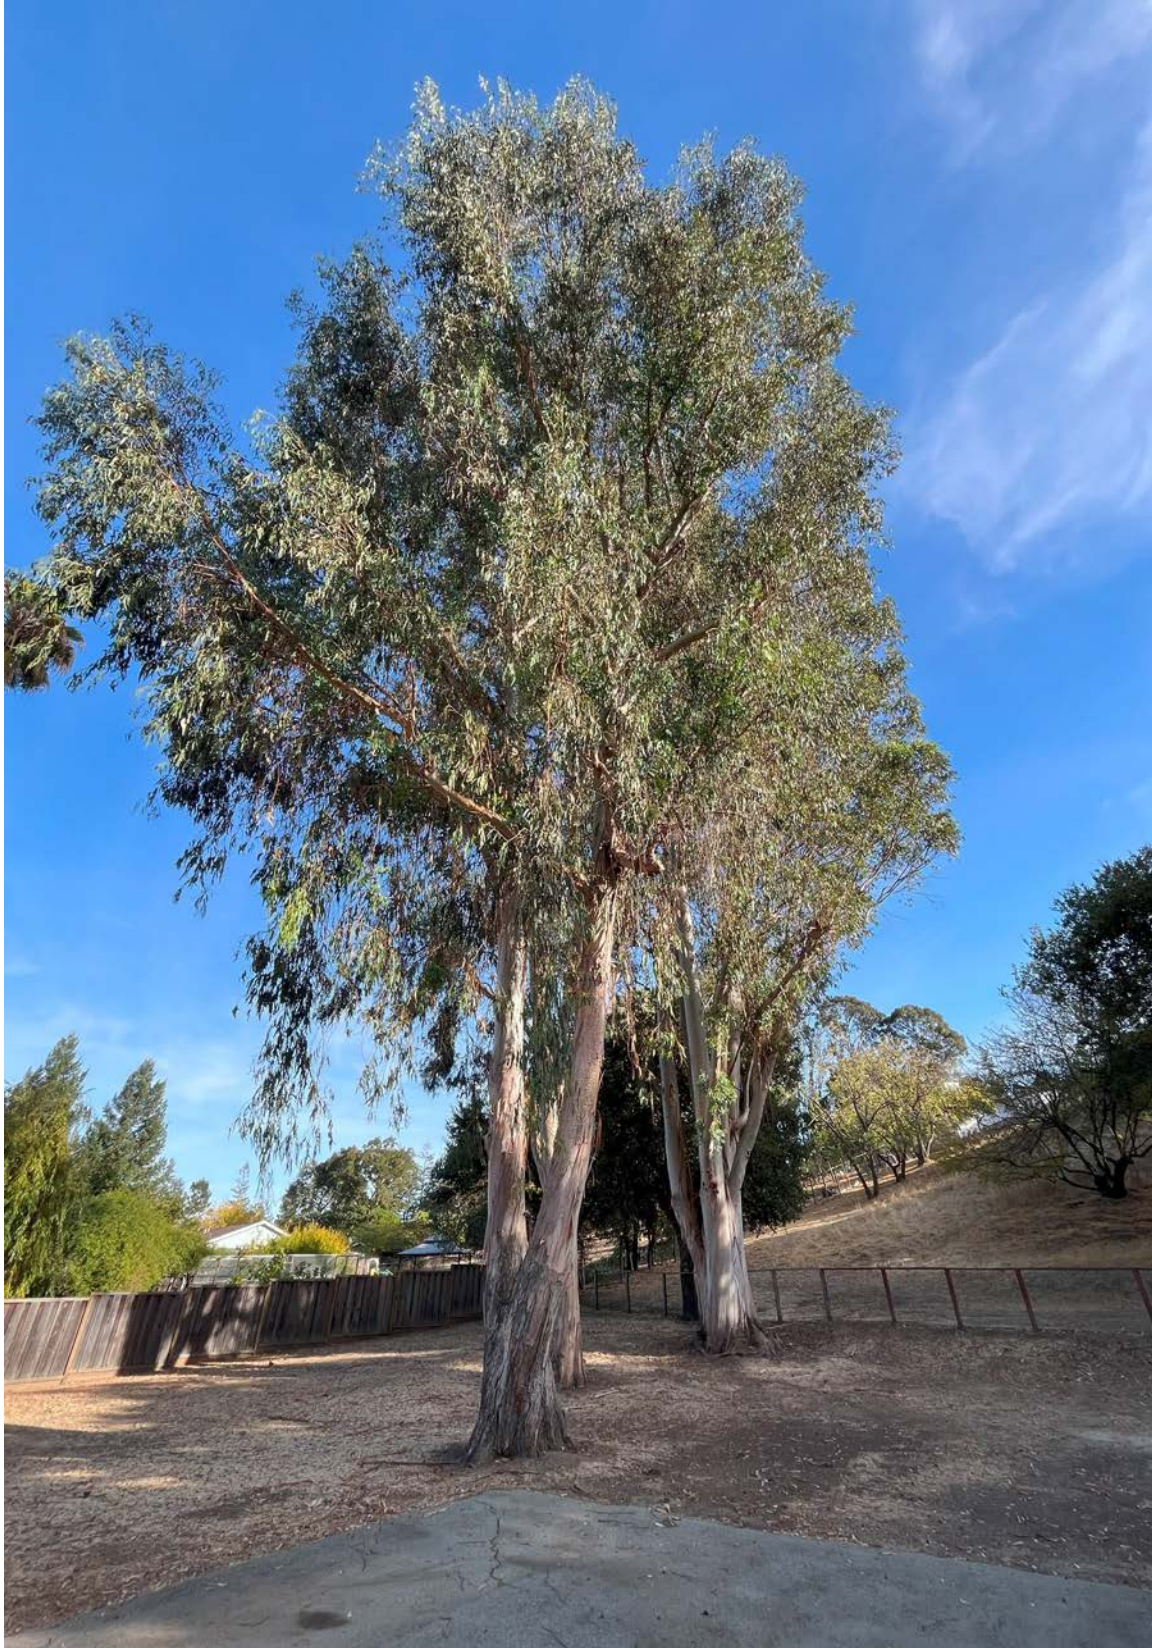
Tree #40

| Tree # | Species Common (<i>Scientific</i>) | Diameter (inches) | Condition (percent) | Height (feet) | Spread (feet) | Comments |
|---|---|---|---|---|---|---|
| 40 | Blue Gum Eucalyptus | 59.4 | 45 | 90 | 40 | Fungus at the base, two-stem at 5 feet high, abundance of loose bark, moderate amount of interior deadwood, fair vigor and poor form. |

Trees #40, #41, and #42 are Blue Gum Eucalyptus trees located along the left rear corner of the site. These trees all have excessive amounts of loose bark, moderate interior deadwood, and several codominant attachments in the upper canopy. Trees #40 and #41 have two-stem attachments at 5 and 8 feet, respectively. Tree #42 has a multi-stem attachment with included bark at 12 to 15 feet. All three trees have poor form and moderate vigor.

I recommend removing all three of these trees.

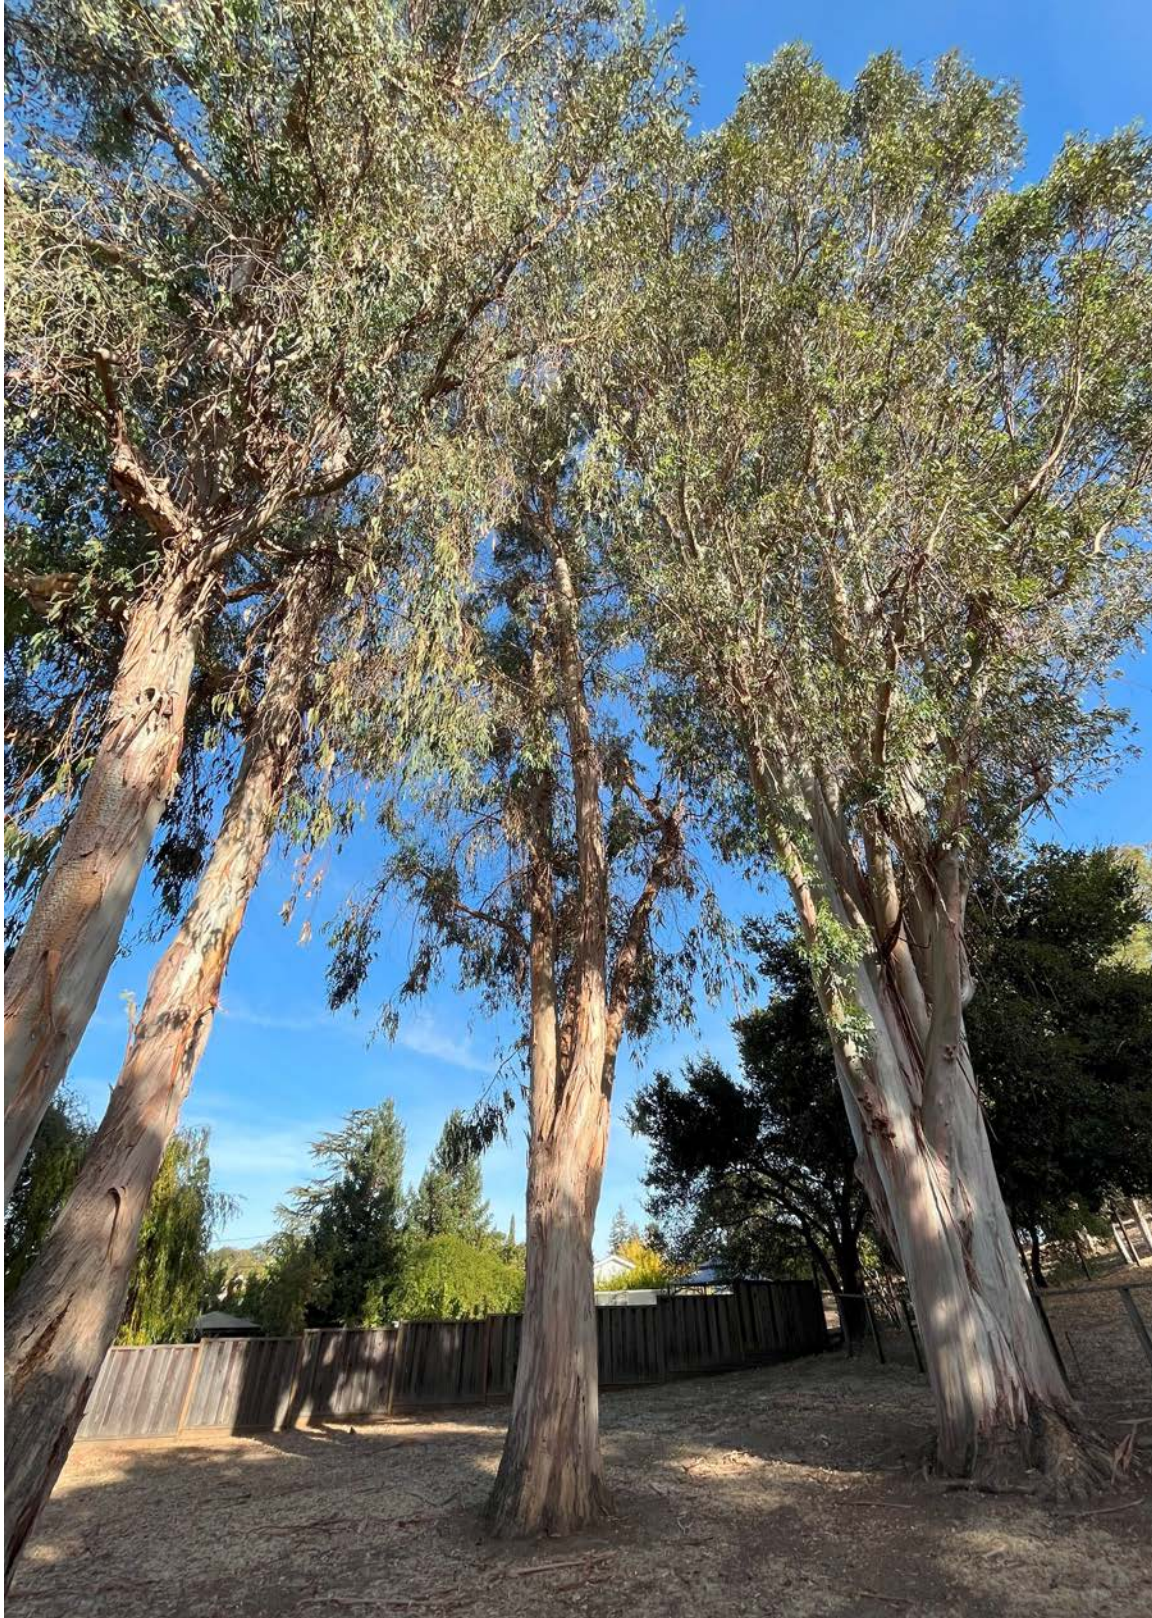
Tree #41

| Tree # | Species Common (<i>Scientific</i>) | Diameter (inches) | Condition (percent) | Height (feet) | Spread (feet) | Comments |
|---|---|---|---|---|---|---|
| 41 | Blue Gum Eucalyptus | 41.5 | 35 | 90 | 36 | Partially covered root crown, two-stem at 8 feet high, and codominant attachments at 10 feet high, abundance of interior deadwood, poor form and fair vigor. |

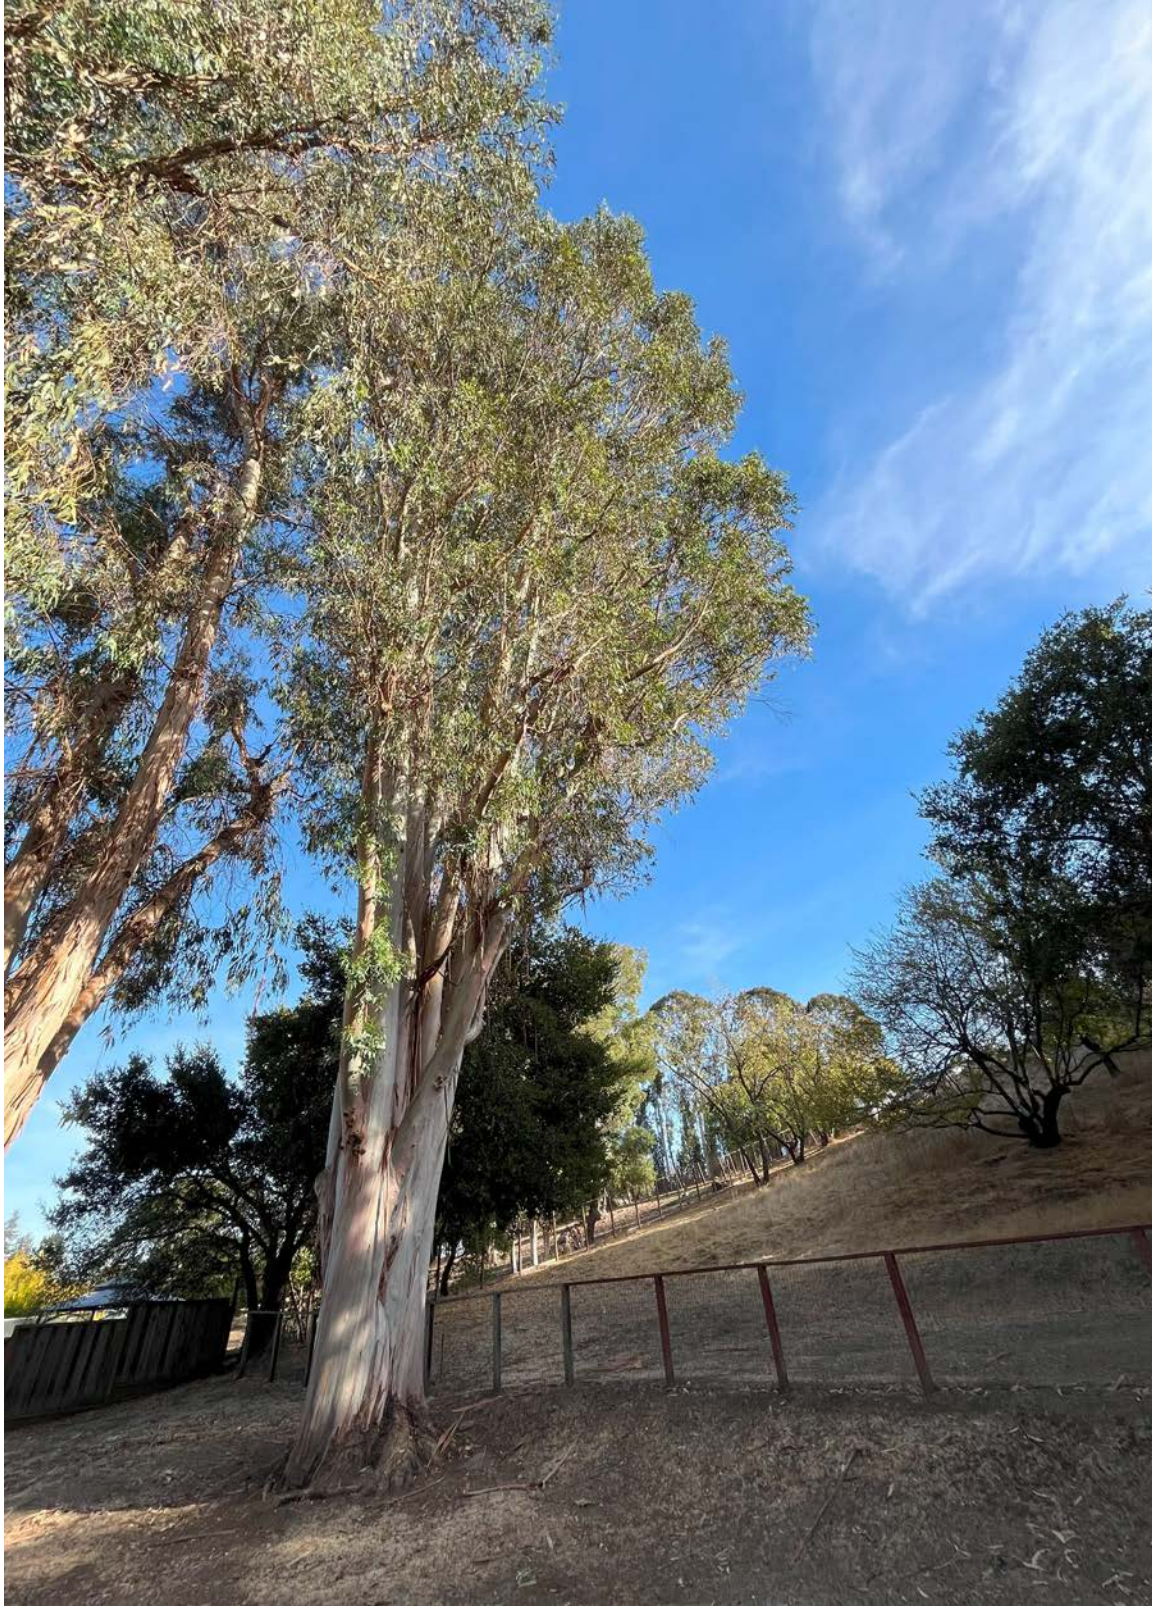
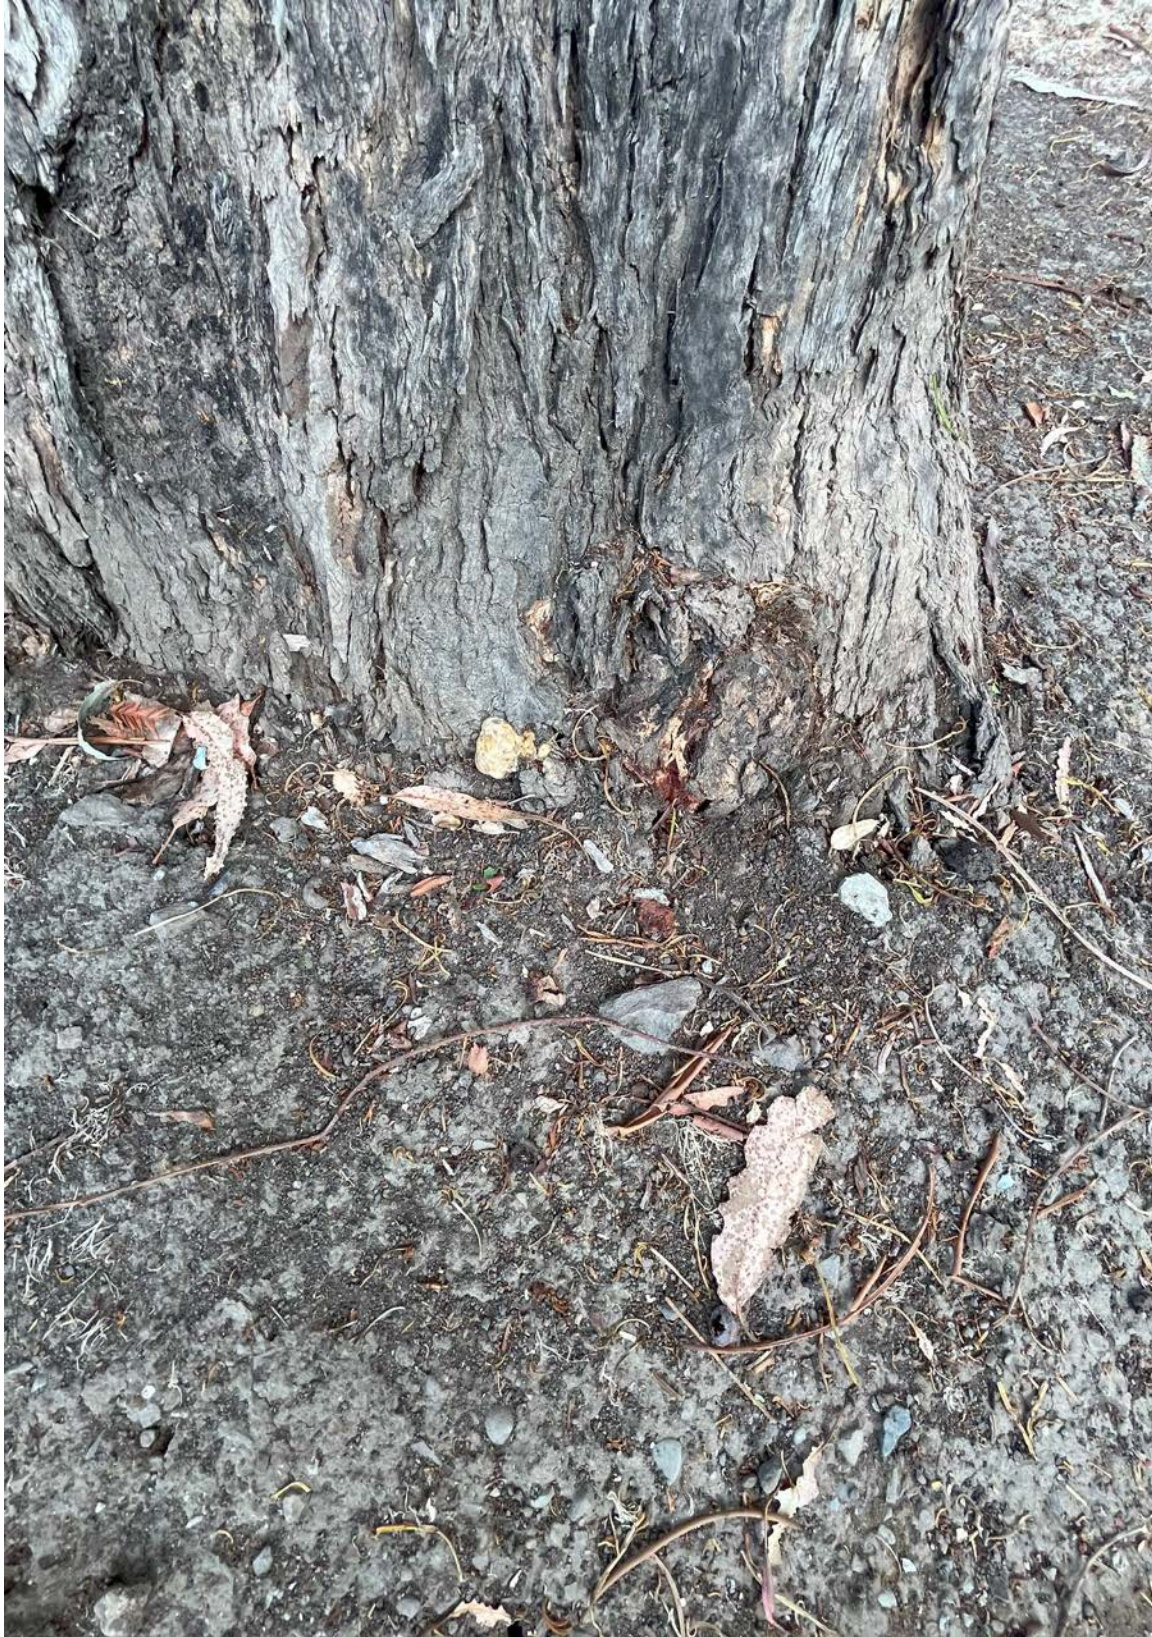
Tree #42

| Tree # | Species Common (<i>Scientific</i>) | Diameter (inches) | Condition (percent) | Height (feet) | Spread (feet) | Comments |
|---|---|---|---|---|---|---|
| 42 | Blue Gum Eucalyptus | 63.9 | 35 | 95 | 40 | Girdling roots at the base, multi-stem attachment with included bark at 12-15 feet high, moderate amount of interior deadwood loose bark throughout the canopy, very poor form, and moderate vigor. |

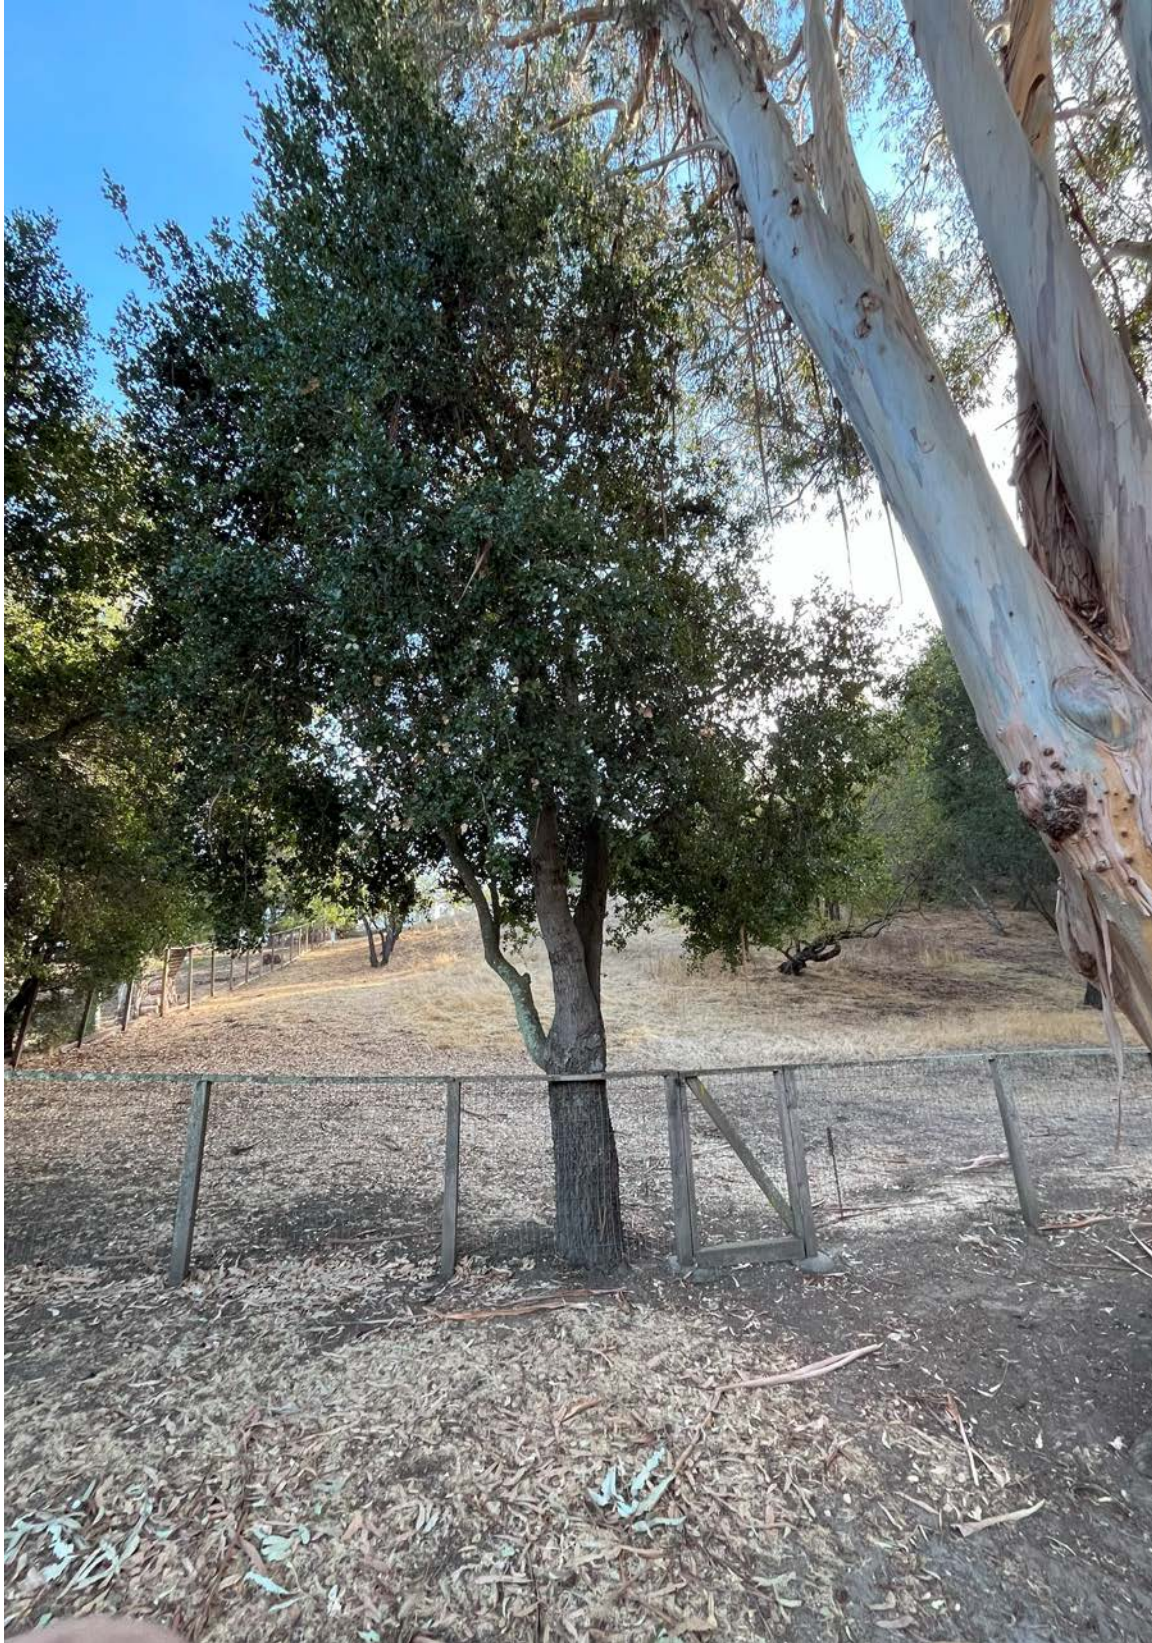
Tree #43

| Tree # | Species Common (<i>Scientific</i>) | Diameter (inches) | Condition (percent) | Height (feet) | Spread (feet) | Comments |
|---|---|---|---|---|---|---|
| 43 | Coast Live Oak | Est. 18.0 | 50 | 30 | 21 | Root crown covered, codominant attachment with included bark at 6 feet high, poor form, and good vigor, located on the rear neighboring property. |

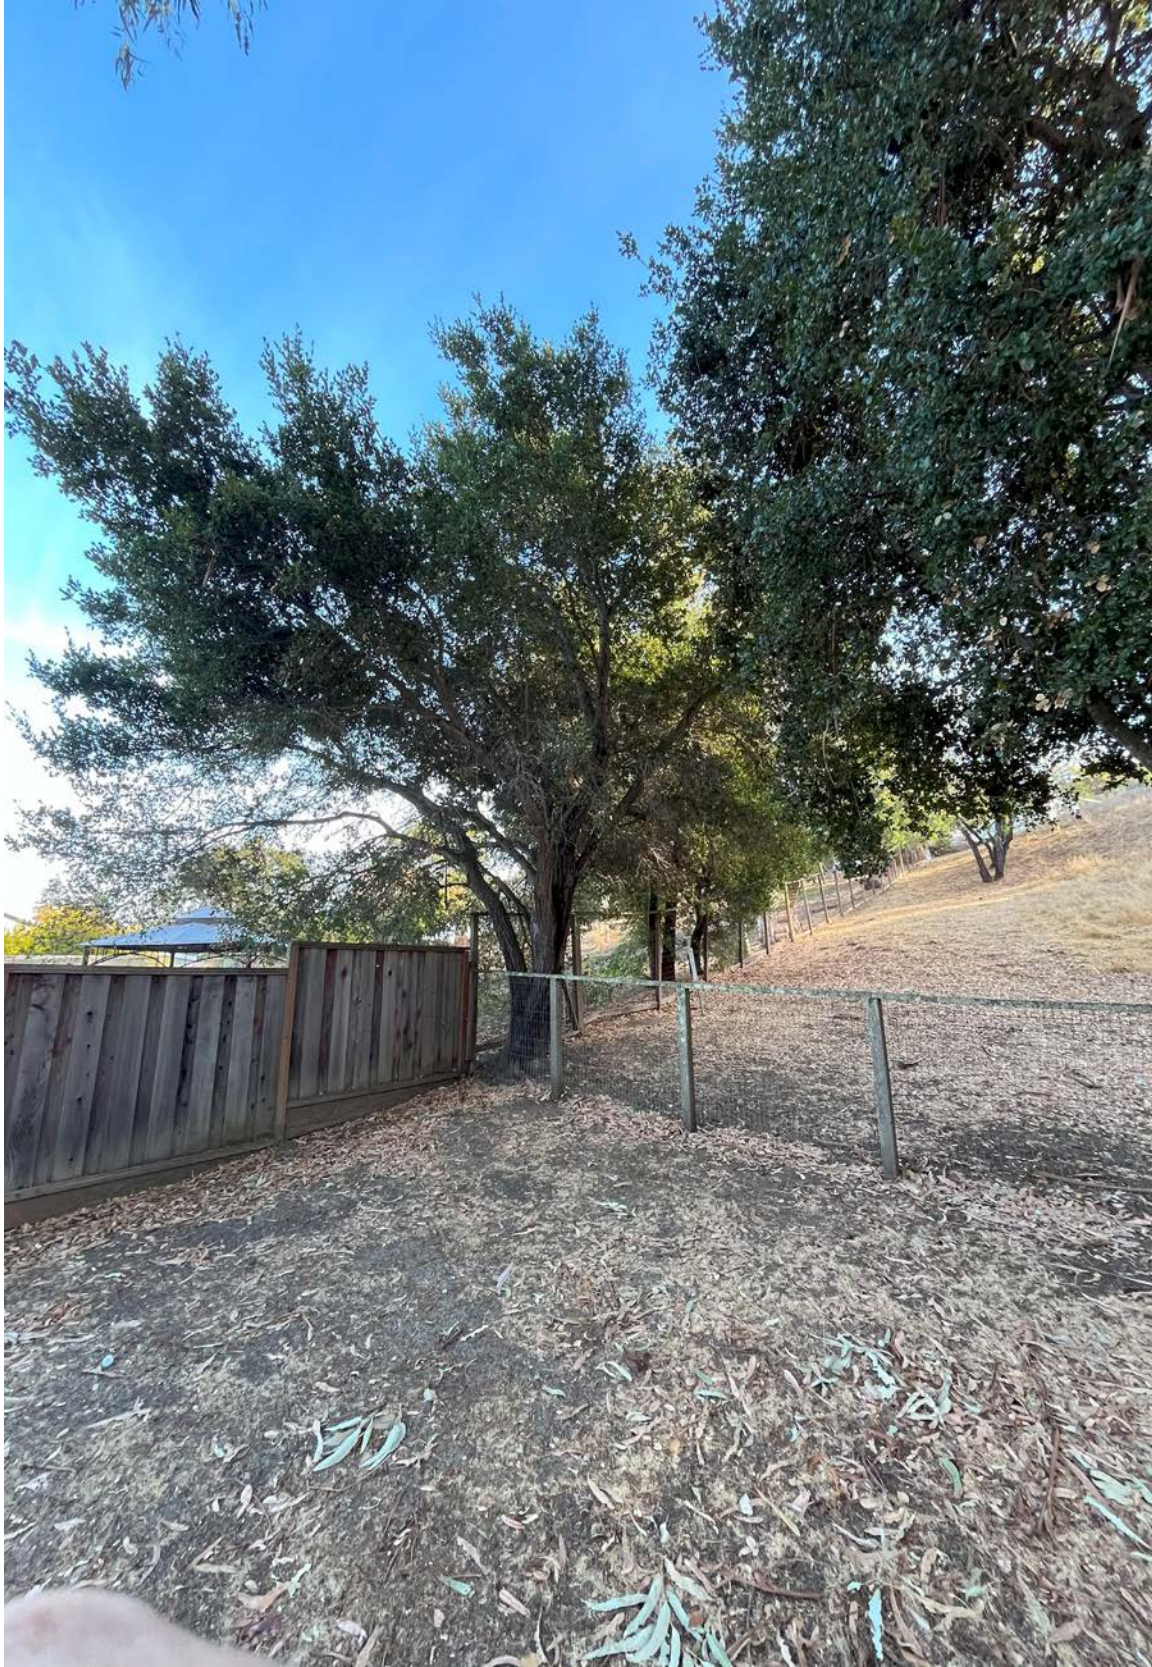
Tree #44

| Tree # | Species Common (<i>Scientific</i>) | Diameter (inches) | Condition (percent) | Height (feet) | Spread (feet) | Comments |
|---|---|---|---|---|---|---|
| 44 | Coast Live Oak | Est. 23.0 | 40 | 20 | 18 | Multi-stem attachment at 5 feet high, abundance of interior deadwood, no tag, poor form, and good vigor. |
