Mayne Tree Expert Company, Inc.

November 16, 2024

RE: 1815 CORDILLERAS RD., EMERALD HILLS (ARBORIST REPORT)

Tree Survey

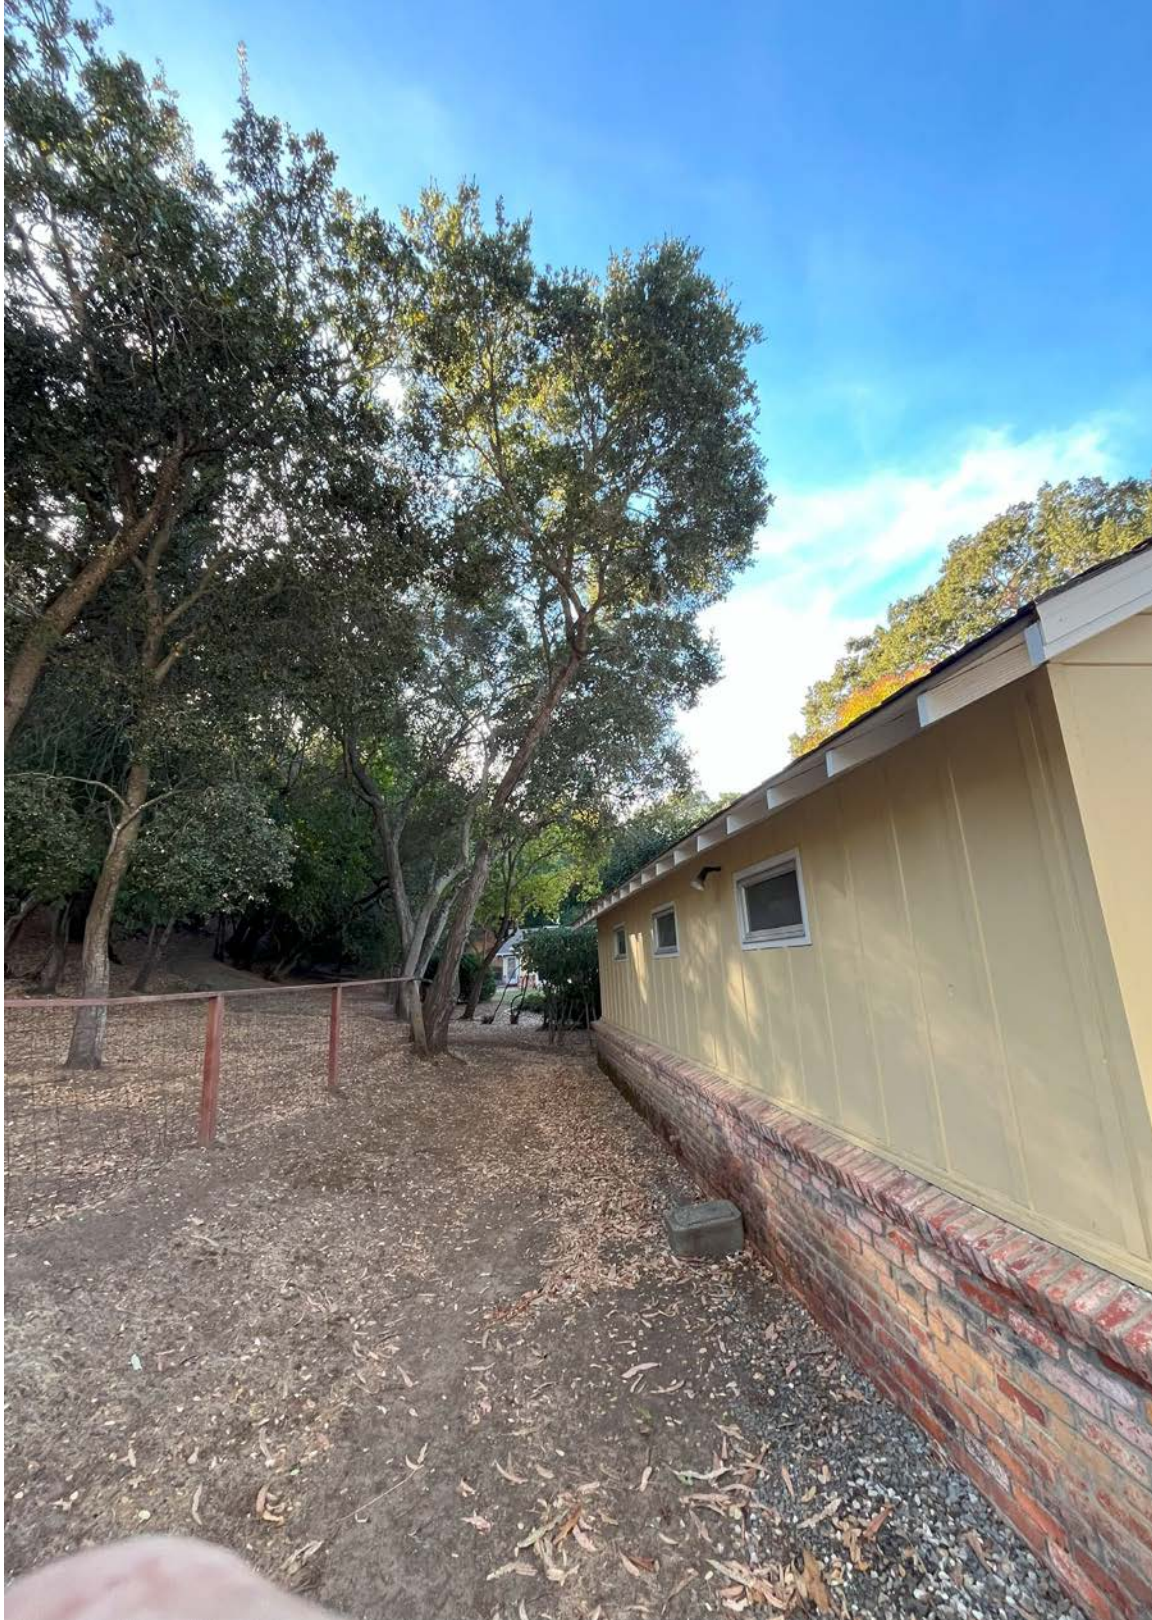
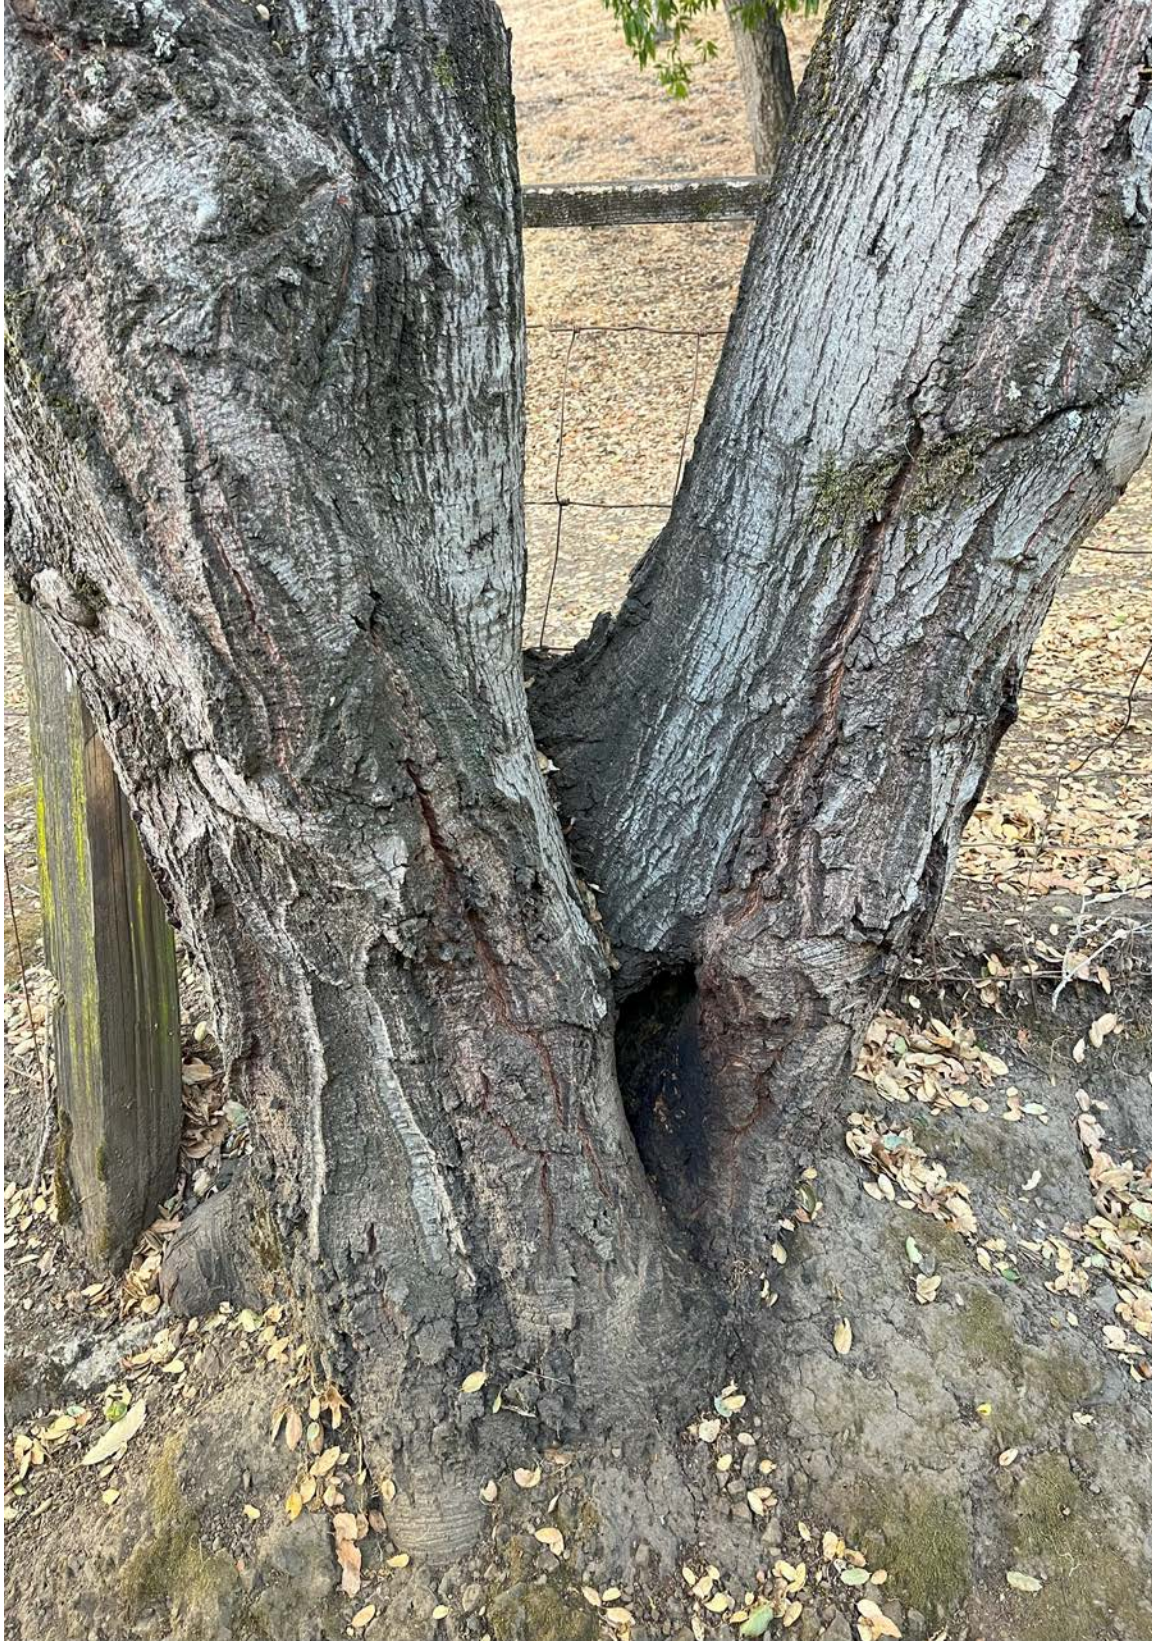
Tree #45

| Tree # | Species Common (<i>Scientific</i>) | Diameter (inches) | Condition (percent) | Height (feet) | Spread (feet) | Comments |
|---|---|---|---|---|---|---|
| 45 | Coast Live Oak | Est. 19.0 | 35 | 40 | 42 | Two-stem at base with included bark, cavity between the two stems, leans to the north over the garage and west towards the pool, poor form, and moderate vigor. |

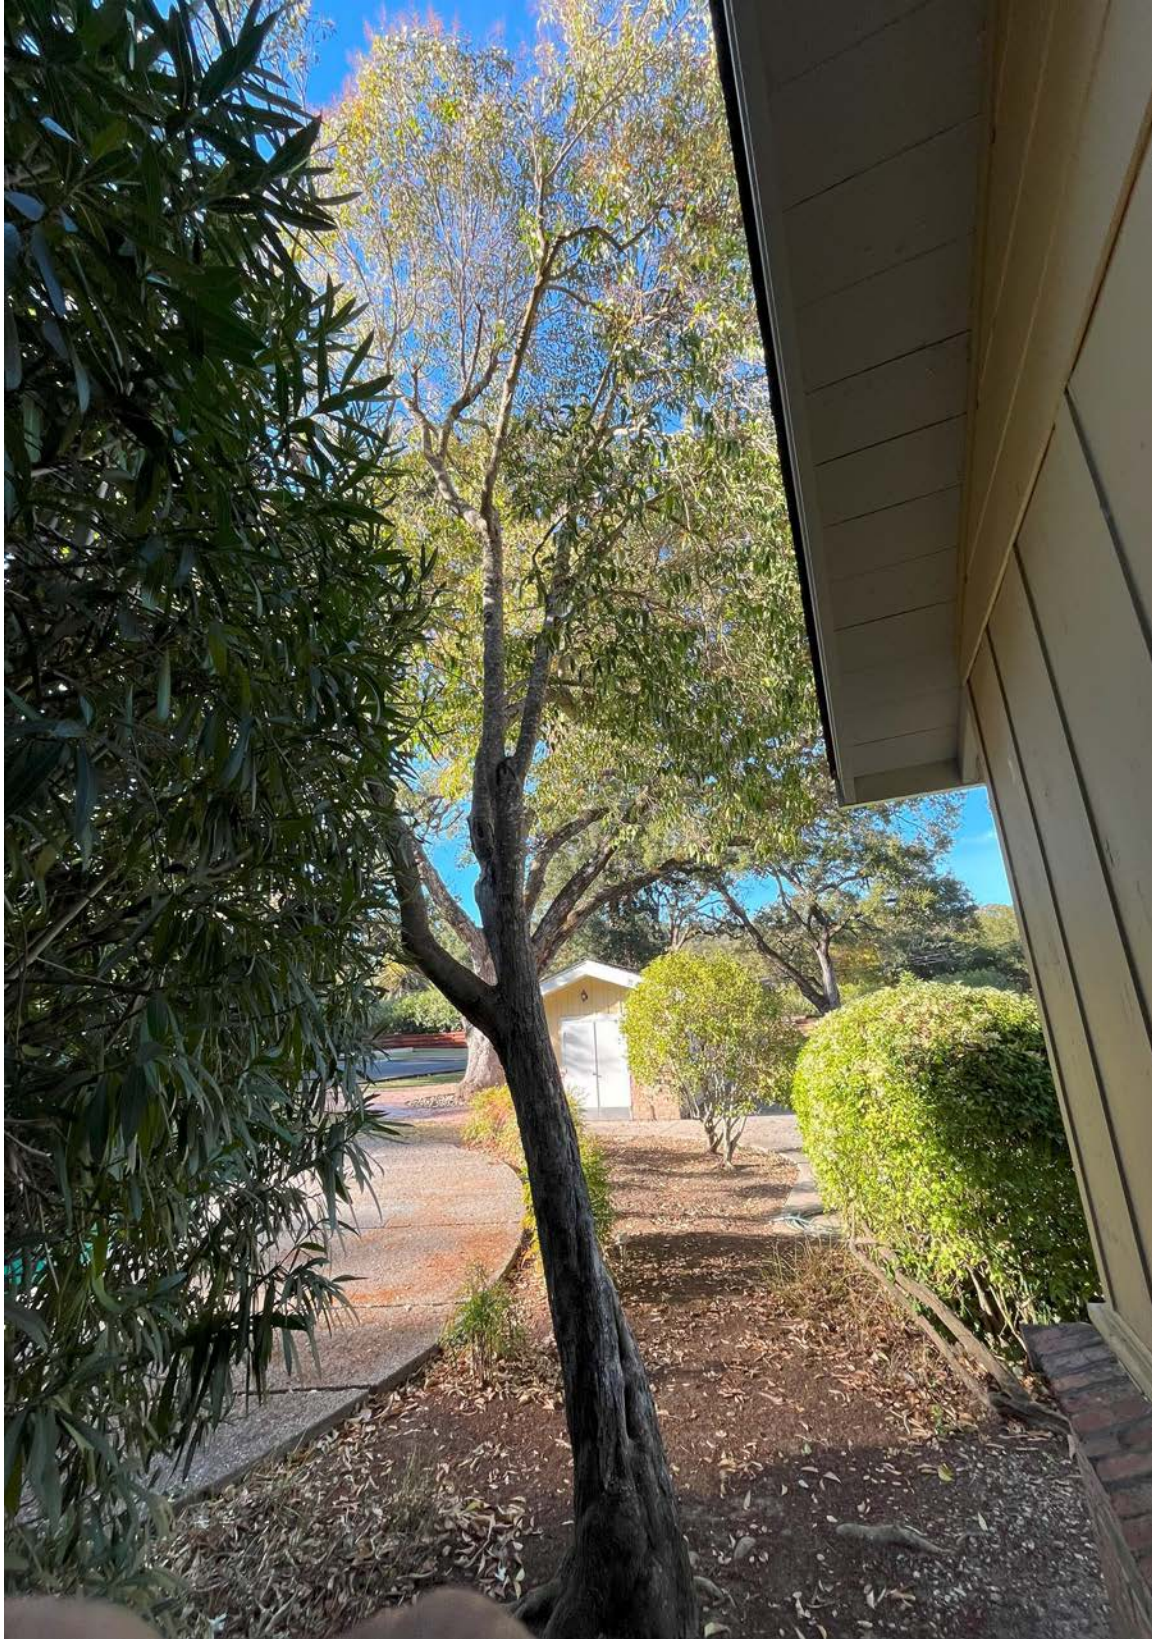
Tree #46

| Tree # | Species Common (<i>Scientific</i>) | Diameter (inches) | Condition (percent) | Height (feet) | Spread (feet) | Comments |
|---|---|---|---|---|---|---|
| 46 | Japanese Privet | 10.2 | 40 | 520 | 12 | Leans west towards the pool, drought stressed, poor vigor and fair form. |

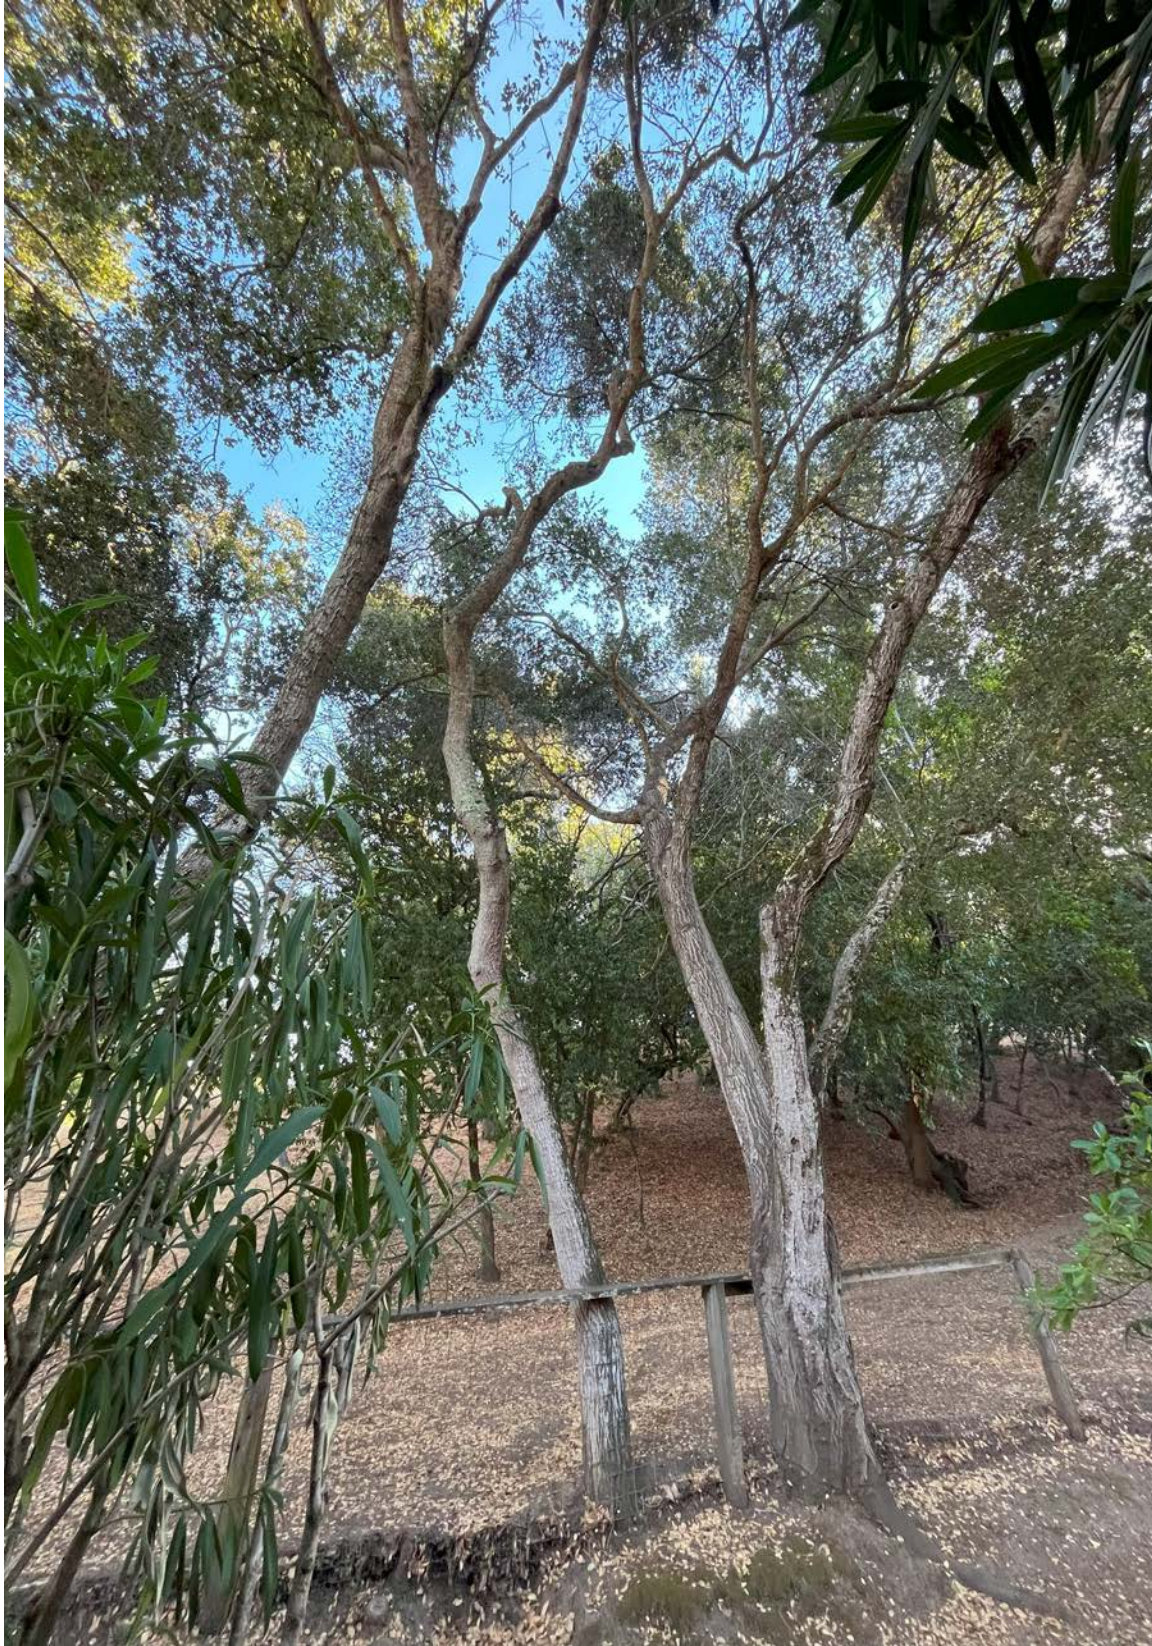
Tree #47

| Tree # | Species Common (Scientific) | Diameter (inches) | Condition (percent) | Height (feet) | Spread (feet) | Comments |
|---|---|---|---|---|---|--|
| 47 | Coast Live Oak | 11.1 | 40 | 25 | 18 | Root crown covered, located on the property line, no tag, top leans to the west, poor form and fair vigor. |
