Tree Inventory Report

Peninsula School
920 Peninsula Way
Menlo Park, CA 94025

PREPARED BY:
HortScience | Bartlett Consulting
2550 Ninth Street, Suite 112
Berkeley, CA 94710

October 27, 2023
Updated December 8, 2023

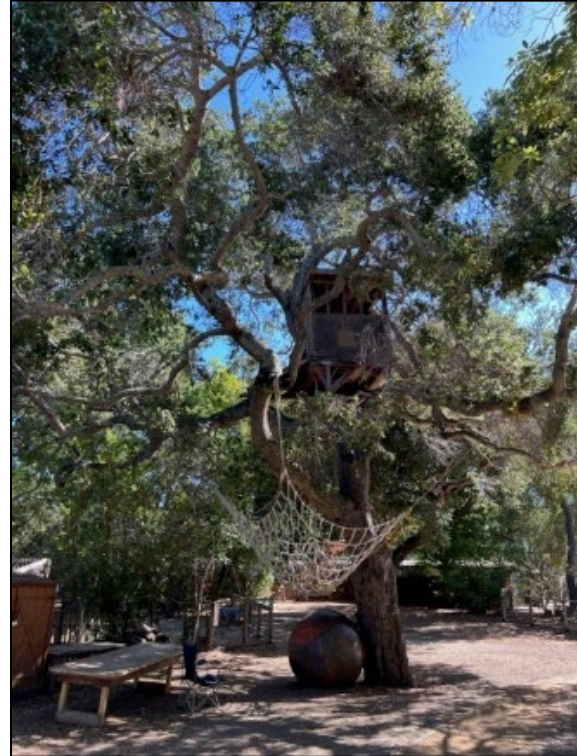
Coast live oak #176 was in the middle of campus on the southeast side of the “Big Building” and had a tree house constructed in the crown (**Photo 1**). Cavities were noted on the south side of the upper branches and there was a history of branch failures. This tree was selected to perform a tree risk assessment (see page 12).

Photo 1. Coast live oak #176 had a tree house constructed in the upper crown.

The tree risk rating was **Moderate**. The likelihood of a branch failure was assessed as *possible*. The likelihood of impacting a person during the school day was *high*. The consequence of a branch failure would be *severe*. The risk of falling from the ropes or tree house was not considered in my assessment, nor was the structural integrity of the tree house. Pruning of dead branches, evaluating defects and reducing weight on branch ends in the upper crown would reduce the potential for branch failure. The only way to reduce the risk level to low is to restrict access from walking under the tree.

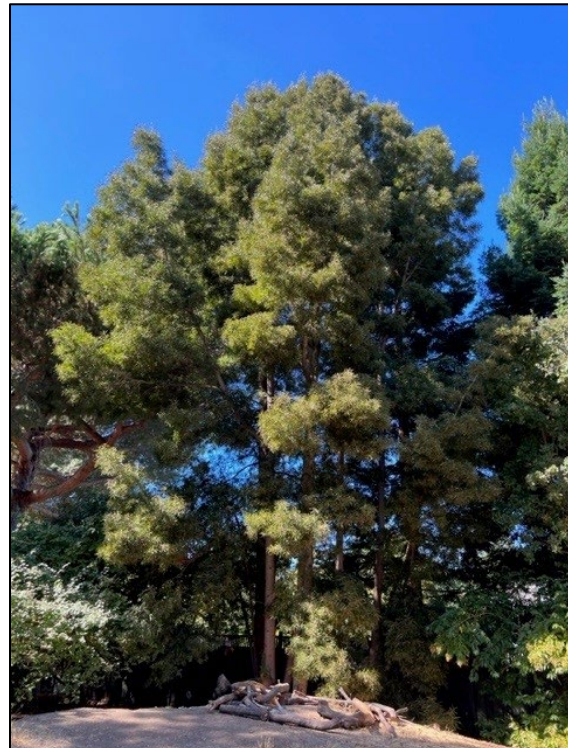
Blackwood acacia was the second most common with 21 trees. Most trees were located on the northwest side of the property (**Photo 2**). Poor structure resulted from poor branch angles and irregular branching. Several trees were below power lines and had been topped to provide clearance. Thirteen (13) trees were in poor condition and eight were fair.

Photo 2. Blackwood acacia grove on the northwest side of the property.

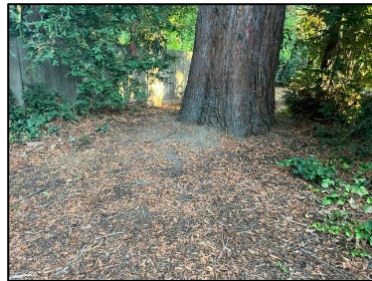
Fourteen (14) coast redwoods were located throughout the campus. Eight were in fair condition with variable leaf color (green and brown). All redwood had an upright (excurrent) form that is typical of the species. Redwoods #218 and 219 were stump sprouts in poor condition due to extensive dieback. Redwood #200 was the largest tree on the property with a trunk diameter of 60 inches. It had a very tall, full crown (Photo 3).

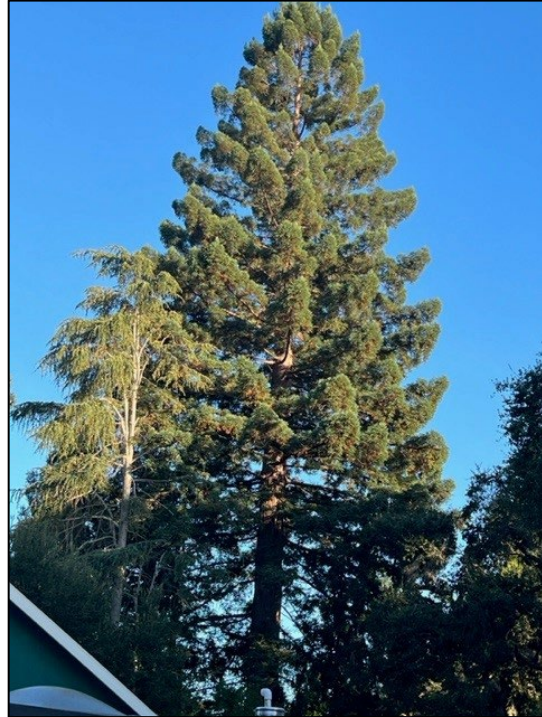
Photo 4 (below). Evidence of soil heaving was found on the west side of redwood #200.

Minor soil heaving was present at the base on the west side (**Photo 4**). This may be an indication of root instability. The tree should be monitored after wind or storm events.

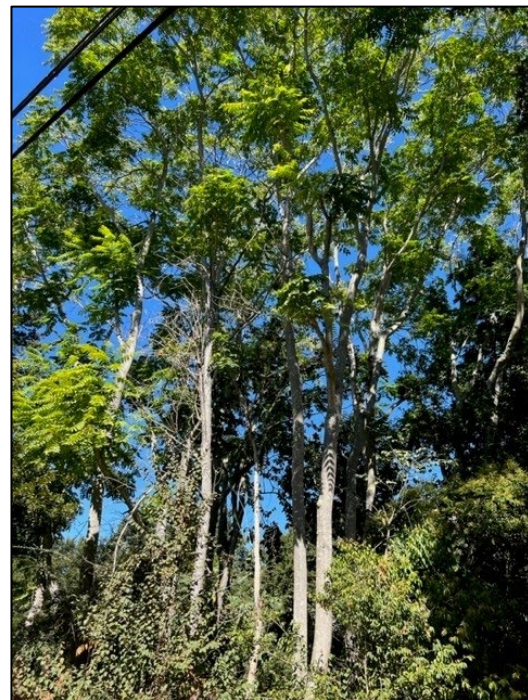
Most of the 14 tree of heaven averaged just over 15 inch diameter and were growing on the southwest side of the property (**Photo 5**). Eight trees were in fair condition and six were poor with poor form and structural defects. The upper crown was thin in several trees, an indication of low vigor.

Photo 5. Tree of heaven were concentrated on the southwest side of the property adjacent to the street.

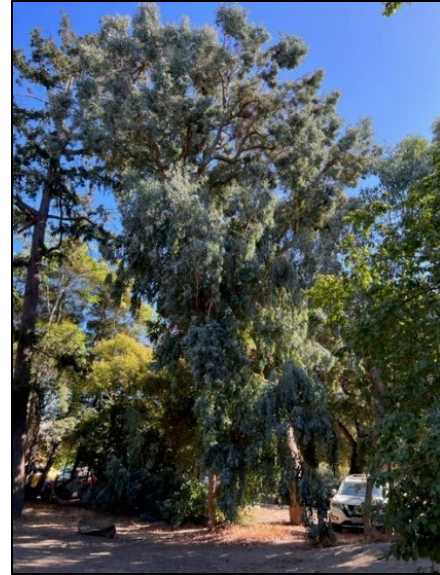
Six (6) silver dollar gum trees were growing on the west side of the parking lot (**Photo 6**). Four had large crowns and were in fair condition. Gums #263 and 267 had 6 inch diameter trunks and were previously topped creating poor structure and form. Silver dollar gum #269 was one of the most unique trees on the property with the parent stem lying prostrate on the ground from which two large vertical stems formed the crown.

Photo 6. Silver dollar gums were growing on the west side of the parking area.

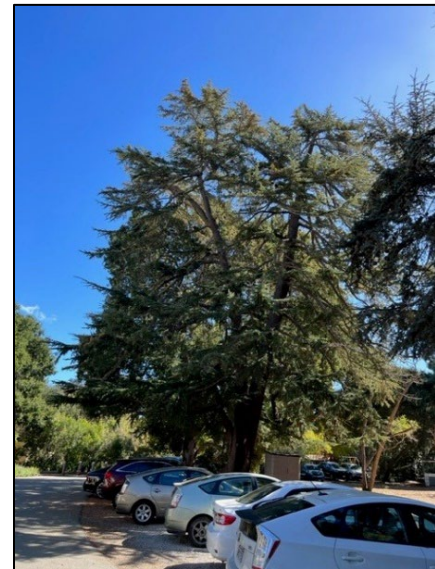
Photo 7. Deodar cedar #298 had a 44 inch diameter trunk and had multiple attachments at 8 feet.

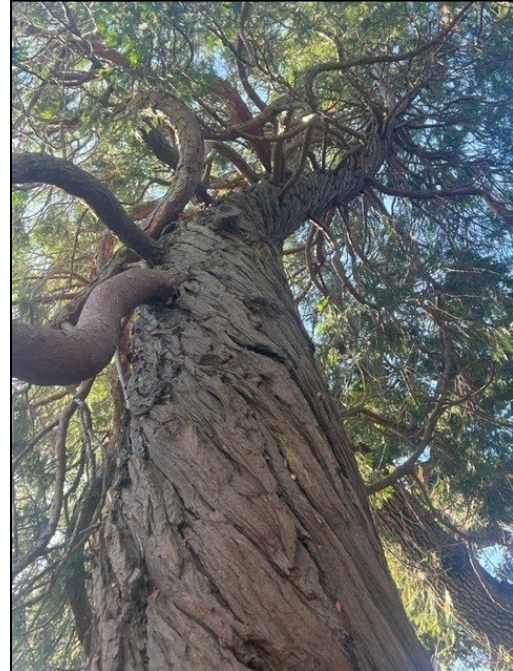
- Three out of four Chinese elms were in fair condition with medium crowns. They all had poor structure and form. Elm #120 had been previously topped and was in poor condition with branch dieback.
- Three incense cedars were in fair condition with trunk diameters ranging from 10 – 30 inches. Cedar #280 had a twisted 30 inch trunk and was codominant at four feet with included bark and leaned south (**Photo 8**).

Photo 8. Incense cedar #280 had a 30 inch sinuous trunk.

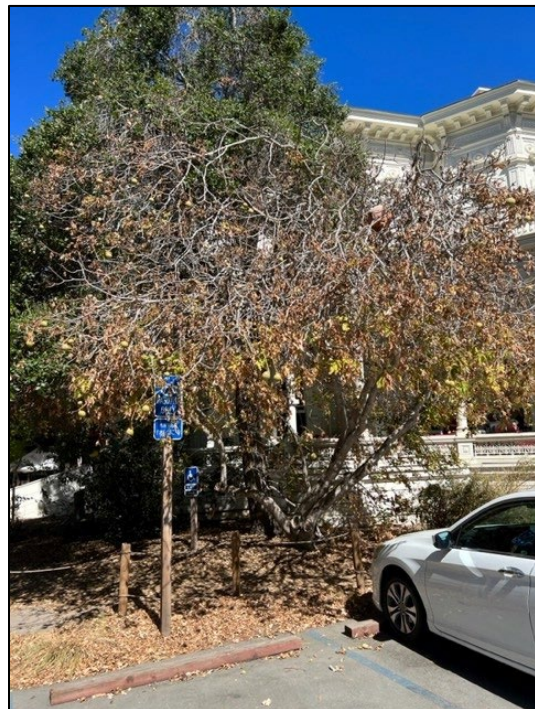
- California buckeyes #284 and 293 were in fair condition. Buckeye #293 had a 16 inch diameter trunk and had multiple attachments at 1 foot (**Photo 9**).

Photo 9. California buckeye #293 had multiple attachments at the base and was used as a climbing tree by children.

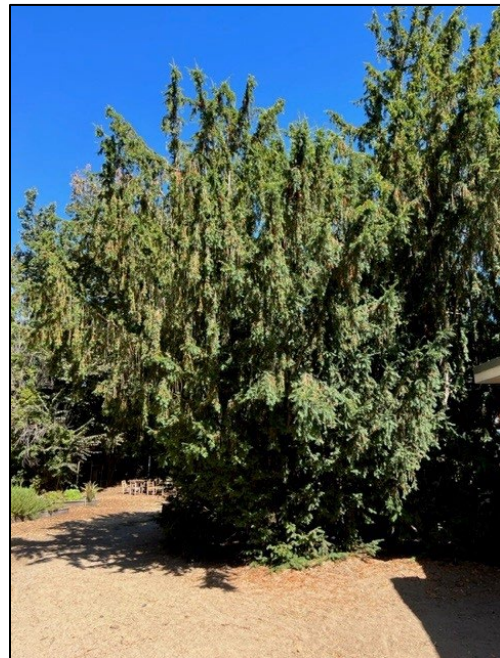
- Yew #223 was in fair condition with multiple attachments at the base and had a wide crown (**Photo 10**).
- Xylosma #325 had a 13 inch diameter trunk with multiple attachments at the base and contoured growth. The tree was in poor condition.

Photo 10. Yew #233 had multiple attachments at the base and had a wide crown.
