August 26, 2020

Subject: Geologic Hazard Evaluation: New Driveway Entrance, La Honda Road.
PLN2020-00245; APN 078-190-200

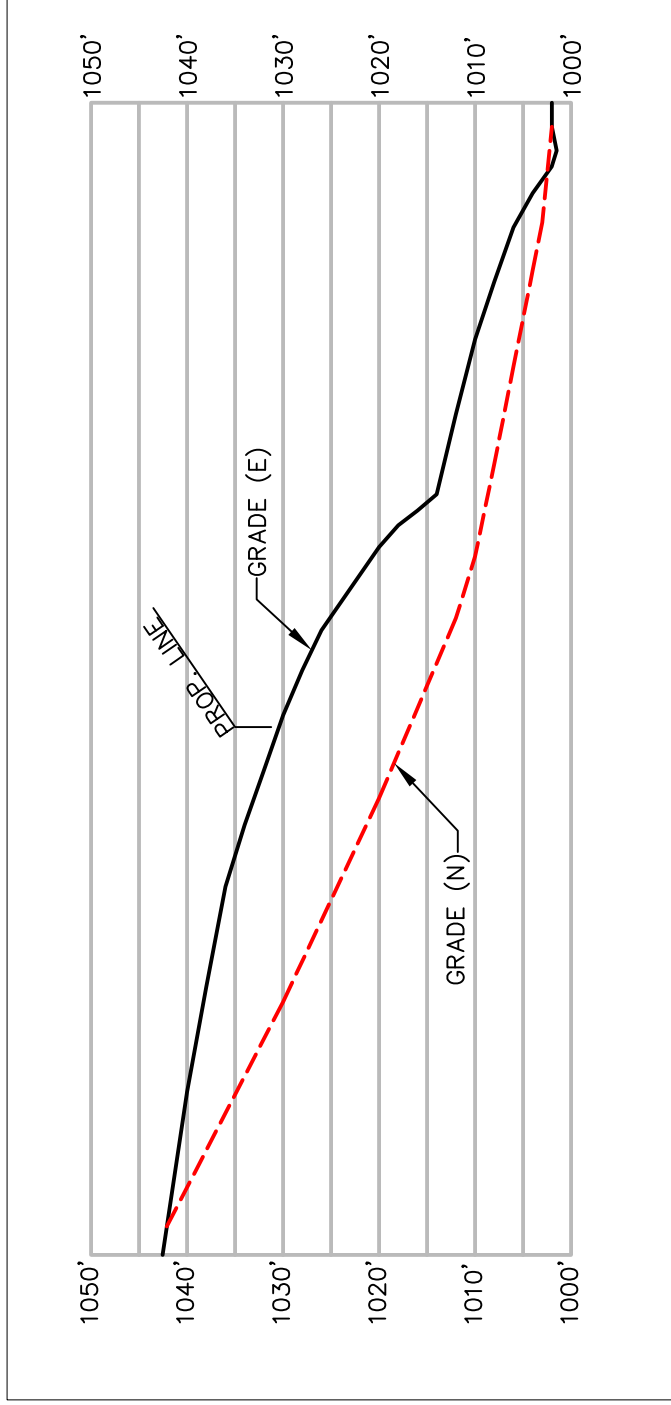
Figure 3

The proposed driveway entrance will result in new cuts inclined at 2:1 (H:V), in an area where the old road cuts are as steep as 1:1. As the proposed driveway approaches the property line and the top of the road cut, the slope of the land lessens to 5:1, allowing the proposed 2:1 driveway cut to daylight at a reasonable distance. The cut will be in the same material as the existing road cut along La Honda Road. Therefore, the proposed

driveway cut will be substantially more stable than the existing nearby road cuts. Since the existing 1:1 road cuts have been stable for over 100 years, the proposed 2:1 driveway cut should be very stable.

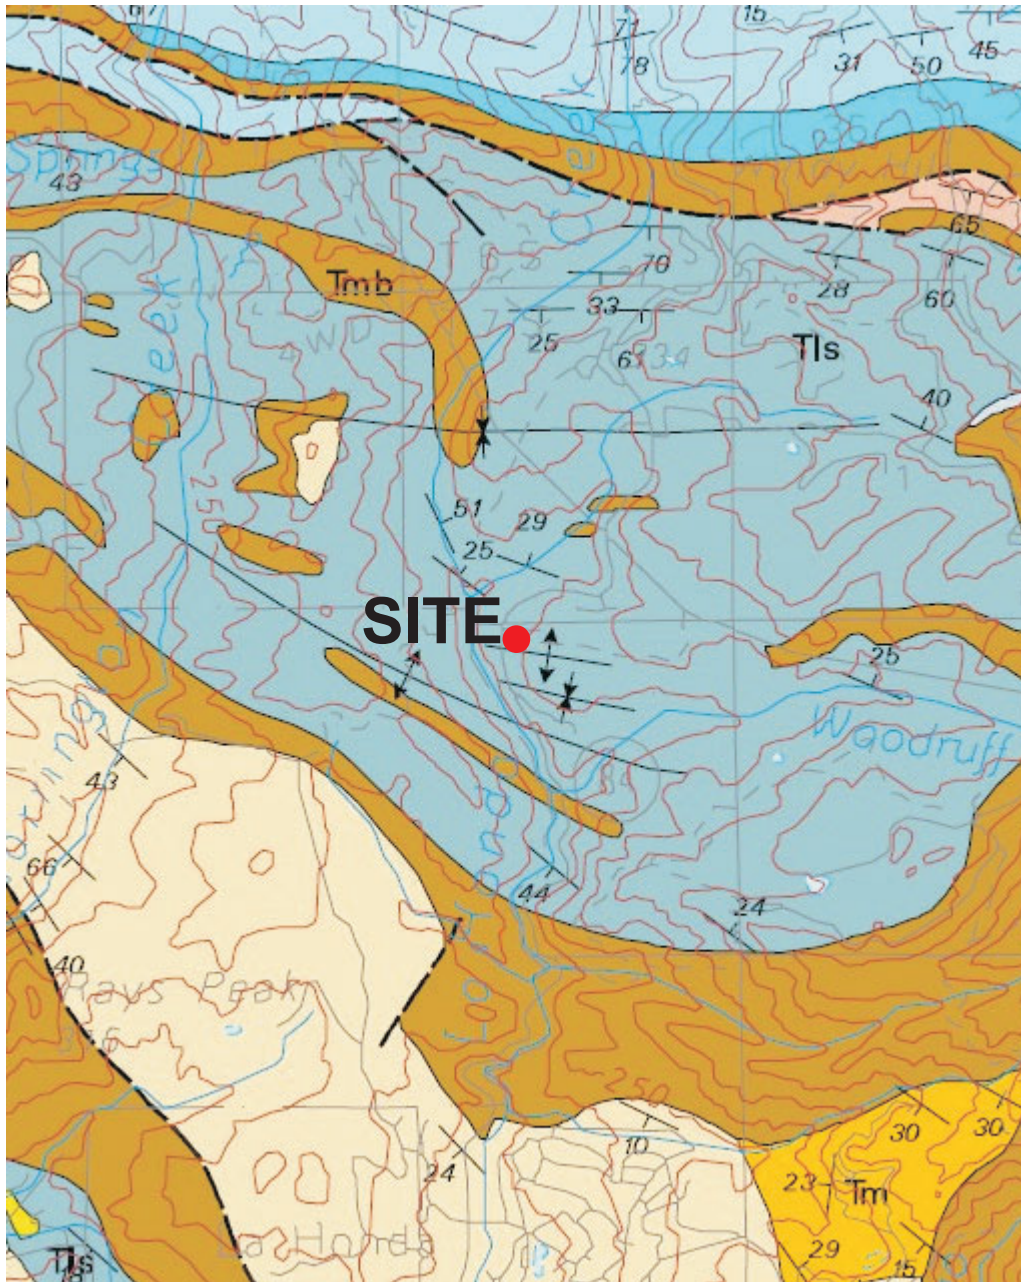
Figure	4
Date:	8/24/20
Job No.:	19-209

The site is underlain by the lower Miocene, Oligocene, and middle and upper Eocene age Lambert Shale and San Lorenzo formations, as shown in Figure 4. The units are both described as brown and dark gray to gray, brown, and red mudstone, siltstone, and shale. Includes some beds of fine to coarse grained sandstone. Weathered fine-grained bedrock is exposed in parts of the road cut. There is very little soil cover.

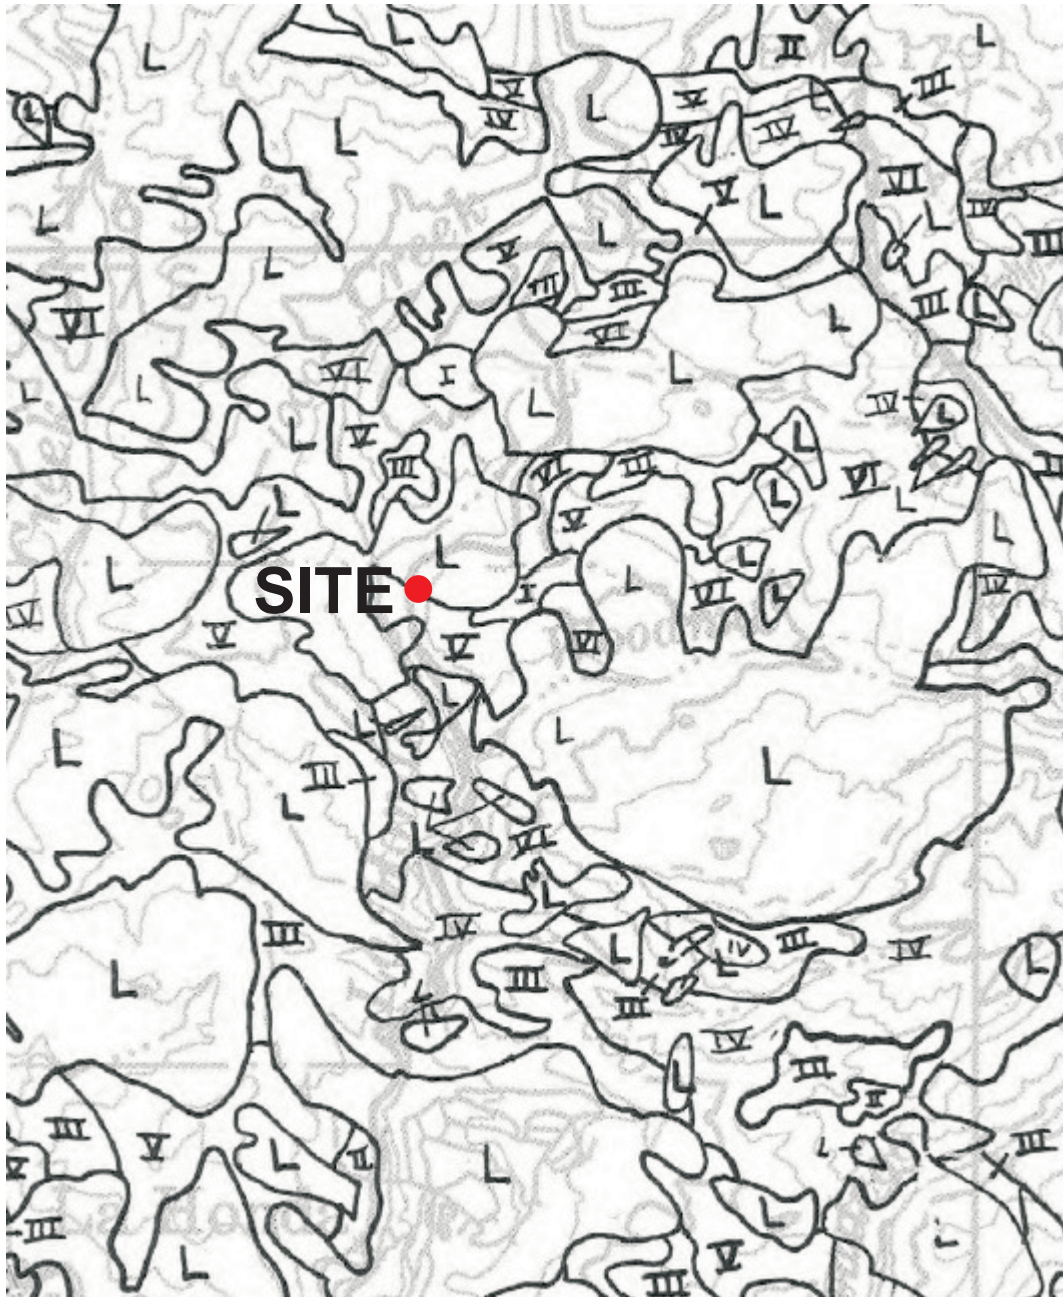
Figure	5
Date:	8/24/20
Job No.:	19-209

As Figure 5 shows, the site vicinity is mapped as having a high potential for slope instability. Units "V" and "L" are described as having high to highest landslide potentials, although it is acknowledged that some areas in these mapped zones may be stable. There are active landslides on the creek-side of La Honda Road, several hundred feet up the road toward Skylonda. The road has been under repair many times over the years. However, in the near vicinity of the proposed driveway entrance, the road has been stable for at least 50 years. The subject property in this area is dominated by a broad ridge. The slope stability issues occur in nearby broad swales where surface and subsurface water concentrates. The road cut shows no signs of instability. The site vicinity does not exhibit hummocky topography or any other geomorphic evidence of past landslide activity.
