Project Name and Location Highlands 2188 Cobble Hill, San Mateo, CA			
GENERAL INFORMATION			
Date and Time of Inspection:	Date Report Written:		
Thu, 08/06/2020 09:32 AM	8/6/2020 2:40:01 PM		
Inspection Type:

Weekly

Project Name and Location Highlands 2188 Cobble Hill, San Mateo, CA

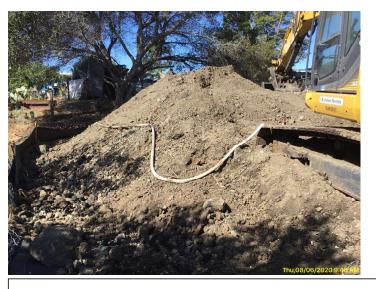
Talked about covering stockpile with plastic.
