rommen						Page _	1	of	7
Project Name and Loc Highlands 2188 Cobble Hill, San										
			GENERA	L INFORM	IATION	<u> </u>				
Date and Time of	Inspection:			Date	Report \	Written:				
Wed, 09/30/2020 0	9:37 AM			9/30/	2020 1:5	9:51 PM				
Inspection Type:				'						
Weekly										
			SITE II	NFORMA [*]	ΓΙΟΝ					
Construction Site	Name:									
2188 Cobble Hill, S	an Mateo, CA	١								
Construction stag	e and compl	eted activities	 S:	Appro	ximate	area of site tha	it is exposed	:		
Vertical				80.00						
General Photo: [>	Yes No	ı		Actio	Photo:	Yes 1	No			
			W	'EATHER						
Estimate storm beginning:			Estim	Estimate storm duration:						
Estimate time sind	ce last storm	:		Rain	gauge r	eading and loca	ation:

BMP INSPECTION REPORT

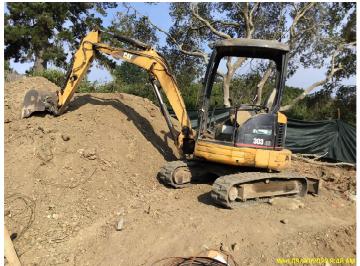
No. 1989 Control of the Control of t
Comments:	Lot 11
Category	
Location

7.1		s are established and effective sion and sediment discharges	No	Yes	Reinstalling Silt fence needs repairing/replacing	at Lot 11	4	+ X
7.2		its are stabilized to control ment discharges from the site	Yes				-	+ X
