From: [Michelle Kuehn](#)
To: [Planning Commission](#)
Subject: Angelo Consentino - County File Number: PLN2024-00327
Date: Tuesday, March 11, 2025 1:42:37 PM
Attachments: [Morria Shaffer Engineering.pdf](#)

June 25, 2024
MSE # 24176

RE: Rear property line retaining wall
2897 Adeline Drive, Burlingame, CA

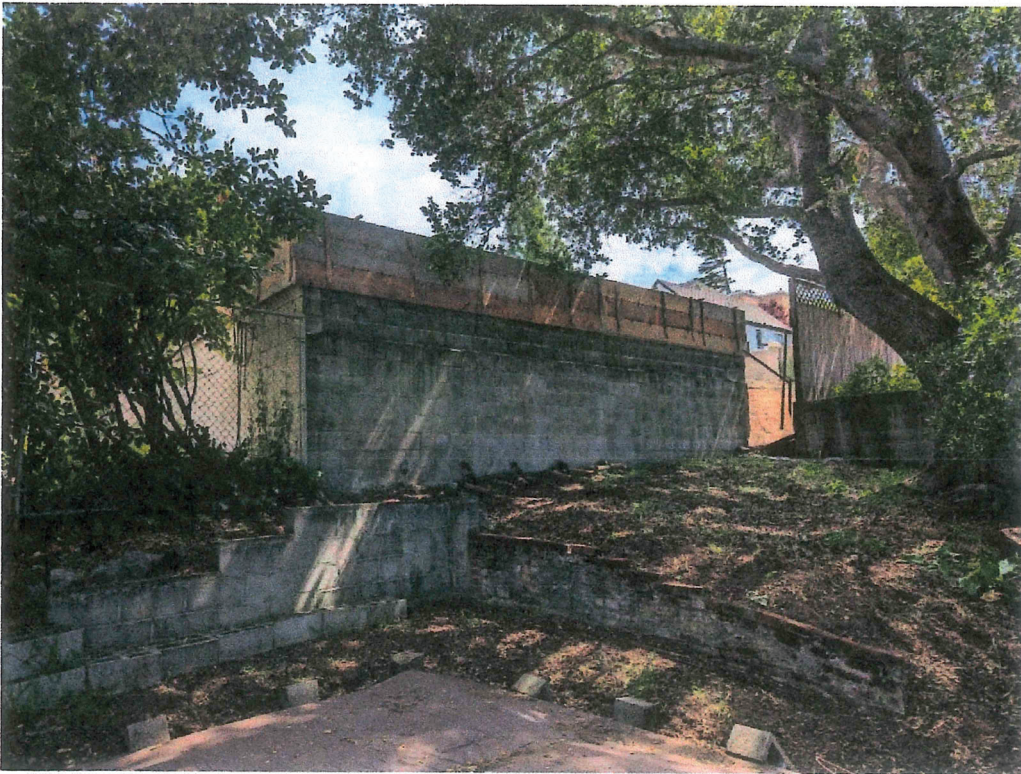
We noted an existing concrete block wall built in two phases. An original lower portion extending approximately 5'-4" above the low grade at the subject property and a 2'-0" extension above the original wall. See Figure 2 and Photo 1. It is the owner's recollection that original retaining wall is at least 40 years old. We were unable to verify the age of either segment of the wall, but the estimated age is reasonable based on our visual review. A portion of the soil at the toe of the wall was excavated to verify the foundation dimensions which extends horizontally 18" from the front face of the wall. (See Photo 2 on next page). There was no documentation available for the wall construction, thus the drainage, reinforcing and grout for the block wall, and the depth and reinforcing of the wall foundations are unknown.

It is our opinion that the existing wall condition is already inadequate for the retained condition present. In Photo 1 there is evidence that water may be seeping through the block grout at the middle joint which over time will break down the wall. The addition to its height will exacerbate the visible movement at the joint between the original block wall and extension. Many jurisdictions limit retained wall heights to 6'-0" to minimize the imposition of downhill site condition. We did not confirm if the local zoning codes include such restrictions, but note that where they are implemented, it is to restrict property owners from creating conditions such as the one this construction will create. It is our opinion that construction of the wall extension at the 2896 Hillside Drive property should be halted until engineering work has been done to justify its construction and zoning codes reviewed concerning the maximum height.

Photo 1 – Retaining wall at property line

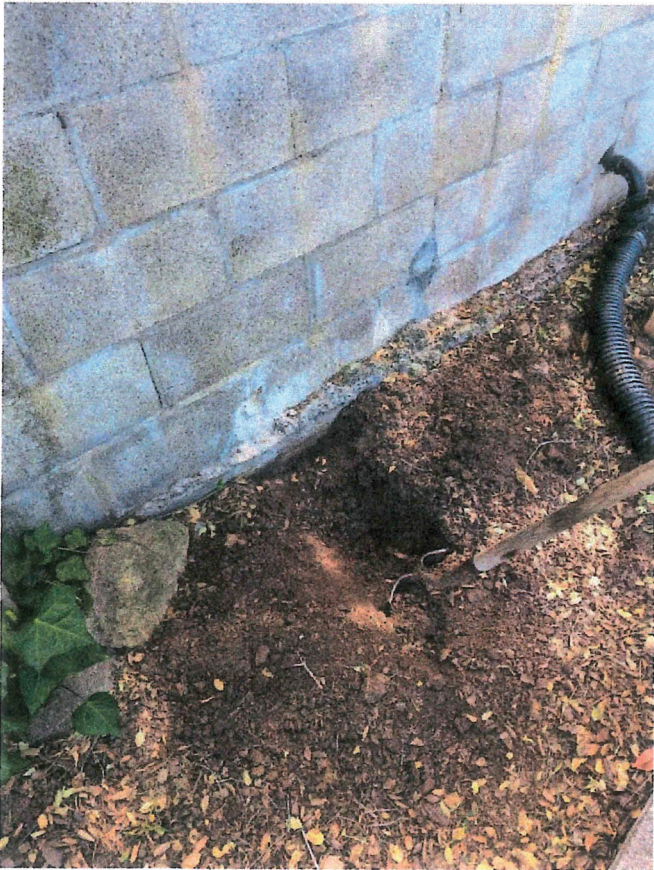
Photo 2 – Embedded shovel showing extent of concrete footing below

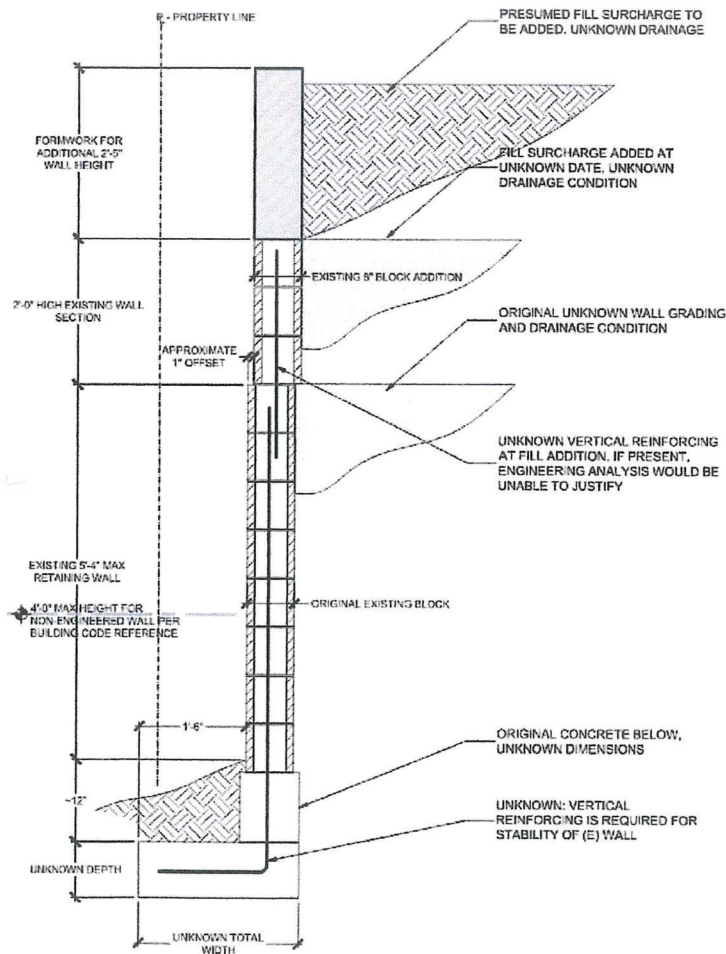
1 **RETAINING WALL SECTION**

It is unlikely that either segment of the existing wall was engineered. The California Building Code requires all walls over 4' high measured from the bottom of the foundation to be engineered, thus the existing wall is non-conforming. We noted the presence of formwork that has been added to the top of this non-conforming wall. We understand this has been added in the course of construction initiated by the owners at the 2896 Hillside Drive property and this will potentially create a retained soil height over 9'-6".

Figure 2 – Section of retaining wall
