**COUNTY OF SAN MATEO  
PLANNING AND BUILDING DEPARTMENT**

**SUBJECT:** After-the-Fact Coastal Development Permit (CDP), pursuant to Section 6328.4 and Grading Permit, pursuant to Section 8600 of the Zoning Regulations to legalize approximately 850 cubic yards (c.y.) of grading associated with repair to a section of the Pine Tree Gulch Creek bank and a new culvert. The project involved the removal of several trees and planting approximately 200 trees to restore the creek bank. The project is appealable to the California Coastal Commission. In conjunction with the requested permits, it is recommended that the Zoning Hearing Officer determine that the project is categorically exempt from the California Environmental Quality Act under Class 33, small habitat restoration projects, typically under five acres, designed to protect or improve habitat for fish, plants, and wildlife.

County File Number: PLN2023-00371 (Twisted Fields/Theobald)

## **Rancho San Gregorio Creek Bank Repair and Grading Work**

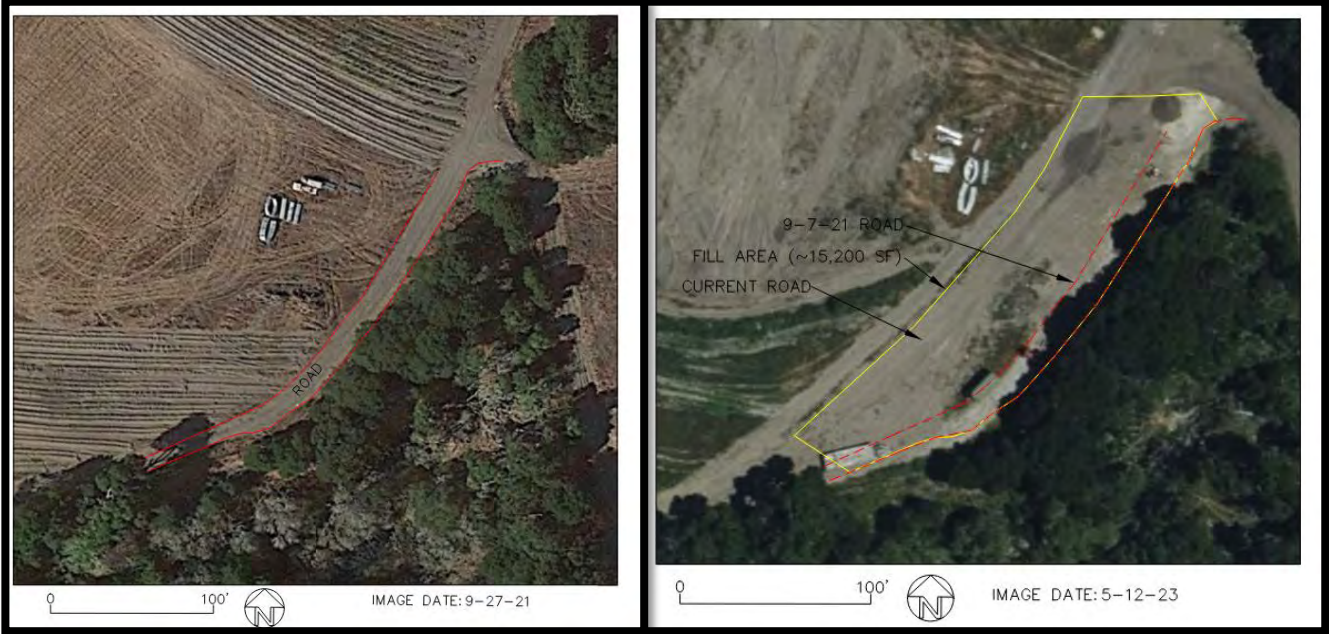
Figure 3 Area of road widening

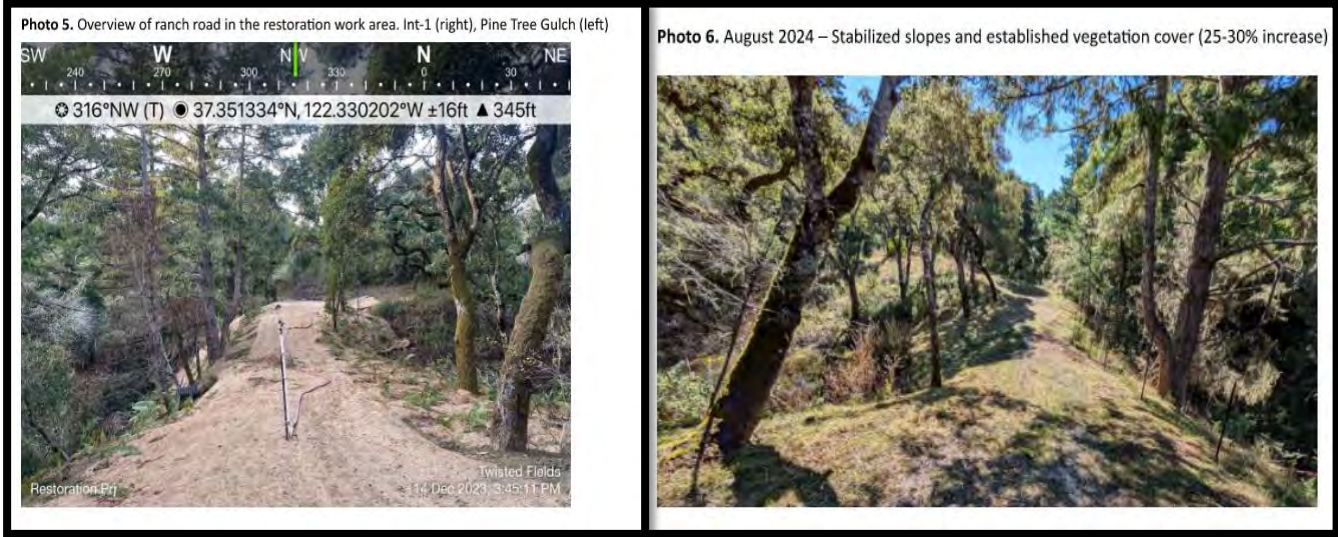
Figure 4 Stabilized and restored area

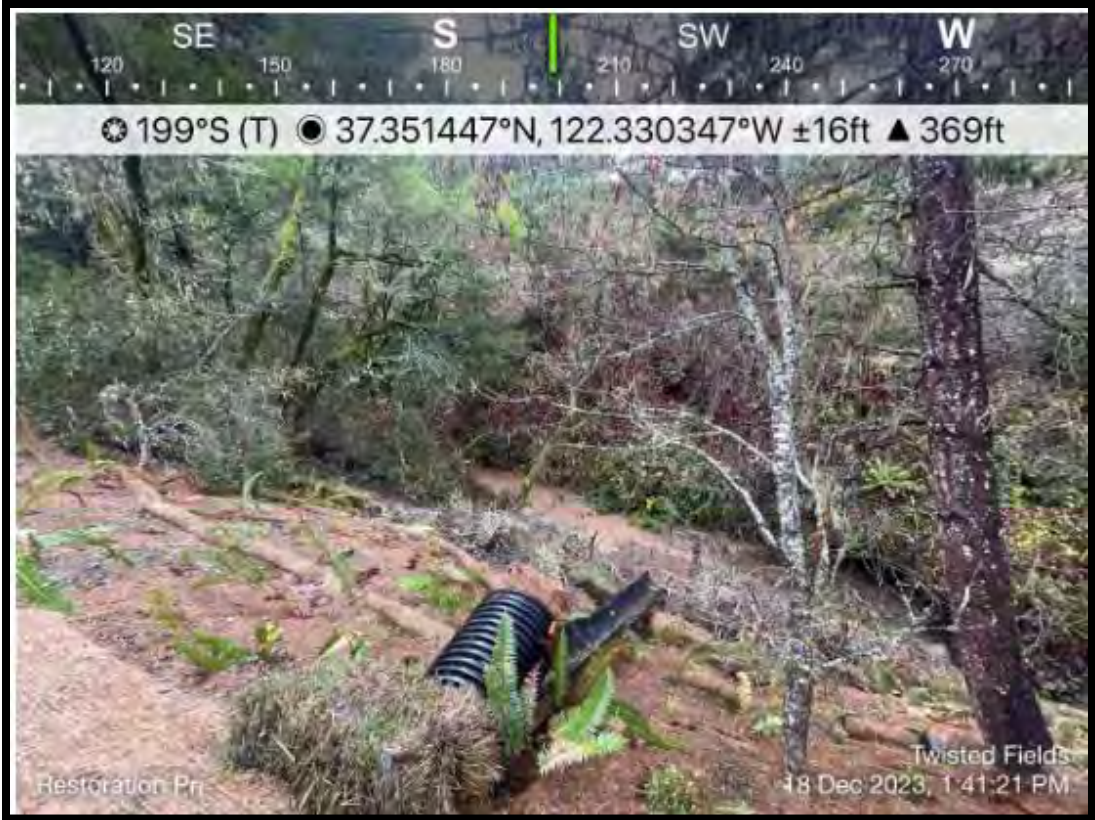
Figure 5 Culvert outfall to Pine Tree Gulch in Restoration Area, December 18, 2023

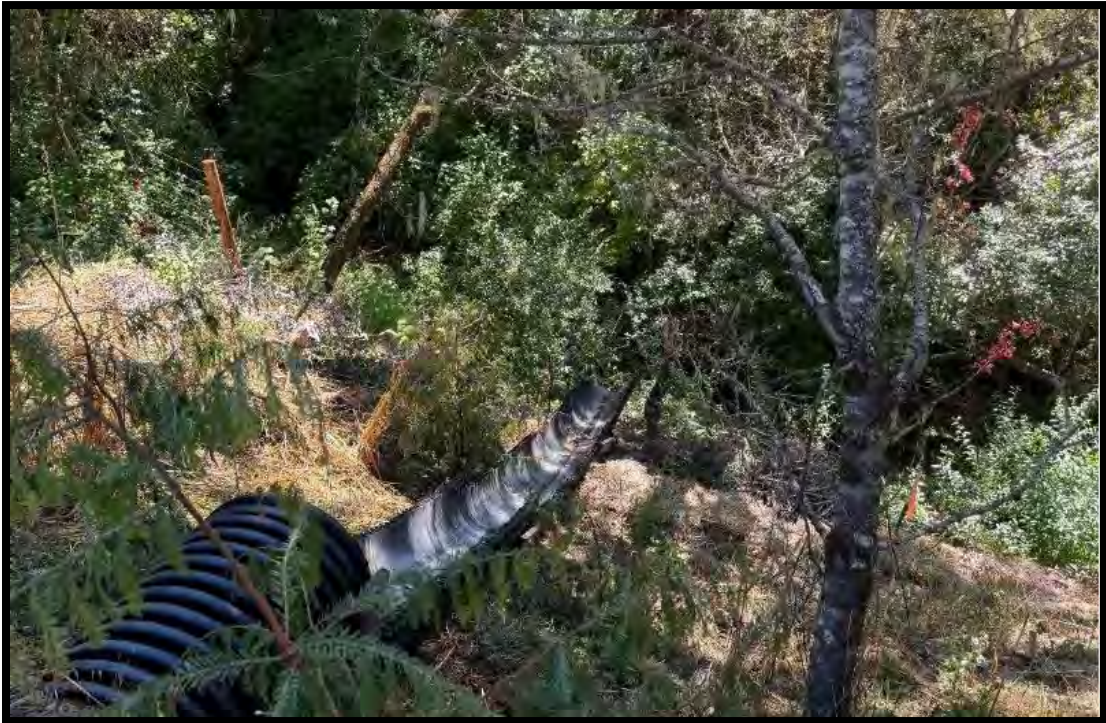
Figure 6 August 2024 picture with BMP Measures installed and increased vegetation cover by 20-30%

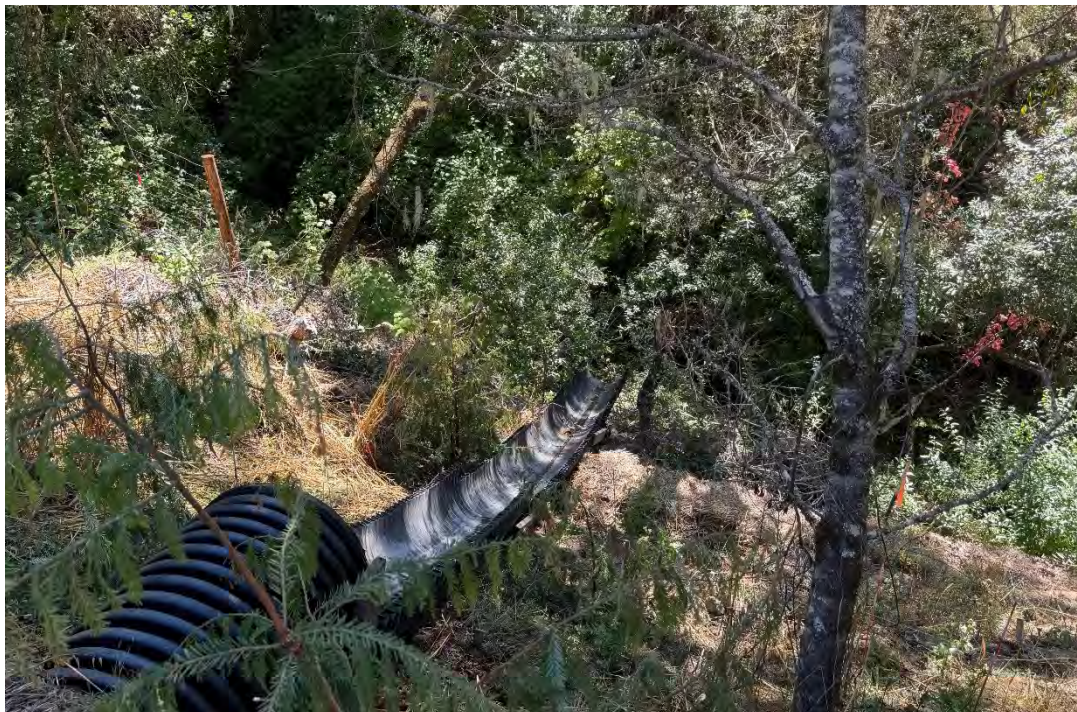
**Photo 2.** August 2024 – BMPs stable and vegetation cover increase of ~20-30%

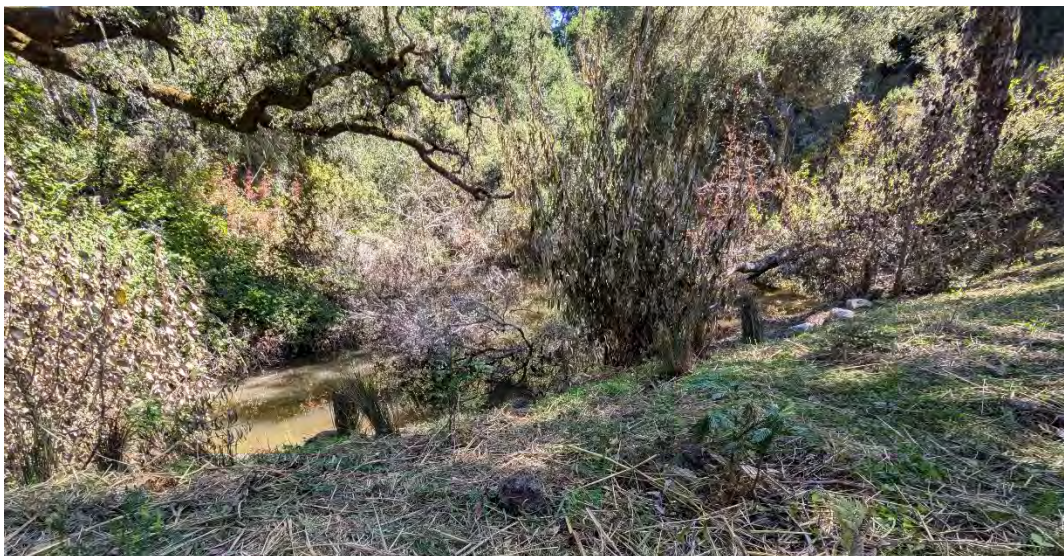
**Photo 4.** August 2024 – stabilized slope and established vegetation (~20-30% increase)

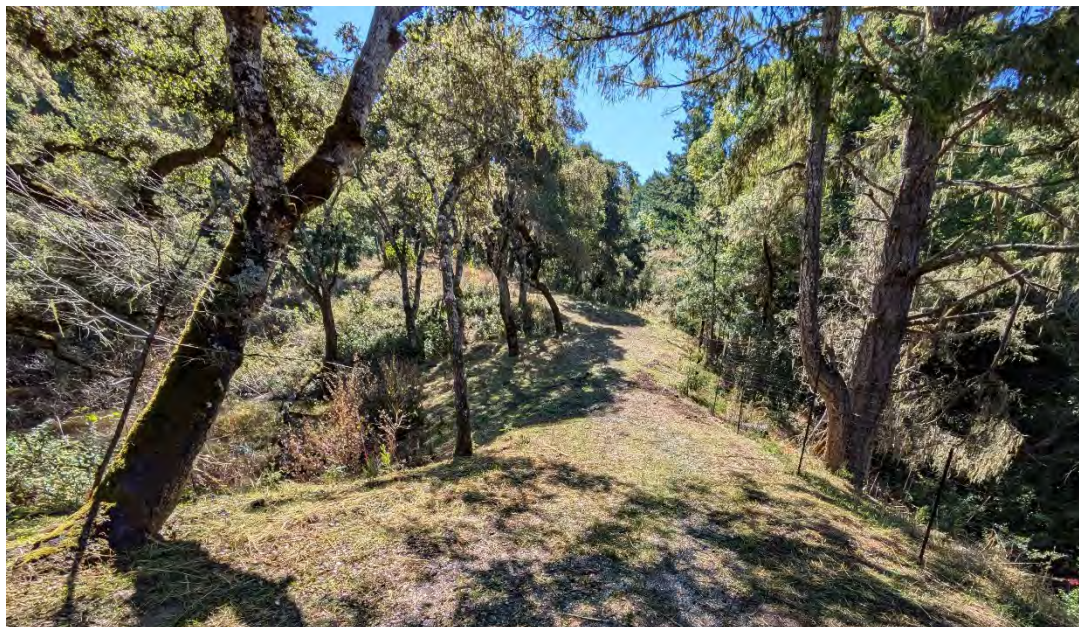
**Photo 6.** August 2024 – Stabilized slopes and established vegetation cover (25-30% increase)

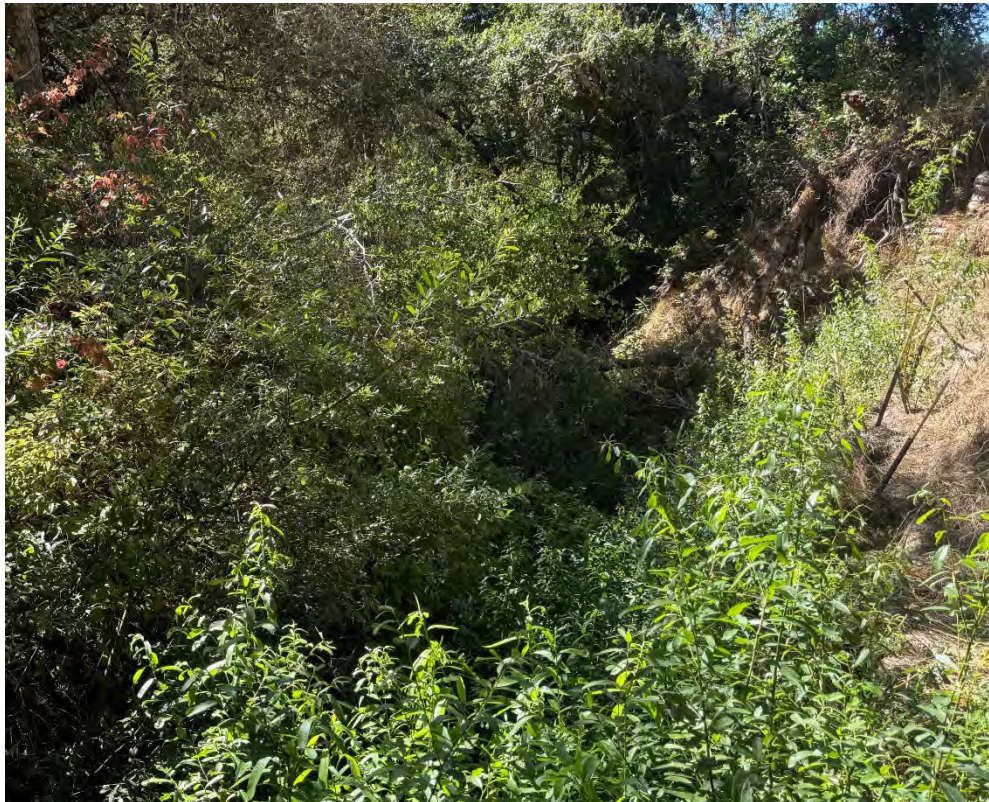
**Photo 8.** August 2024 – Successful willow staking (~65% increase in vegetation cover)

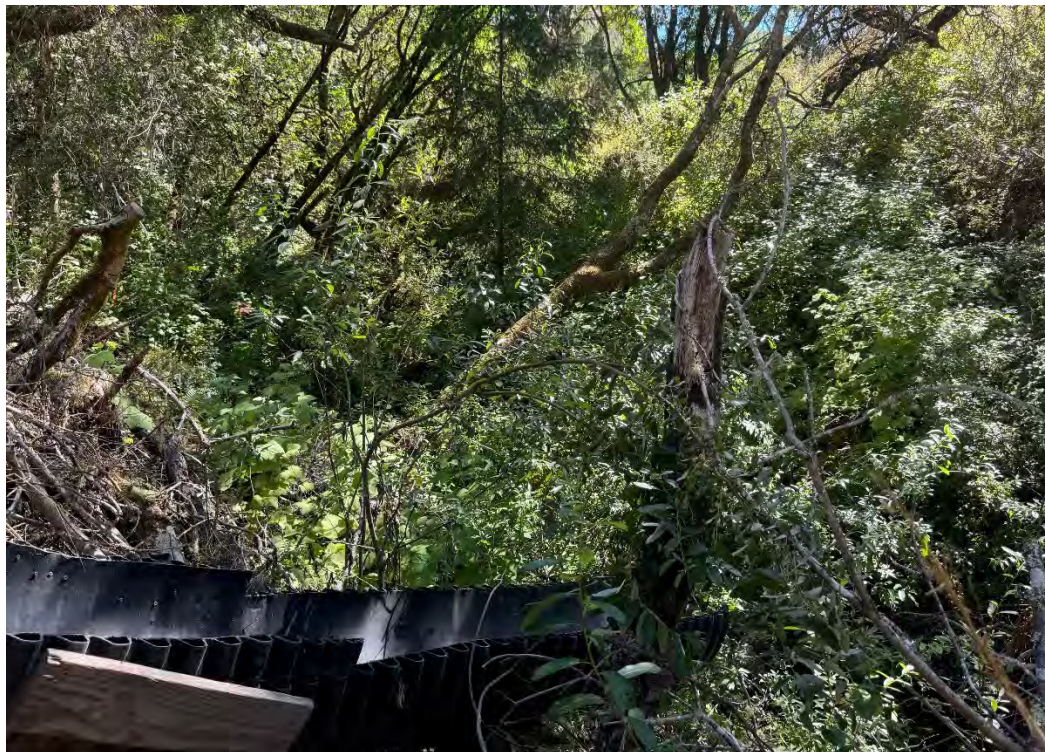
**Photo 10.** Augst 2024 – Willow staking has been effective and increased veg cover ~65%

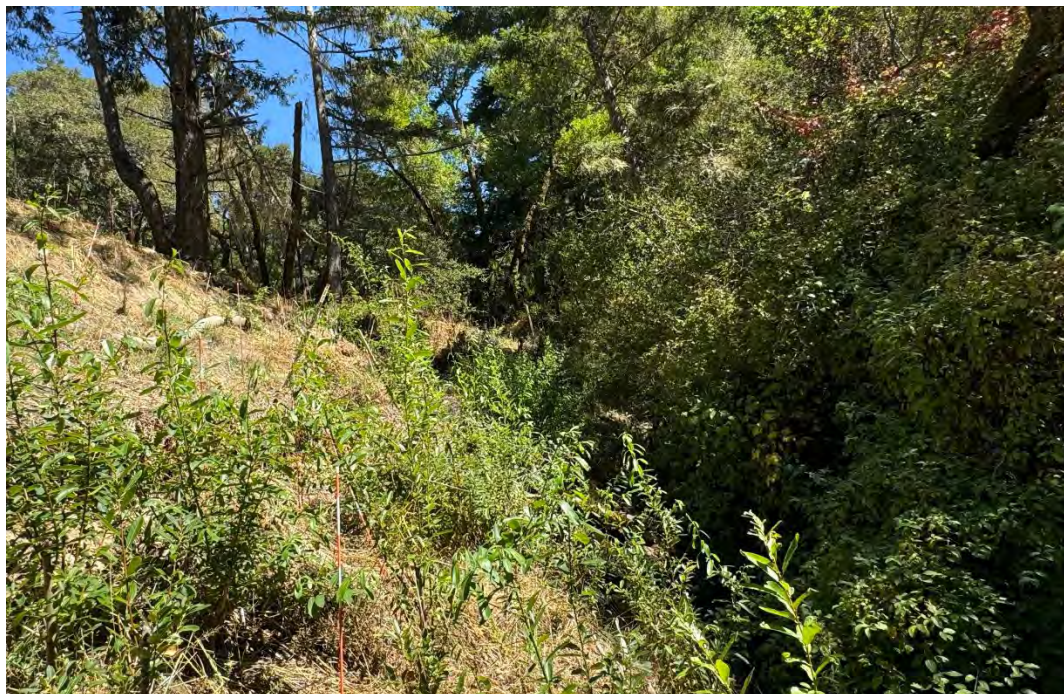
**Photo 12.** August 2024 – Slope stabilization, re-vegetation, and willow staking have been effective.

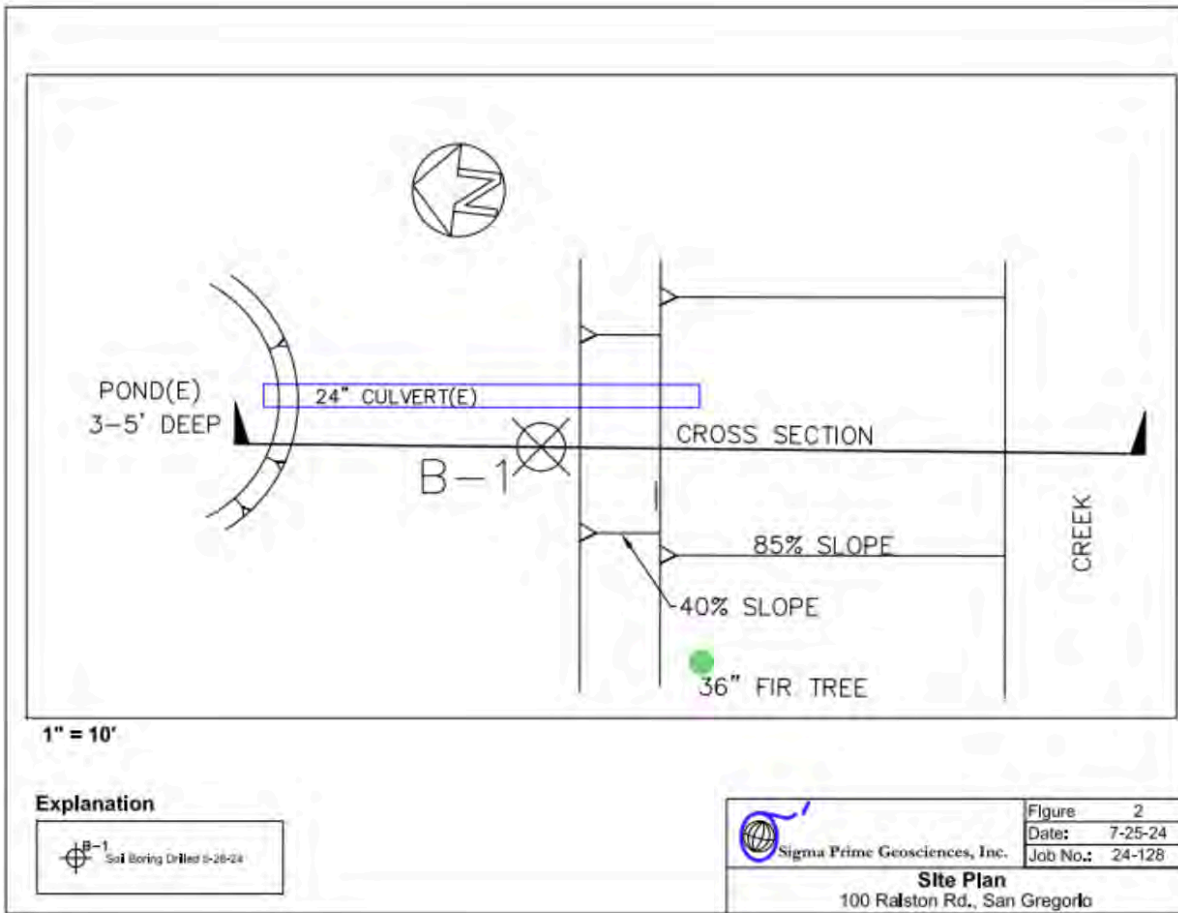
**Figure 3.** Map showing pond, replacement culvert pipe, and slope grade into the creek. Figure pulled from Charles Kissick’s “Slope Stability Study”, completed in 2024.

In addition to re-vegetation efforts for bank stabilization, we also upgraded an existing 18 inch culvert pipe. The pipe was upgraded in 2023 to an in-kind 24-inch wide, 38 ft long HDPE pipe (Figure 3).

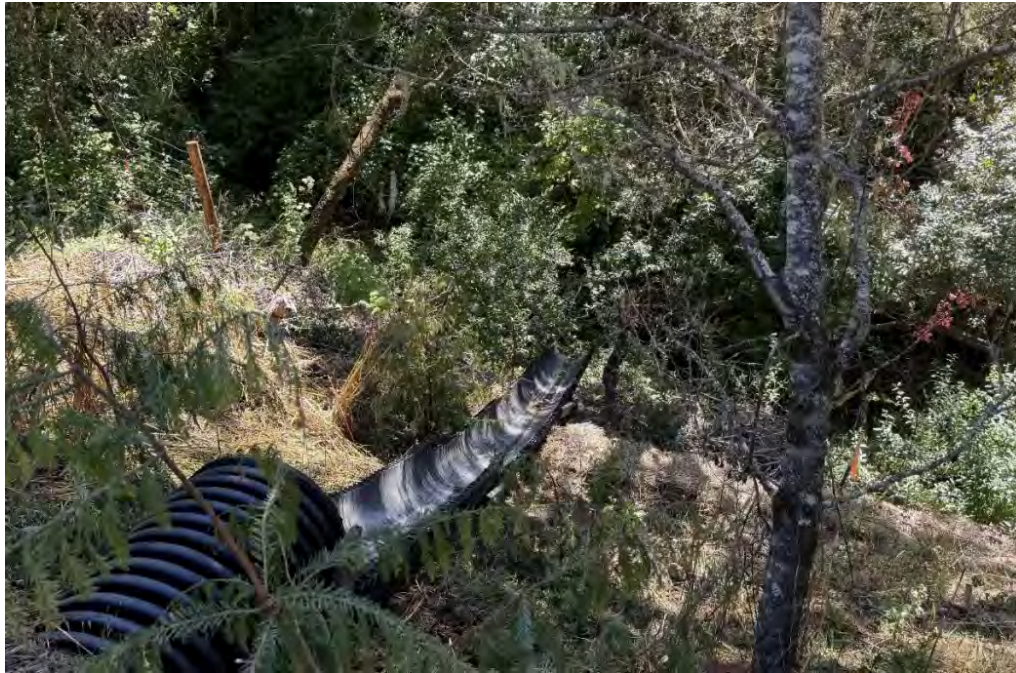
Photo 1. August 2024 - BMPs stable and vegetation cover increase ~20-30%.

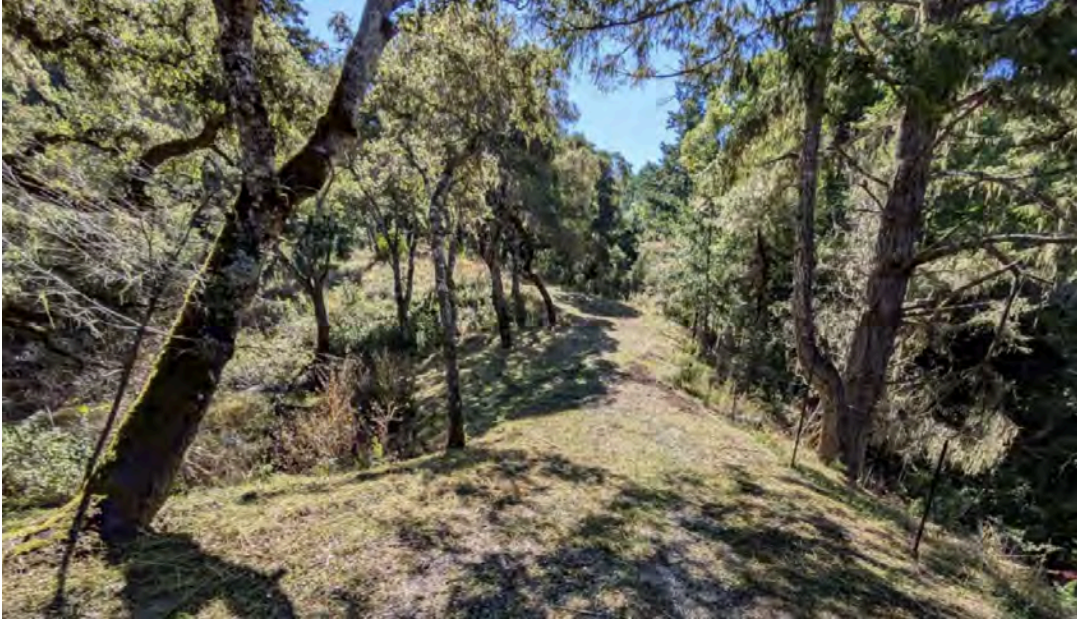
Photo 3. August 2024 - Stabilized slopes and established vegetation cover (25-30% increase).

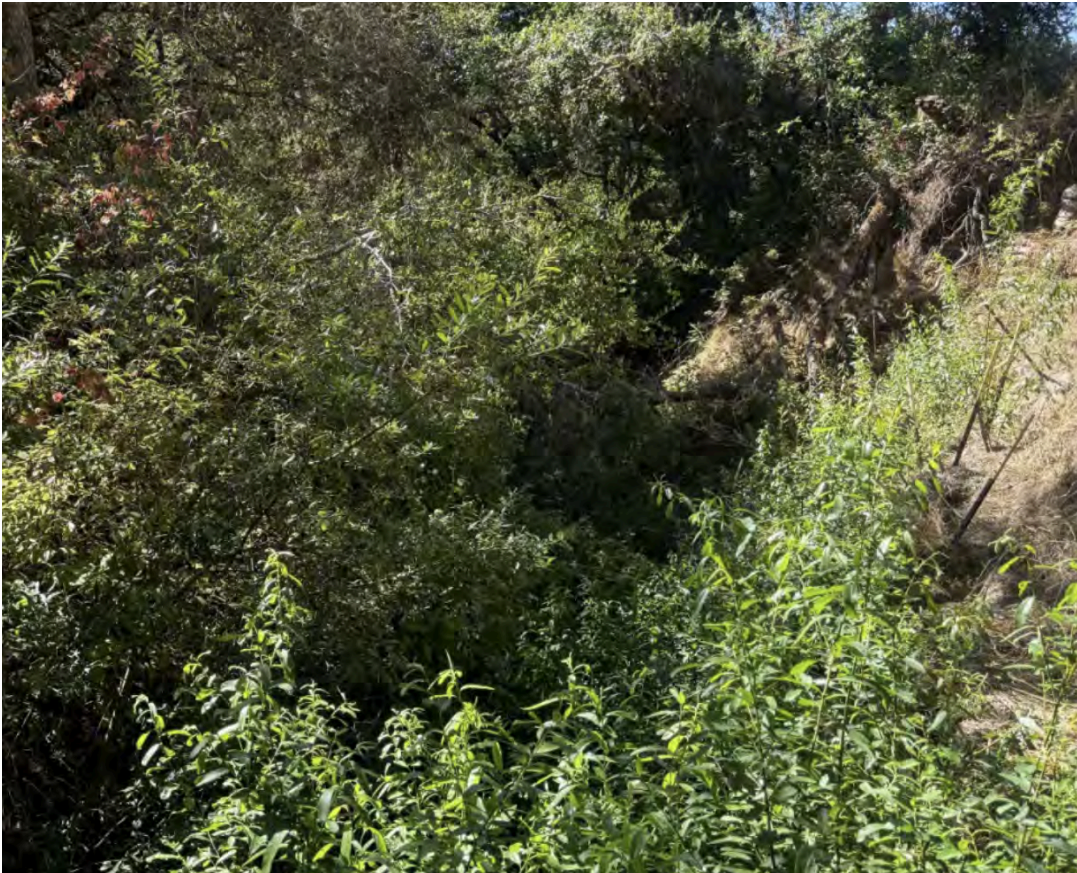
Photo 4. August 2024 - Successful willow staking (~65% increase in vegetation cover).

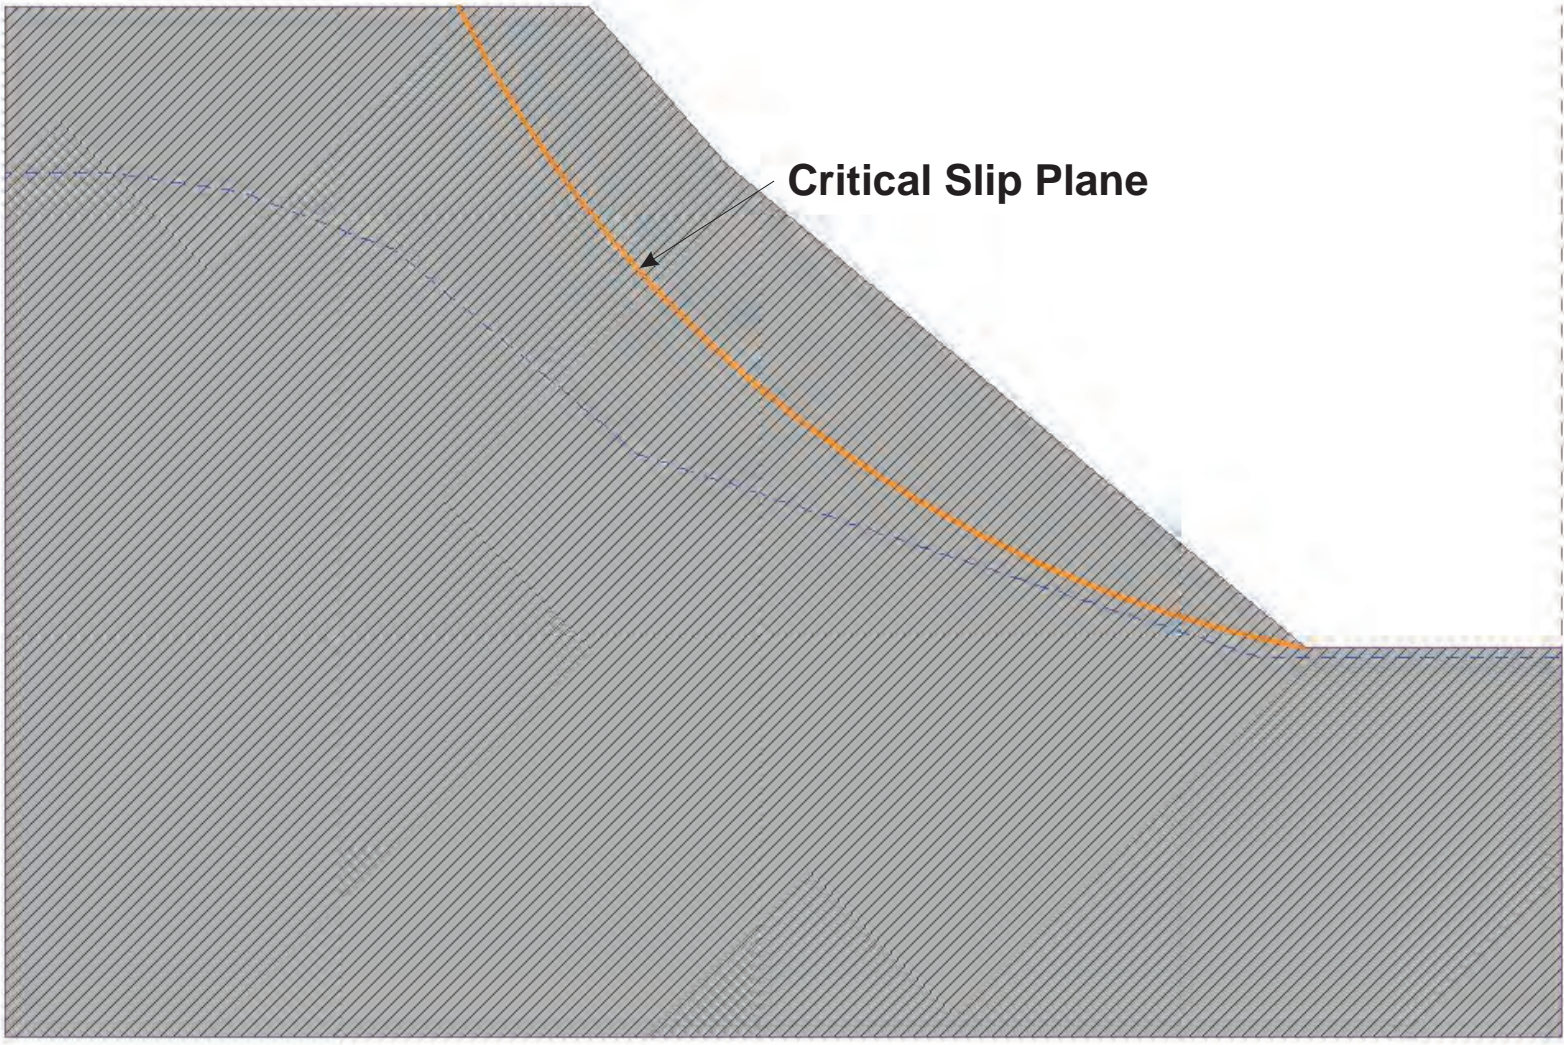
Static Factor of Safety = 1.39  
 Assumed ground water as shown by blue line

Clay: (Ultimate Strength Values)  
 Unit Weight = 117 pcf  
 Phi= 34.6 degrees  
 Cohesion = 157 psf

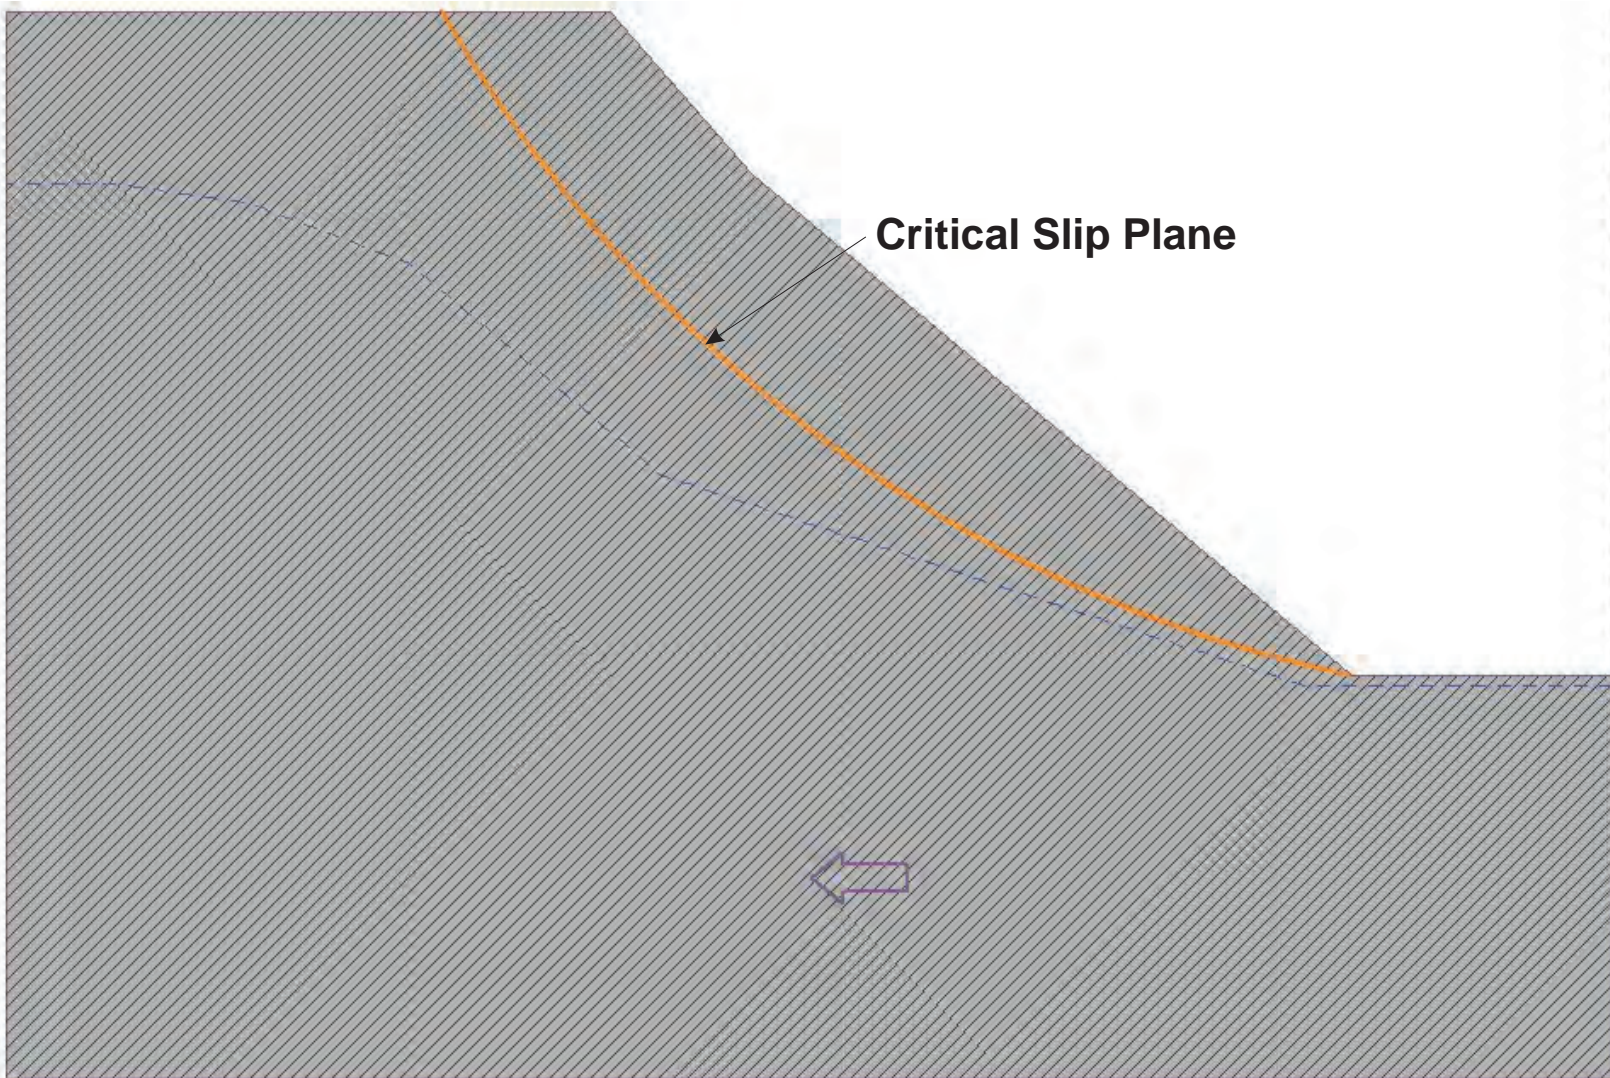
Pseudo-Static Factor of Safety = 1.05 (allowing 15 cm deformation, per SP-117A)  
 Assumed ground water as shown by blue line

Clay: (Ultimate Strength Values)  
 Unit Weight = 117 pcf  
 Phi= 34.6 degrees  
 Cohesion = 157 psf
