**Cordilleras Mental Health Center  
Replacement**

Preliminary Engineering Geology  
and Geotechnical Engineering  
Feasibility Report

Issue 2 | June 12, 2014

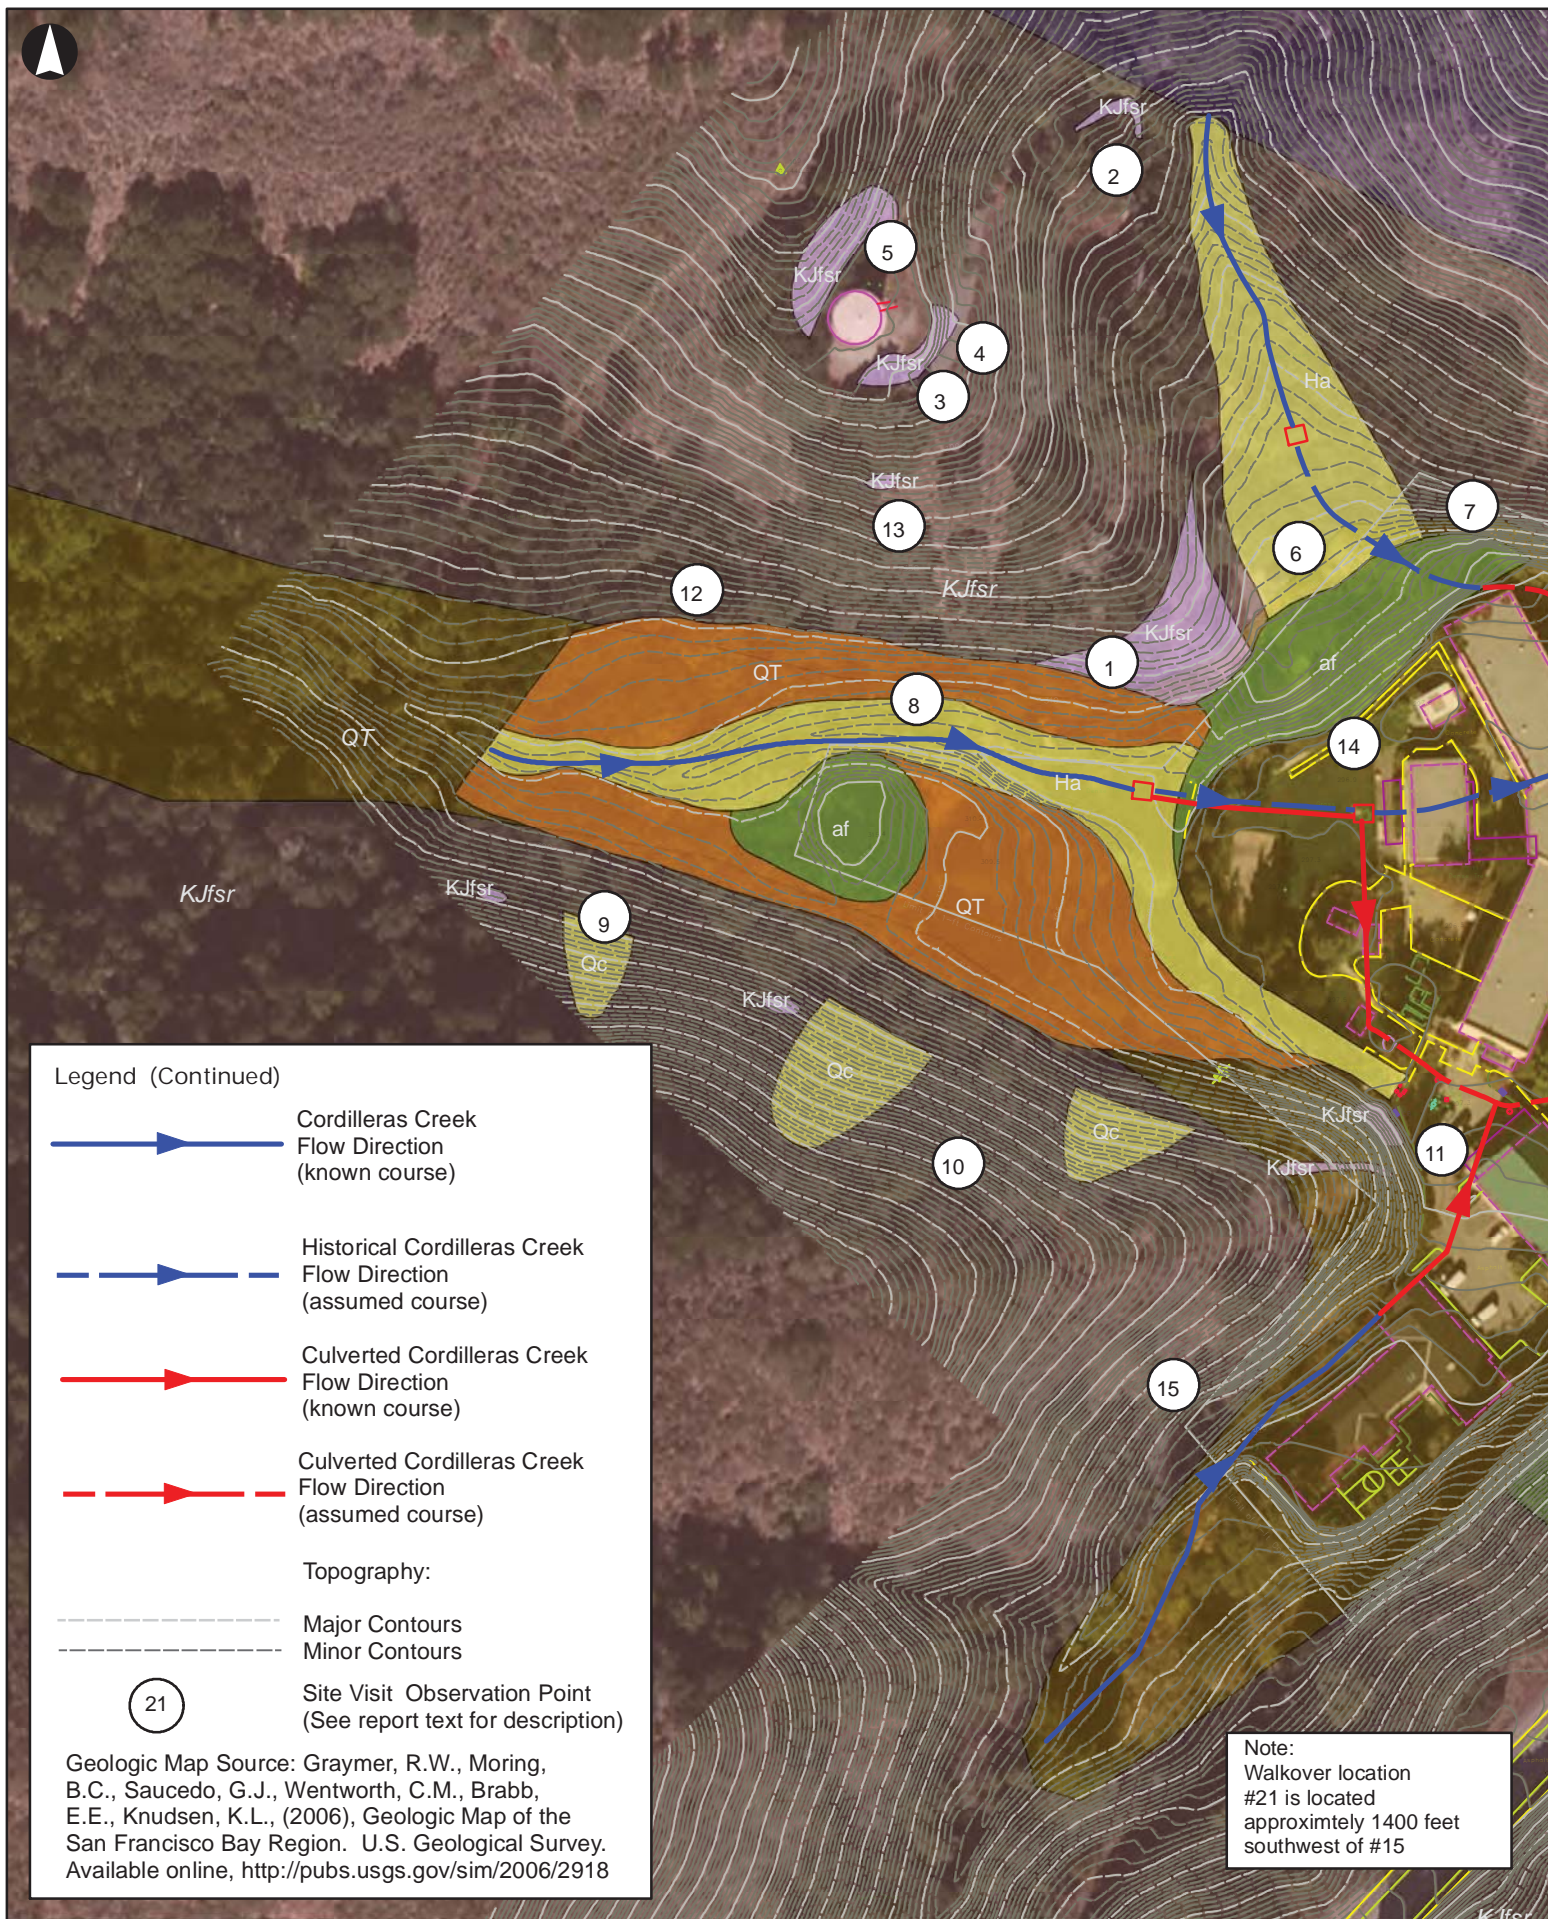
The outcrops investigated on the site are recorded on Figure 4 and in Table 2. The observed bedrock outcrops at the site typically occurred at topographic protrusions at the base of the valley slopes. The northern valley had more rock exposures, noted along the access road to the water tank and in the cut behind the watertank.

The current drainage system diverts both Cordilleras Creek and the unnamed creek around the existing structure through buried culverts (Figure 4). Should debris or backed-up high flow dam the culvert, flooding could occur around the building. The site reconnaissance survey identified that the culvert was partially blocked by leaves and other detritus and in a poor state of repair.

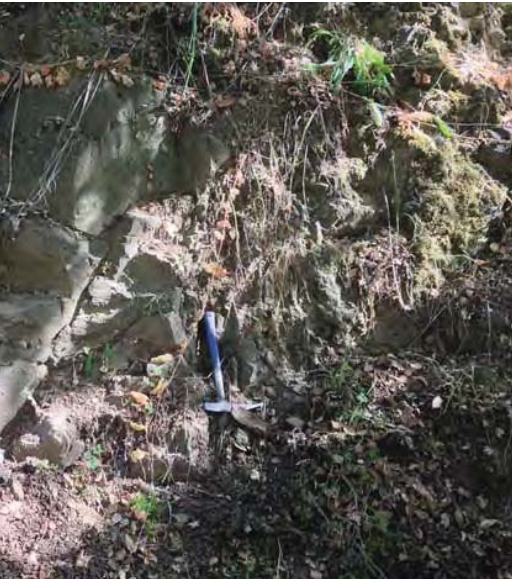
in road cut embankment

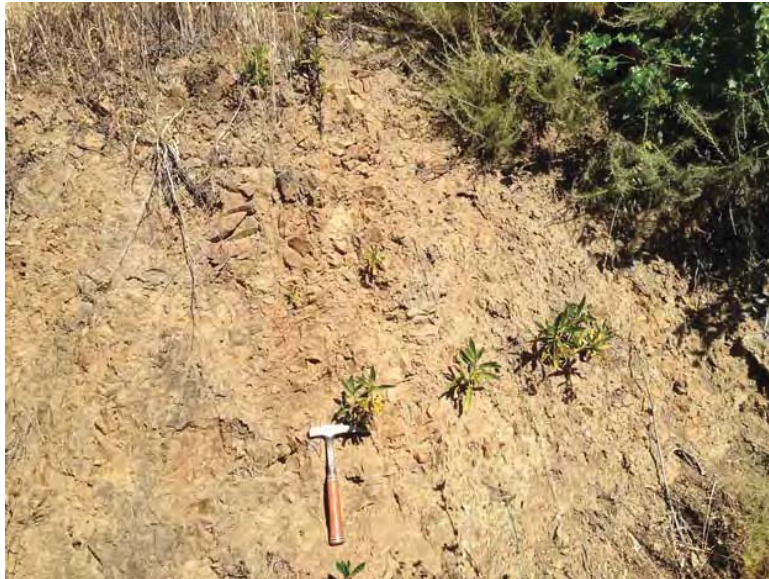
Photo 2: Cut slope beneath water tank

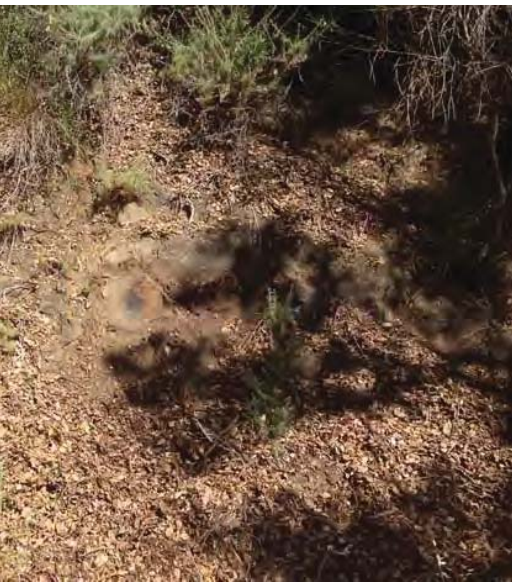
water tank

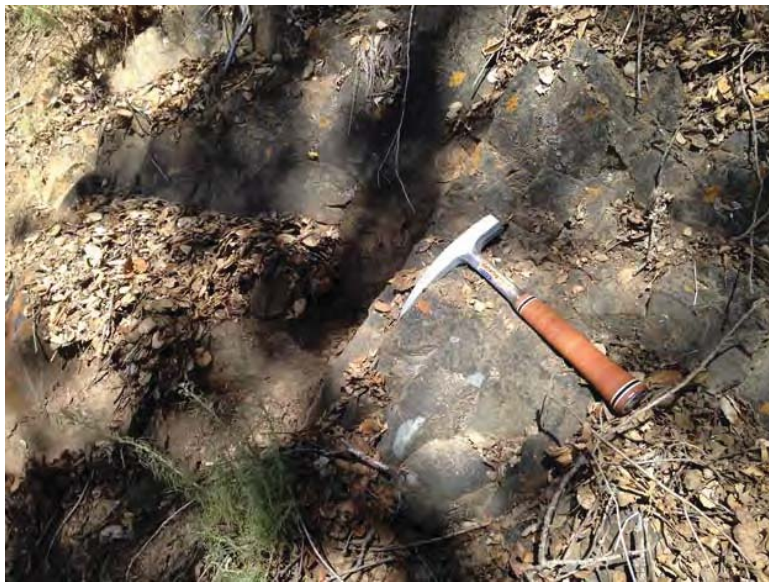
Photo 4: Sandstone outcrop behind water tank

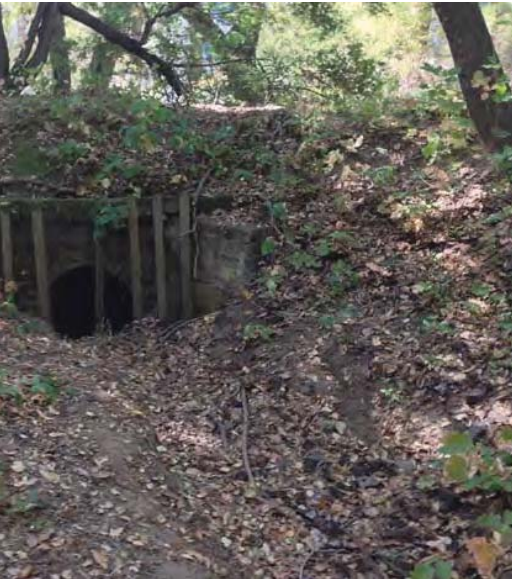
ary to Cordilleras Creek

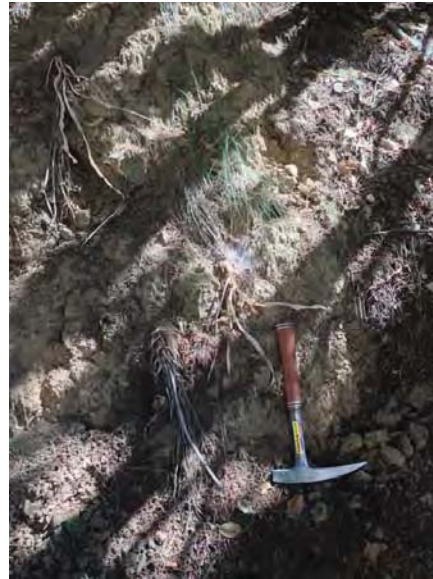
Photo 6: Cut slope north of building loading dock

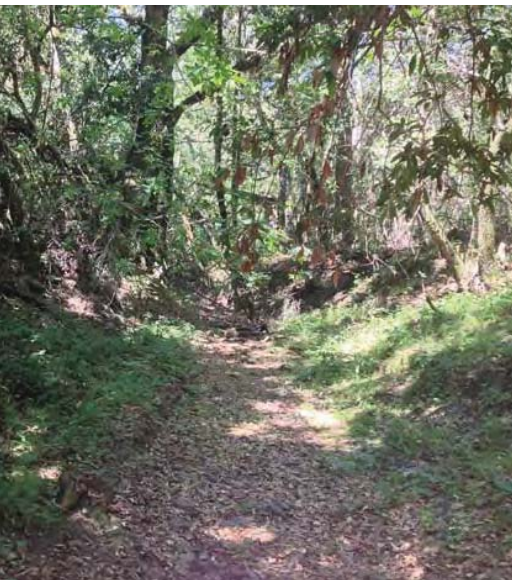
dry during site visit

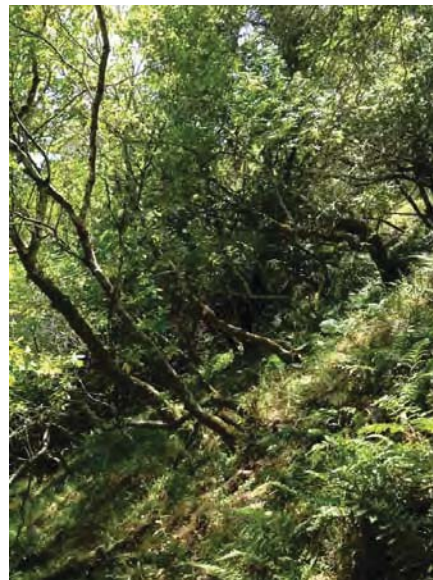
9 and 10	8 and 9	South slope of northern valley containing Cordilleras Creek – three distinct, northeast-facing, steep colluvial hollows intersect this slope. The slopes are inclined approximately 40 to 45° and are mantled with shallow, loose soil and sandstone clasts. No rock outcrops were noted in the main slope, but slope colluvium consisted nearly entirely of sandstone, consistent with regional mapping.
11	N/A	Sandstone outcrop, base of valley slope adjacent to fire station – sandstone outcrop is same sandstone material seen elsewhere on site, highly weathered and fractured, with blocky and closely spaced fractures.
12	N/A	North slope of northern valley – cobbles of igneous intrusive dioritic/granitic rock noted, source of material not located. Quartz, biotite, small crystals – potentially a building material/dumped, few cobbles noted.
13	N/A	Sandstone outcrop on north slope of northern valley – disintegrated, structureless, fractures spacing of 2 to 5 inches.

Photo 8: South slope of north valley

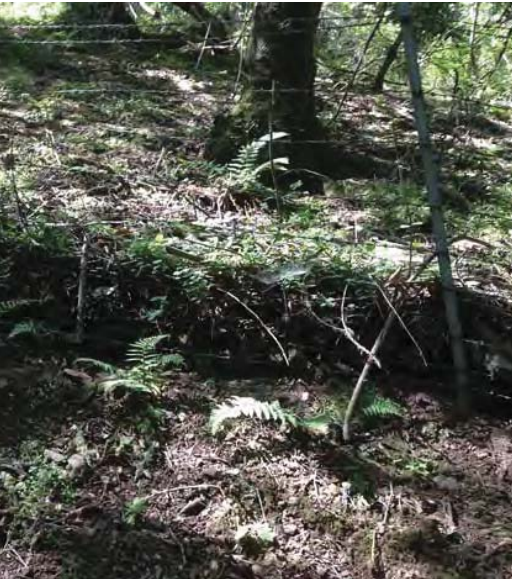
Debris accumulation against site boundary fence

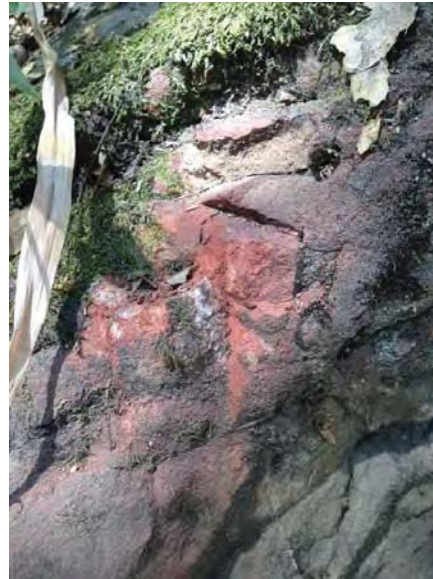
Photo 10: Outcrop of Whiskey formation on trail off Edmonds Road

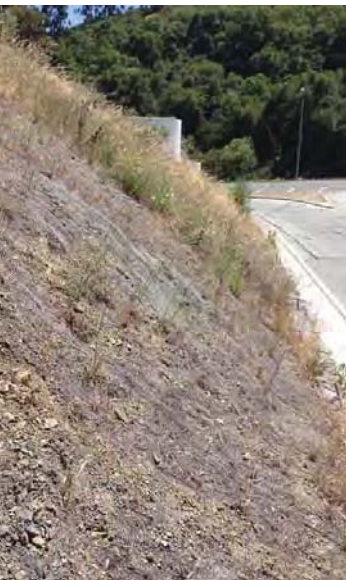
Figure 4 Key	Photograph Log Reference No (Attachment A)	Observation
18	11	Junction between Edmonds road and Edgewood Road – cut slope of sheared sandstone and shale, material completely weathered comprising disintegrated sandstone and shale, unit KJfs (Brabb et al., 1998). Slope angle 65°, supported with temporary soil netting and straw wattles with stakes.
19	12	Road cut on Edgewood Road, east of site 1:1 rock cut slope within mélange unit KJfsr (Brabb et al., 1998) that consists of loose material; highly weathered and sheared rocks suggests a risk for raveling and slide debris during periods of heavy rainfall. Sandstone boulders, 4 feet in diameter at the base of the slope.
20	13	Road cut on Edgewood Road, south-east of site – sandstone, appears to be similar in composition to material found at the site. Rock mass structure is very blocky, more homogeneous than material from the site, appears to be fewer areas of disintegrated material. Slope cut to approximately 70°, little to no raveling of slope materials.

Section of Edmonds Road and Edgewood Road composed of  
stone and shale  
Survey Photos

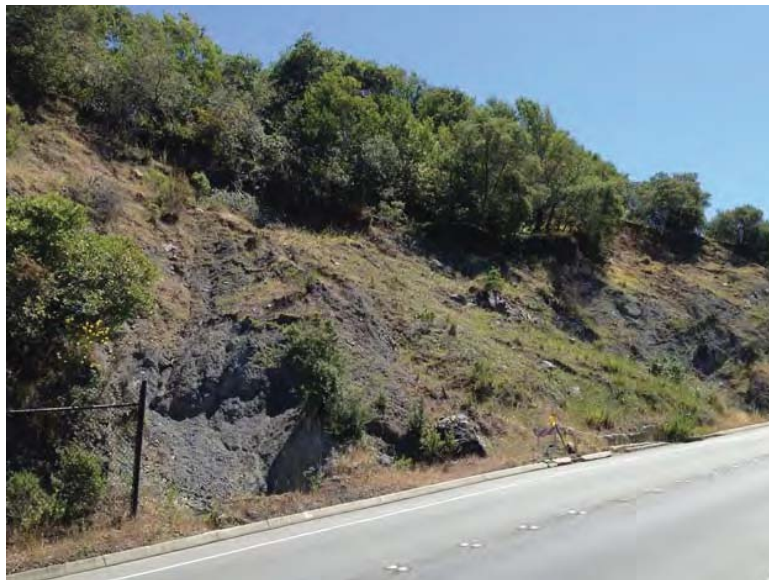
Photo 12: Road cut on Edgewood Road (east of site) composed of melange

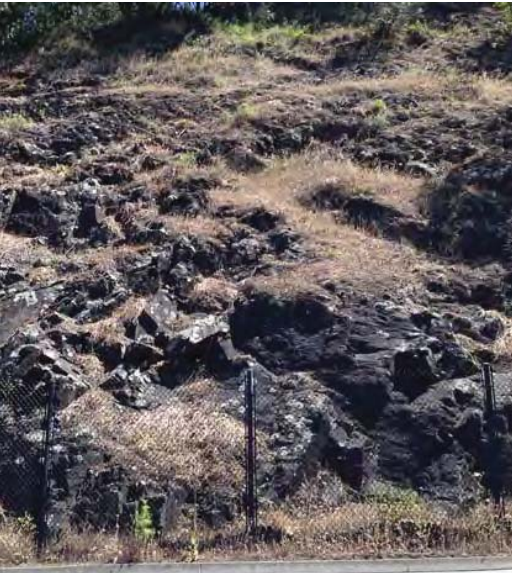
wood Road (southeast of site) composed of blocky sandstone

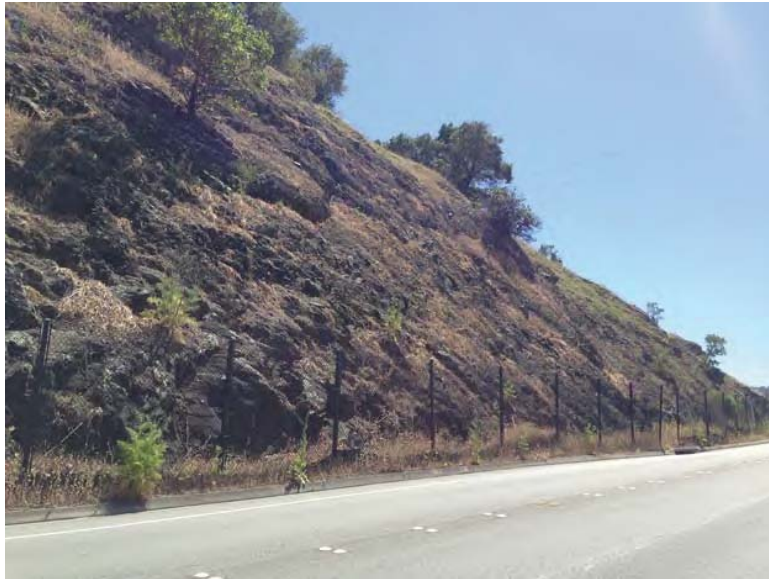
Photo 14: Road cut on Edgewood Road (south of site) composed of competent sandstone
