COUNTY OF SAN MATEO - PLANNING AND BUILDING DEPARTMENT

HYDROLOGY STUDY

1750 Cordilleras Road, Redwood City, California (Un-Incorporated San Mateo County) APN: 057-062-110

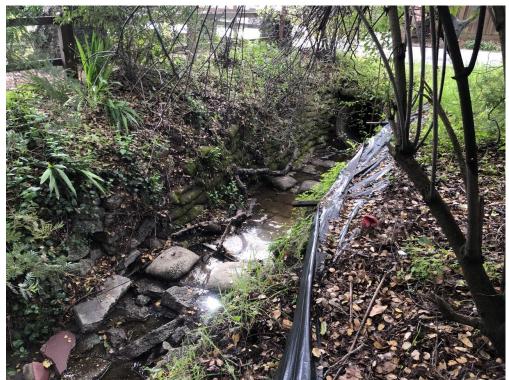
Photo 5. View of sandbag and rock-lined channel that connects a concrete culvert under Cordilleras Rd. to Cordilleras Creek. Photo date: March 22, 2019.

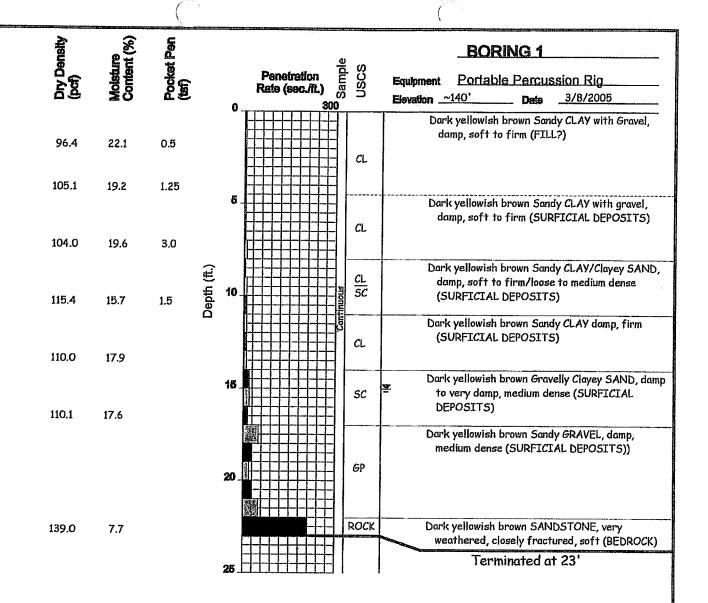
Earth Investigations	JOD No.	1104.06.00	LOG OF BORING	Plate
Consultants	Date	4/5/05	1750 Cordilleras Road Redwood City, California	3

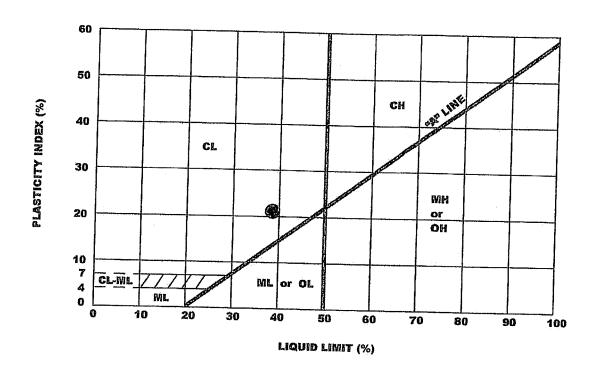
BORING NO.	Sawple Depth (feet)	WATER CONTENT (%)	Liquid Limit (%)	Plasticity Index (%)	Passing No. 200 Sieve (%)	LIQUUDITY	USCS
B-5	5'	19	39	21	69	0.05	CL
							·
			į				
				·			
		(feet)	NO. DEPTH CONTENT (%)	NO. DEPTH CONTENT LIMIT (%) (%)	NO. DEPTH CONTENT LIMIT INDEX (%) (%)	NO. DEPTH CONTENT LIMIT INDEX SIEVE (%) (%) (%)	NO. DEPTH (Feet) CONTENT LIMIT INDEX SIEVE INDEX (%) (%) (%) (%)

I. loh Ma	1104.06.00		
Earth Investigations		***************************************	PLASTICITY CHART	Plate
Annual L	Ħ			a 1001110g
Consultants	Date	4/5/05	1750 Cordilleras Road	10
		410100	Redwood City, California	TO
	-

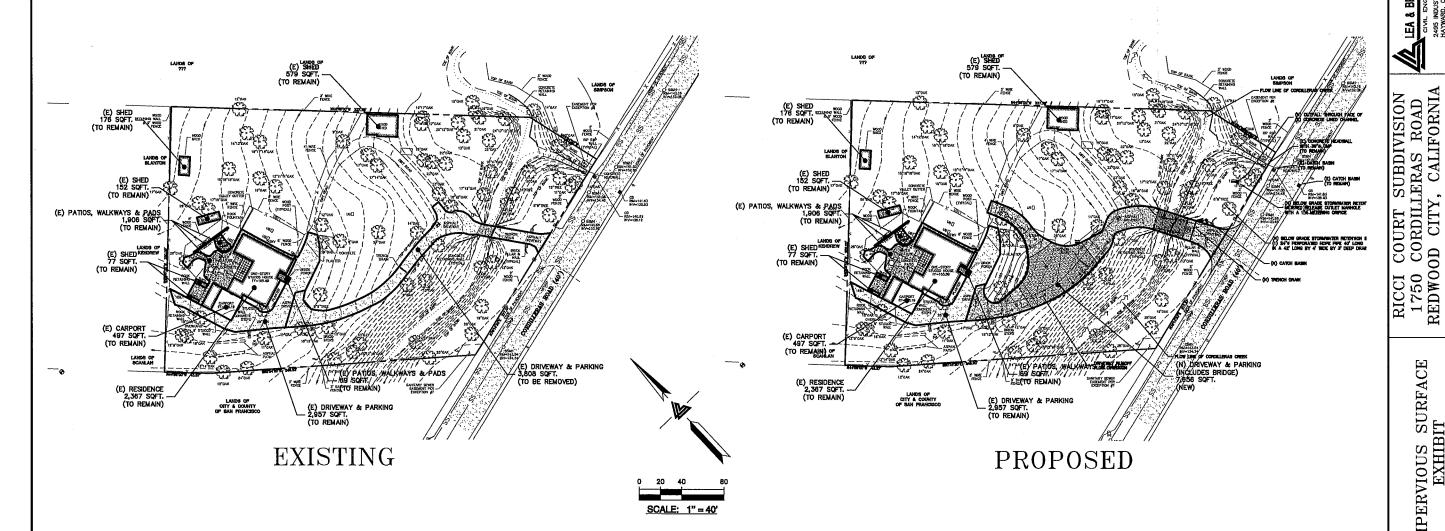
HYD-1

TOTAL SITE AREA	AREA 83,118 SQUARE FEET (1.908 ACRES)				
TOTAL DISTURBED AREA	13,400 SQUARE FEET (0.308 ACRES)				
IMPERVIOUS AREAS	EXISTING TOTAL S.F.	REMOVED TOTAL S.F.	NEW TOTAL S.F.	PROPOSED TOTAL S.F.	
RESIDENCE & GARAGE CARPORT SHEDS DRIVEWAY & PARKING PATIOS, WALKWAYS & PADS	2,367 497 984 6,765 1,975	0 0 0 3,808 0	0 0 0 7,656 0	2,367 497 984 10,613 1,975	
TOTAL IMPERVIOUS AREA	12,588	3,808	7,656	16,436	
NET CHANGE IN DEVELOPED AREA	+3,848 SQFT (N	ET INCREASE)

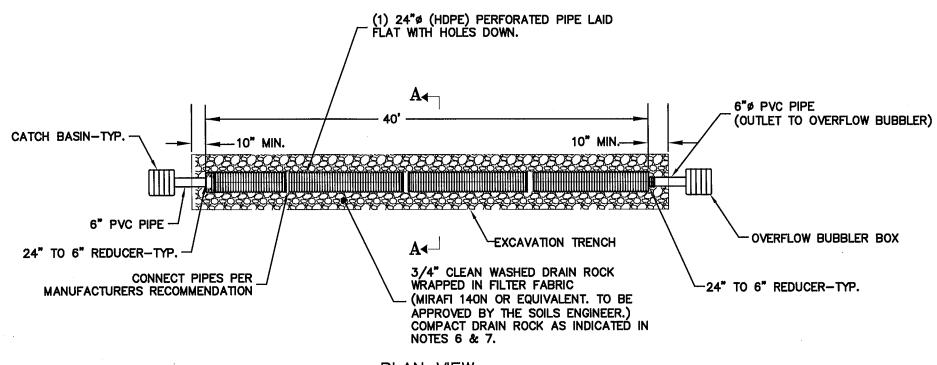
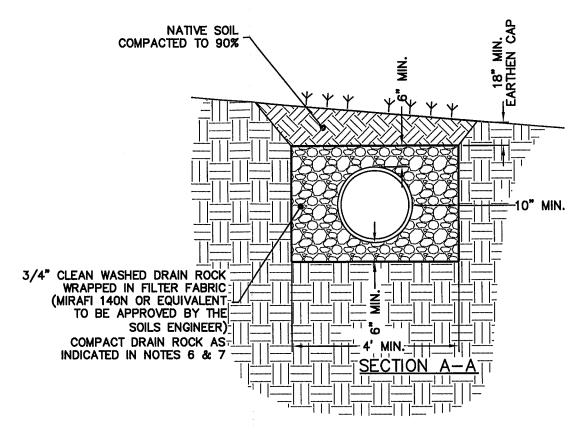
TYPICAL 24" INFILTRATION PIPE AND TRENCH DETAIL

PLAN VIEW

STORAGE PIPE	NOMINAL	MIN. SIDE
NOMINAL I.D.	O.D.	COVER
24"	28"	10"
(600 MM)	(711 MM)	(254 MM)

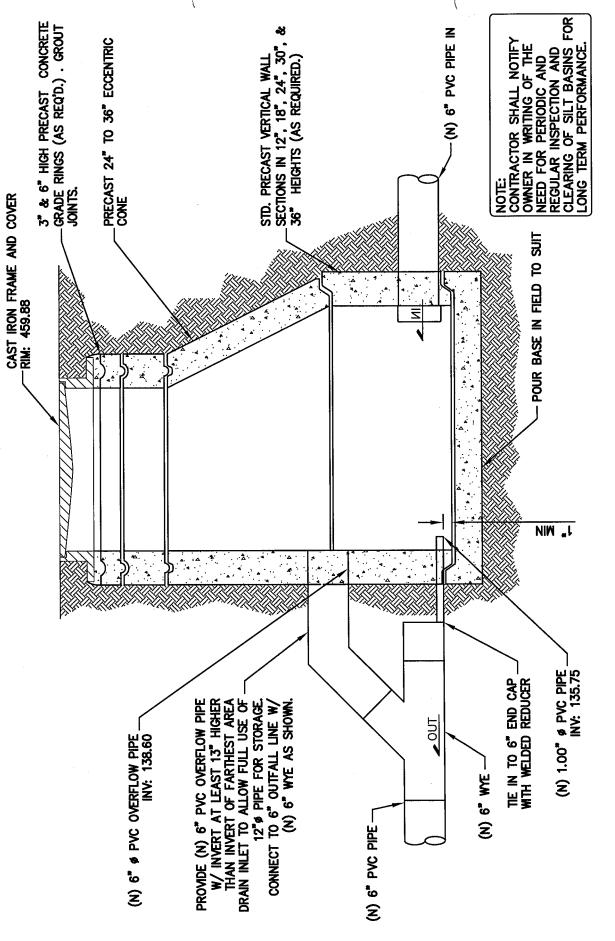
METERED RELEASE OUTLET

Should the metering orifice become clogged, an overflow riser to the outfall is provided in the manhole structure. Should an event occur that overwhelms the system, runoff will overflow the catch basin and release overland to Cordilleras Creek in the historical manner.
