August 10, 2021
Project #2109

Subject: **ENGINEERING GEOLOGIC CONSULTATIONS**
 APN 051-022-180
 738 Loma Court
 San Mateo County, California

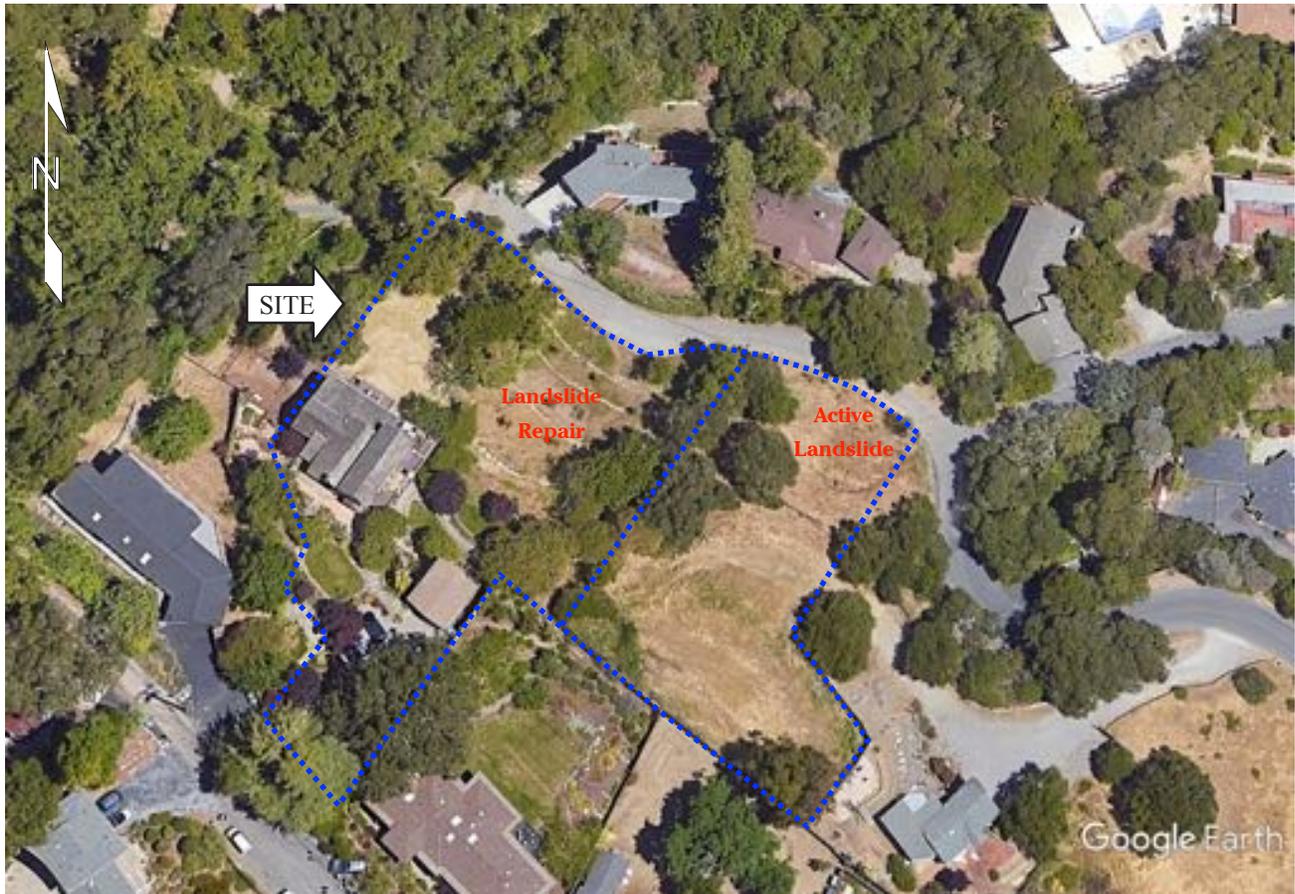
Photo 1: Aerial view from April 2018 of the subject property to the left and 634 Palomar Drive to the right. The landslide repair is visible on the subject property and an active landslide is apparent on 634 Palomar Drive.

An existing home and detached garage are located on the upper southwest half of 738 Loma Court. A landslide repair is located within the drainage swale below the residence (see Photo 1 above and Photo 4 below). The landslide repair occurred on a separate parcel on Los Cerros Road that has since been combined with 738 Loma Court. The adjacent property at 634 Palomar Drive is undeveloped. An active landslide on the property (see Photo 1 above and Photo 4 below) has since been repaired.

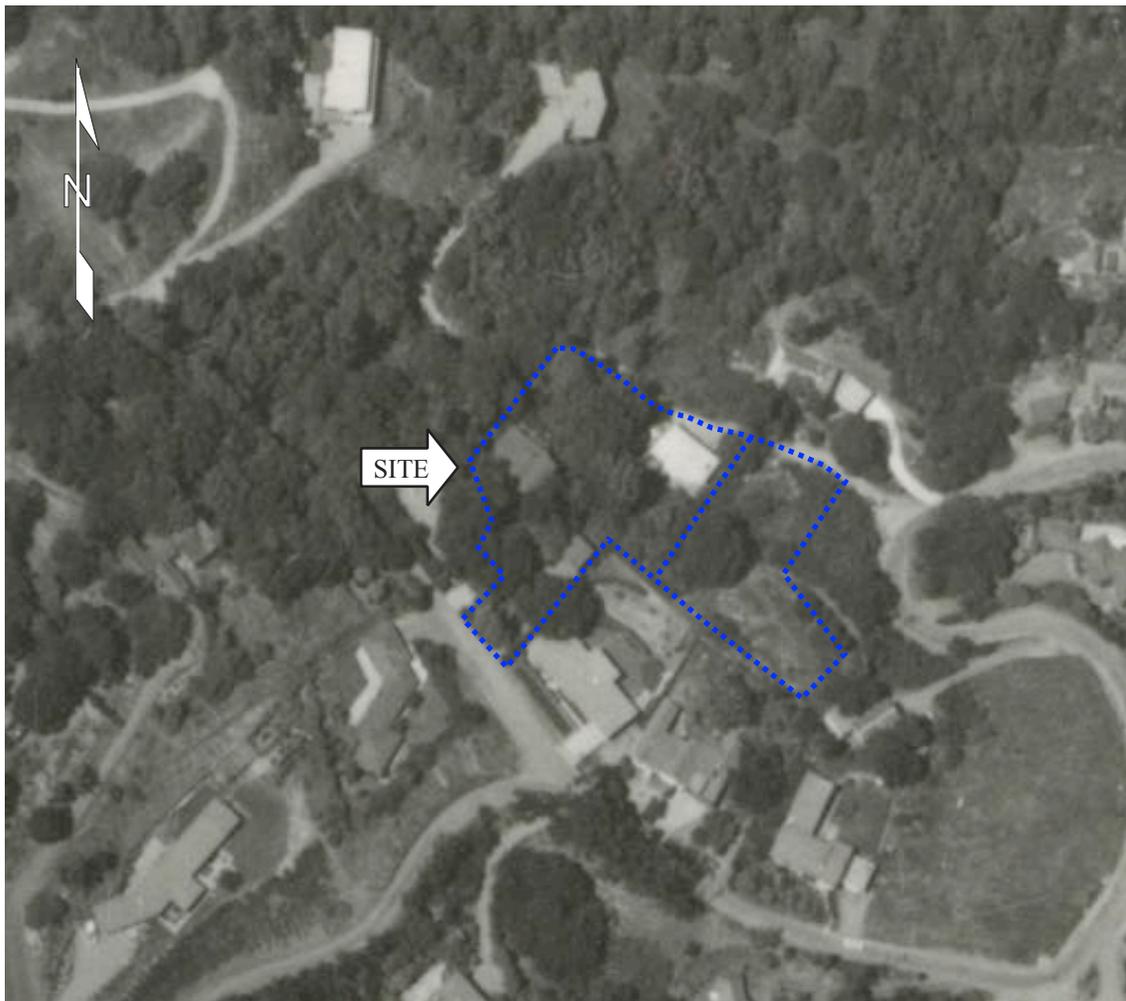
Photo 2: 1965 air photo showing the subject property.

The subject property is clearly visible in the photos reviewed, as shown on Photos 2, 3, and 4, above and below. The existing residence was constructed sometime prior to the 1948 photos. A home was also constructed on the parcel below on Los Cerros Road sometime prior to 1948 (see Photo 2 above). That home was removed sometime between 1965 and 1991. Grading to construct a building pad on the upper southwest portion of 634 Palomar Drive occurred sometime between 1991 and 2002. A lawn had been installed on the pad by 2007, as shown on Photo 3 above.

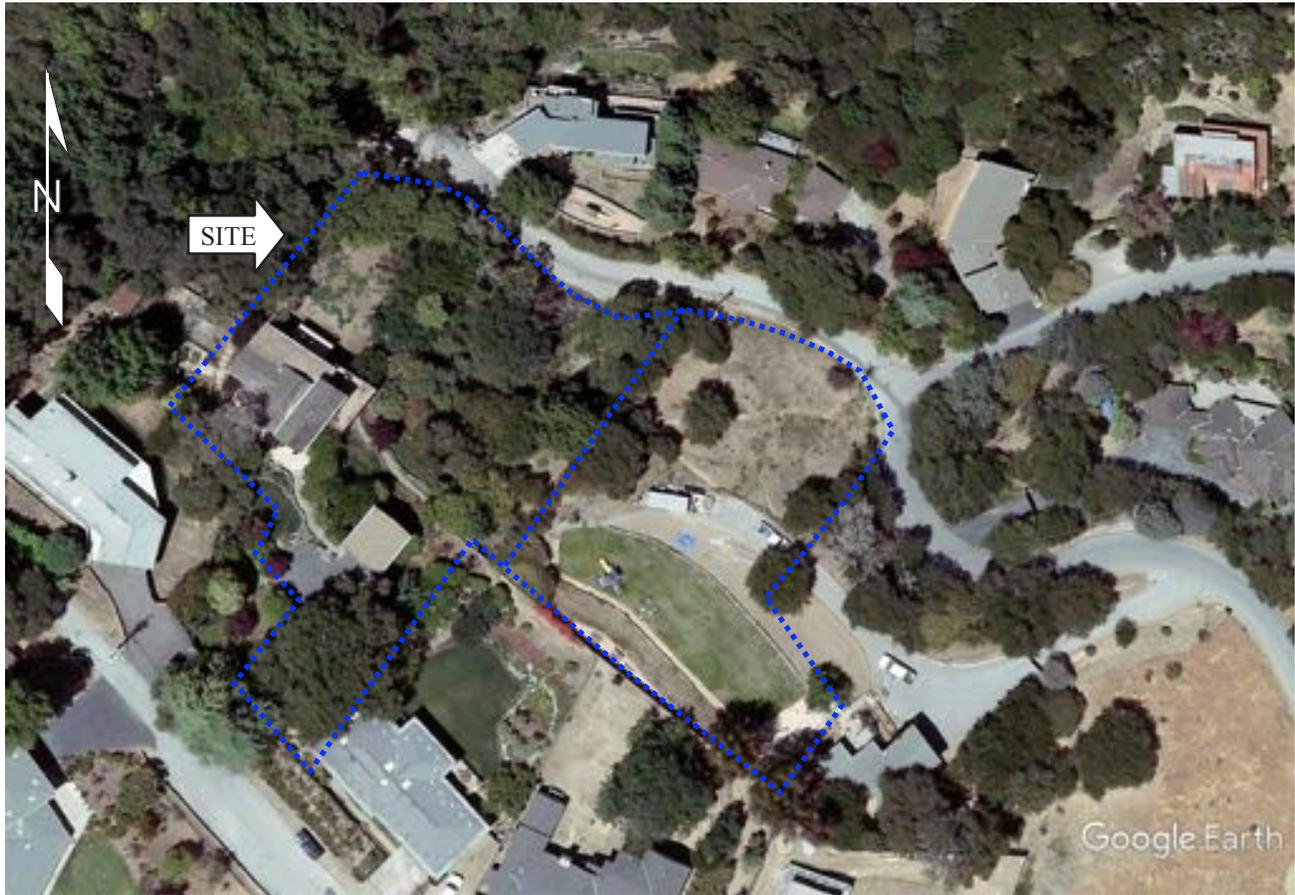
Photo 3: 2007 air photo showing the subject property. Note the graded pad and lawn area on 634 Palomar Drive.

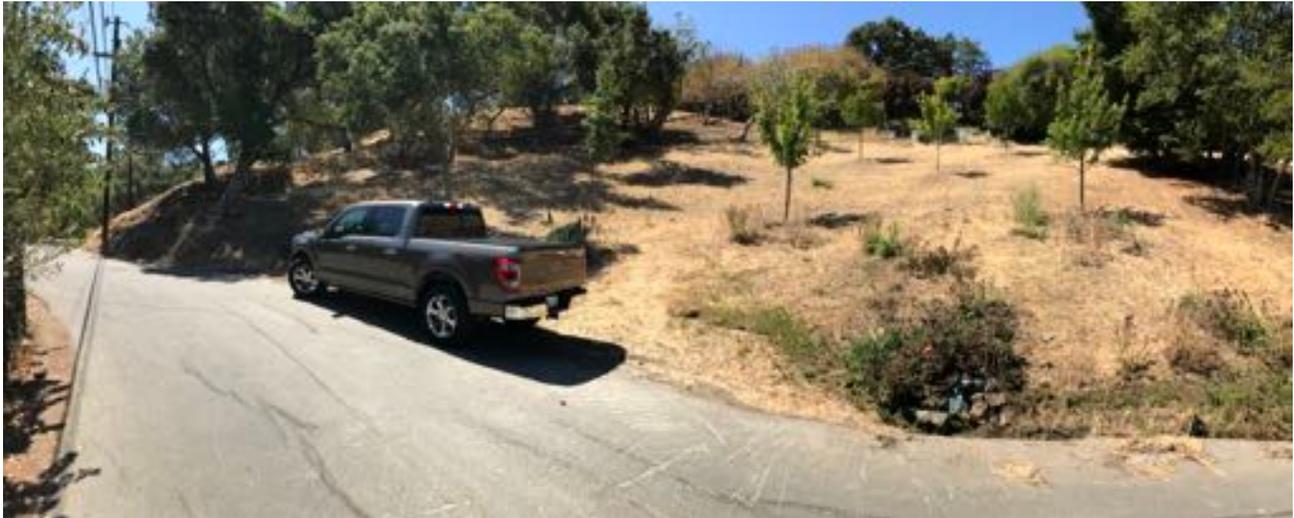
A site reconnaissance was completed of the subject property and adjacent property at 634 Palomar Drive on July 17, 2021. The natural ground in the site vicinity slopes moderately towards the northeast. Bedrock is not exposed as natural outcrops on the properties or site vicinity. Landslide repairs are apparent within a broad swale on the lower portion of 738 Loma Court and at the base of a broad ridge on 634 Palomar Drive, as shown on Photos 5, 6, 7, and 8 below.

Photo 5: View towards the south across Palomar Drive. A landslide repair is apparent at the bottom of 738 Loma Court (to the right of the truck) and at the base of 634 Palomar Drive (to the left of the truck).

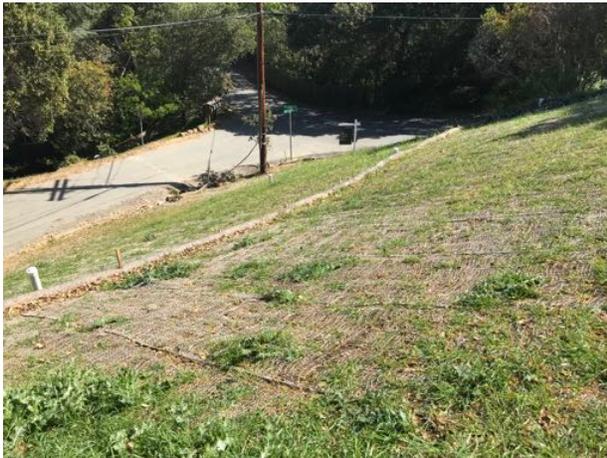
A series of subdrains are located within the landslide repair at 634 Palomar Drive, as shown on Photo 6 below. Subdrains are also installed within the landslide repair at 738 Loma Court. These subdrains outlet at the base of the slope, as shown on Photo 7 below. Water was actively flowing out of this outlet at the time of my site reconnaissance.

Photo 6: View of landslide repair and sub drain clean outs at the base of 634 Palomar Drive.

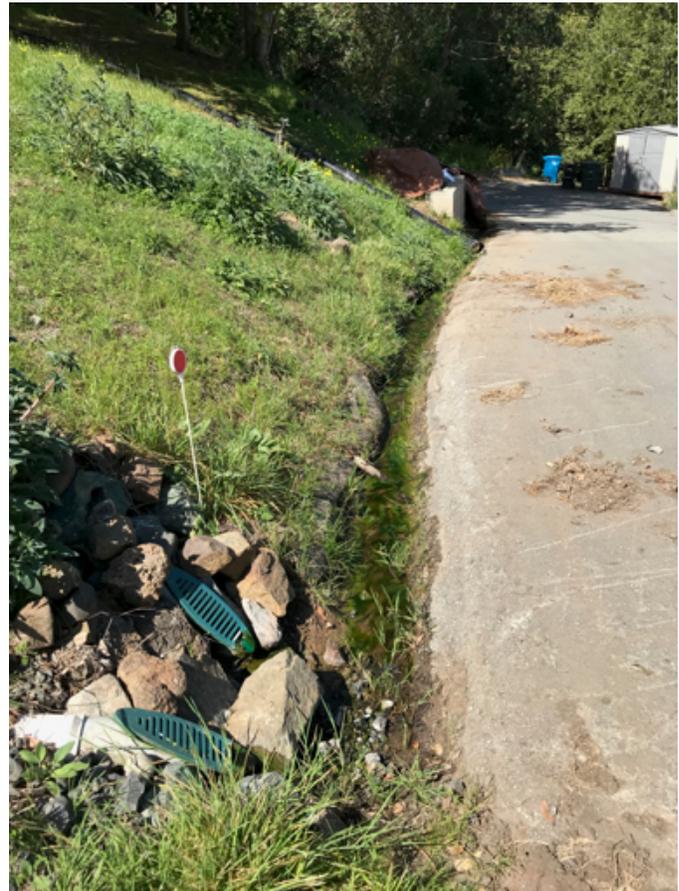
Photo 7: View of landslide repair at the base of 738 Loma Court. Water is actively seeping out of the sub drain outlet.

In my opinion, the risk of degradation of this water from the adjacent proposed leachfield system should be carefully assessed. Effluent from the proposed leachfield should not be allowed to contaminate the natural spring water on 738 Loma Court or allowed to contribute to the drainage system of the landslide repair at 738 Loma Court. Setback requirements presented by the Cotton Shires and Associates, Inc. should be adhered to and setback recommendations by GeoForensics, Inc. should be considered.

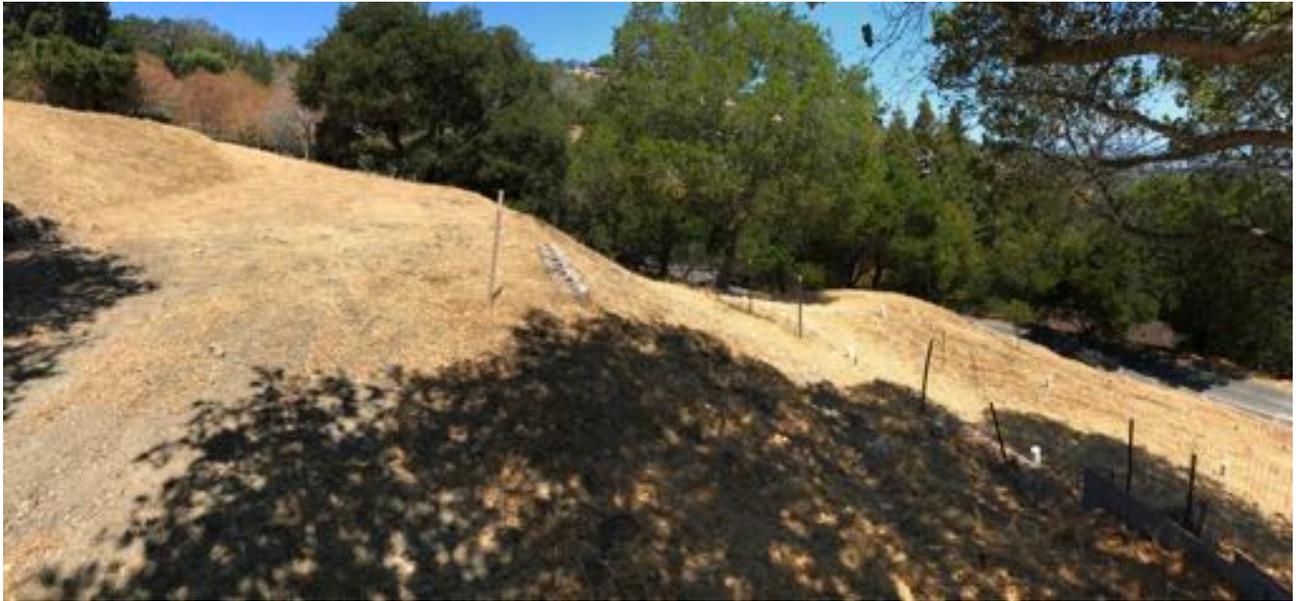
Photo 8: View towards the west of the access road on 634 Palomar Drive. Subdrain clean outs associated with the landslide repair are visible below and to the right of the access road.

An access road and level building pad have been graded onto the upper portion of 634 Palomar Drive, as shown on Photos 8 and 9 above. Artificial fill appears to form the outer margins of the access road and building pad.

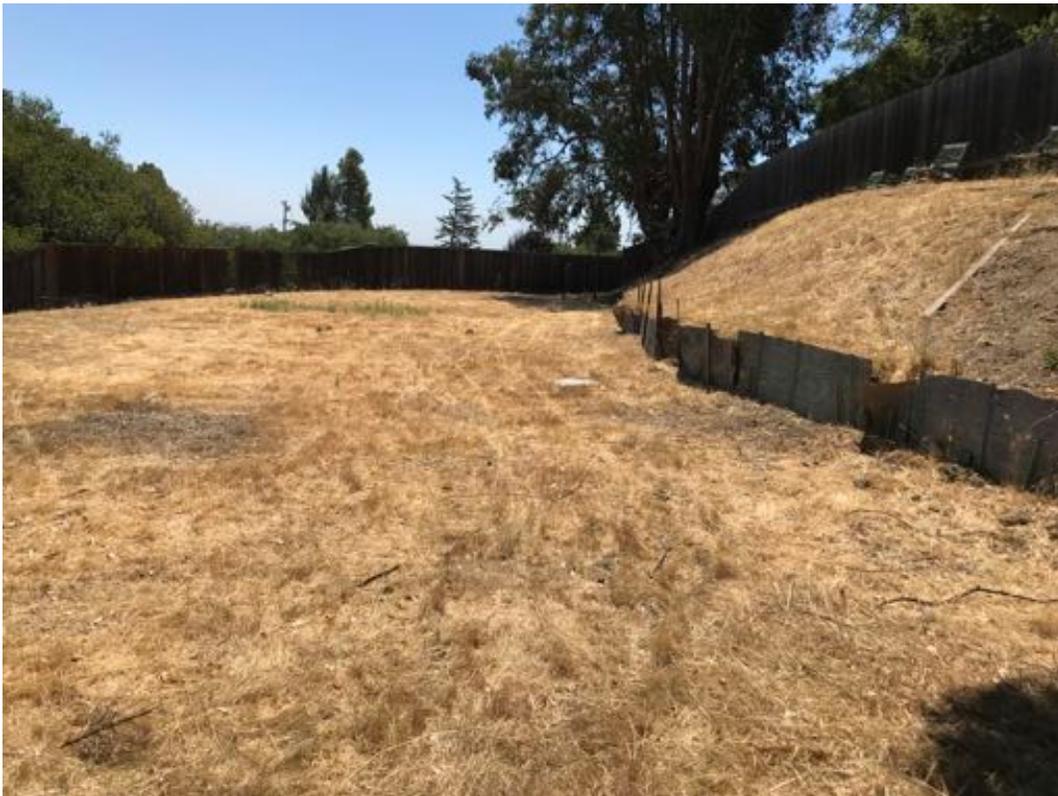
Photo 9: View towards the southeast of the building pad on 634 Palomar Drive.

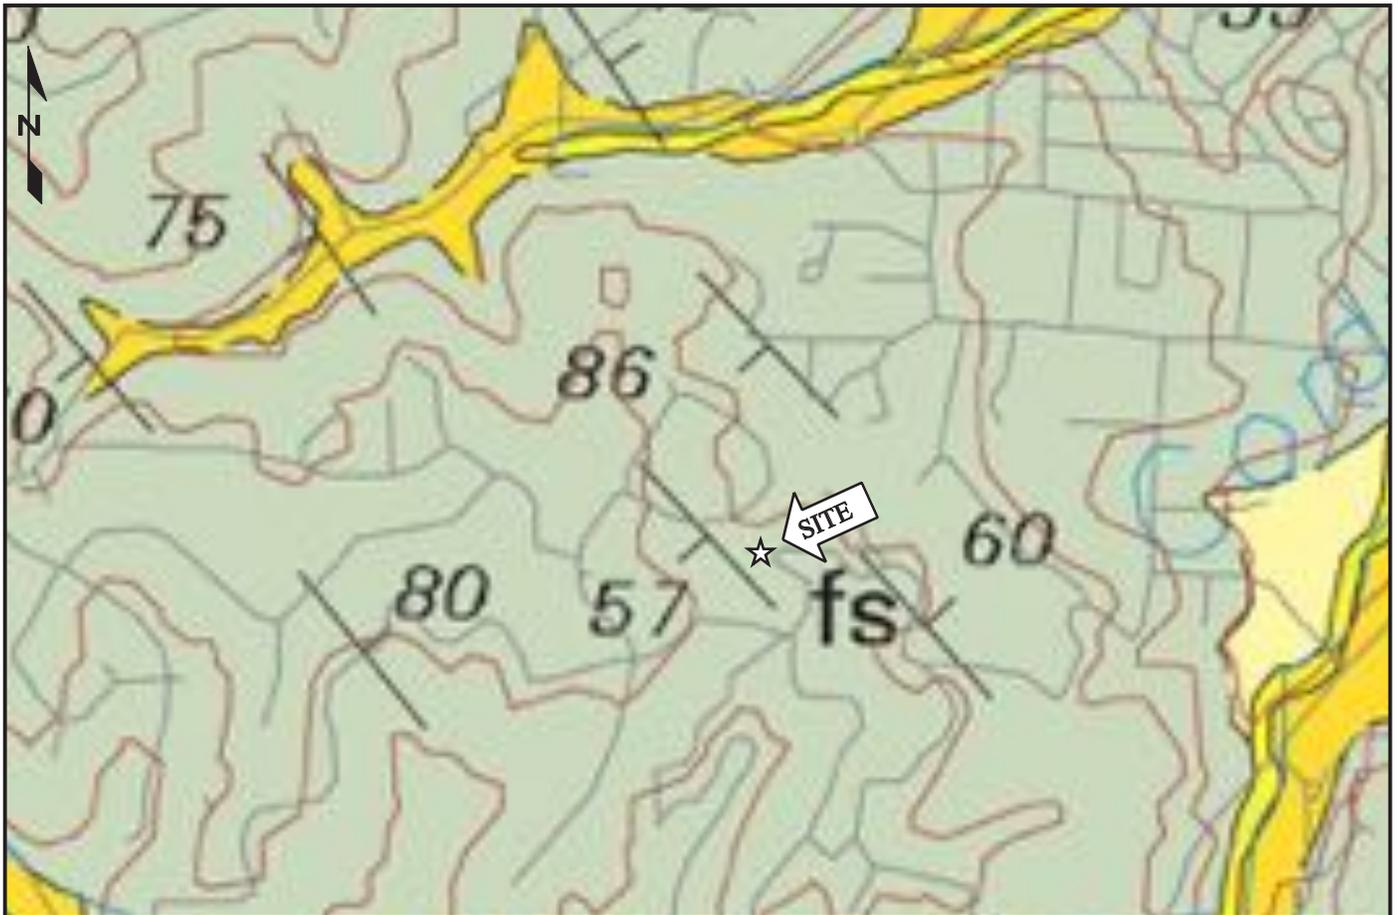
Regional Geologic Map		APN 051-022-180		
STEVEN F. CONNELLY, C.E.G.		738 Loma Court		
		San Mateo County, California		
Project #	Scale	Date	Figure	
2109	1 Inch = 1000 Feet	8/10/21	1

Regional geologic mapping by Brabb, Graymer, and Jones (1998) indicates that the subject property and site vicinity are underlain by Cretaceous to Jurassic age (66 to 201 million years old) sandstone, as shown on Figure 1, Regional Geologic Map. The bedrock is composed of sandstone with interbedded siltstone and shale. Beds strike towards the northwest and dip moderately towards the southwest.
