**COUNTY OF SAN MATEO
PLANNING AND BUILDING DEPARTMENT**

SUBJECT: UPDATED REPORT: Consideration of a Planned Agricultural District Permit, Coastal Development Permit, and Grading Permit, to address facility and operational violations (VIO2023-00035) at Terra Gardens, including grading of 14,050 cubic yards (c.y.) associated with site clean-up, drainage/access improvements, and permitting existing work, located at 12761 San Mateo Road (Highway 92) within the unincorporated Half Moon Bay area of San Mateo County.

County File Number: VIO2023-00035, PLN2023-00334 (Smith/Guan)

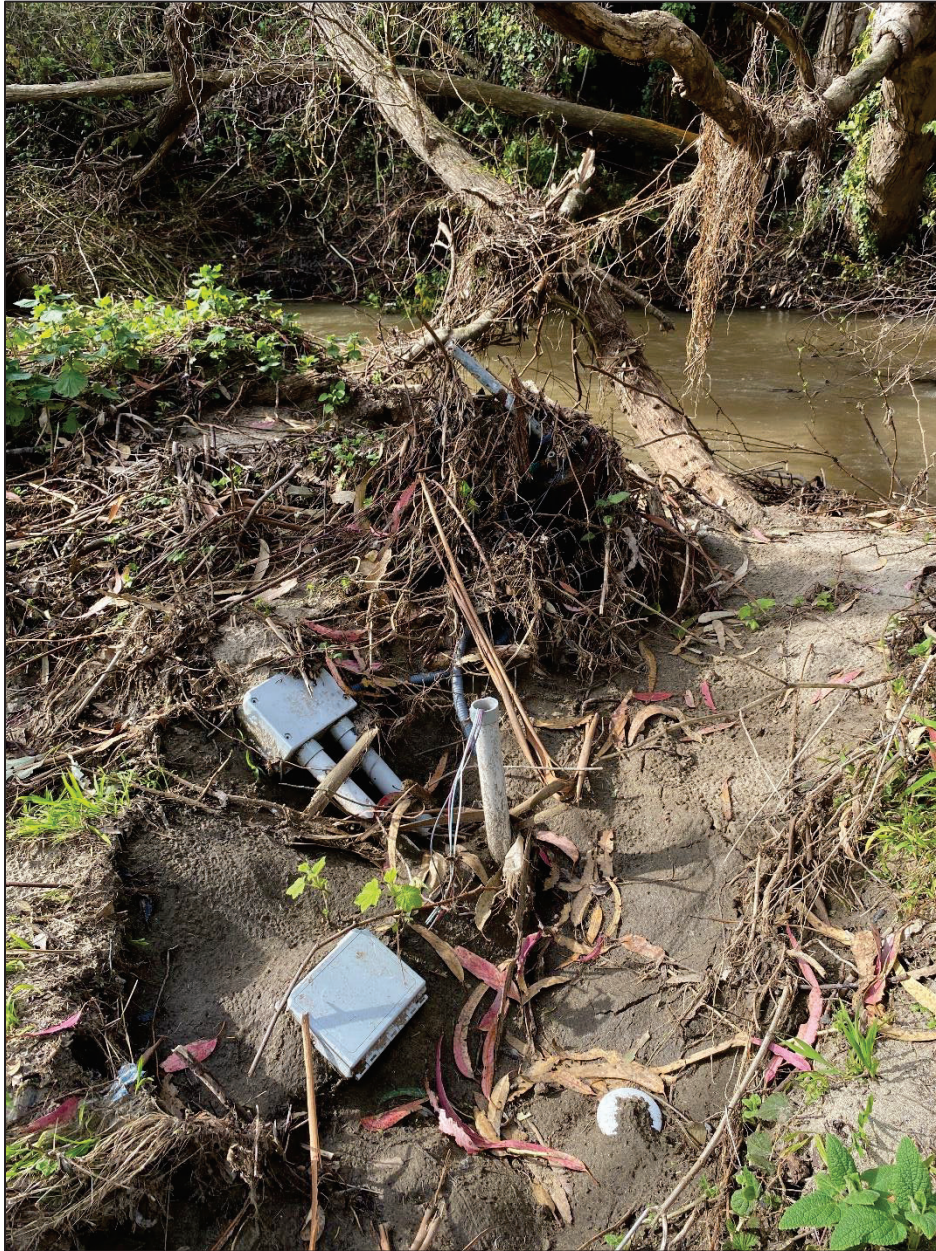
Figure 1. Broken equipment at the bank of Pilarcitos Creek, associated with water diversion and pumping, at WS-1.

- 1) Stop all diversions from Pilarcitos Creek if you have not done so already.
- 2) Remove all loose trash and debris that exists within 150 feet from the ordinary high water mark of Pilarcitos Creek.
- 3) Prevent mushroom waste runoff from entering Pilarcitos Creek.
- 4) Provide CDFW with evidence these immediate actions have been completed within **15 days** of receipt of this letter by submitting via email to Will.Kanz@wildlife.ca.gov or mailing to the CDFW Fairfield regional office.

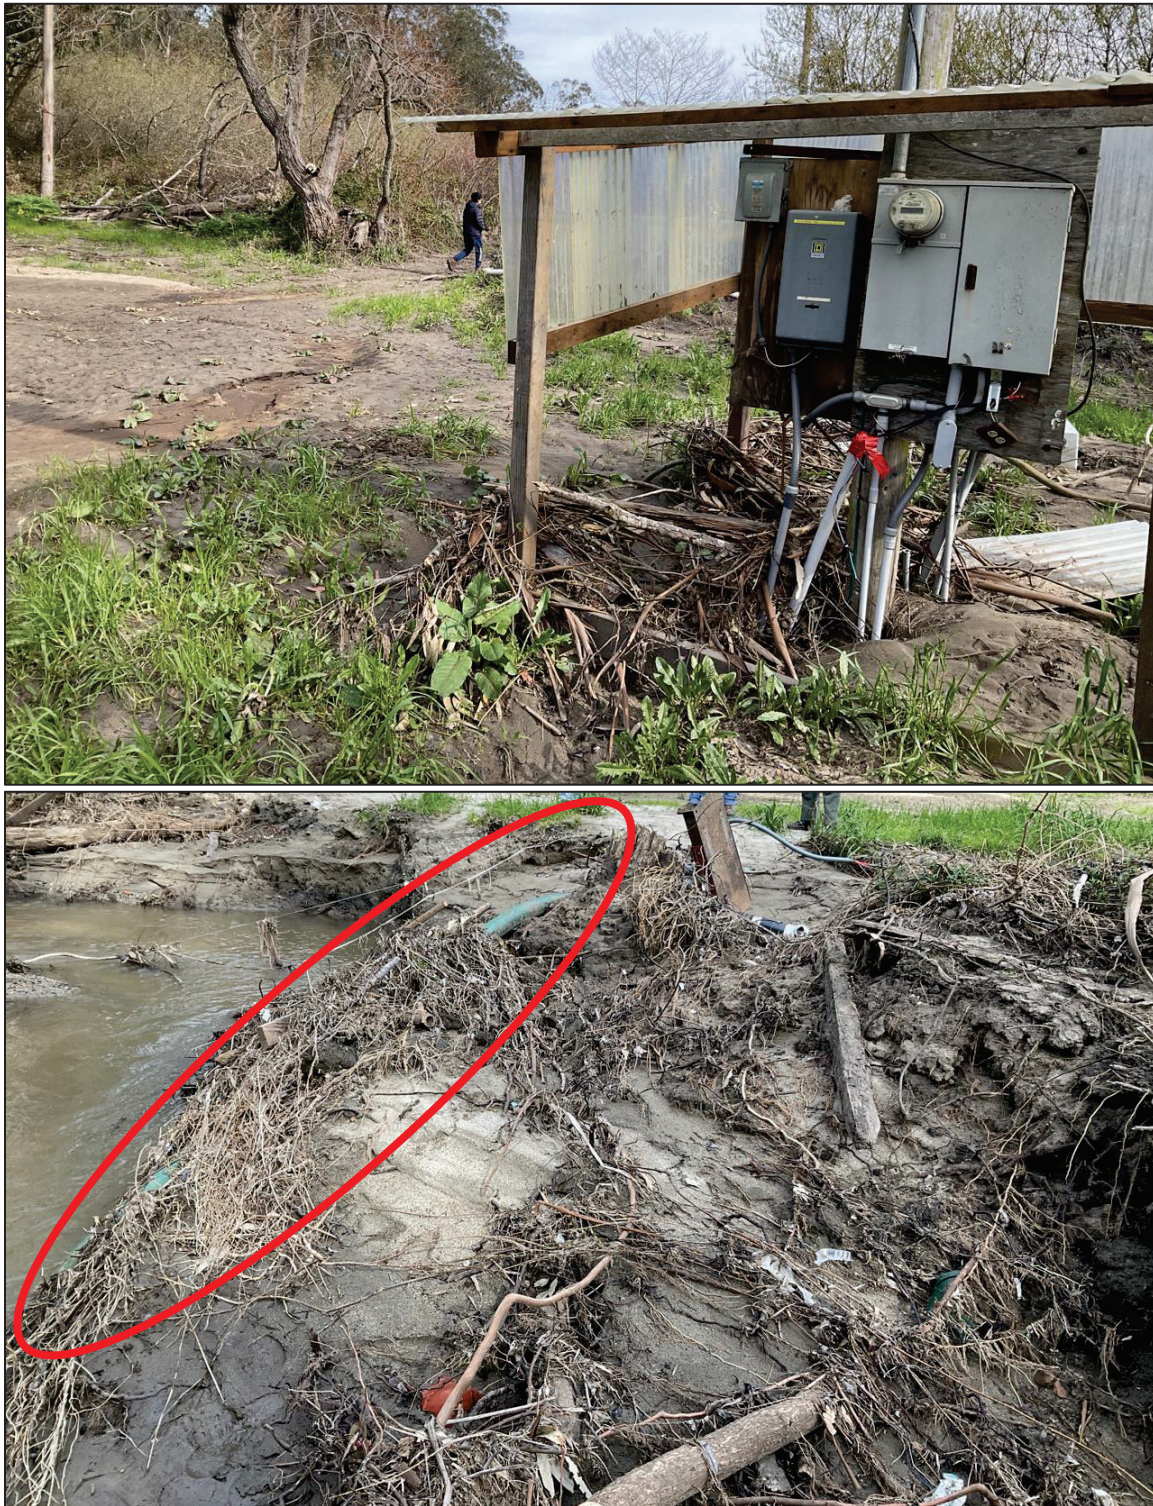
Figure 2. View of debris located at WS-1 includes an electrical panel within 150 feet of

Pilarcitos Creek (top). A green pipe (circled in red) is visible in Pilarcitos Creek partially buried in sediment and debris (bottom). The pipe was previously associated with a diversion from Pilarcitos Creek.

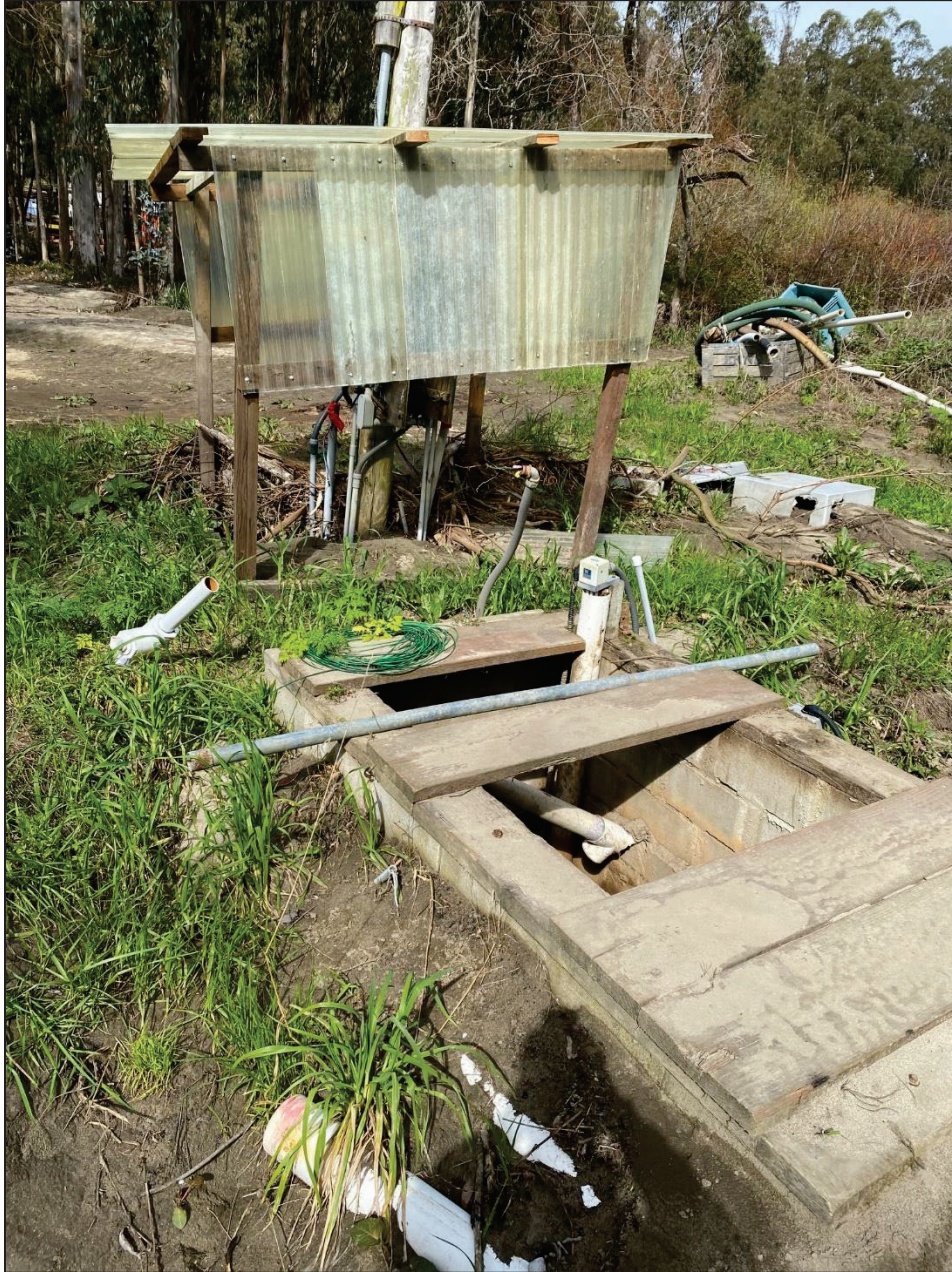
Figure 3. Steep-walled hole or pit next to the water diversion system (WS-1).

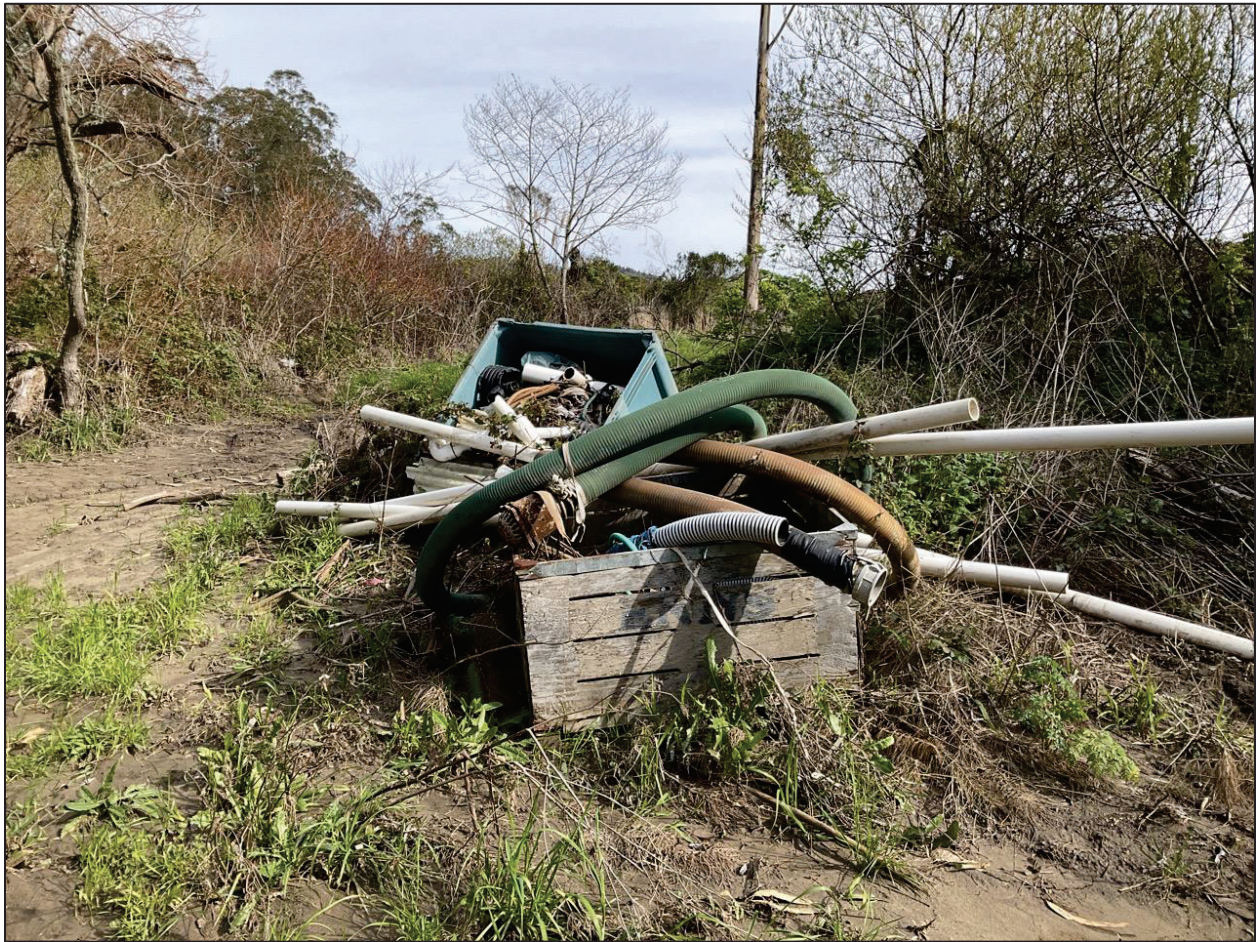
Figure 4. Old pipes and debris within 150 feet of Pilarcitos Creek located at PP-1.

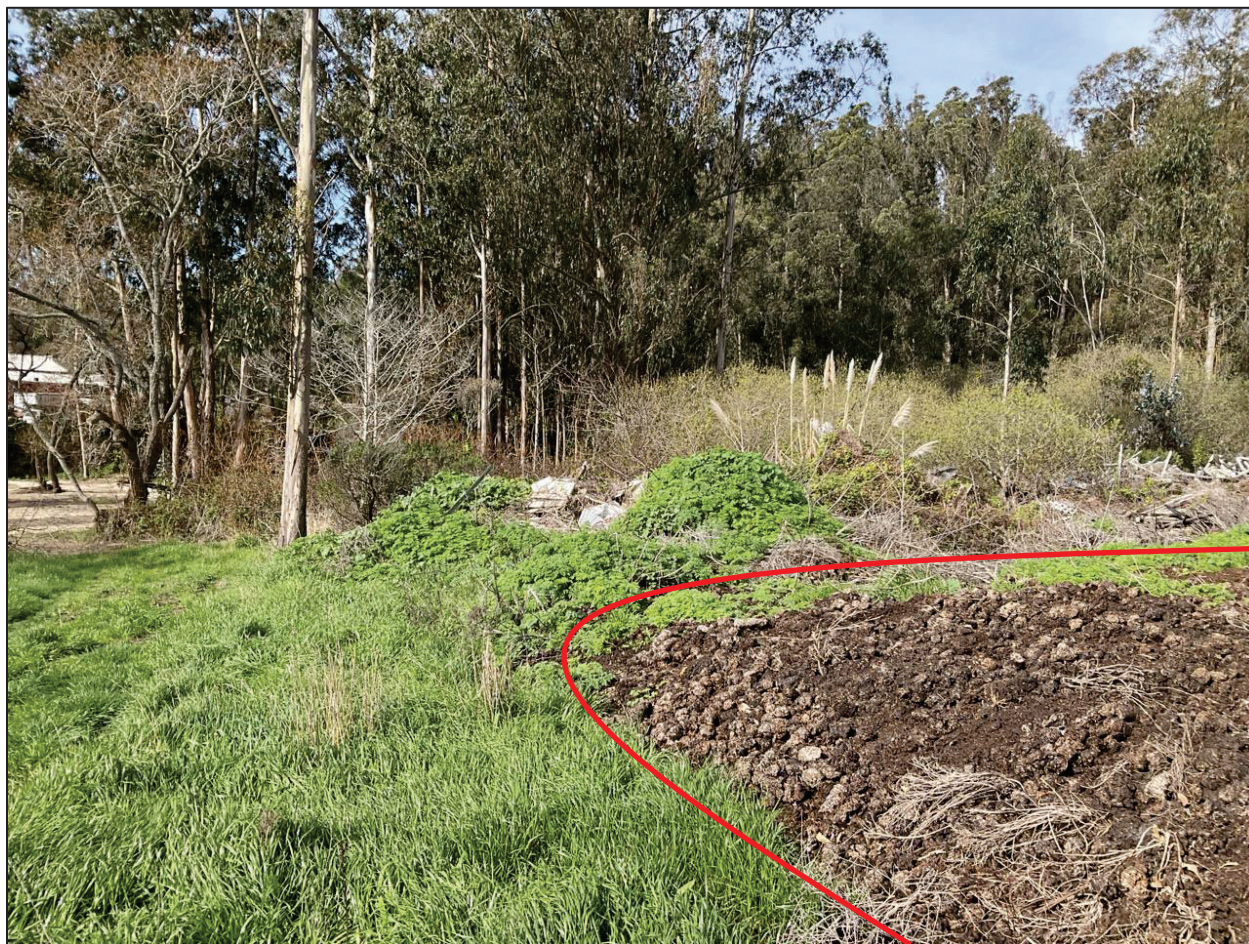
CDFW staff observed a large pile of organic mushroom waste piled approximately 150 feet from Pilarcitos Creek (Figure 5). Stormwater runoff appeared to have flowed from the organic waste down the earthen path to Pilarcitos Creek.

Figure 5. View of a portion of the mushroom waste pile in the foreground at PP-2 (on the right of the red line). Pilarcitos Creek flows in the background along the tree line, within 150 feet.

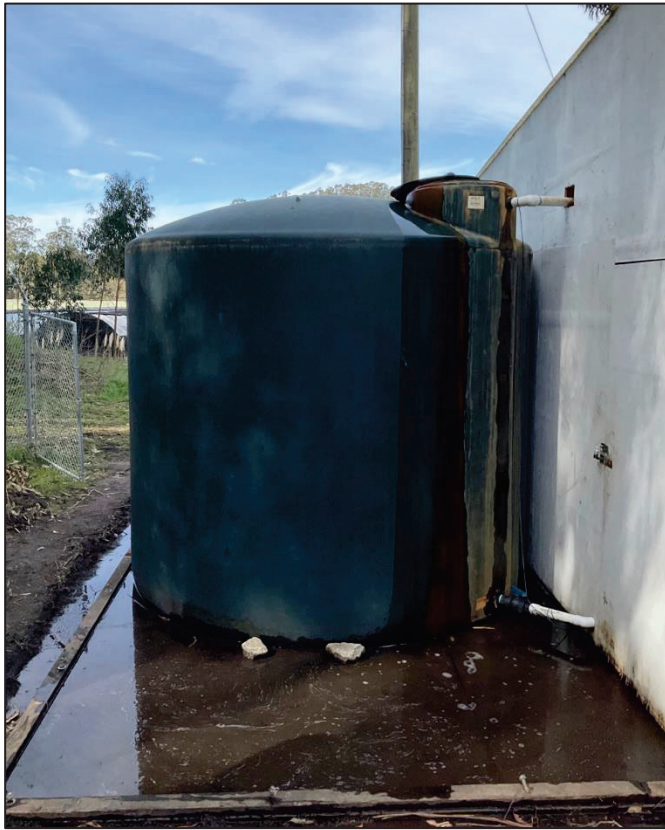
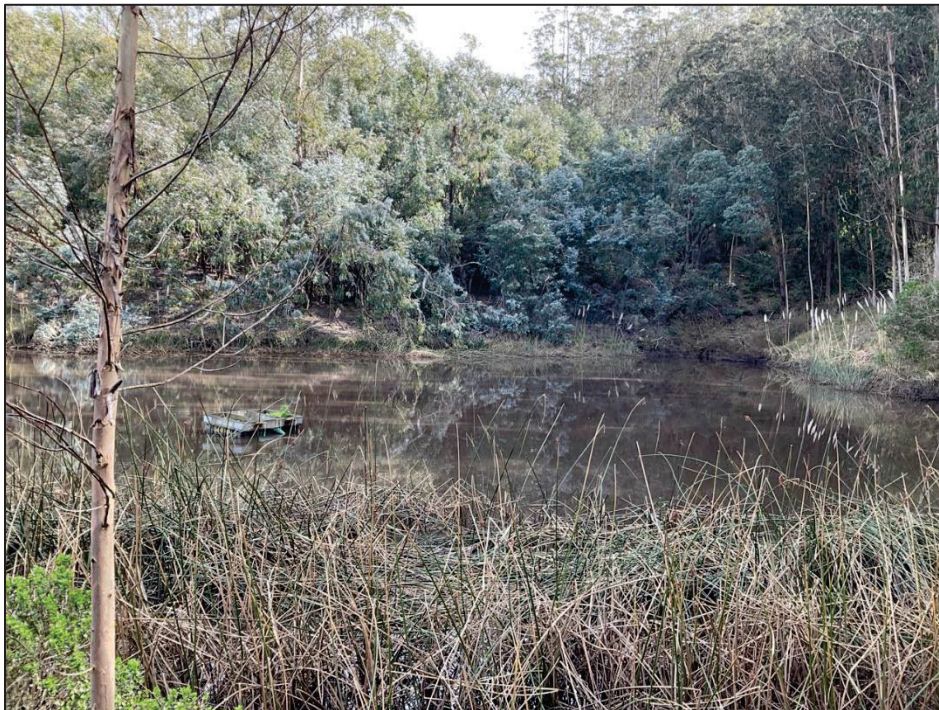
Figure 6. Site WSt-1 includes a 5,000-gallon storage tank next to a shed (top). The storage tank is situated below the on-stream reservoir at WSt-2 (bottom).

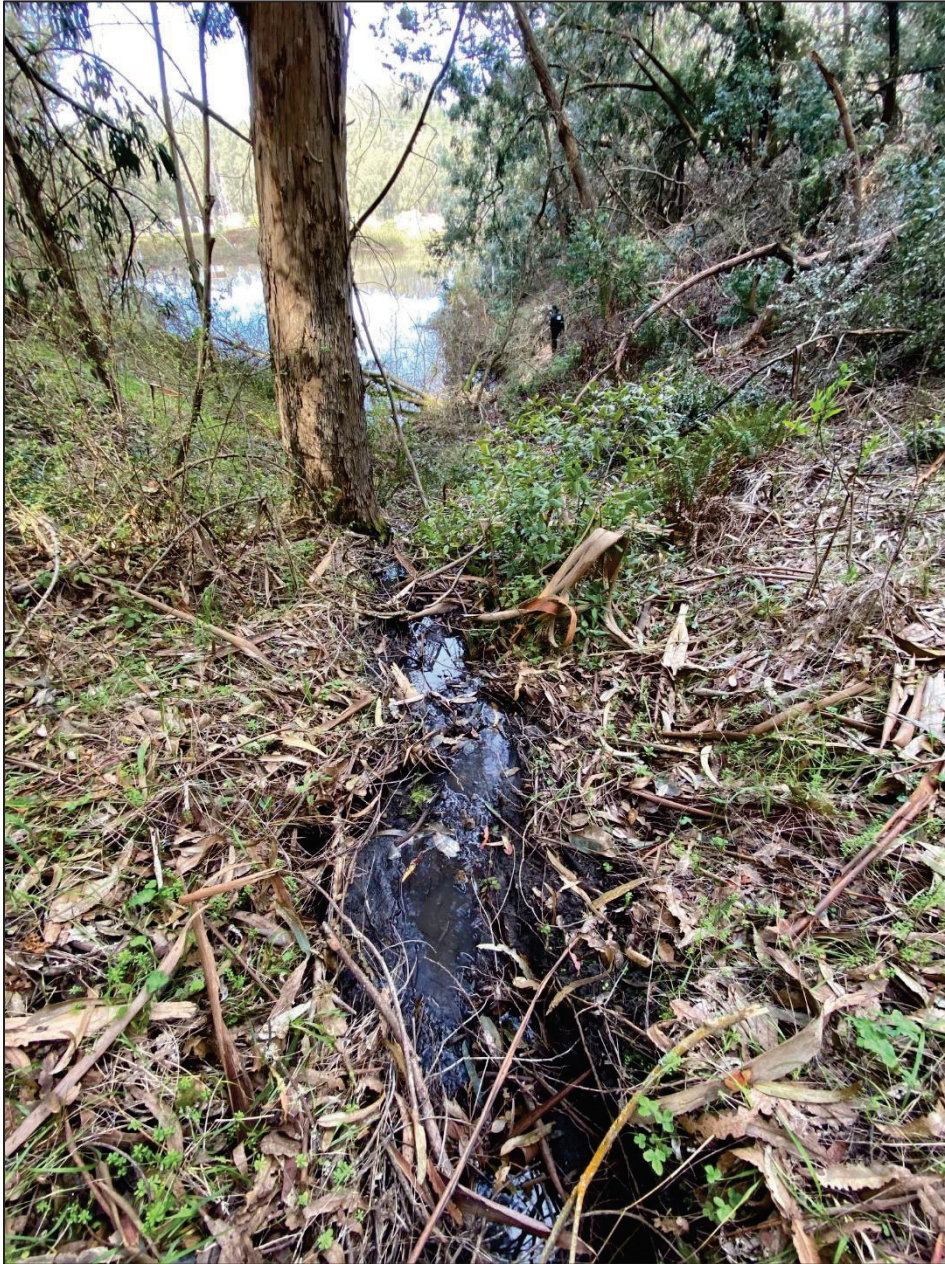
Figure 7. An unnamed stream in the foreground flows to the on-site reservoir (WSt-2) in the background.

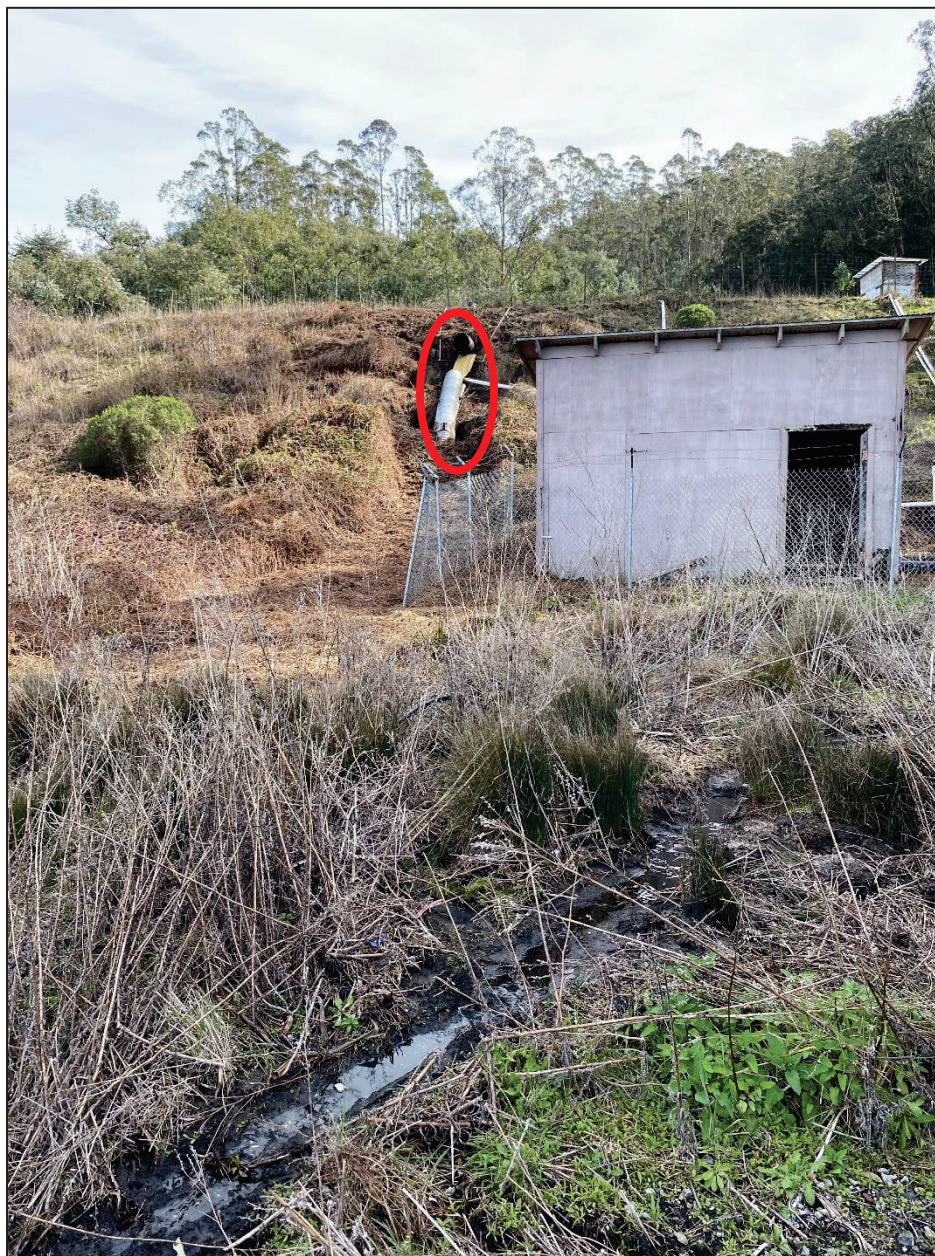
The Property's on-stream reservoir that dams the unnamed tributary to Pilarcitos Creek must ensure sufficient water downstream to keep fish in good condition.

Figure 8. An existing earthen dam built on-top of an unnamed tributary prevents water from flowing downstream until the water surface level in the reservoir (WSt-2) reaches the culvert spillway (circled in red).

- 2) On-stream reservoir built and operated without a prior 1602 notification. The reservoir should be evaluated by a qualified professional to determine any modifications or upgrades necessary to protect fish and wildlife including downstream resources. Examples could include installation of plumbing infrastructure to bypass streamflow, spillway repairs, and/or development of an invasive species management plan.

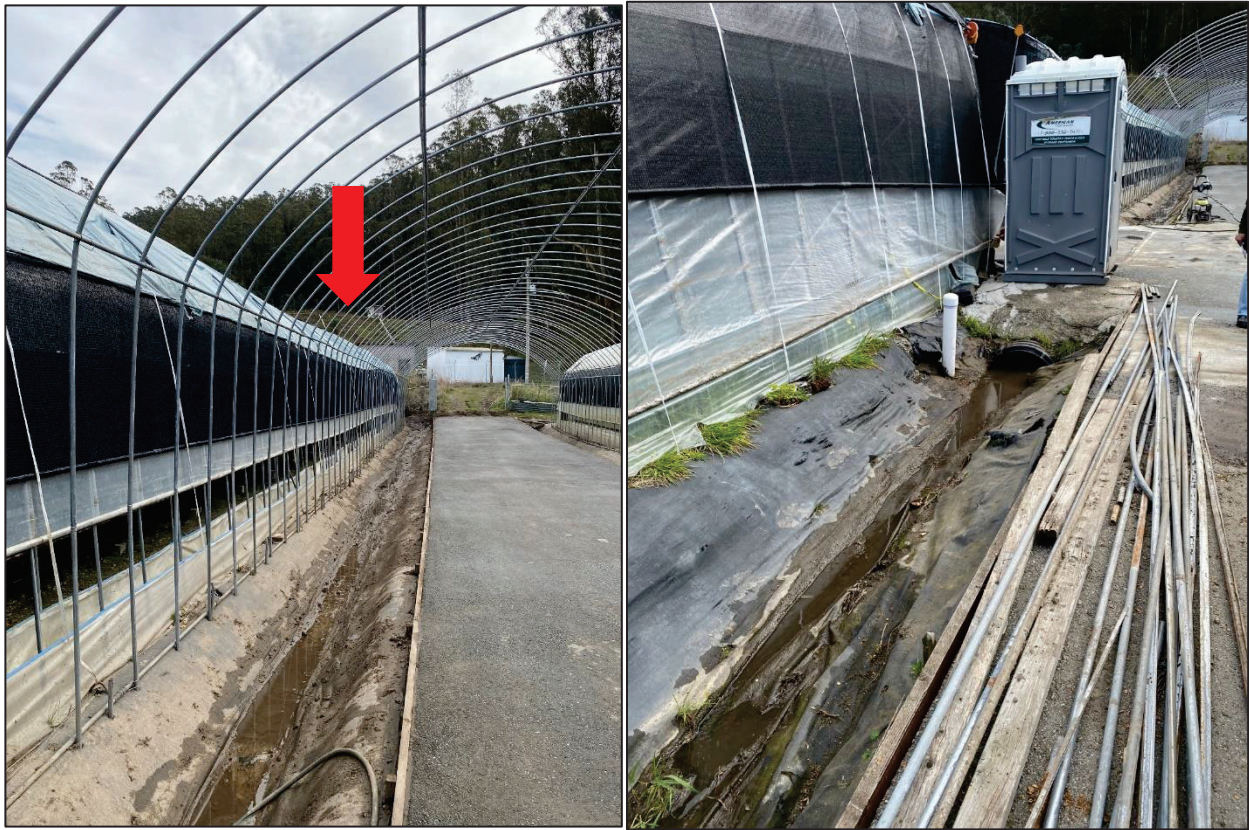
Figure 9. A concrete and geotextile-lined modified tributary adjacent to a mushroom building (left and right picture, PL-1). The reservoir embankment is visible in the background (red arrow in left picture).

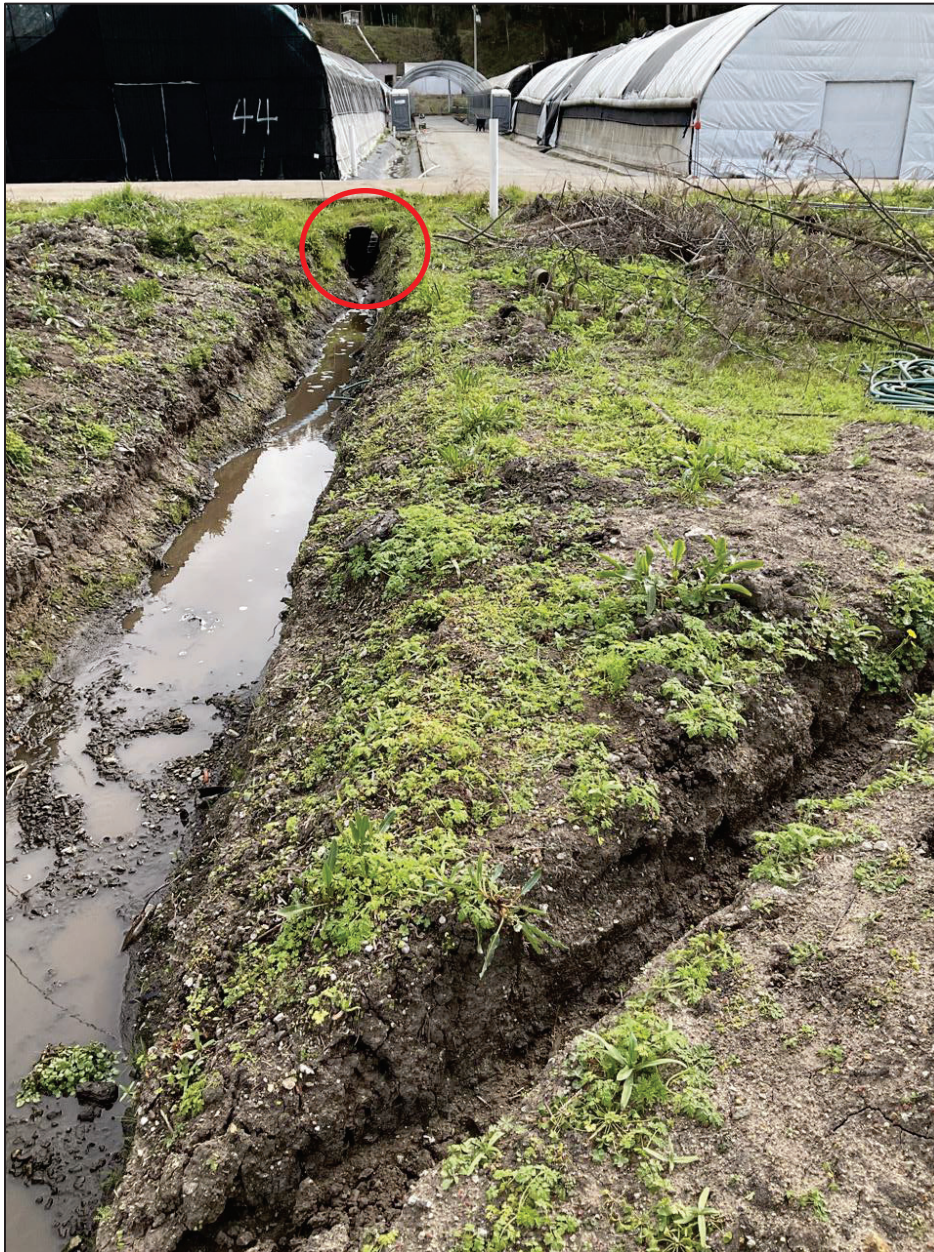
Figure 10. A 26-inch corrugated metal pipe (red circle, SC-1) marks the transition to a modified tributary that flows to Pilarcitos Creek.

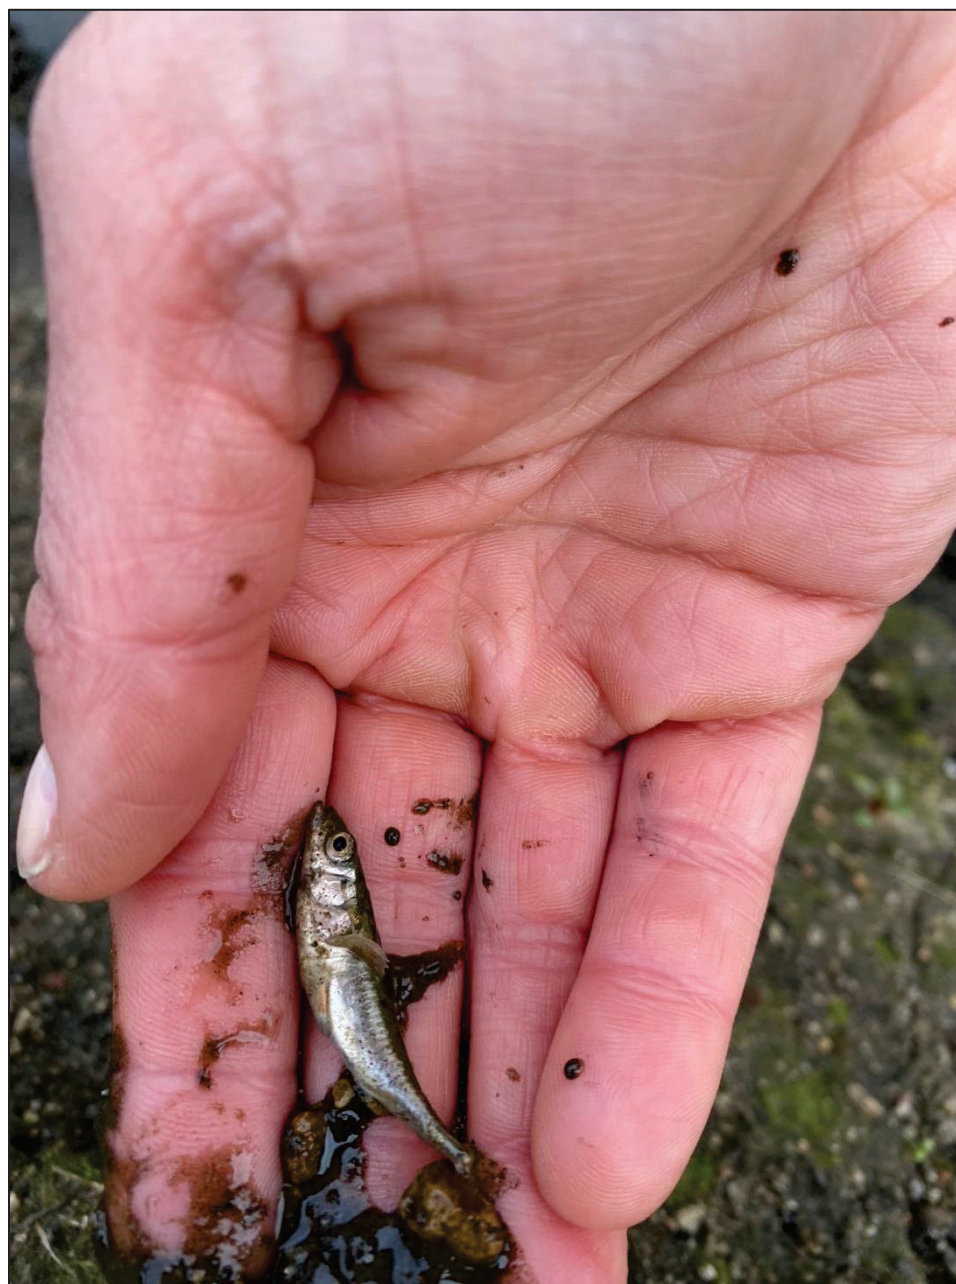
Figure 11. A three-spined stickleback (*Gasterosteus aculeatus aculeatus*) was located within an isolated drying pool located in the same modified tributary as Figure 9.

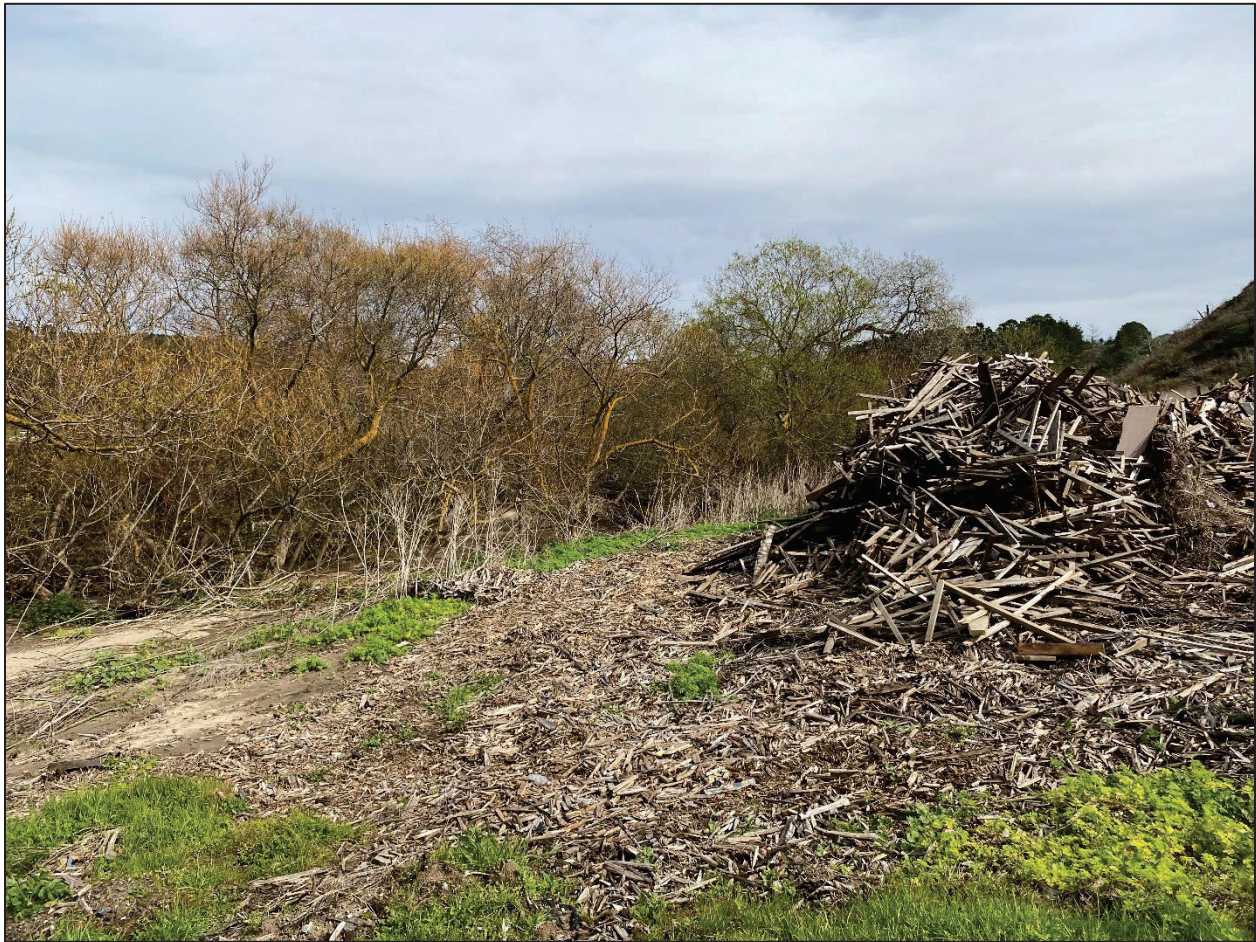
CDFW staff walked to the northern end of the Property where, according to Mr. Guan, an old slaughterhouse used to be. CDFW staff observed large piles of wood, including some pressure-treated lumber from the recently demolished building approximately 75 feet from Pilarcitos Creek (Figure 12). CDFW staff also observed trash and debris in Pilarcitos Creek, as well as an existing railroad flatcar bridge over the stream.

Figure 12. Wooden debris from a demolished building at PP-3 within 150 feet of Pilarcitos Creek.

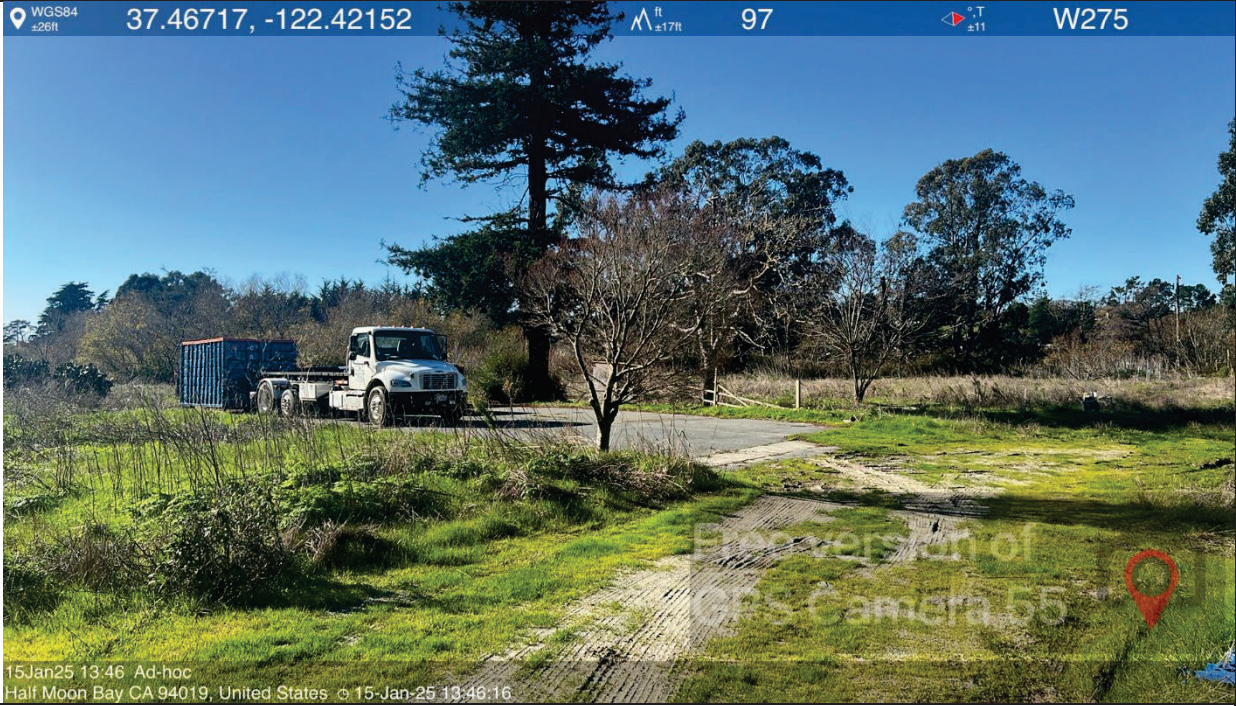
Photo 1. Action 1 – mobile home (R1, R2) removal

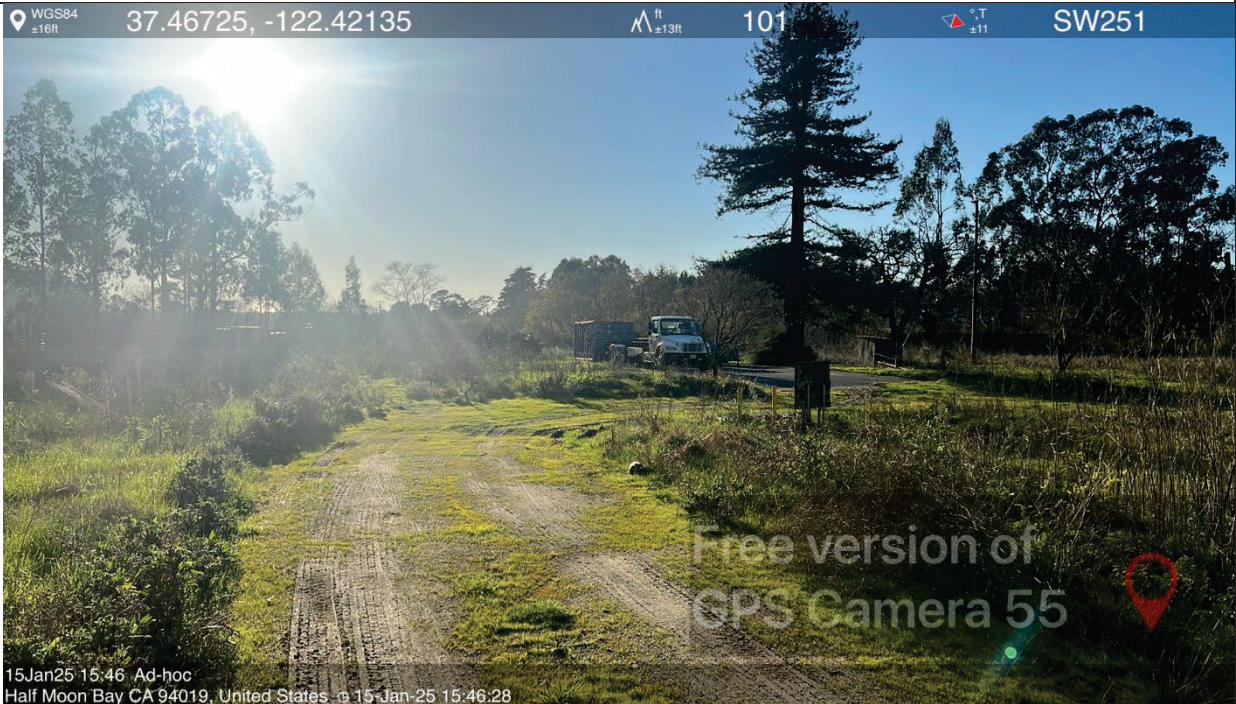
Photo 2. Action 1 – mobile home (R1, R2) removal)

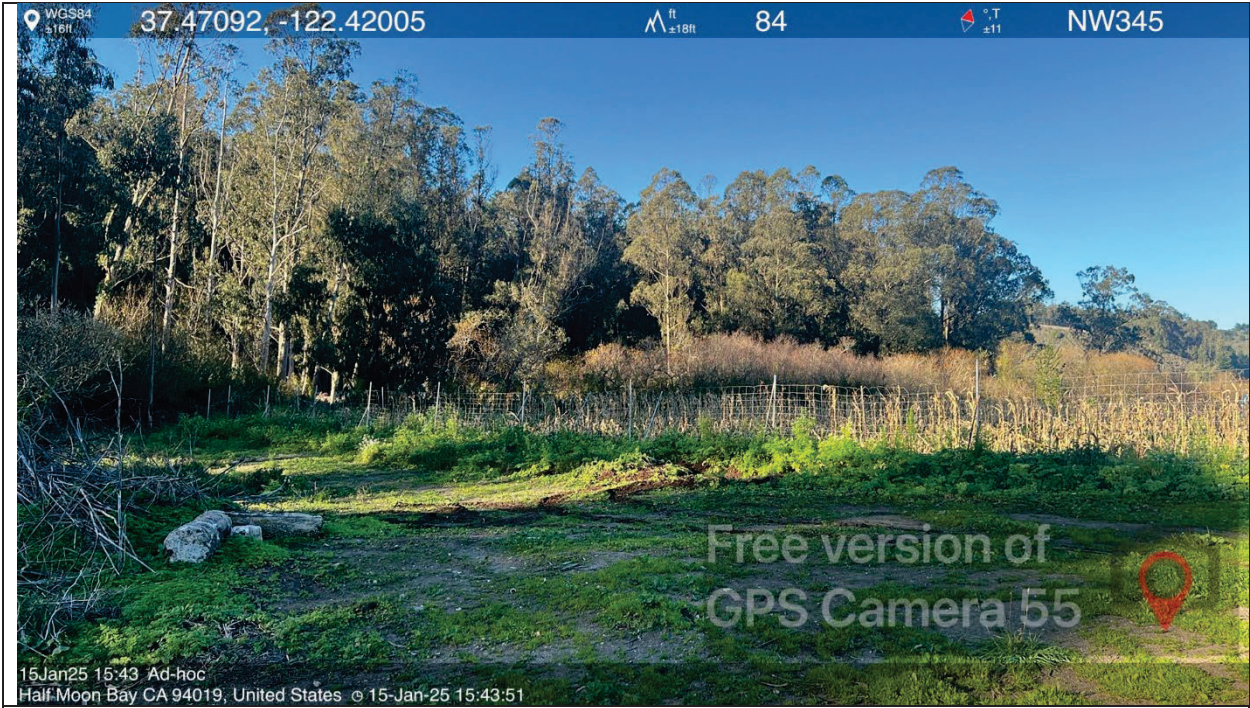
Photo 3. Action 3 - mushroom waste removal

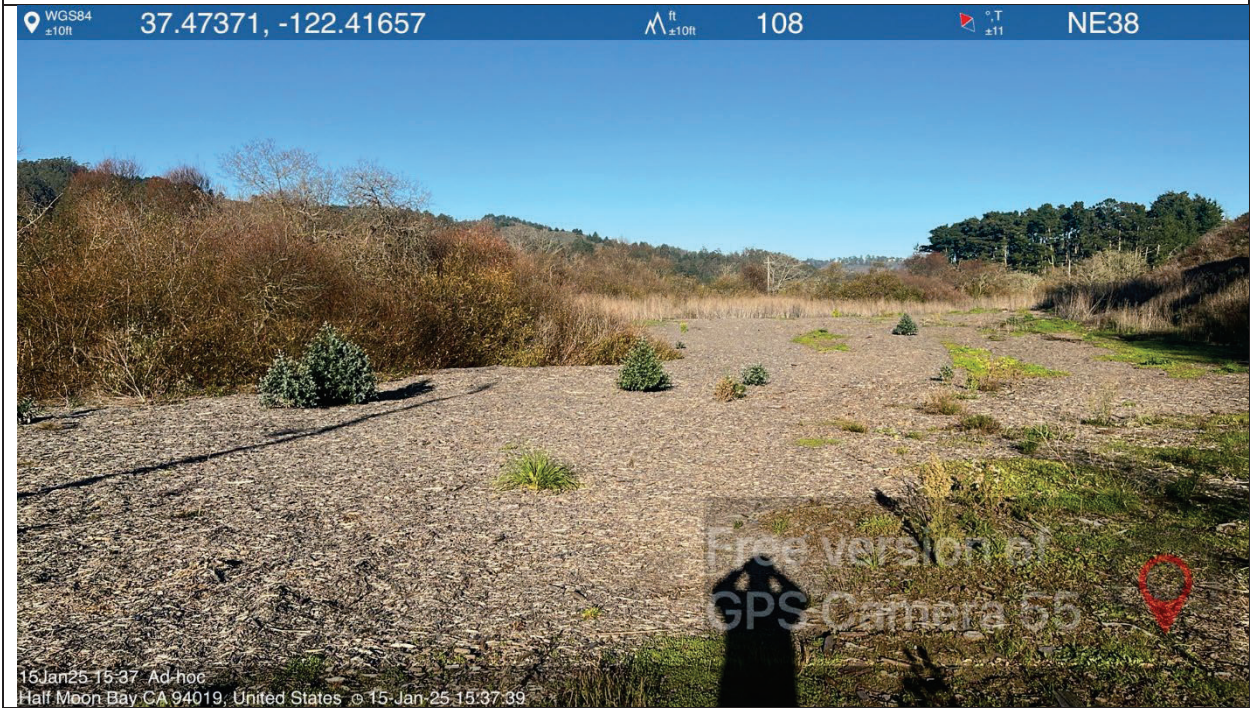
Photo 4. Action 3 – wood debris removal

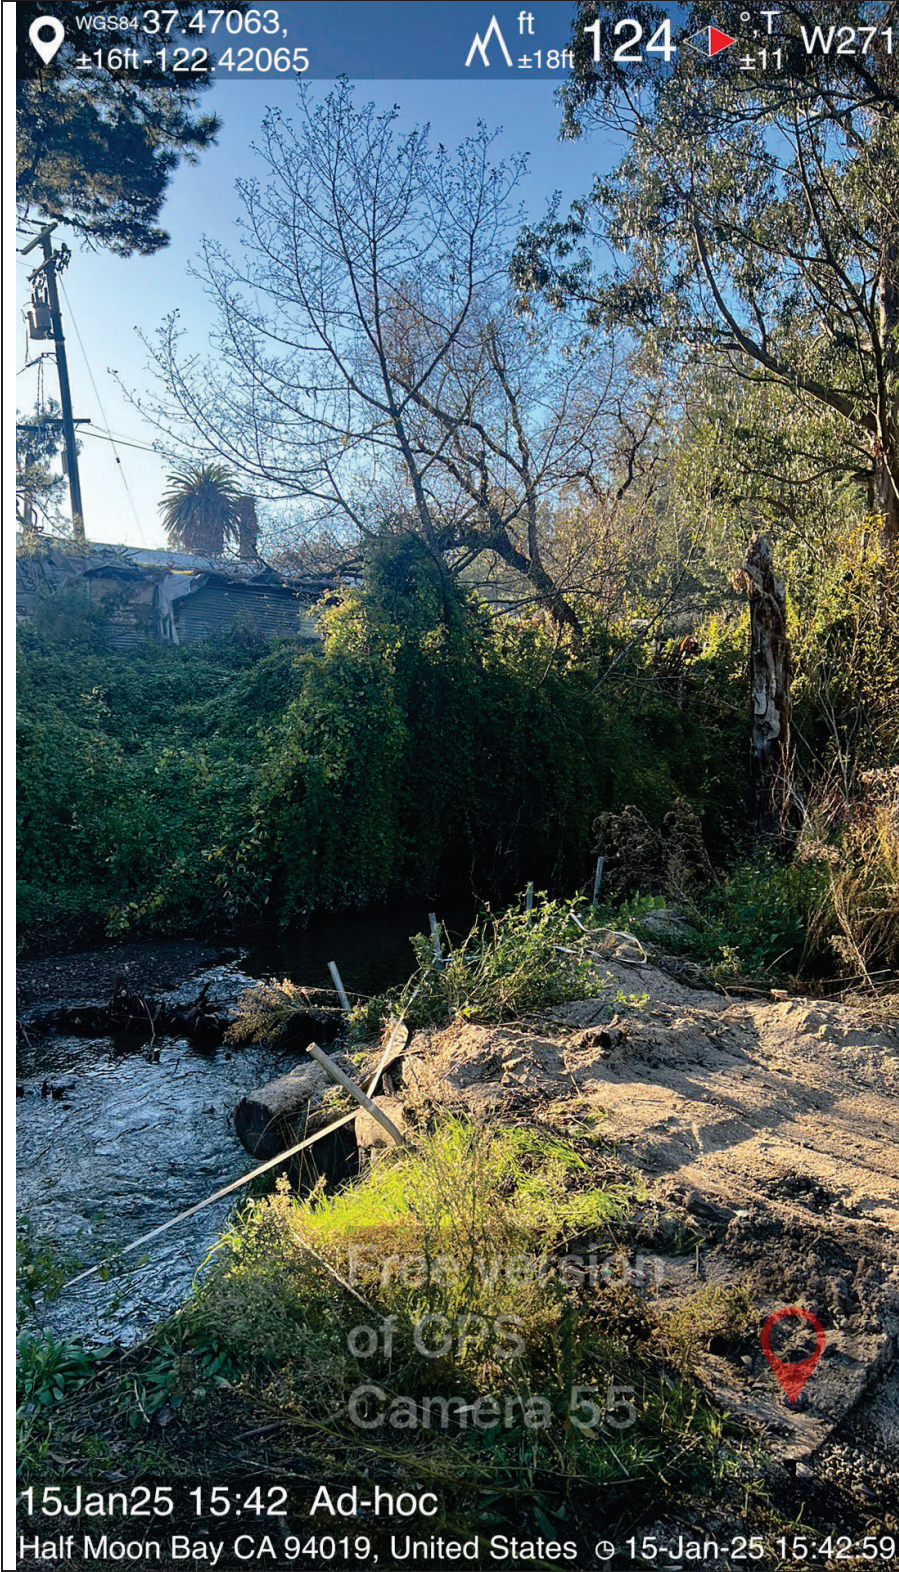
Photo 5. Action 4 – diversion structure removal location.

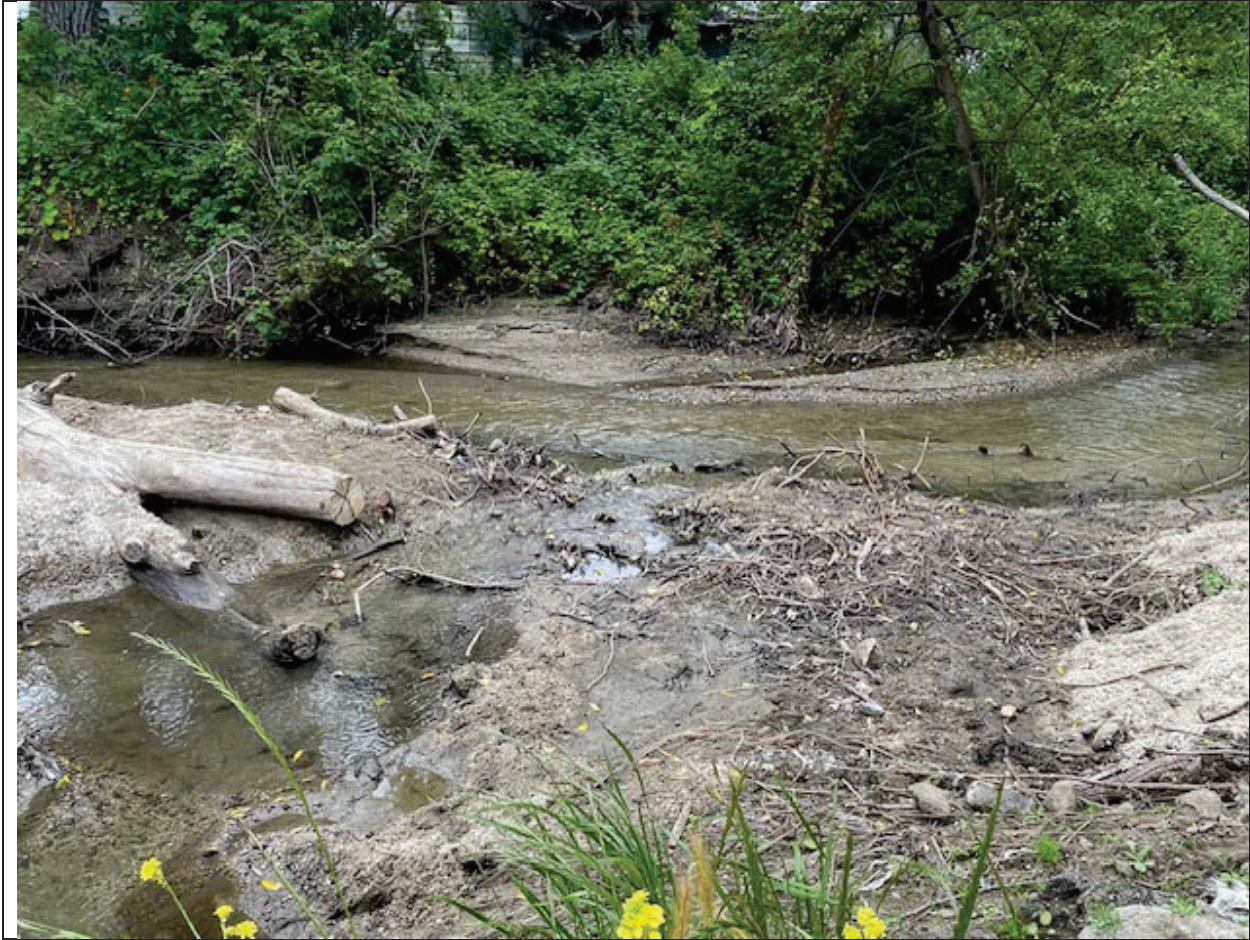
Photo 6. Action 4 – Diversion structure removed as of June 7, 2023
