**COUNTY OF SAN MATEO
PLANNING AND BUILDING DEPARTMENT**

SUBJECT: UPDATED REPORT: Consideration of a Planned Agricultural District Permit, Coastal Development Permit, and Grading Permit, to address facility and operational violations (VIO2023-00035) at Terra Gardens, including grading of 14,050 cubic yards (c.y.) associated with site clean-up, drainage/access improvements, and permitting existing work, located at 12761 San Mateo Road (Highway 92) within the unincorporated Half Moon Bay area of San Mateo County.

County File Number: VIO2023-00035, PLN2023-00334 (Smith/Guan)

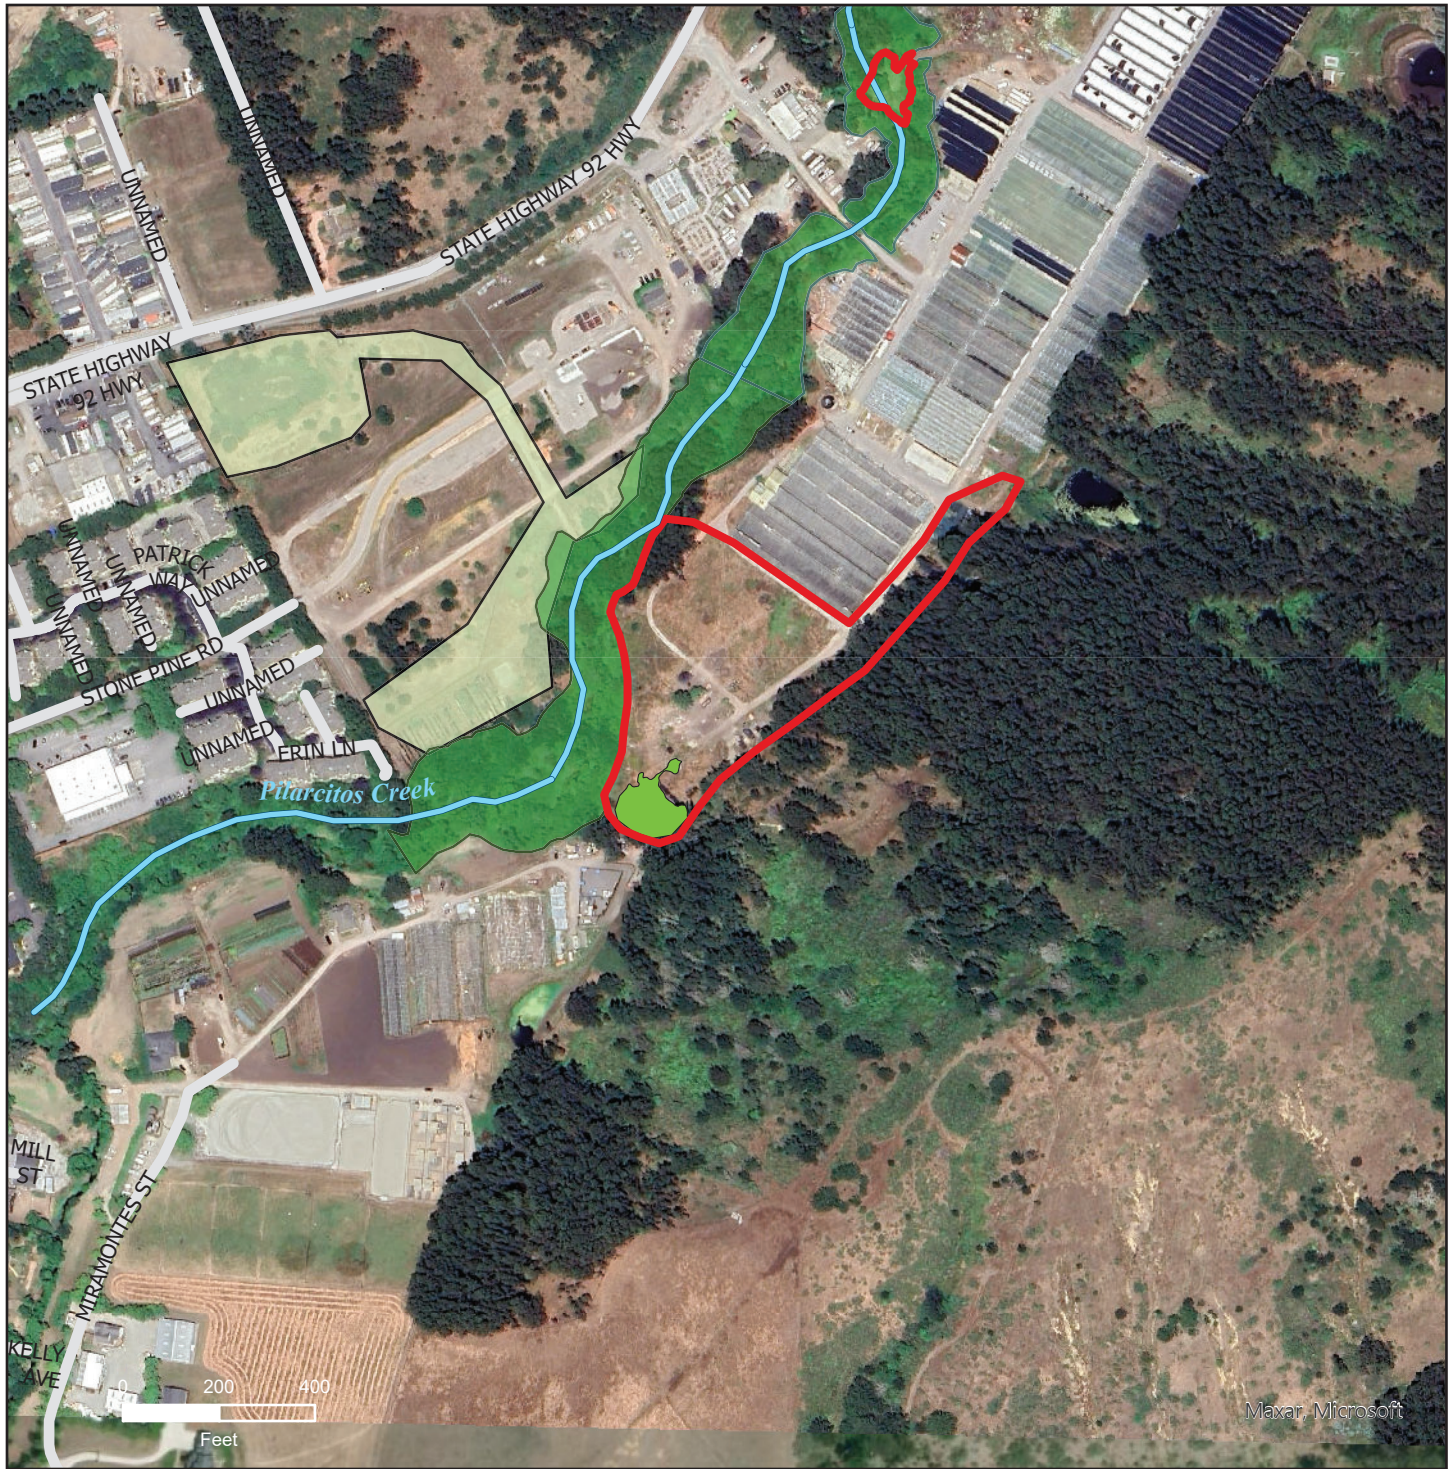
Attachment 2 Figure 6. Restoration Plan Area
 California Terra Garden, Half Moon Bay, CA

- Restoration Area
- City of Half Moon Bay Wildlife Corridor Conservation Area
- Streets
- Seasonal Wetland
- Riparian Habitat
- Pilarcitos Creek

Yes, approximately 0.22 acres of riparian habitat, and an additional 1.15 acre of riparian buffer area were impacted by project operations. The proposed habitat restoration area, approximately 5.3 acres located on the west side of the processing areas as shown in Attachment 4 (Figure 6 Proposed Restoration Plan Area) in the City of Half Moon Bay, is proposed in this area to offset the impacted areas.

Action 8: Restoration. Habitat restoration is proposed to offset temporal losses associated with areas of impact throughout the property. The proposed habitat restoration area is approximately 5.8 acres and is located on the west side of the processing areas as shown in Attachment 2 (Figure 6 Restoration Plan Area) and fully described within the accompanying HRMMP (Attachment 3). Habitat restoration is proposed in this area to offset 0.22 acres of impacts to riparian habitat, and an additional 1.10 acres of impacts to riparian buffers from activities as identified in the Biology Report; the proposed vegetated swale described under Action 6 will offset impacts to approximately 730 linear feet of drainage impacts.

In addition to the coastal wetland described in the Biology Report, a 0.26-acre coastal wetland feature (2-parameter) has been identified within the planned Restoration Area, as shown in Attachment 2, Figure 6. This feature appears to be formed as the result of a perched water table, with additional hydrological inputs from the former septic leach field, and an upstream drainage feature located adjacent to the southern property boundary. A slight depression is present at the southern end of the property. Wetland composition is predominantly herbaceous, with several small arroyo willow (*Salix lasiolepis*) shrubs established along the southern portions of the feature. Common rush (*Juncus effusus*) is the dominant species, occurring in relatively patchy clusters, interspersed with non-native grasses and forbs including harding grass (*Phalaris aquatica*), velvet grass (*Holcus lanatus*), bristly ox-tongue (*Helminthotheca echioides*) and poison hemlock (*Conium maculatum*). The native California blackberry (*Rubus ursinus*) is also present on the upper margins of the wetland feature. This feature may meet the definition of Waters of the U.S. and/or State.

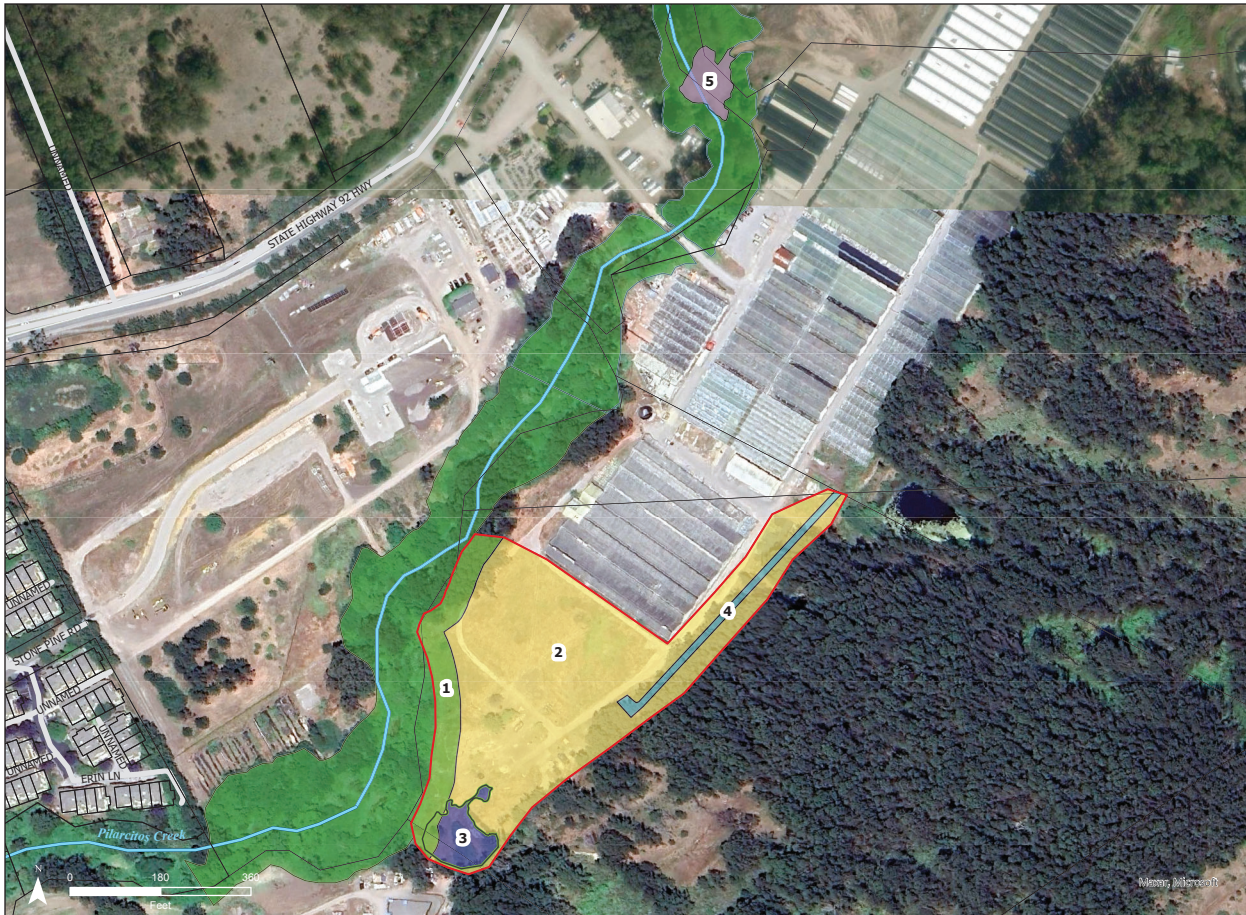
Figure 2. Vegetation Restoration Zones
 California Terra Garden, Half Moon Bay, CA

- Restoration Zones**
- 1-Riparian Setback Mitigation (0.80 ac)
 - 2-Upland Habitat Mitigation (4.54 ac)
 - 3-Seasonal Wetland Enhancement (0.26 ac)
 - 4-Vegetated Swale (0.20 ac)
 - 5-Riparian Habitat Restoration (0.22 ac)
