**COUNTY OF SAN MATEO  
PLANNING AND BUILDING DEPARTMENT**

**SUBJECT:** EXECUTIVE SUMMARY: Consideration of an appeal of the Director of Planning and Building's decision to adopt an Initial Study/Mitigated Negative Declaration (MND) pursuant to the California Environmental Quality Act (CEQA) and approve a Design Review Permit, Coastal Development Permit (CDP), and Grading Permit, for the construction of a new 2,653 sq. ft., three-story, single-family residence with attached 625 sq. ft. garage on a legal 6,000 sq. ft. parcel located at the corner of 15th Street and East Avenue in the unincorporated area of Montara. The project includes the removal of 19 significant trees and 435 cubic yards (c.y.) of grading (300 c.y. of cut and 135 c.y. of fill). The CDP is appealable to the California Coastal Commission.

County File Number: PLN2014-00490 (Wilkins)

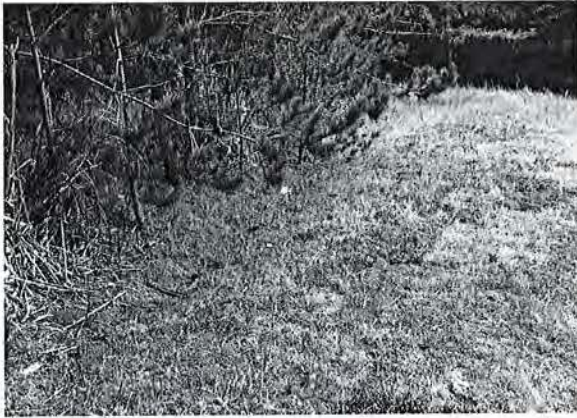
A convergence of topography is seen on the proposed driveway; however, no hydrologic, vegetative, or soil indicators as described in the 2017 report are currently present.

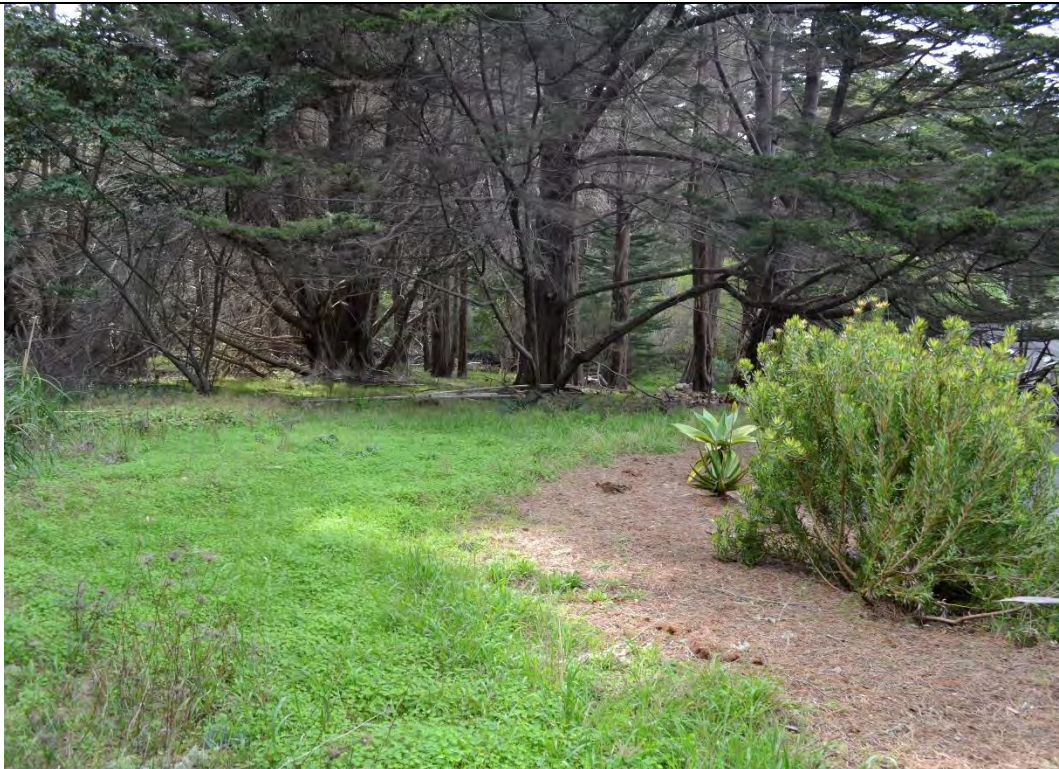
Photo 4. Northeast side of planned residence location.
