# Aquatic Resources Delineation

## Granada Community Park and Recreation Center Project

### El Granada, San Mateo County, California

August 18, 2025

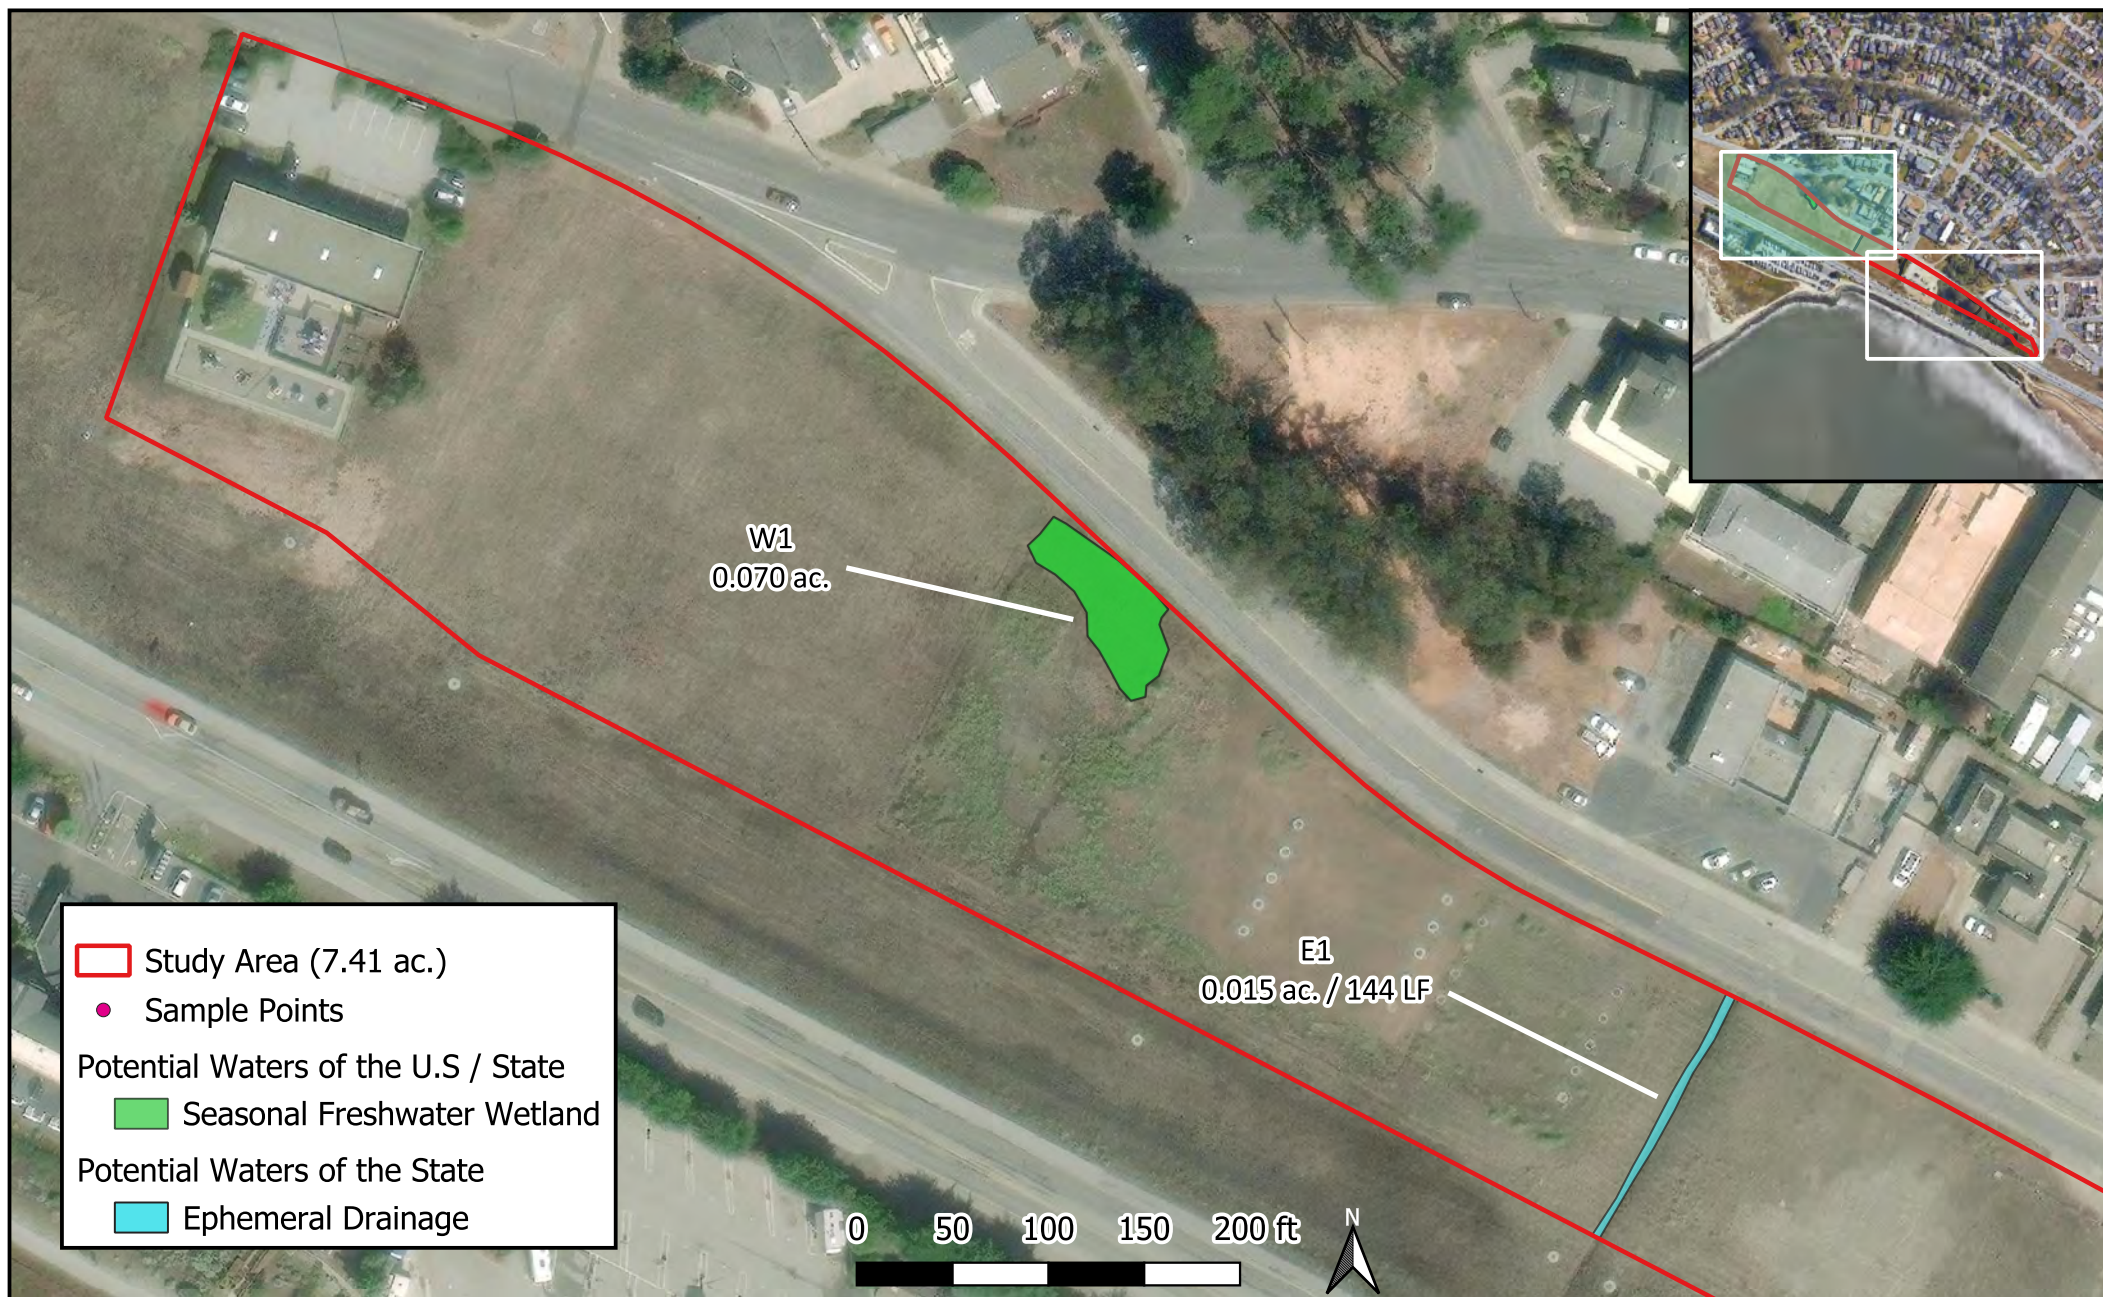
## Figure 7a. Potential Waters of the U.S. / Waters of the State

Within the Study Area, 0.106 acres of potential waters of the United States were identified and mapped, comprising 0.070 acres of wetlands and 0.036 acres of non-wetland waters. There was a total of 0.106 acres of waters of the state identified, comprised of 0.036 acres of intermittent drainage, 0.015 acres of ephemeral drainage, and 0.070 acres of wetlands. A total of 1.291 acres of CDFW jurisdictional habitats were identified, comprised of 1.24 acres of riparian vegetation, 0.015 of ephemeral drainage and 0.036 acres of intermittent drainage. Elements identified under CCC jurisdiction include the 1.24 acres of riparian vegetation with a 30-foot buffer, 0.070 acres of freshwater wetland with a 100-foot buffer, 0.015 acres of ephemeral drainage and 0.036 acres of intermittent drainage. See Table 1 below for a summary of aquatic resources identified.

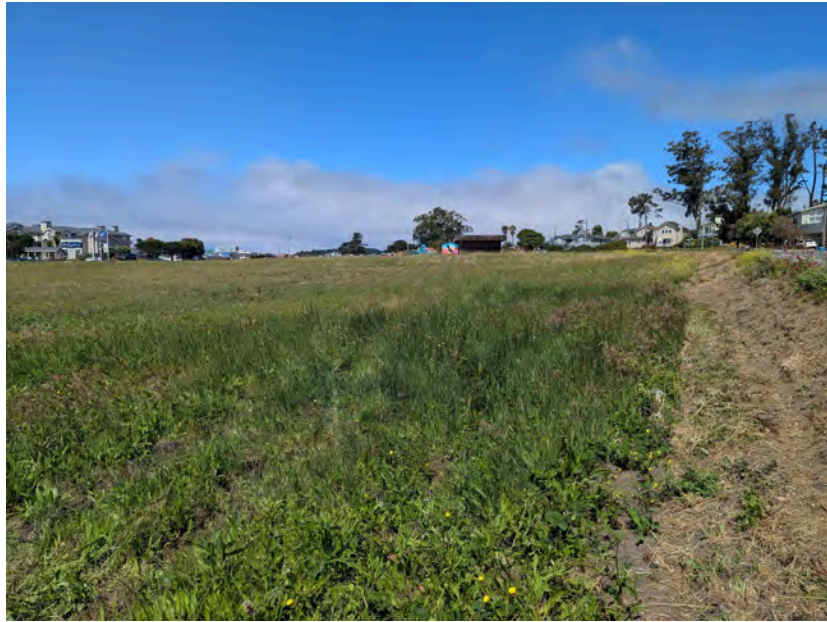
Photograph 1. View of the potential seasonal freshwater wetland. Notice the darker shade of green from the presence of *Schoenoplectus pungens*, an obligate wetland species. Photo taken facing west on 7/9/25.

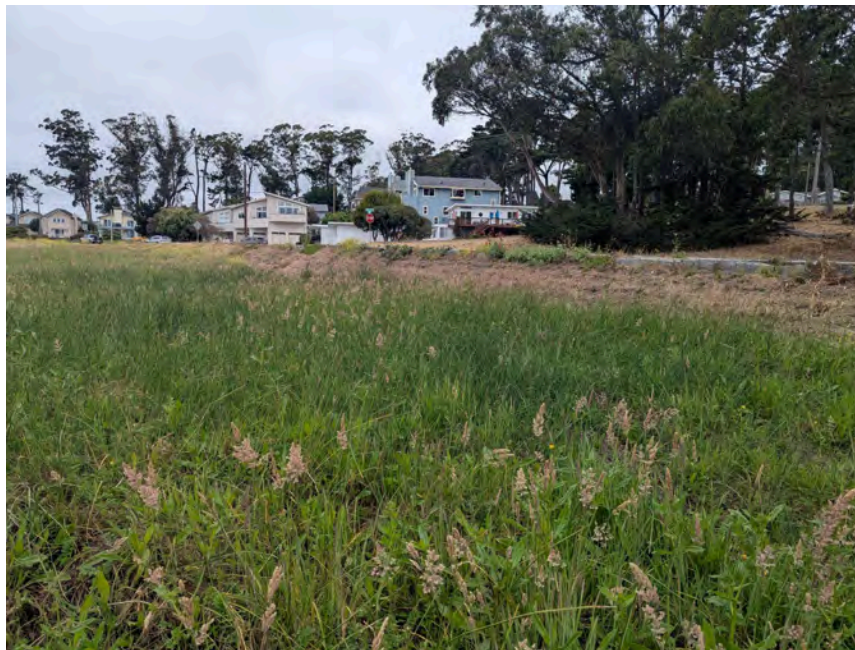
Photograph 2. Second View of the potential wetland. Note the slight concave position of the darker vegetation (*Schoenoplectus pungens*). Photo taken facing northwest on 7/9/25.

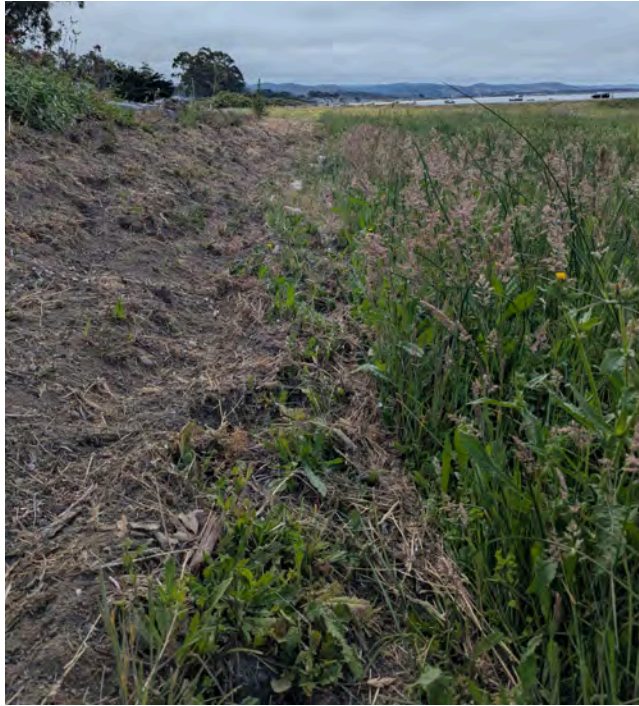
Photograph 3. Edge of potential wetland, adjacent to a maintained and barren slope along Obispo Road. Photo taken facing southeast on 7/9/25.

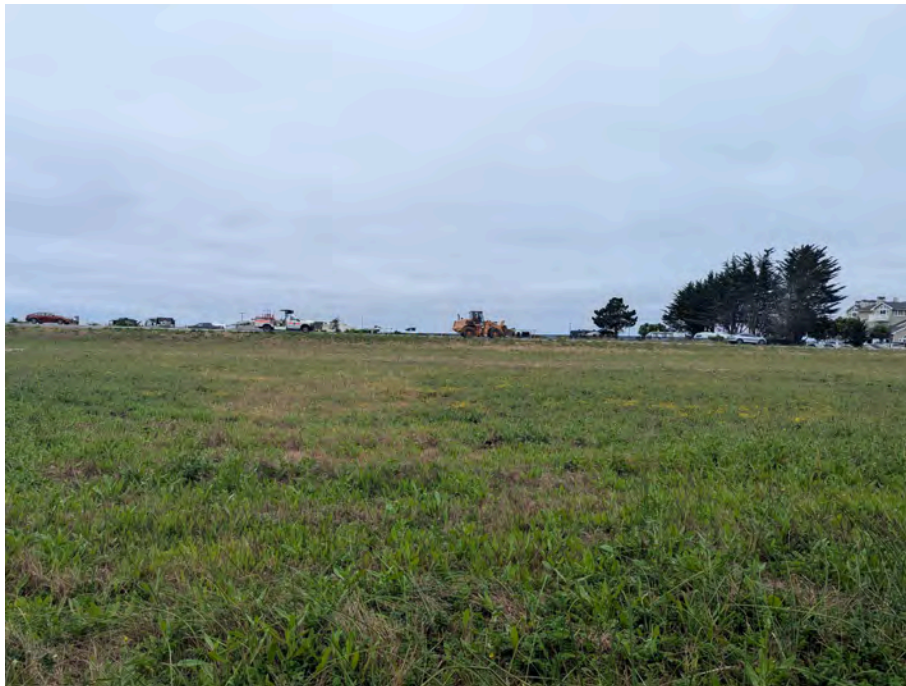
Photograph 4. View of ruderal grassland uplands surrounding the potential wetland. During a site visit in June 2025, clear mowing marks across the grassland and wetland were observed. Photo taken facing southwest on 7/9/25.

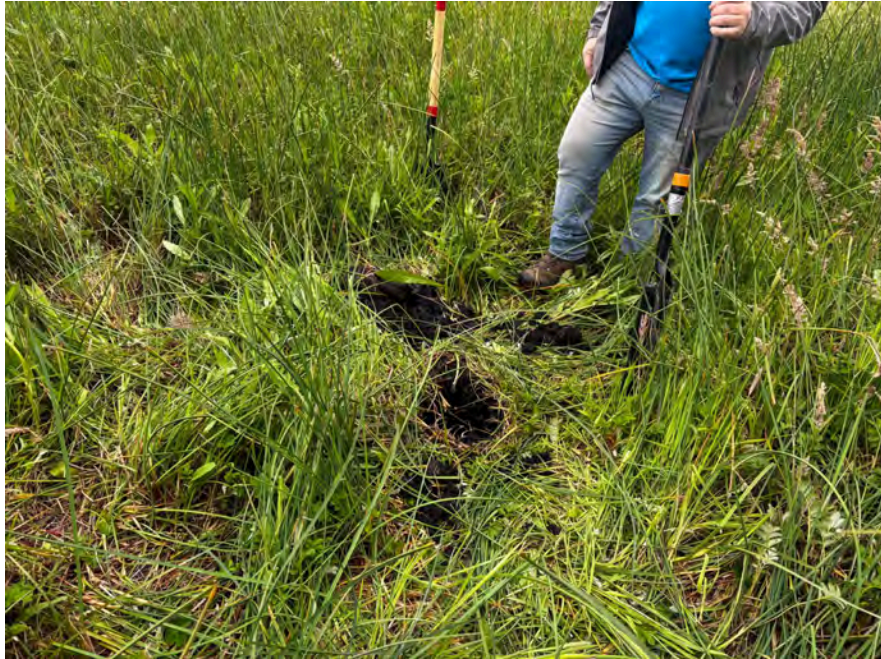
Photograph 5. Location of Sample Point 1, located in the potential USACE wetland. Note the abundance of bullrush (*Schenoplectus pungens*, OBL). Photo taken on 7/9/25.

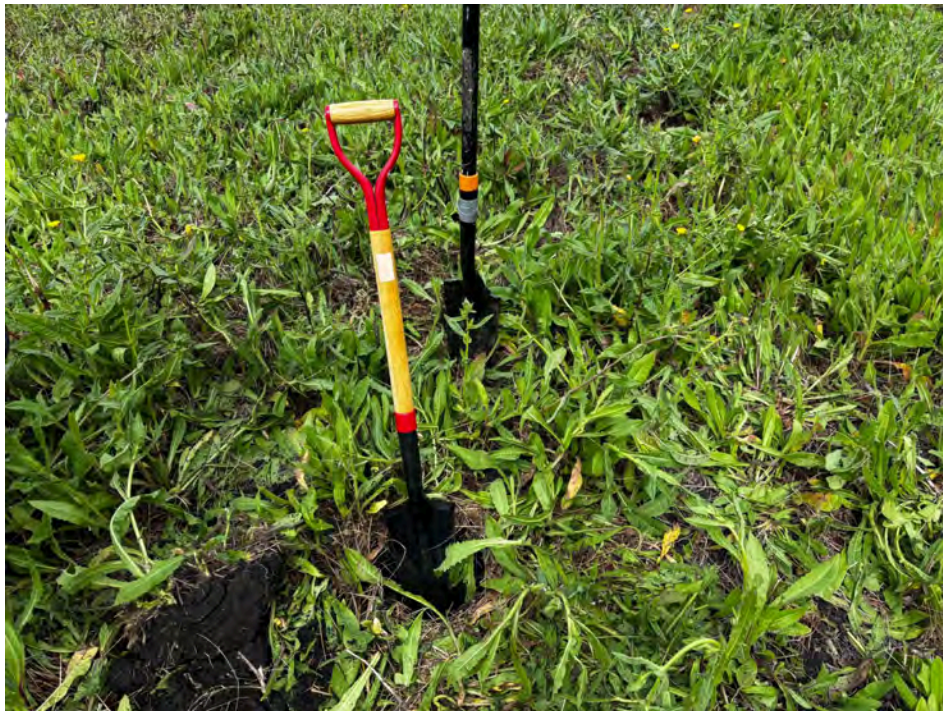
Photograph 6. Location of Sample Point 2, located outside of the potential wetland. Although bristly ox tongue dominated the vegetation, that is likely only due to recent mowing of the ruderal grasses.

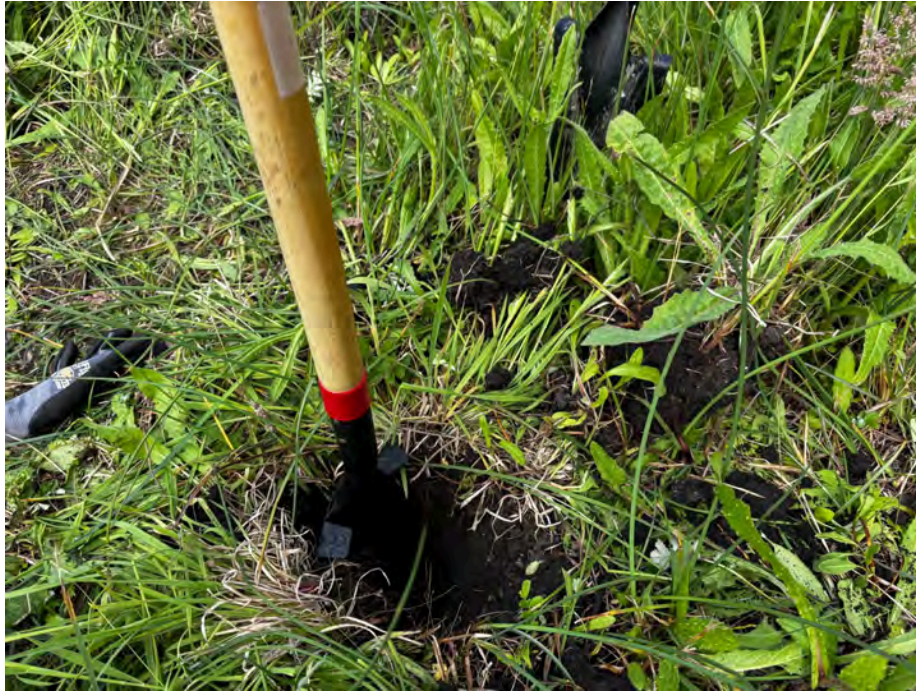
Photograph 7. Location of Sample Point 3, located inside of the potential wetland. Photo taken on 7/9/25.

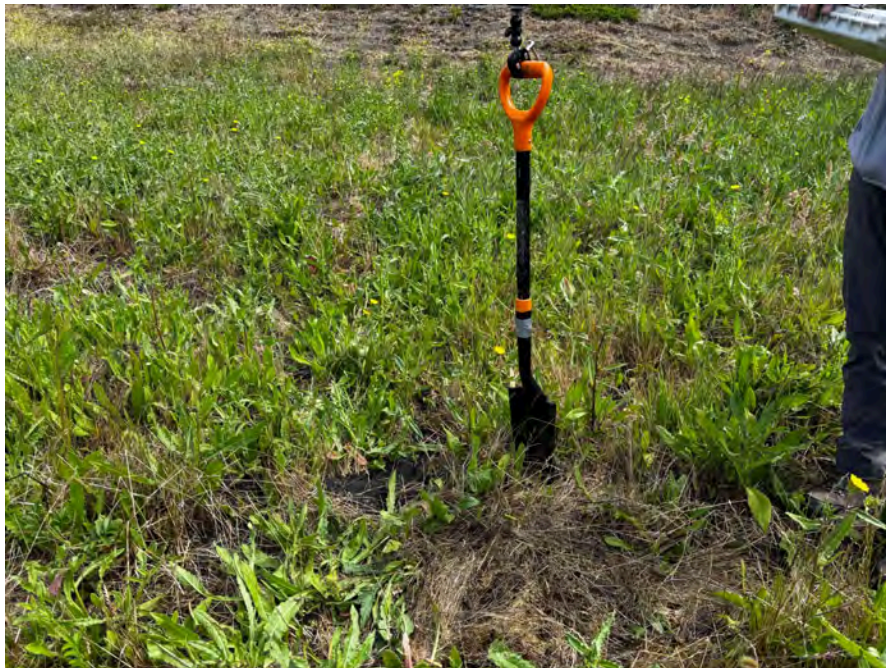
Photograph 8. Location of Sample Point 4, outside of the potential wetland. Note the abundance of dried, trampled, and mowed grass. Photo taken on 7/9/25.

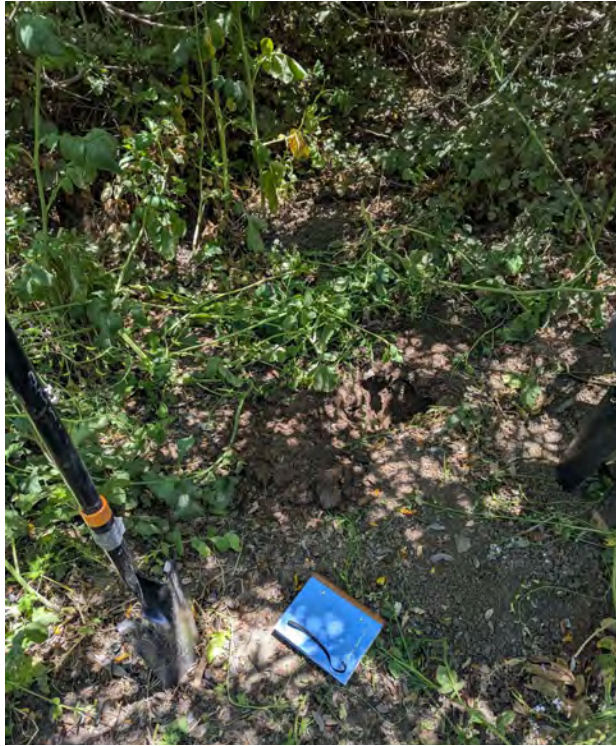
Photograph 9. Location of Sample Point 5, in an upland adjacent to the eastern intermittent drainage underneath the willow thicket.

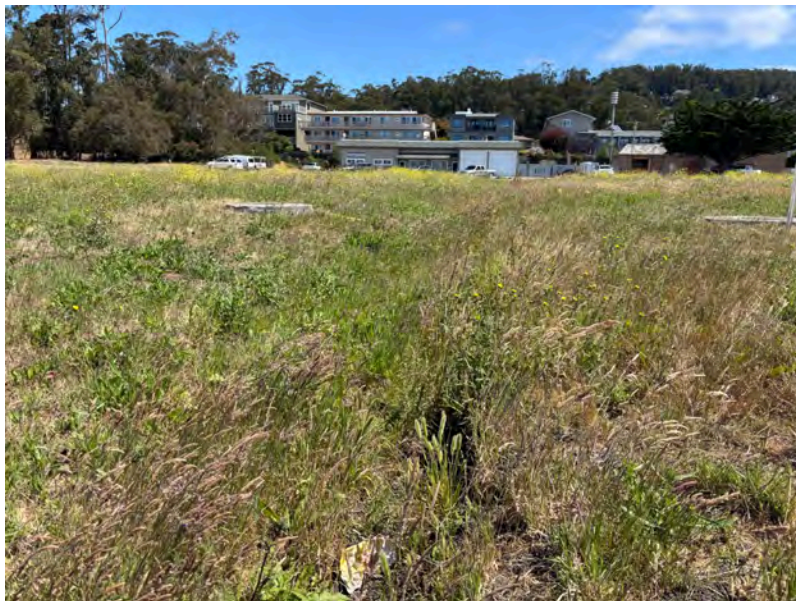
The ephemeral drainage comprises 0.015 acres of the Study Area, cutting through the non-native grassland in a straight line from Obispo Road to the culvert leading to the Pacific Ocean. It has minimal presence of annual riparian vegetation. During the July site visit, no flowing nor standing water was observed in the drainage. The drainage is fed by runoff from the unincorporated community of El Granada within the Santa Maria watershed.

Photograph 10. View of the non-jurisdictional ephemeral drainage in the ruderal grassland to the western side of the study area. Photo taken facing northeast on 7/9/25.

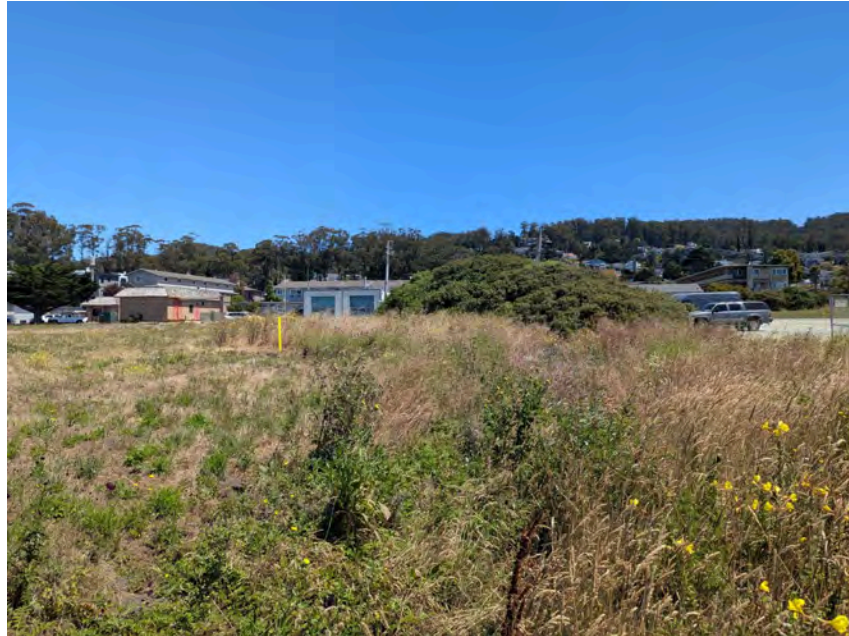
Photograph 11. View of the intermittent drainage in the middle of the site, adjacent to the existing hardscaped parking lot. Photo taken facing northeast on 7/9/25.

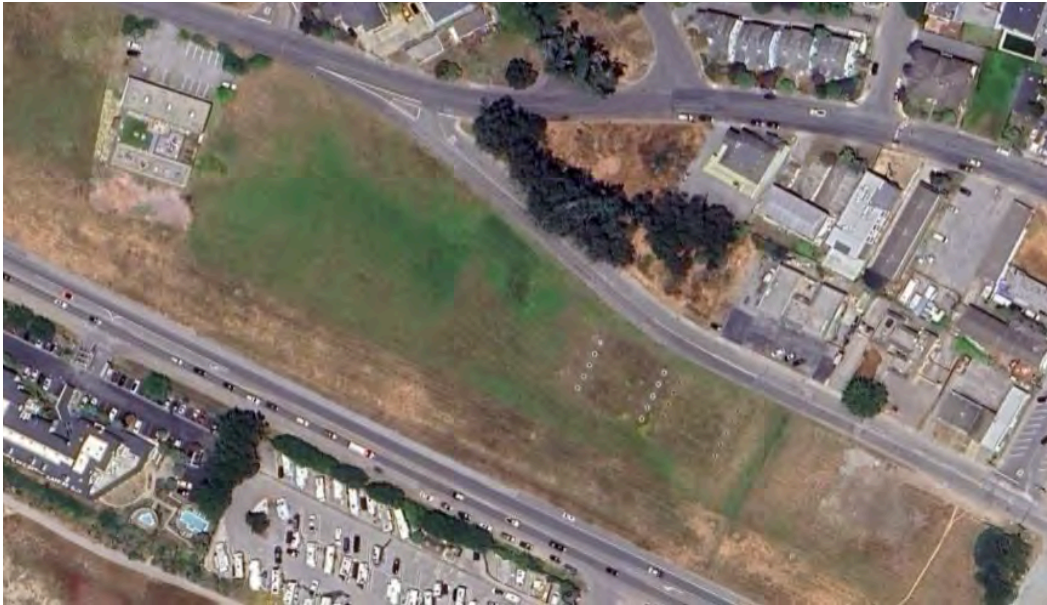
Photograph 1. Google Earth aerial image of the potential wetland from July 30, 2023. Note the darker area of vegetation, which is likely due to saturation of the area throughout the dry season.

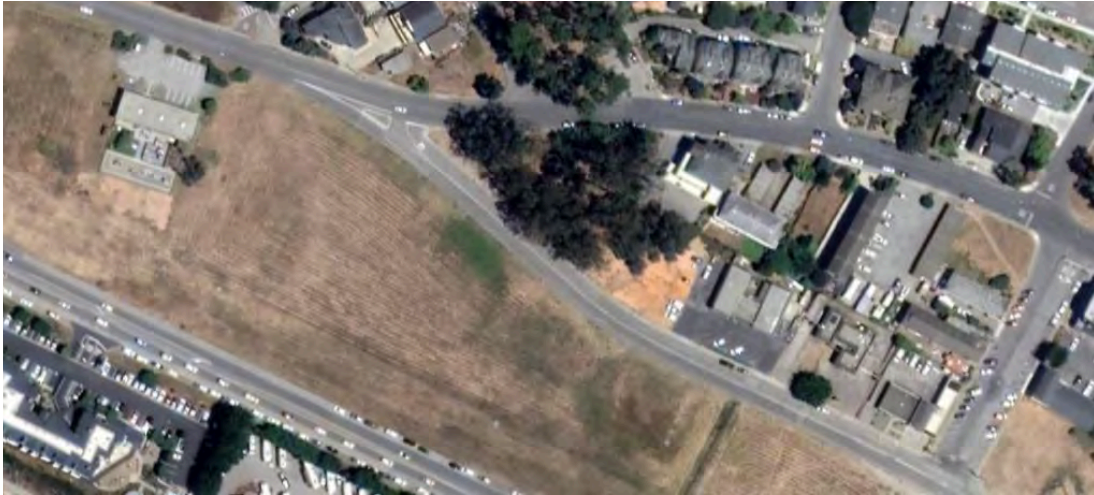
Photograph 3. Google Earth aerial image of the potential wetland from July 30, 2020. Note the presence of mowing tracks throughout the grassland and potential wetland.

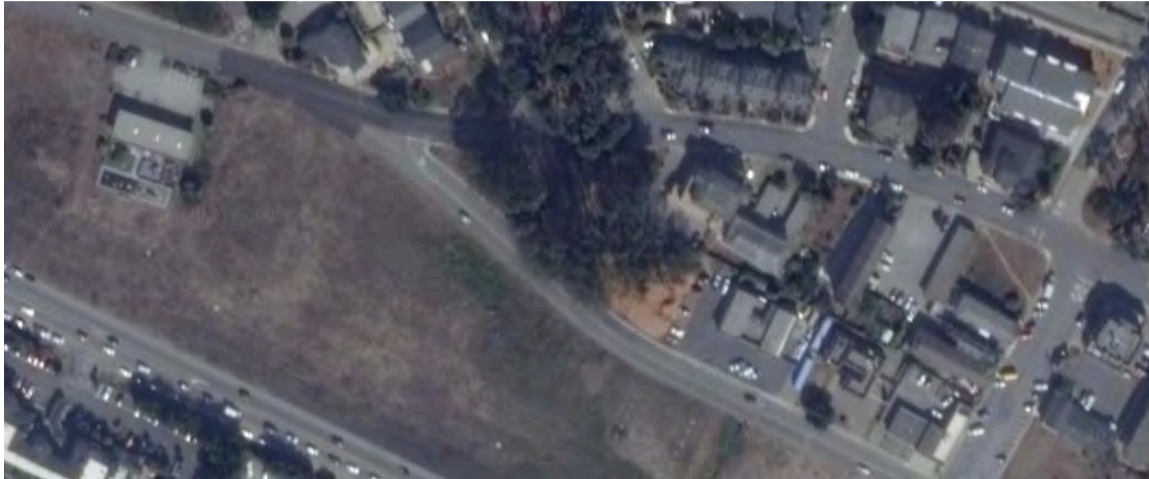
Photograph 5. Google Earth aerial image of the potential wetland from October 30, 2017. The area of greener vegetation and saturation is present from at least this year onward.
