# CORDILLERAS MENTAL HEALTH CENTER REPLACEMENT PROJECT

## DRAFT ENVIRONMENTAL IMPACT REPORT APPENDICES

## Cordilleras Health System Replacement Project EIR

### Appendix A: Notice of Preparation and Public Scoping Comments

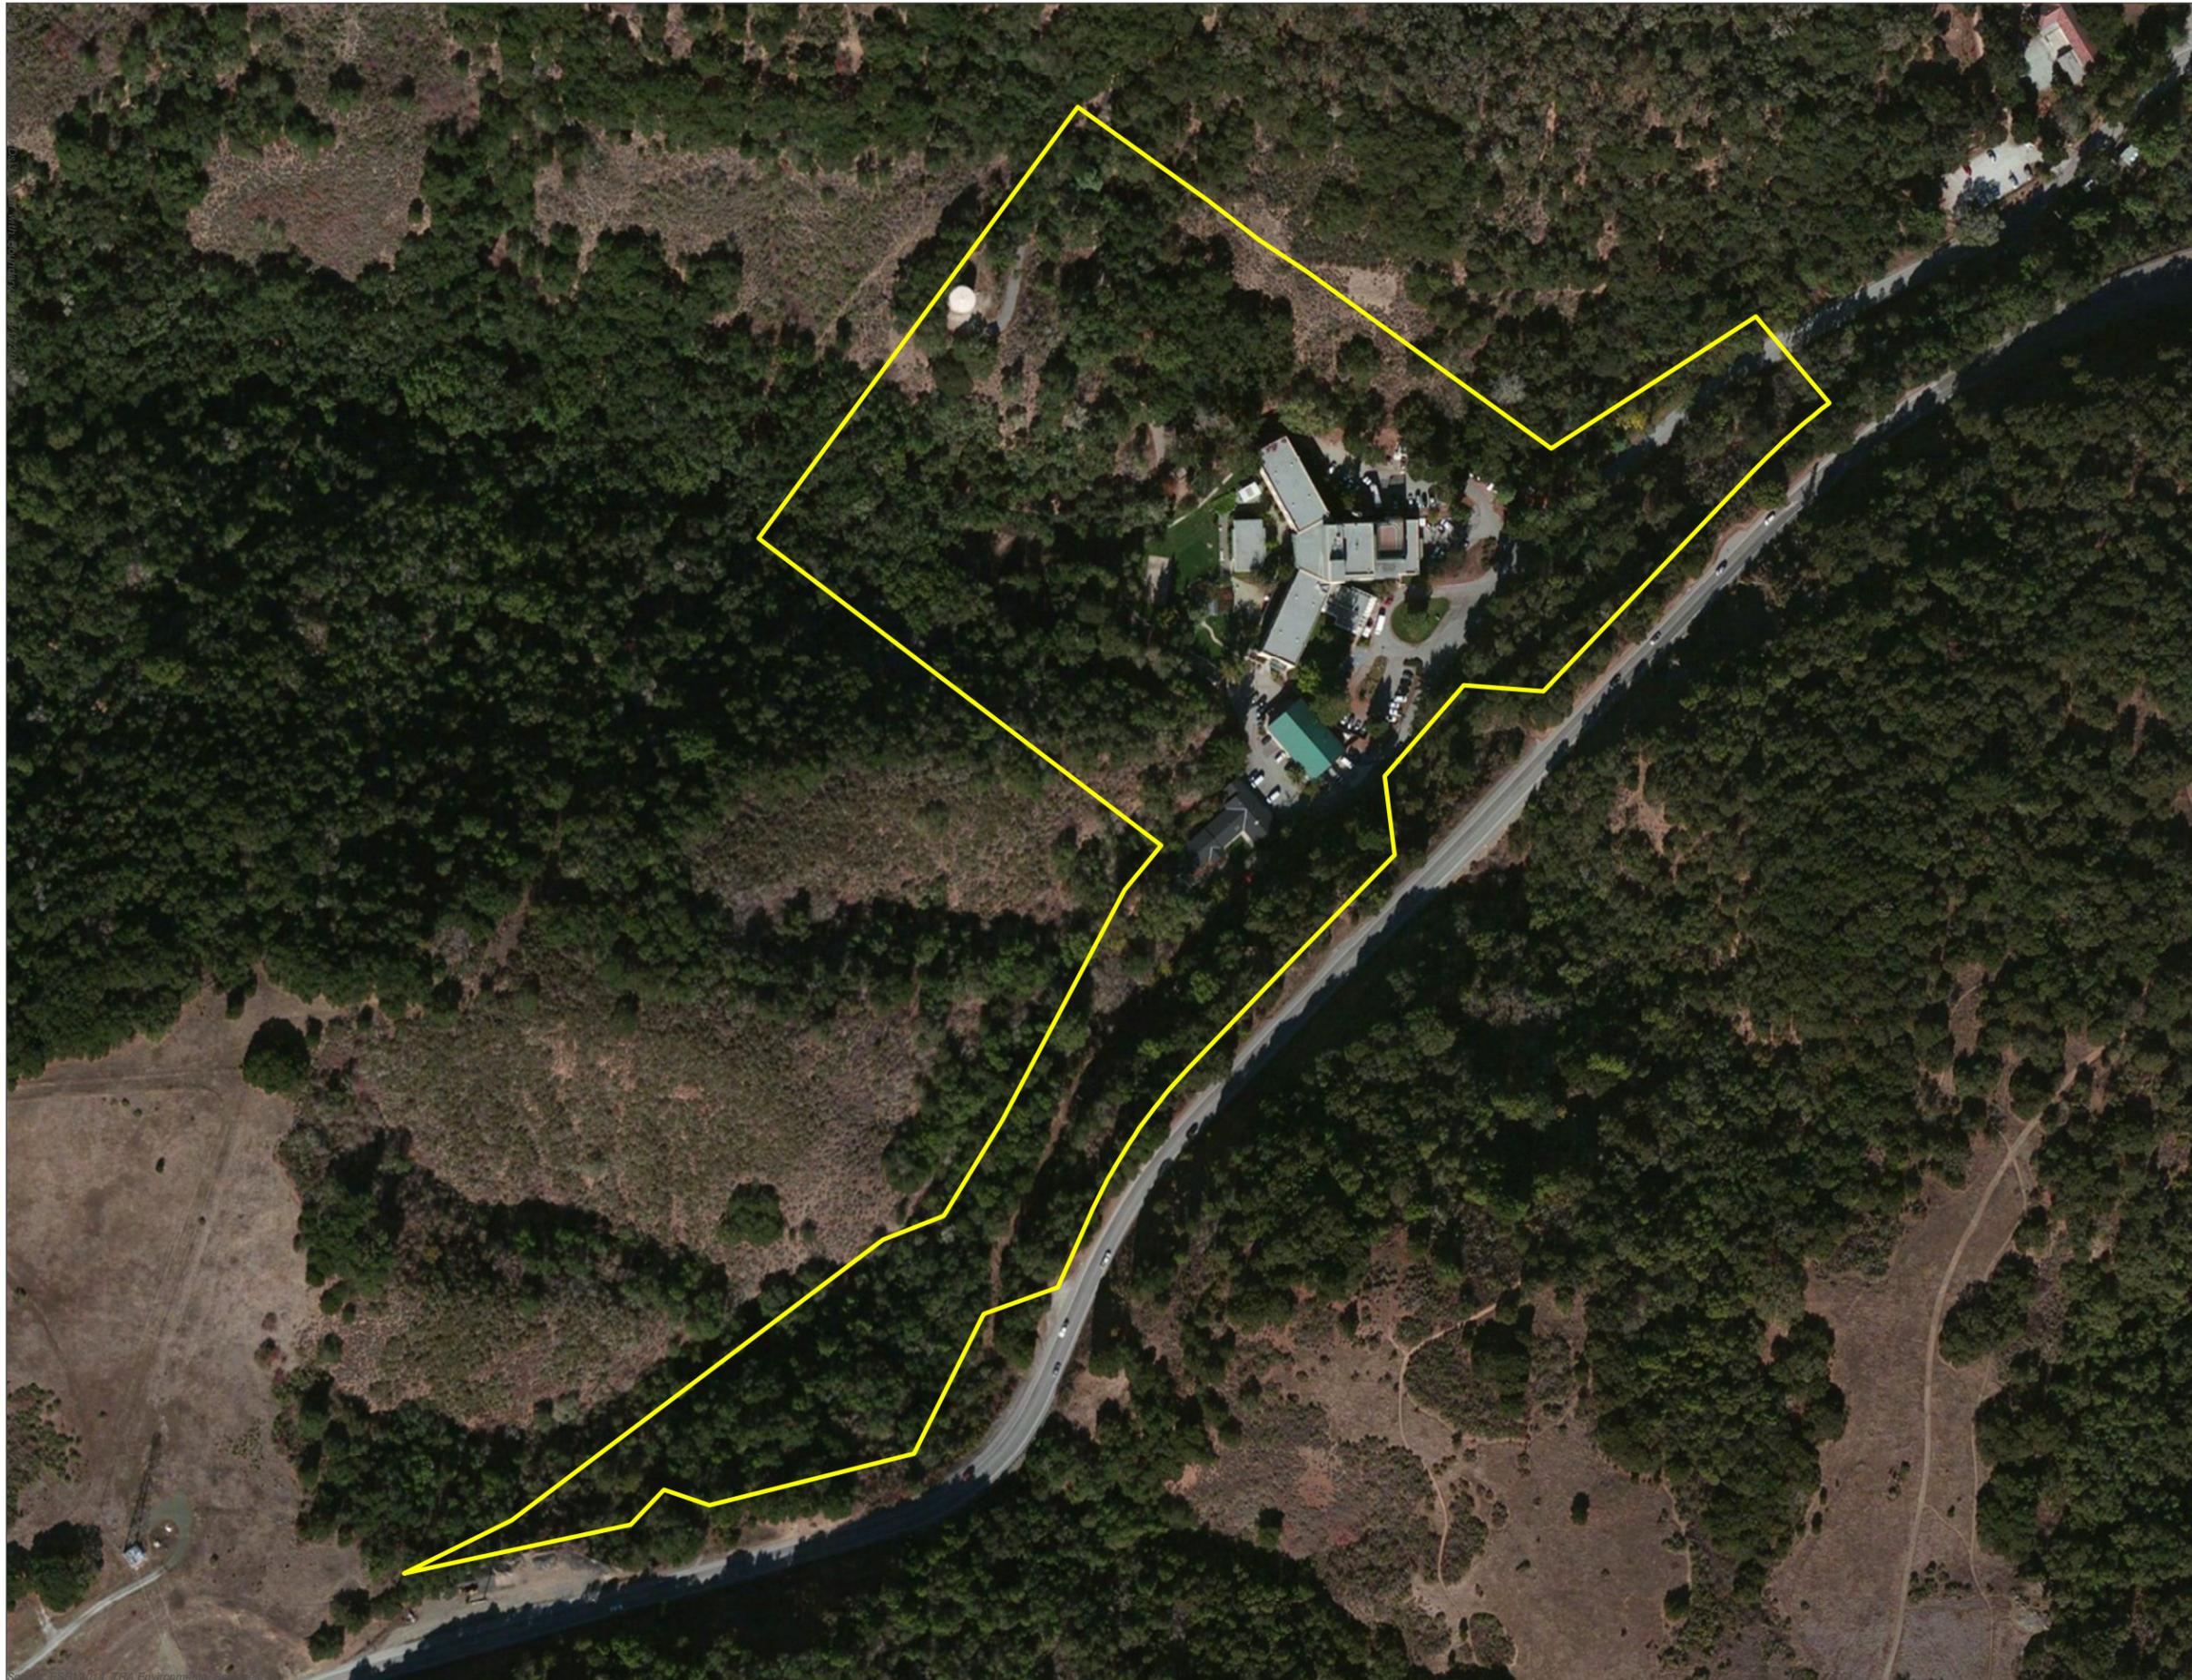
**Figure 4**  
Site Topography and Vegetation

- Top of Bank
- - - Culvert
- Low Flow Channel
- Annual Grassland
- Coastal Sage Scrub
- Developed
- Mixed Live Oak Woodland
- Riparian

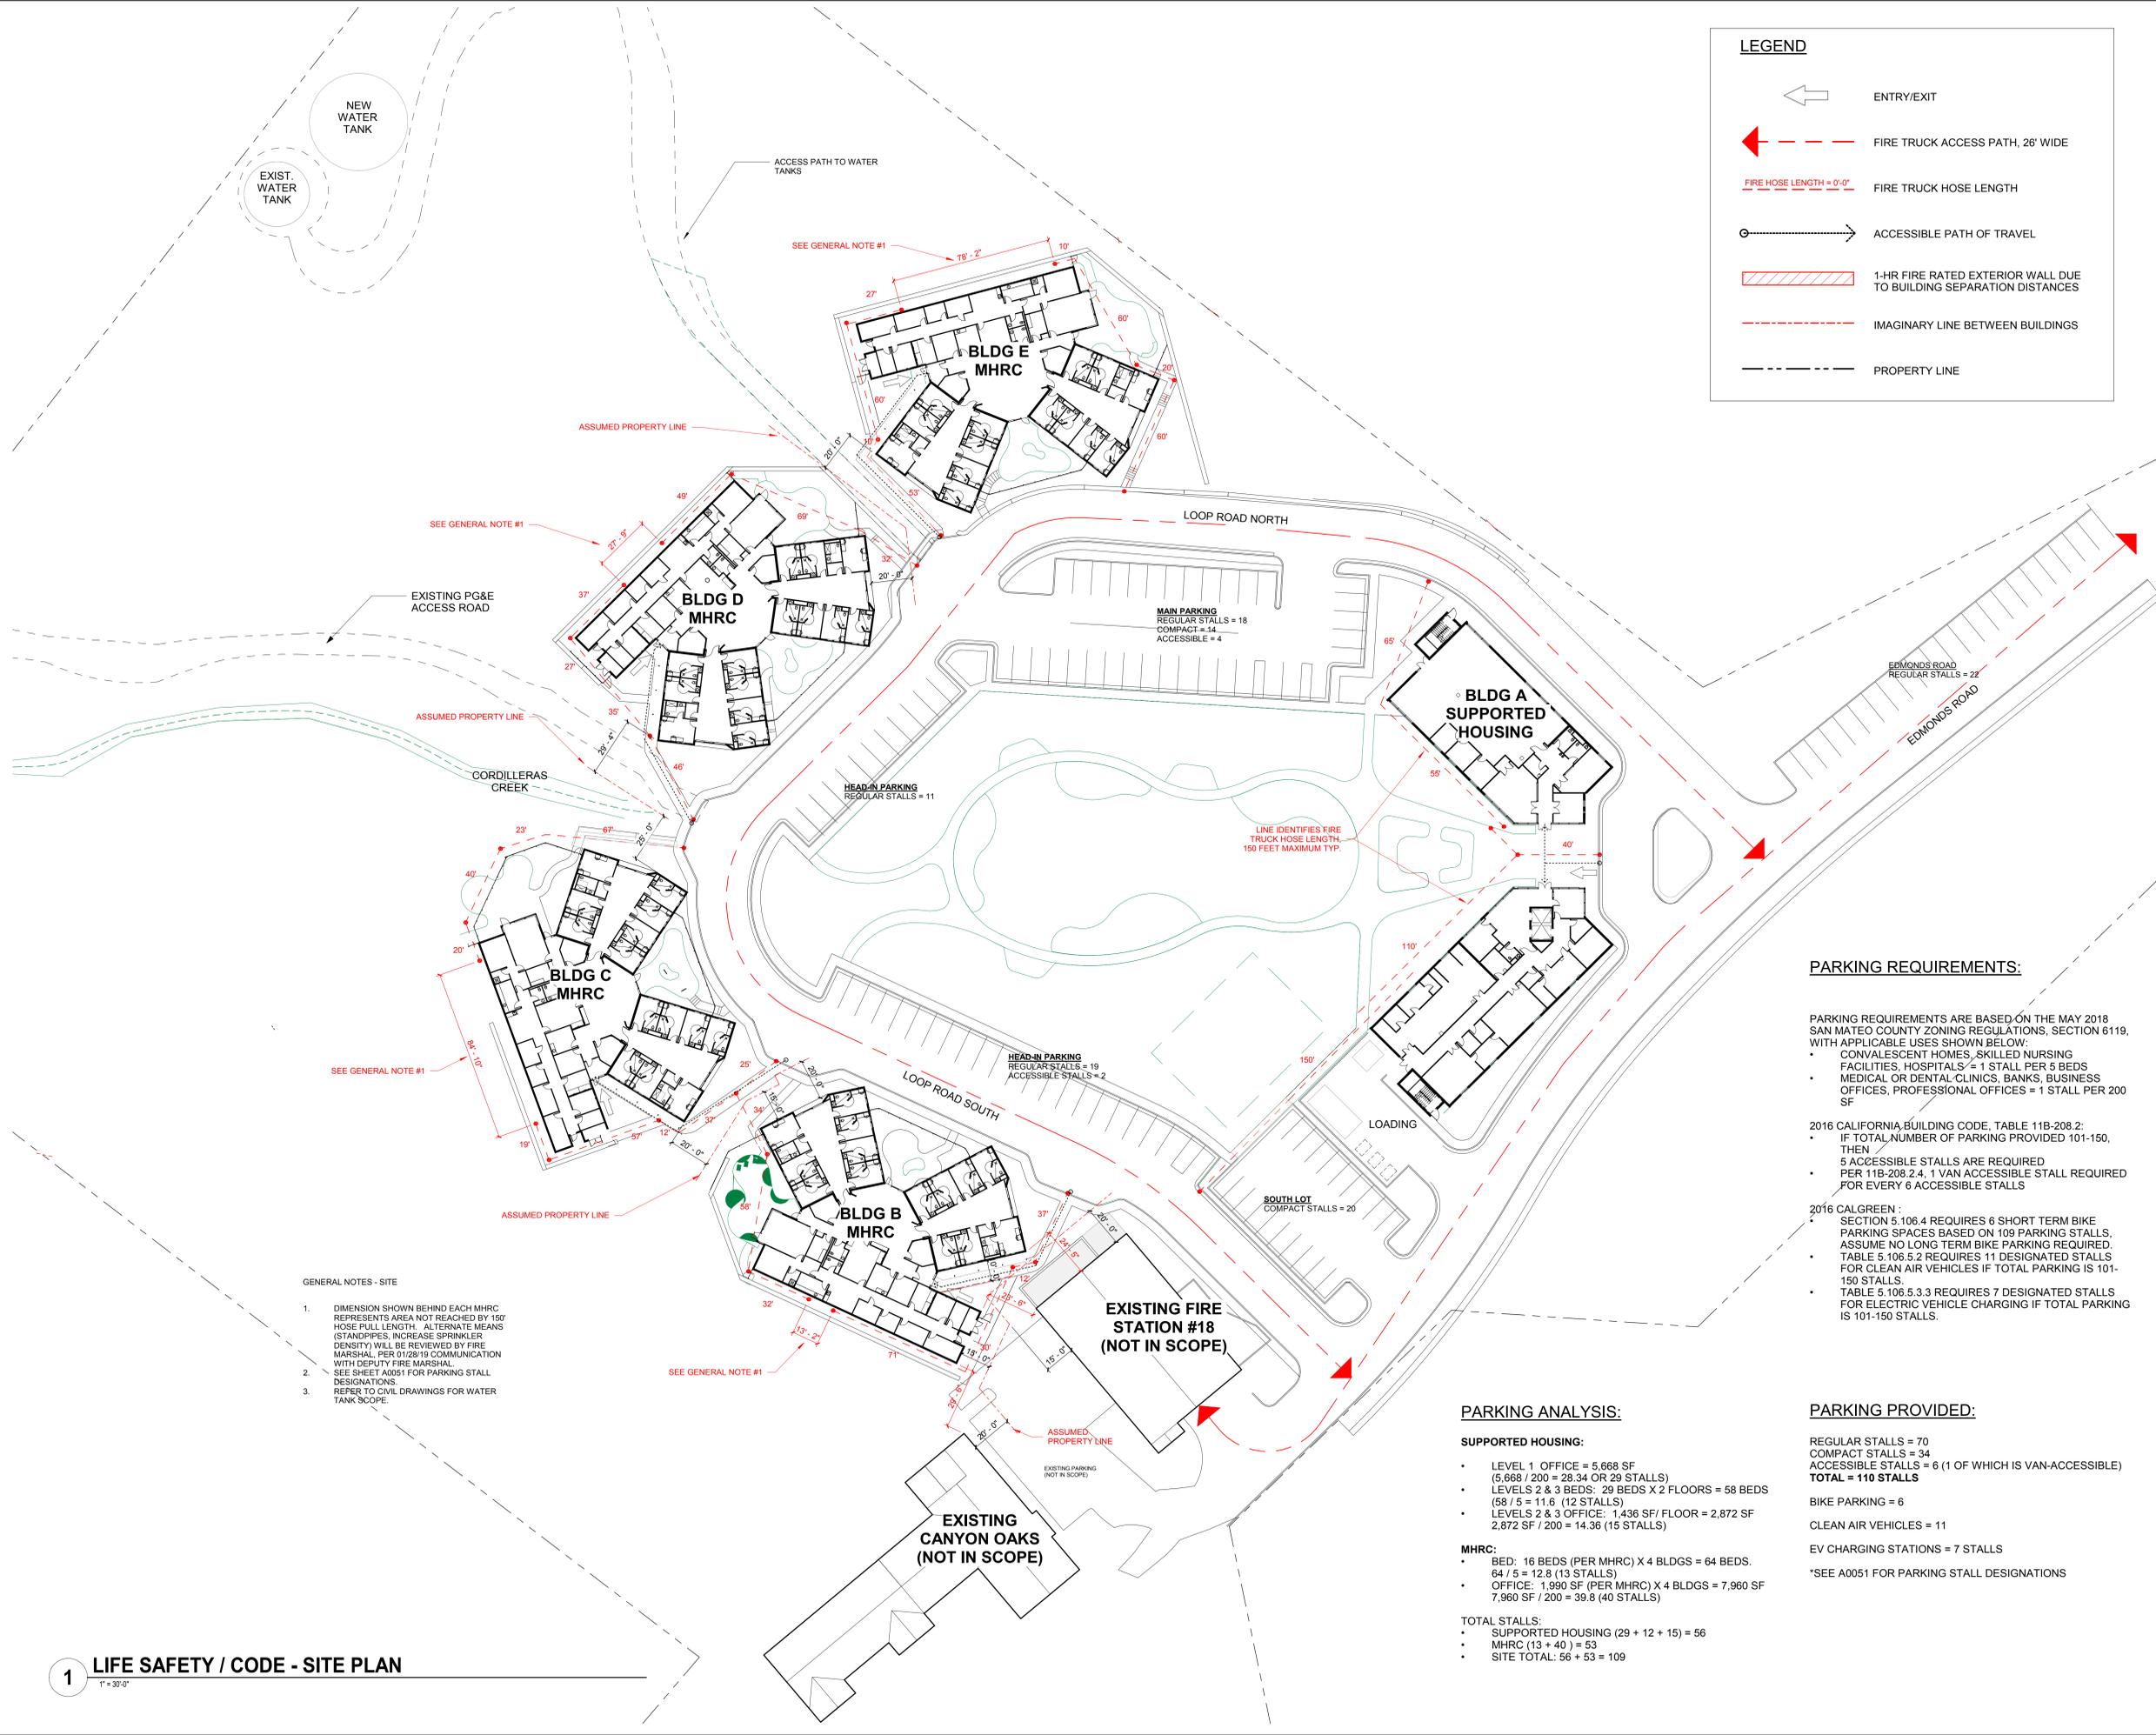
**G0051**

- GENERAL NOTES - SITE**
- DIMENSION SHOWN BEHIND EACH MHRC REPRESENTS AREA NOT REACHED BY 150' HOSE PULL LENGTH. ALTERNATE MEANS (STANDPIPES, INCREASE SPRINKLER DENSITY) WILL BE REVIEWED BY FIRE MARSHAL. PER 01/28/19 COMMUNICATION WITH DEPUTY FIRE MARSHAL. SEE SHEET A0051 FOR PARKING STALL DESIGNATIONS. REFER TO CIVIL DRAWINGS FOR WATER TANK SCOPE.
  - SEE SHEET A0051 FOR PARKING STALL DESIGNATIONS.
  - REFER TO CIVIL DRAWINGS FOR WATER TANK SCOPE.

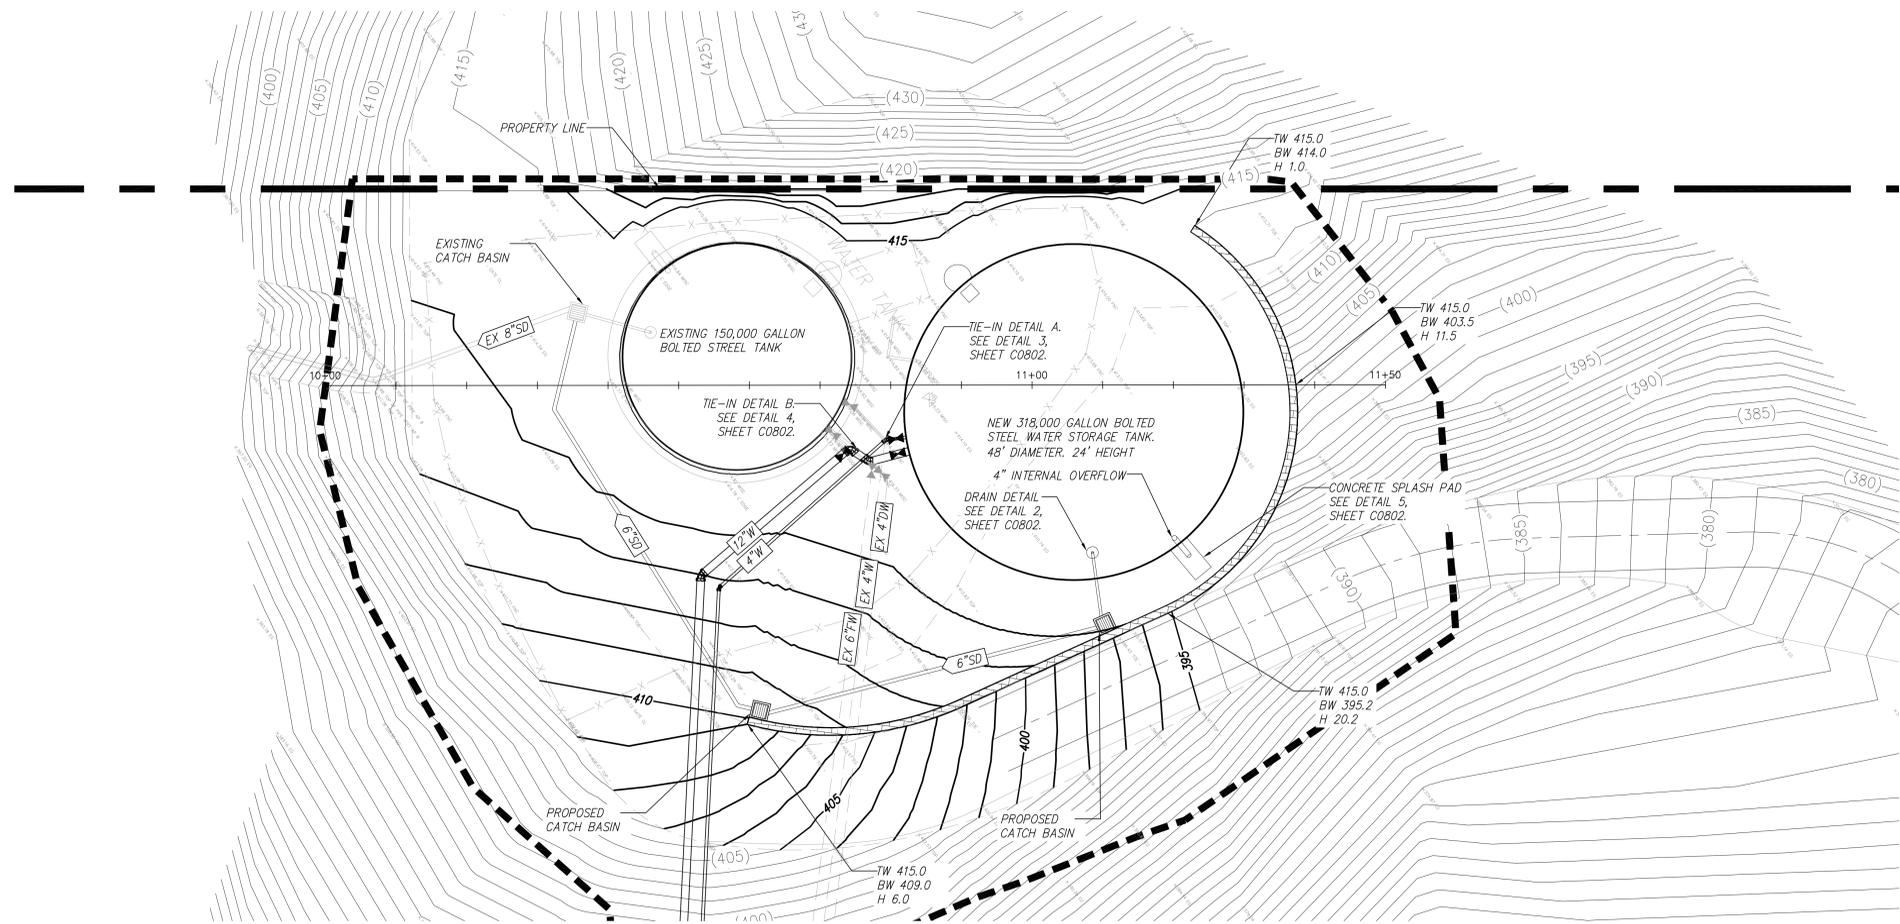
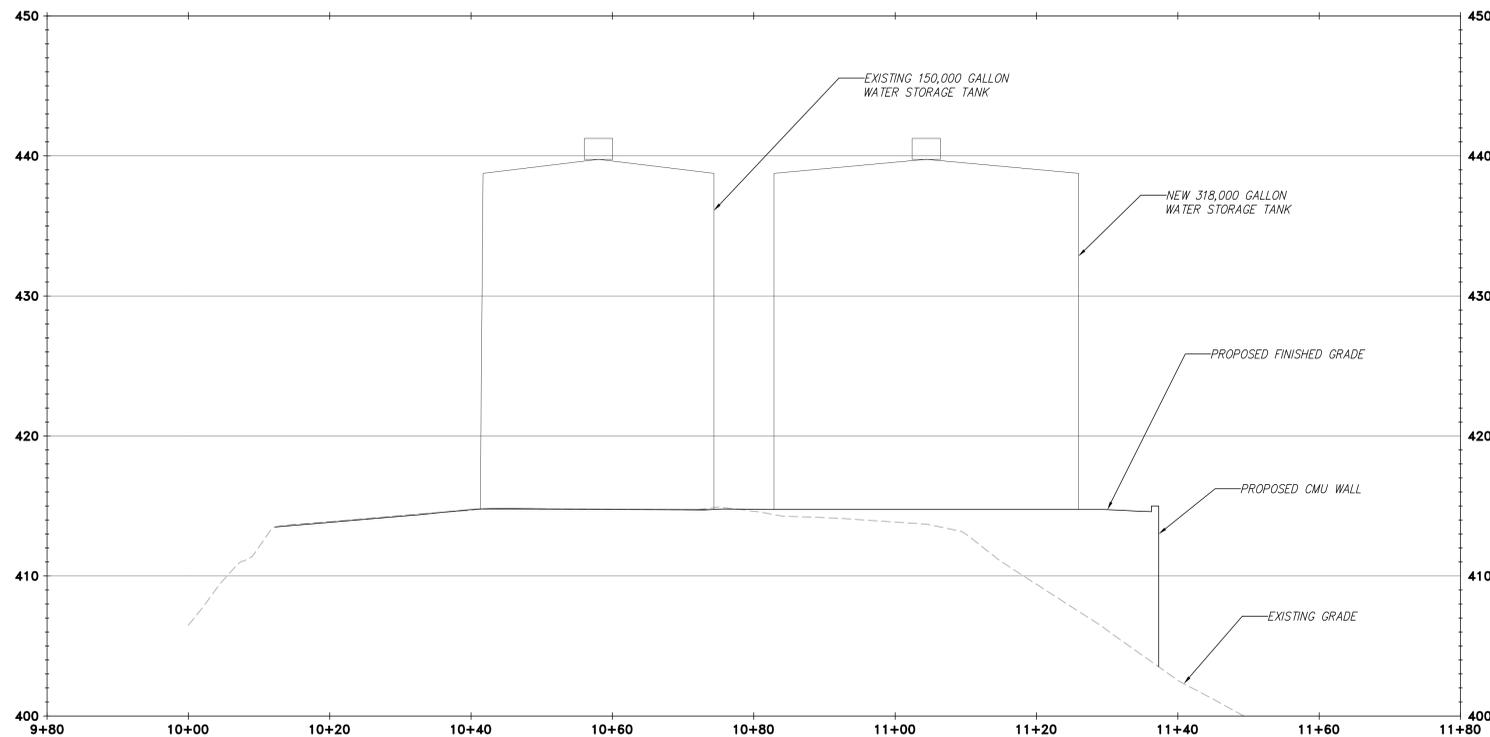
**WATER STORAGE TANK PLAN**

**TANK PROFILE**  
HORIZONTAL SCALE: 1"=10'  
VERTICAL SCALE: 1"=5'

ADDITIONAL TANK  
TYPE IIIA CONSTRUCTION 39,700 SF MAX  
2,750 GPM FIREFLOW  
2 HOUR DURATION  
SPRINKLER DEMAND 1,000 GPM  
30 MINUTE DURATION

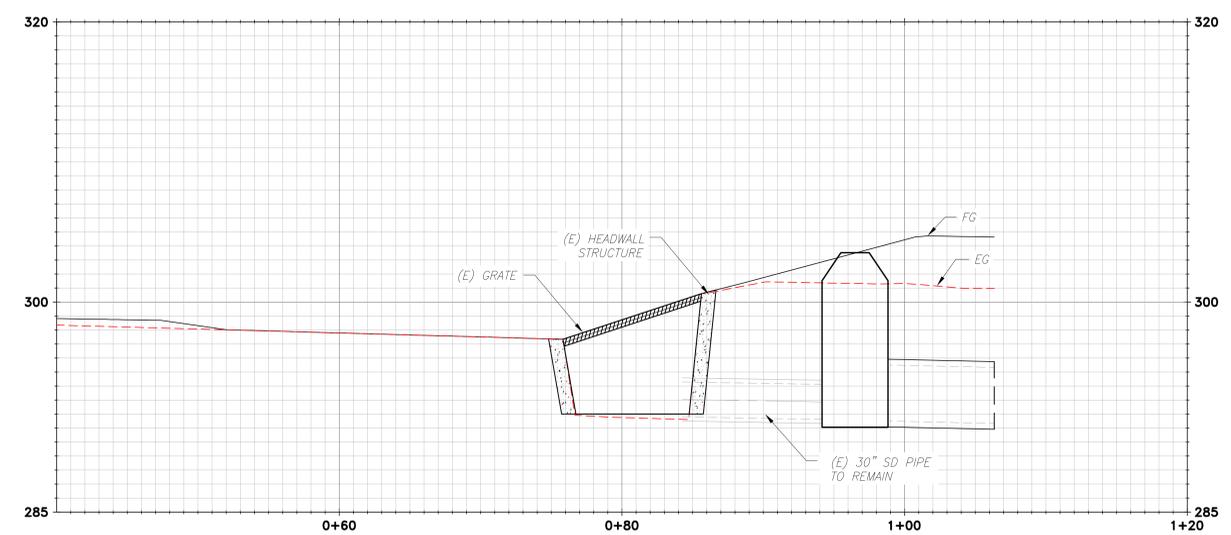
**CD HEADWALL STRUCTURE 1**  
HORIZONTAL SCALE: 1"=5'  
VERTICAL SCALE: 1"=5'

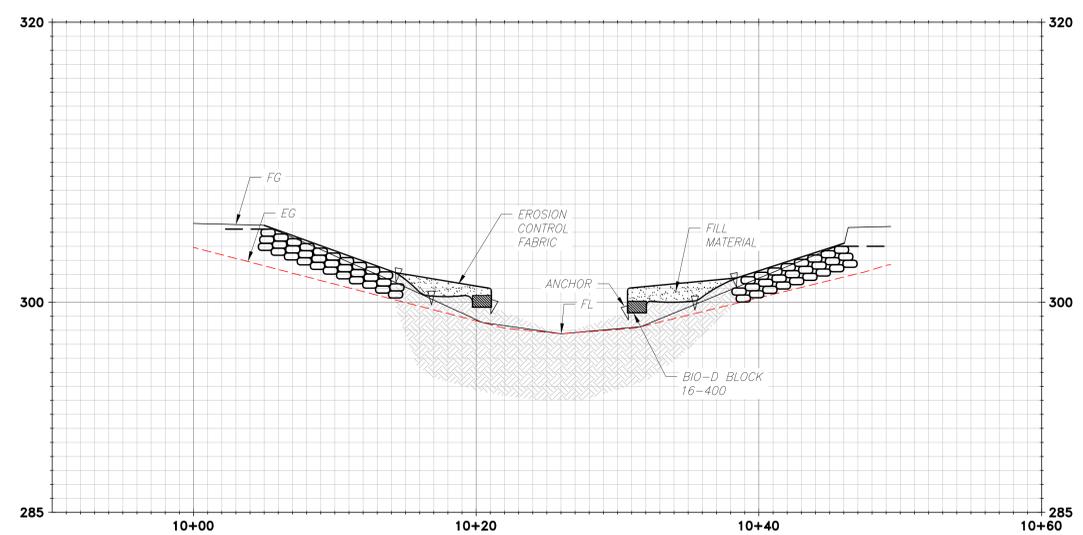
**CD OUTFALL DETAIL 2 (1)**  
HORIZONTAL SCALE: 1"=5'  
VERTICAL SCALE: 1"=5'

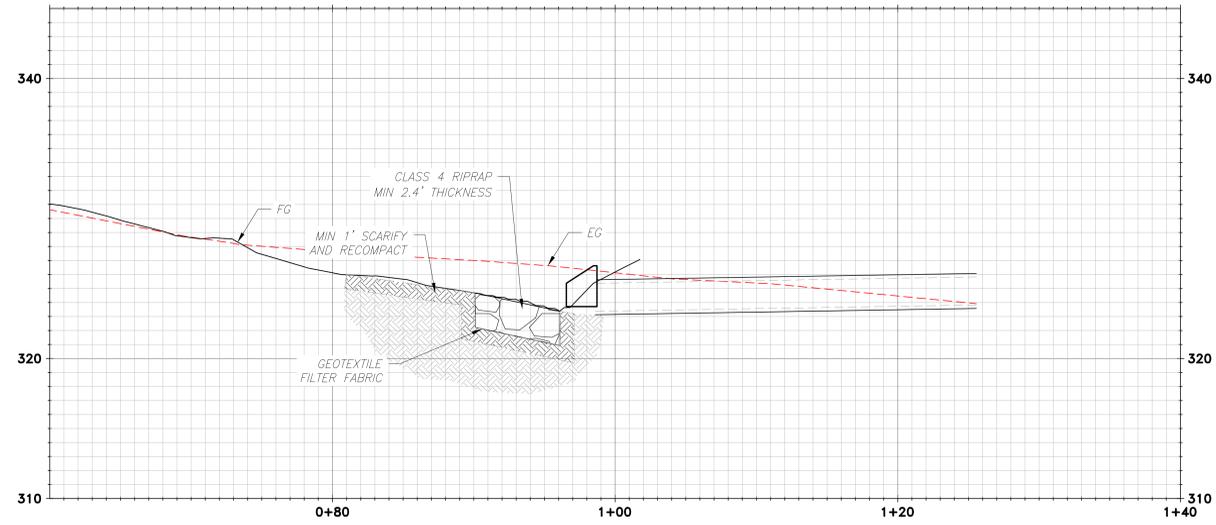
**CD HEADWALL STRUCTURE 2 (1)**  
HORIZONTAL SCALE: 1"=5'  
VERTICAL SCALE: 1"=5'

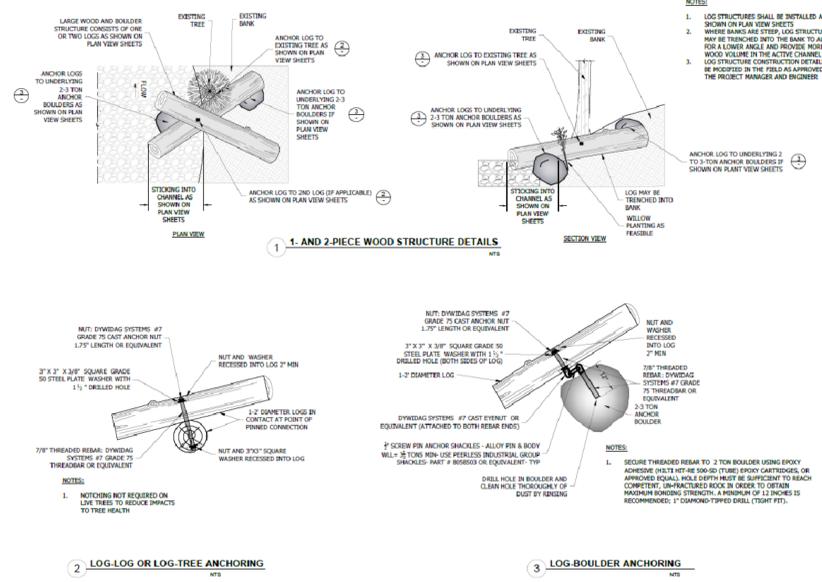
1  
C0705  
LOG AND BOULDER ANCHORING DETAIL AS SHOWN

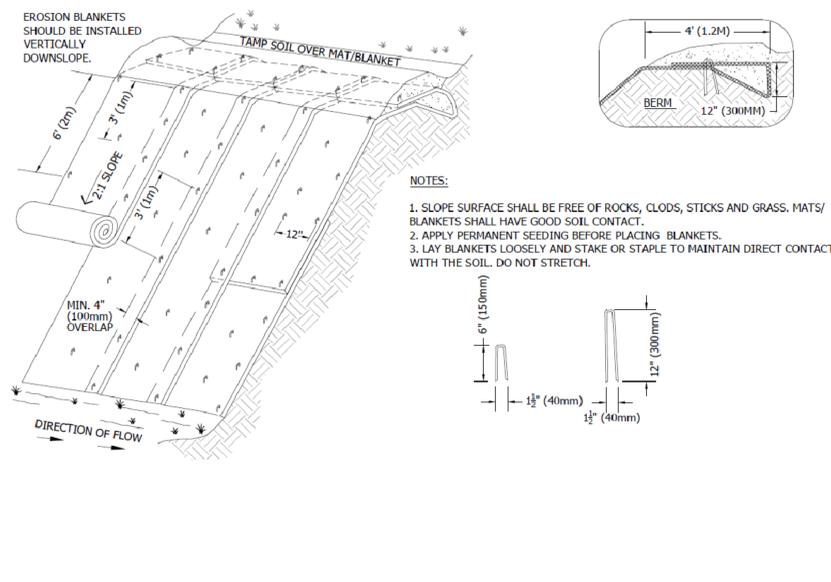
2  
C0705  
EROSION CONTROL FABRIC DETAIL AS SHOWN

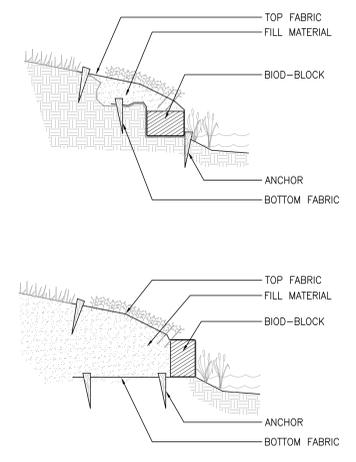
5  
C0705  
BIO-D BLOCK SYSTEM DETAIL AS SHOWN

**NOTES:**  
1. LIVE PLANTS AND CUTTINGS SHOULD BE USED IN EITHER SITUATION.  
2. INSTALLATION TO BE COMPLETED IN ACCORDANCE WITH MANUFACTURER'S SPECIFICATIONS.  
3. DO NOT SCALE DRAWING.  
4. THIS DRAWING IS INTENDED FOR USE BY ARCHITECTS, ENGINEERS, CONTRACTORS, CONSULTANTS AND DESIGN PROFESSIONALS FOR PLANNING PURPOSES ONLY. THIS DRAWING MAY NOT BE USED FOR CONSTRUCTION.  
5. ALL INFORMATION CONTAINED HEREIN WAS CURRENT AT THE TIME OF DEVELOPMENT BUT MUST BE REVIEWED AND APPROVED BY THE PRODUCT MANUFACTURER TO BE CONSIDERED ACCURATE.  
6. CONTRACTOR'S NOTE: FOR PRODUCT AND COMPANY INFORMATION VISIT [www.CADdetails.com/info](http://www.CADdetails.com/info) AND ENTER REFERENCE NUMBER 084-011.

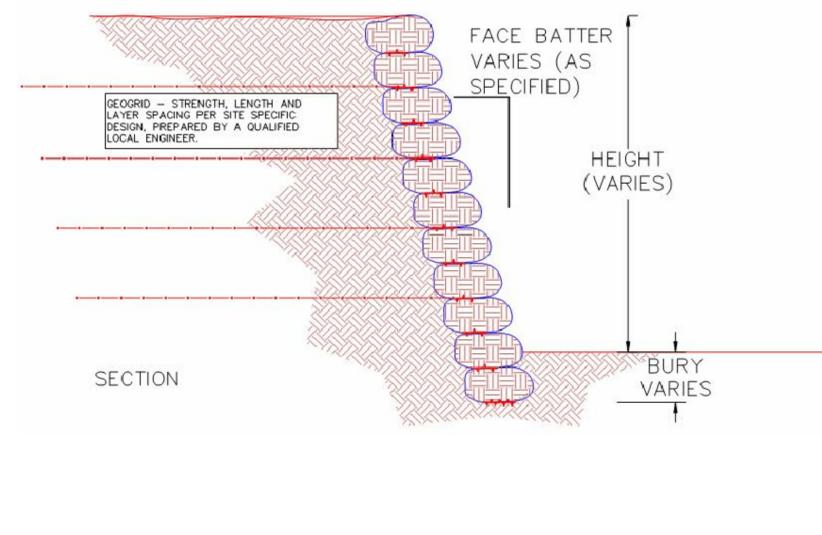
3  
C0705  
GEOGRID REINFORCED FLEX MSE WALL AS SHOWN

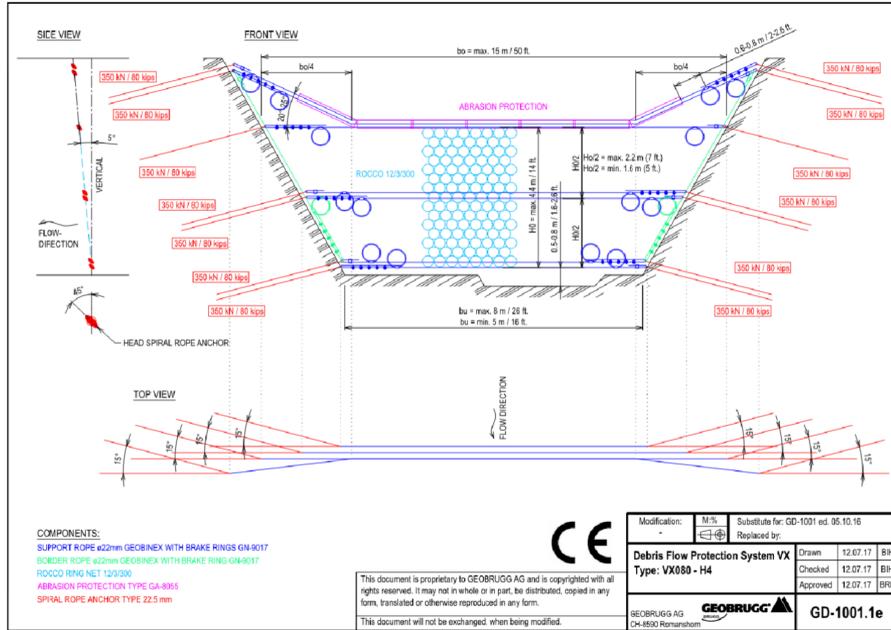
4  
C0705  
TYPICAL DEBRIS FLOW PROTECTION SYSTEM AS SHOWN

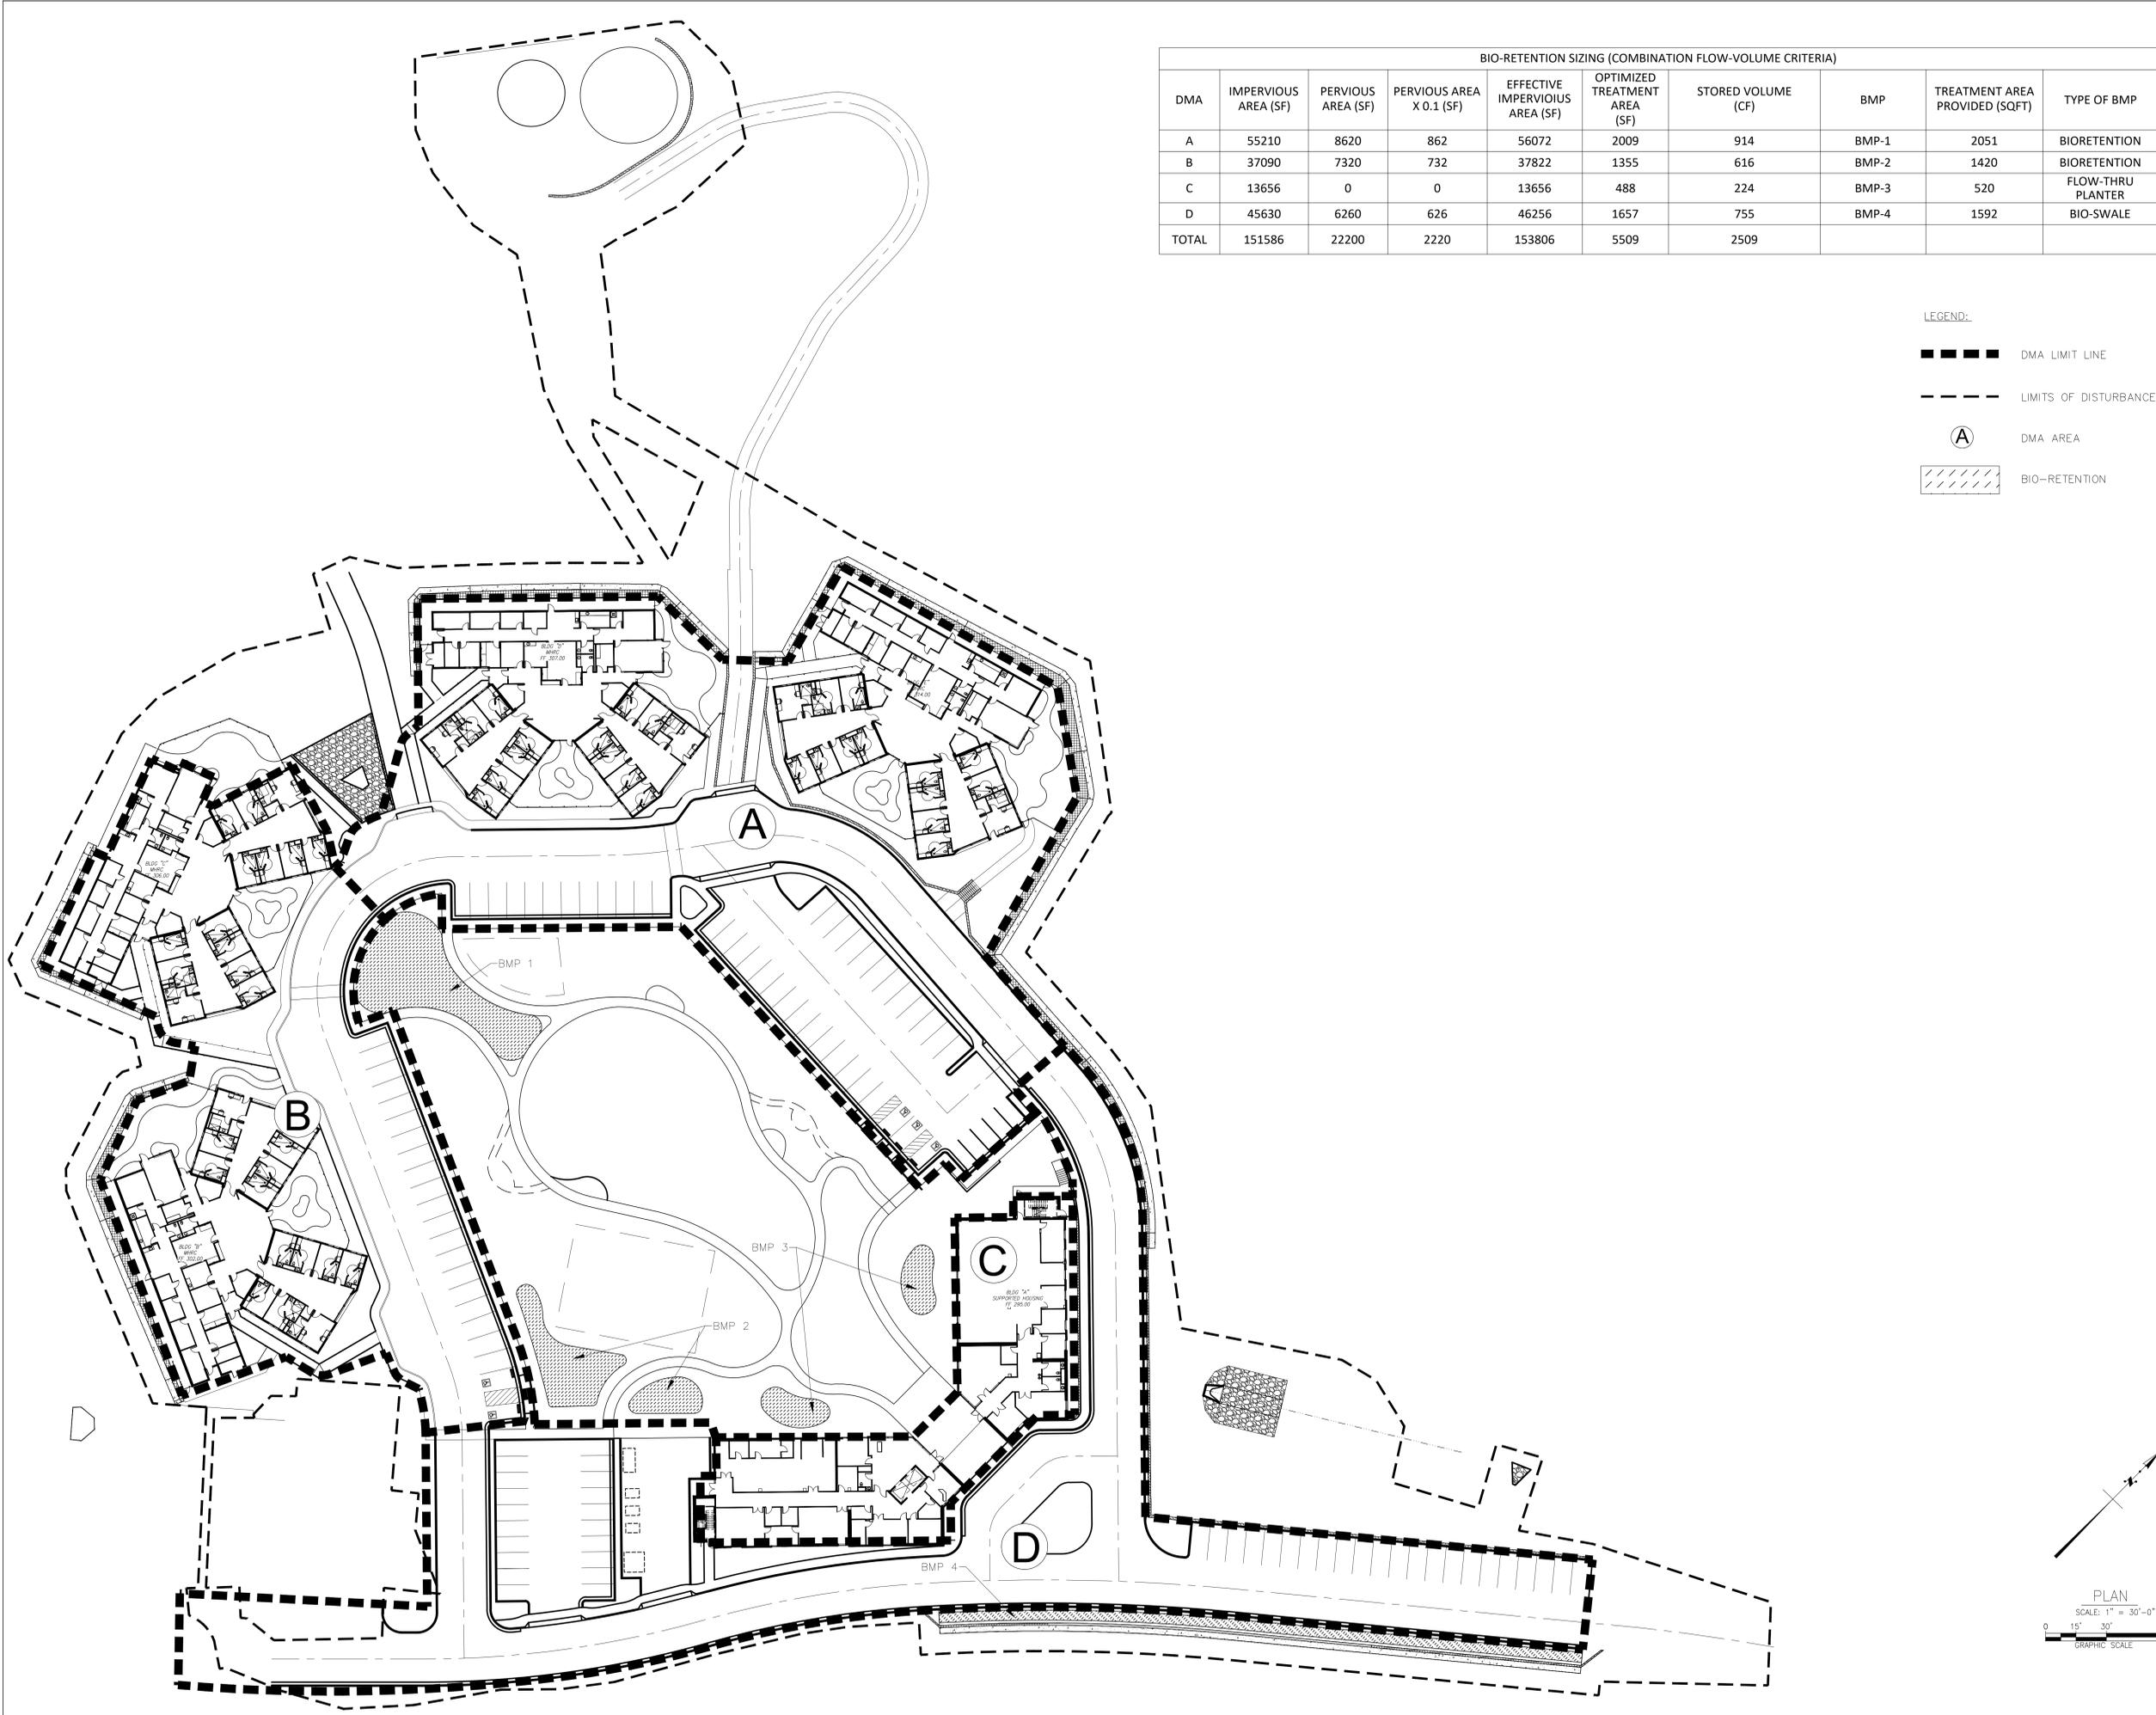
**C1401**

BIO-RETENTION SIZING (COMBINATION FLOW-VOLUME CRITERIA)

DMA	IMPERVIOUS AREA (SF)	PERVIOUS AREA (SF)	PERVIOUS AREA X 0.1 (SF)	EFFECTIVE IMPERVIOUS AREA (SF)	OPTIMIZED TREATMENT AREA (SF)	STORED VOLUME (CF)	BMP	TREATMENT AREA PROVIDED (SQFT)	TYPE OF BMP
A	55210	8620	862	56072	2009	914	BMP-1	2051	BIORETENTION
B	37090	7320	732	37822	1355	616	BMP-2	1420	BIORETENTION
C	13656	0	0	13656	488	224	BMP-3	520	FLOW-THRU PLANTER
D	45630	6260	626	46256	1657	755	BMP-4	1592	BIO-SWALE
TOTAL	151586	22200	2220	153806	5509	2509

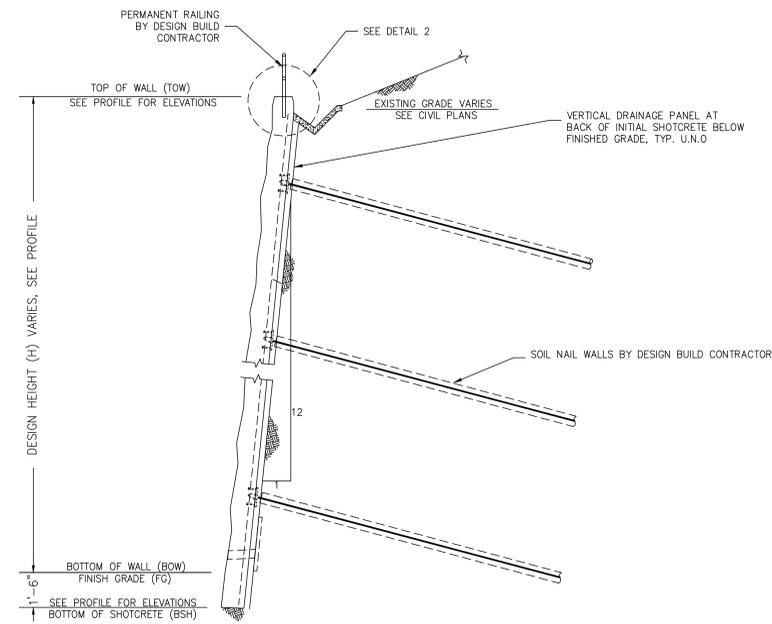
NOTE: CONTRACTOR TO PROVIDE AND REMOVE FORMWORK AS REQUIRED FOR FINAL SHOTCRETE PLACEMENT ABOVE TEMPORARY GRADE

1 SOIL NAIL WALL SECTION VIEW N.T.S.

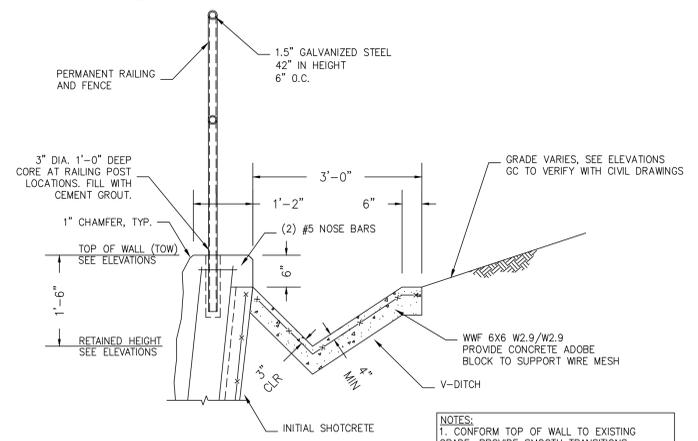
NOTES:  
1. CONFORM TOP OF WALL TO EXISTING GRADE. PROVIDE SMOOTH TRANSITIONS MATCHING EXISTING GRADE BETWEEN TOP OF WALL SPOT ELEVATIONS PROVIDED ON PROFILE

2 SOIL NAIL WALL TOW & VALLEY GUTTER N.T.S.

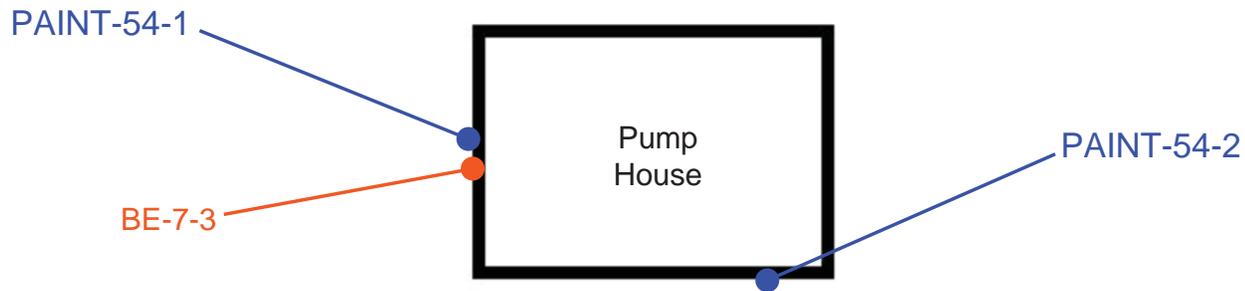
Figure 6: Asbestos & Lead Sample Locations  
Cordilleras Facility Pump House  
200 Edwards Street Redwood City, CA  
SCA Project #: F11312  
June 2014

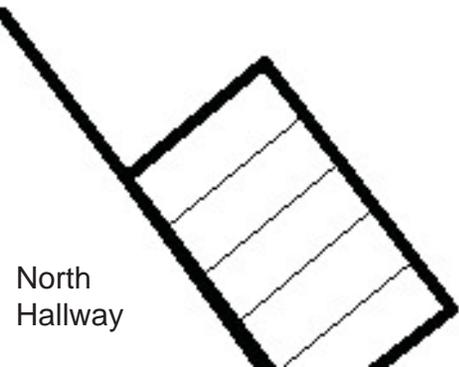
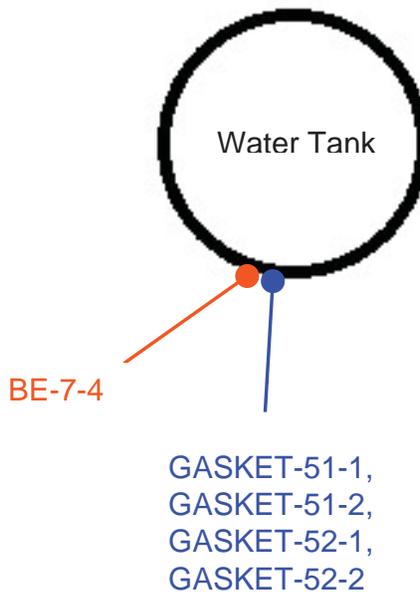
Figure 7: Asbestos and Lead Sample Locations  
Cordilleras Facility Water Tank  
200 Edmonds Street Redwood City, CA  
SCA Project #: F11312  
June 2014
