County of San Mateo - Planning and Building Department

ENGINEERING GEOLOGIC &
GEOTECHNICAL INVESTIGATION
4LOT RESIDENTIAL DEVELOPMENT
ZMAY PROPERTY
1551 CRYSTAL SPRINGS ROAD
SAN MATEO COUNTY, CALIFORNIA

February 10, 2014 Project No. 1847-1R1

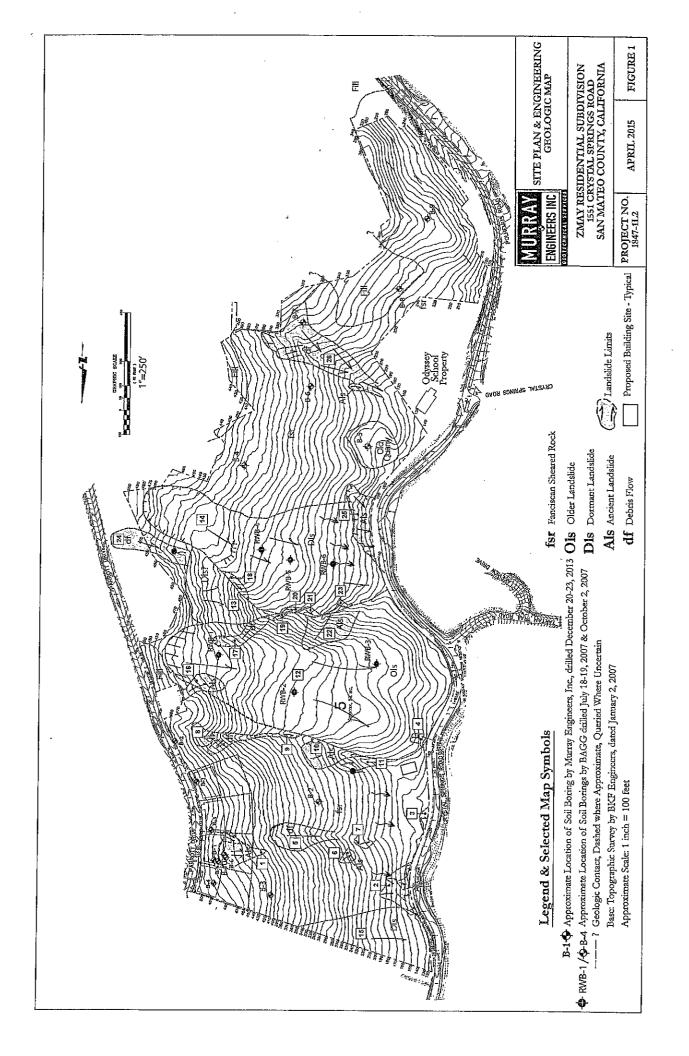
Attachments: Figure 1, Site Plan & Engineering Geologic Map

An active relatively shallow landslide (1) is located near the northeastern property corner within the proposed Lot 2 of the referenced 4-lot subdivision. Based on our review of aerial photographs, our site reconnaissance, and as previously discussed ion our referenced subdivision report, it appears that a 40-foot wide failure appears to have occurred along the downhill side of the graded access road, widening the area of the active landslide from what was previously mapped. This active landslide was absent from the 1943 and 1968 aerial photographs, but appeared in the latest photographs following construction of the graded access road (as discussed above). In our opinion, grading associated with construction of this road is likely the main probable cause of the landslide. It appears that this active landslide is less than 10 feet thick in depth.

An additional active, relatively shallow landslide (2) is located near the northwest property corner, along the road cut above Crystal Springs Road. Based on our site reconnaissance, this feature appears to be approximately 200 feet wide and approximately 100 feet in length. The slide mass is characterized by generally hummocky topography. In our opinion, grading associated with construction of Crystal Springs Road is likely the main probable cause for activation of the landslide. It appears that this active landslide is relatively shallow, likely less than 10 feet thick in depth. Two similar, smaller features (3 and 4) are located further south along Crystal Springs Road with slide mass dimensions of approximately 75 feet wide and approximately 25 feet in length and approximately 50 feet wide and approximately 60 feet in length, respectively.

A) The approximate area for stabilization repair of active landsliding within Parcels 1 and 2 should be depicted in plan view and cross section. Conceptual design measures should be presented that are intended to prevent future reactivation or enlargement of landsliding across the common property line. If a grading repair is selected, approximate grading volume estimates should be prepared.

Based on the reconfiguration of parcel boundaries, the majority of the mapped active landslide is located within Parcel 2. Please refer to Figure 1 for the reconfiguration of the proposed parcel lines and refer to Cross Section B-B' (Figure A-7) of MEI's 2014 report for reference. We understand that the project civil engineer will be providing a cross section depicting the proposed landslide repair, including keying and benching details of the fill, fill subdrainage, and grading volumes.
