From: [Michelle Kuehn](#)
To: [Planning Commission](#)
Subject: Angelo Consentino - County File Number: PLN2024-00327
Date: Tuesday, March 11, 2025 1:42:37 PM
Attachments: [Morria Shaffer Engineering.pdf](#)

June 25, 2024
MSE # 24176

RE: Rear property line retaining wall
2897 Adeline Drive, Burlingame, CA

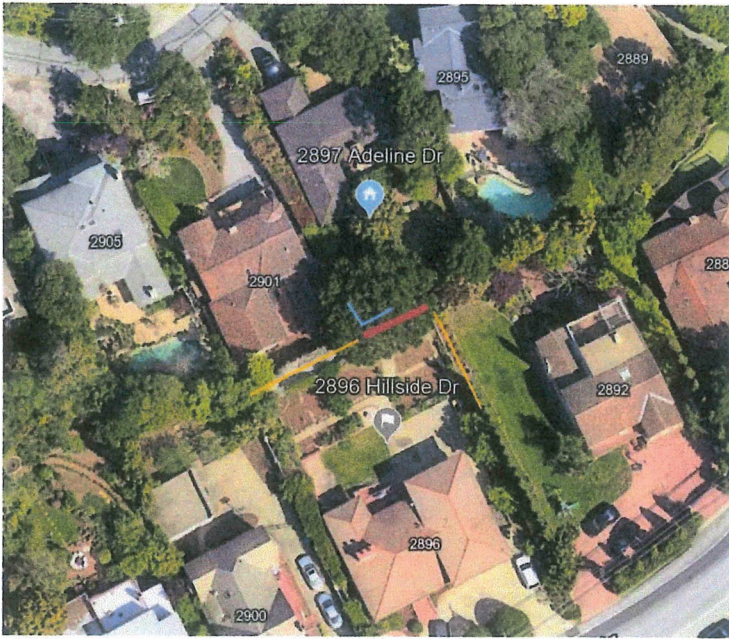
Figure 1 - View of Property and surrounding area

We conducted a site visit at the property located at 2897 Adeline Drive in Burlingame on June 24, 2024 to review the current condition of the retaining wall along the property line separating the subject property and its uphill neighbor at 2896 Hillside Drive. The owner at 2897 Adeline Drive requested the visit to observe the ongoing construction that will increase the height of the existing retaining wall to approximately 9'-9". The visit took place during daylight hours in dry conditions. Figure 1 shows the layout of the walls we observed and the relationship between the properties.
