# 1750 Cordilleras Rd

### Arborist Report 2024

Site: 1750 Cordilleras Rd  
Redwood City, CA 94062

Date: Jan 16, 2025

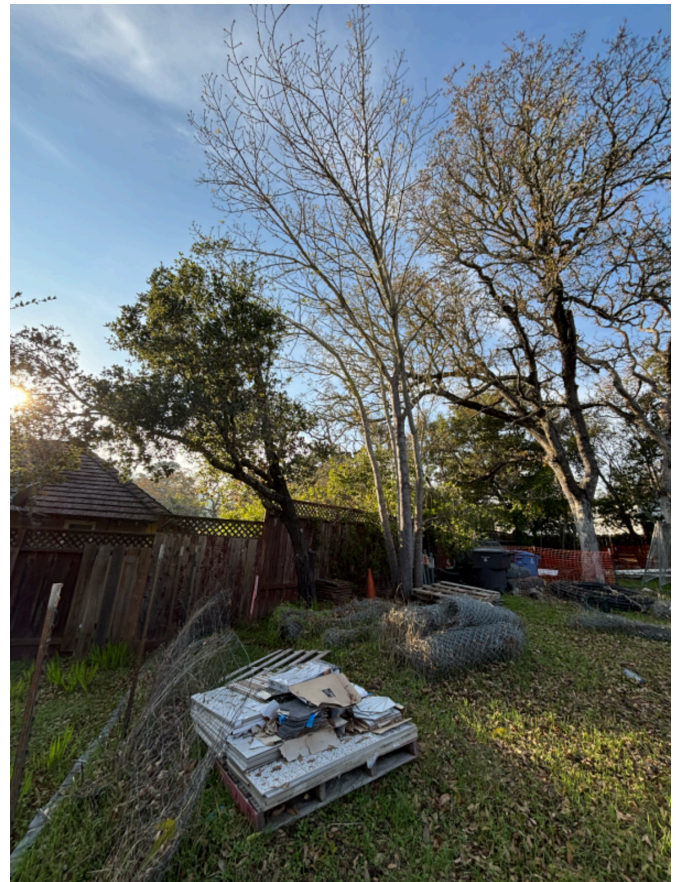
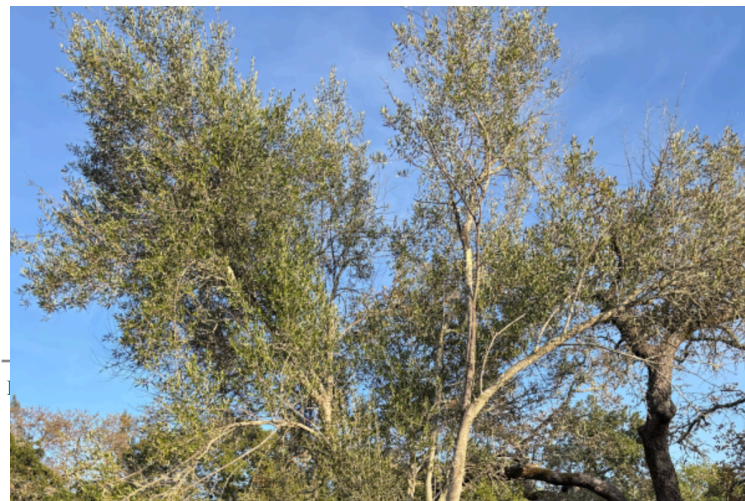
### Showing Tree #59

Tree Tag #59, another Coast Live Oak, has an overall condition rating of 60%. Although its health and structural ratings are fair, its form rating is poor due to its one-sided growth and suppression. The asymmetry and compromised form make it unsuitable for retention, especially given its location within the construction footprint. Retaining this tree would conflict with the objectives of the project and increase the likelihood of structural issues or failure in the future. Its removal is necessary under Section 12,023(a)(6) to ensure the safe and efficient use of the property.
