**COUNTY OF SAN MATEO  
PLANNING AND BUILDING DEPARTMENT**

**SUBJECT:** After-the-Fact Coastal Development Permit (CDP), pursuant to Section 6328.4 and Grading Permit, pursuant to Section 8600 of the Zoning Regulations to legalize approximately 850 cubic yards (c.y.) of grading associated with repair to a section of the Pine Tree Gulch Creek bank and a new culvert. The project involved the removal of several trees and planting approximately 200 trees to restore the creek bank. The project is appealable to the California Coastal Commission. In conjunction with the requested permits, it is recommended that the Zoning Hearing Officer determine that the project is categorically exempt from the California Environmental Quality Act under Class 33, small habitat restoration projects, typically under five acres, designed to protect or improve habitat for fish, plants, and wildlife.

County File Number: PLN2023-00371 (Twisted Fields/Theobald)

## **Rancho San Gregorio Creek Bank Repair and Grading Work**

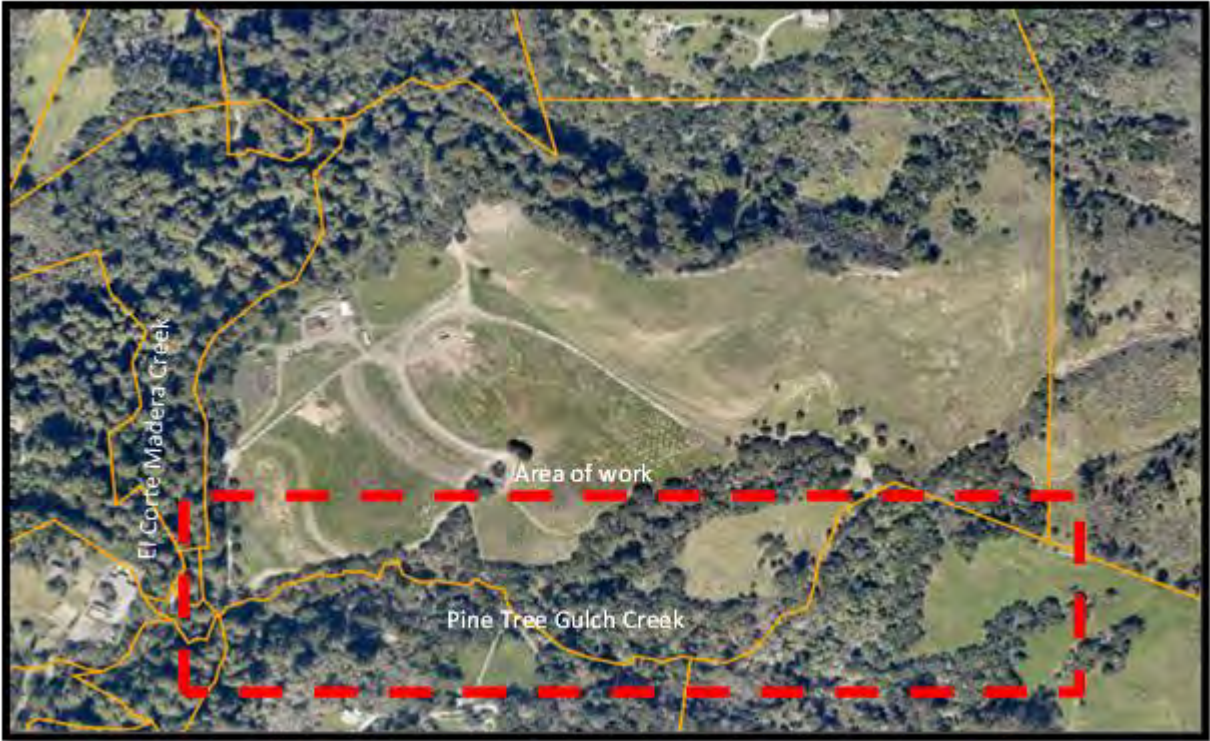
Figure 1 Area of work

The project involves legalizing grading and creek restoration work that was completed by the owner without permits in 2022-2023 (VIO2023-00183). During the winter storms of 2022-2023, the northside of the creek bank at the Pine Tree Gulch collapsed, which created unsafe conditions. To repair the bank, the owner removed several trees, performed 850 c.y. of earth work to re-build the creek bank, widened an existing dirt road, installed erosion control measures, and re-planted several trees along the bank (Figures 3 and 7, Attachment D). The work also involved upgrading an existing 18-inch culvert overflow pipe which connects an on-site detention pond to the creek (Figures 5 and 6, Attachment D). The pipe was upgraded in 2023 to an in-kind 24-inch wide, 38-foot long High-Density Polyethylene (HDPE) pipe. This upgrade was made as a preventive measure to handle any pond overflow extreme weather events.

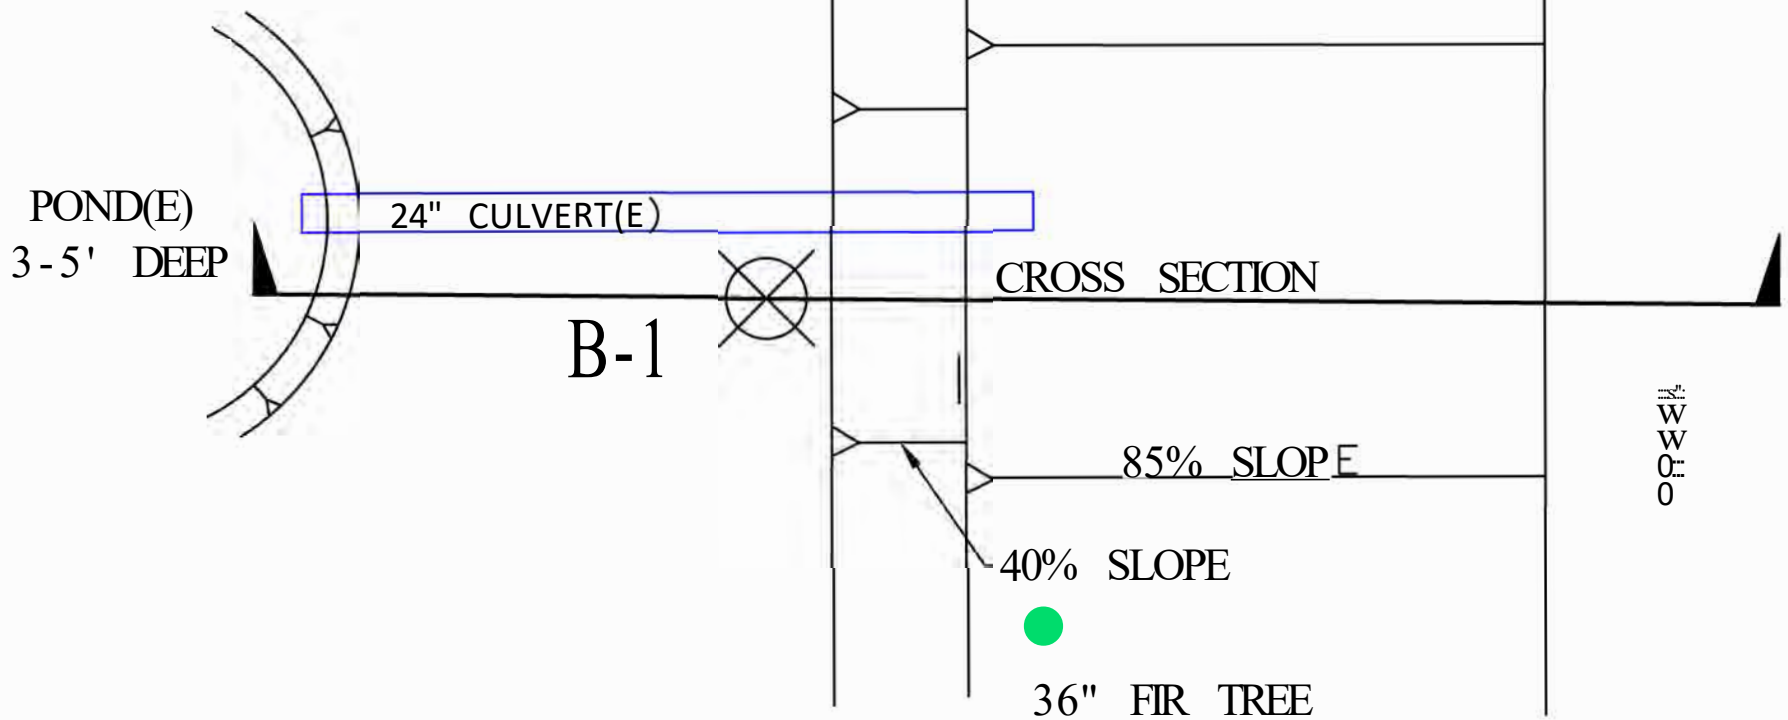
<i>I</i> i:igma Prime Geosciences, Inc.	Figure 2
	Date: 7-25-24
Job No.: 24-128	
<b>Site Plan</b> 100 Ralston Rd., San Gregorio

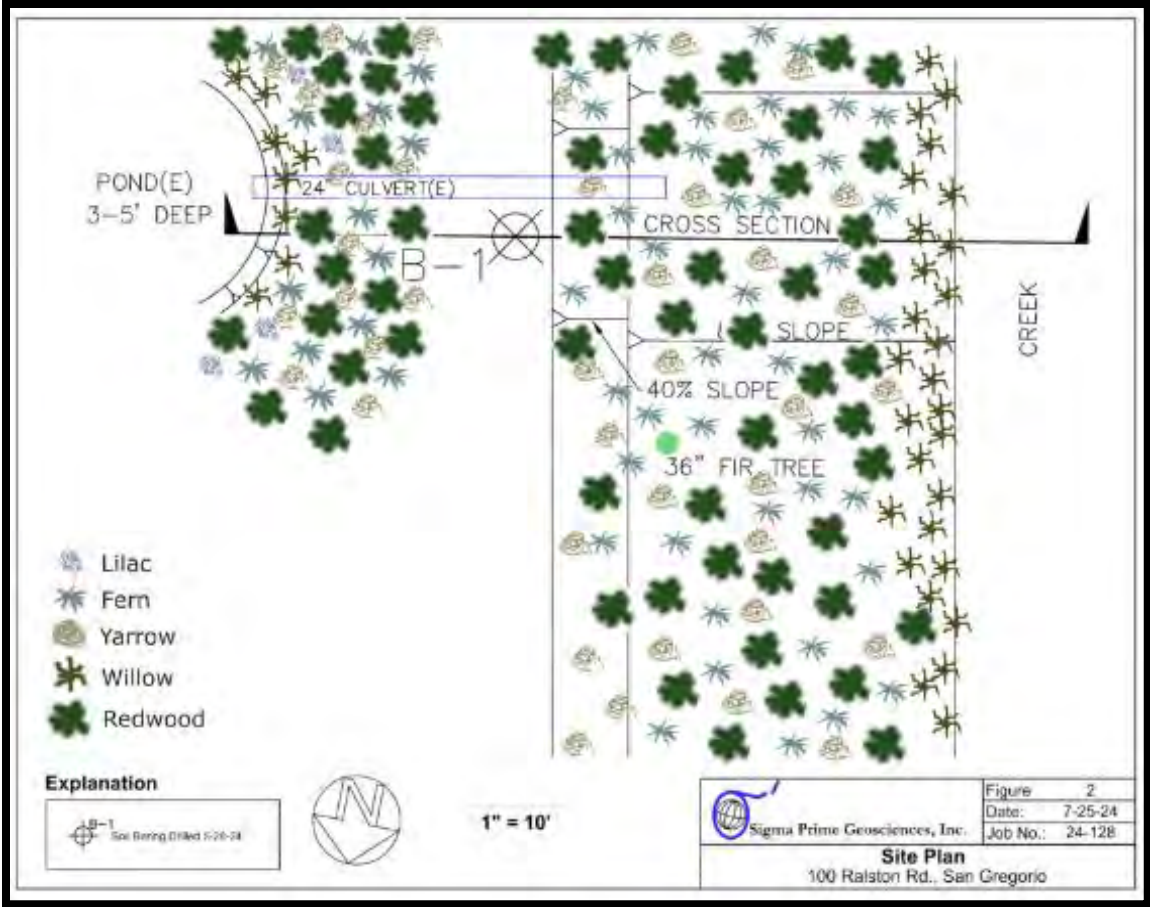
Figure 7 Map showing location of the culvert and re-vegetation efforts.

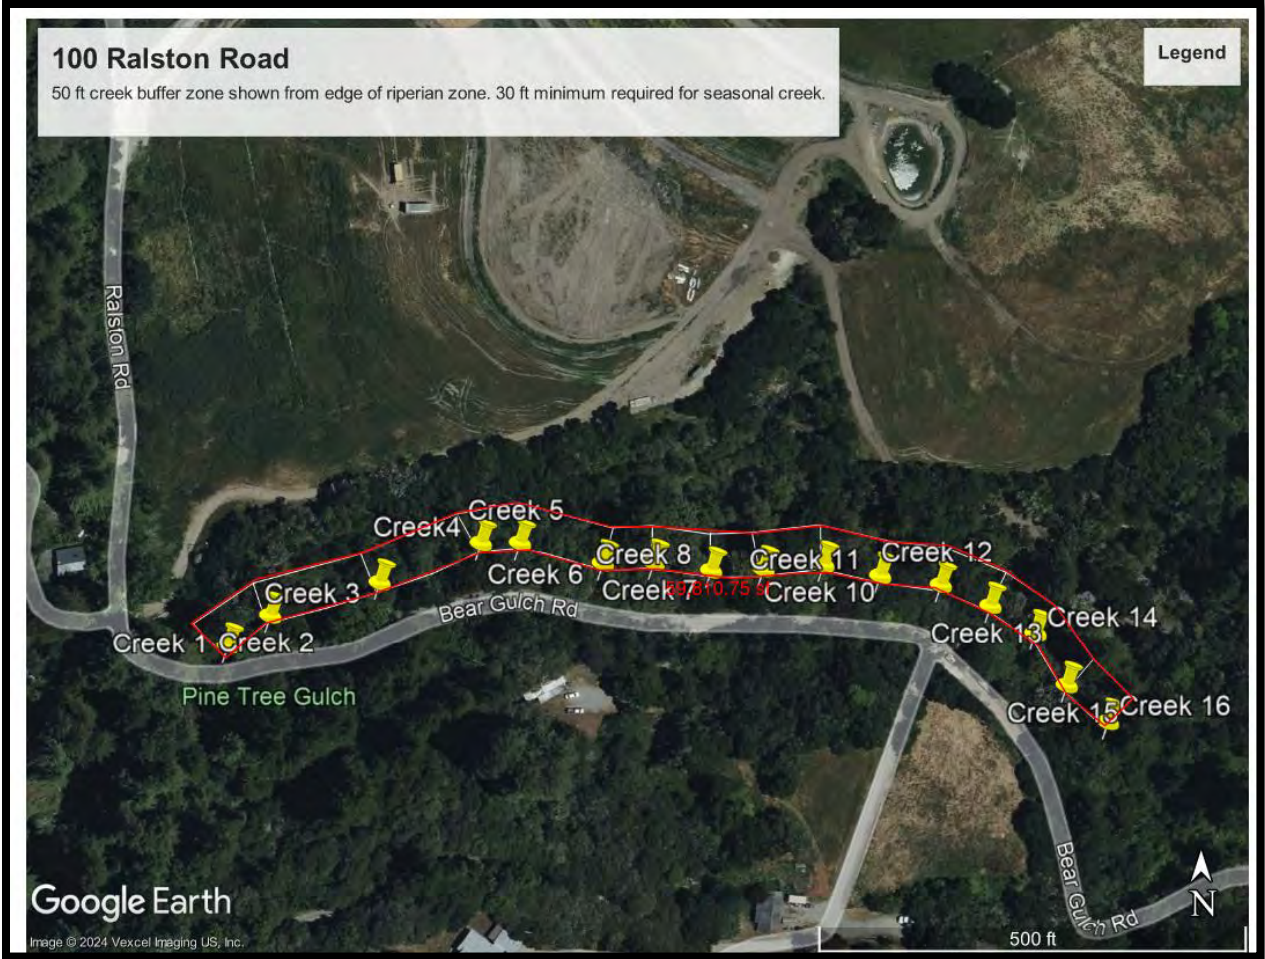
Figure 8 Total area of disturbance

The total area of disturbance is approximately 60,000 sq. ft. as shown in Figure 8 in Attachment D. No significant impact was created on any endangered, rare or threatened species at or around the project site as discussed in Section A. below. Therefore, the project qualifies for the said exemption.

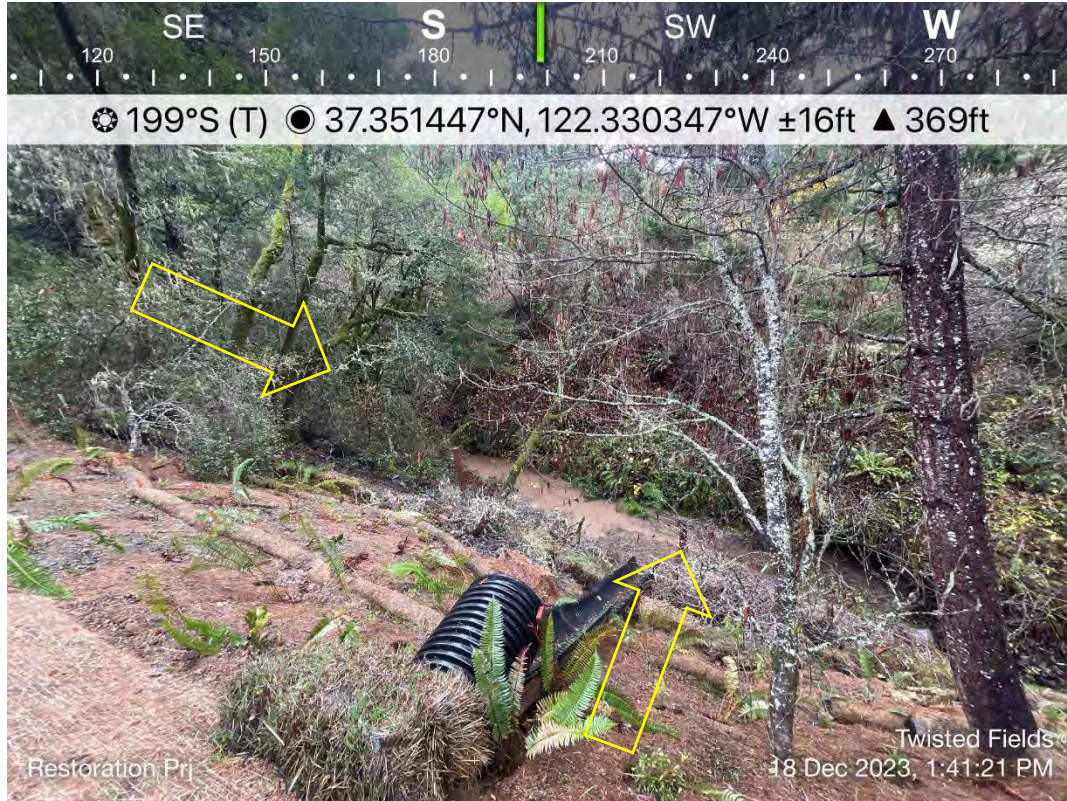
Photo 1. Culvert outfall to Pine Tree Gulch in restoration work area

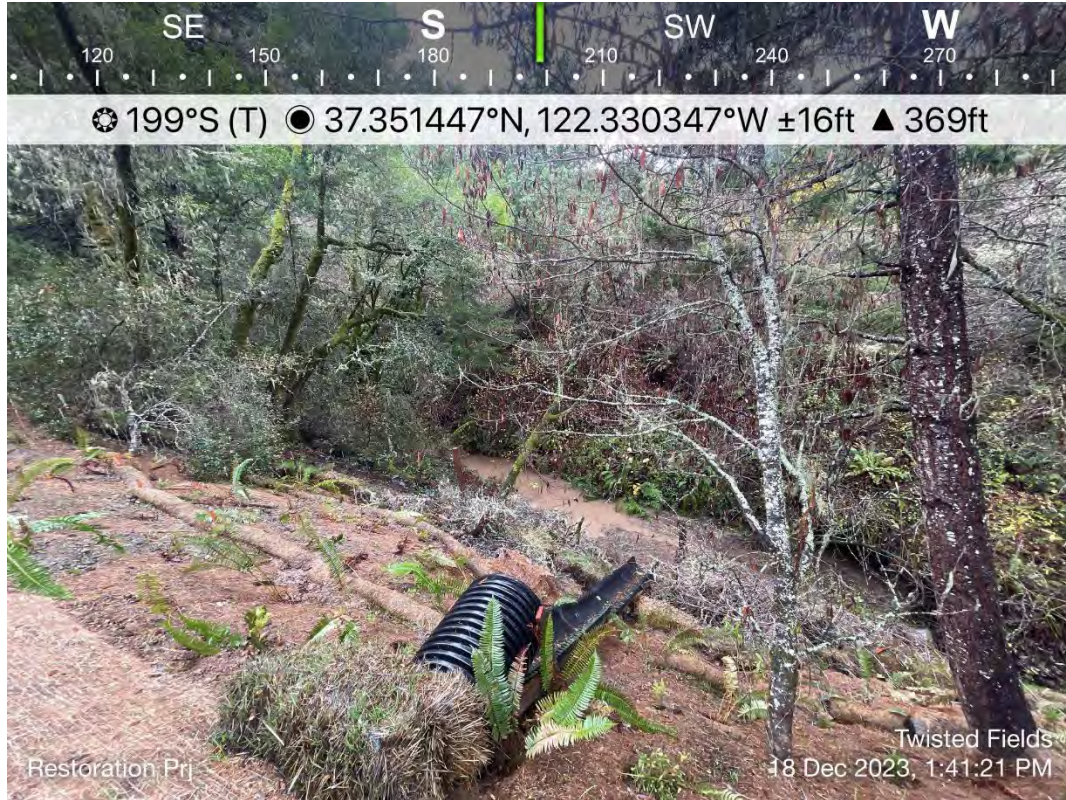
**Photo 1.** Culvert outfall to Pine Tree Gulch in restoration work area

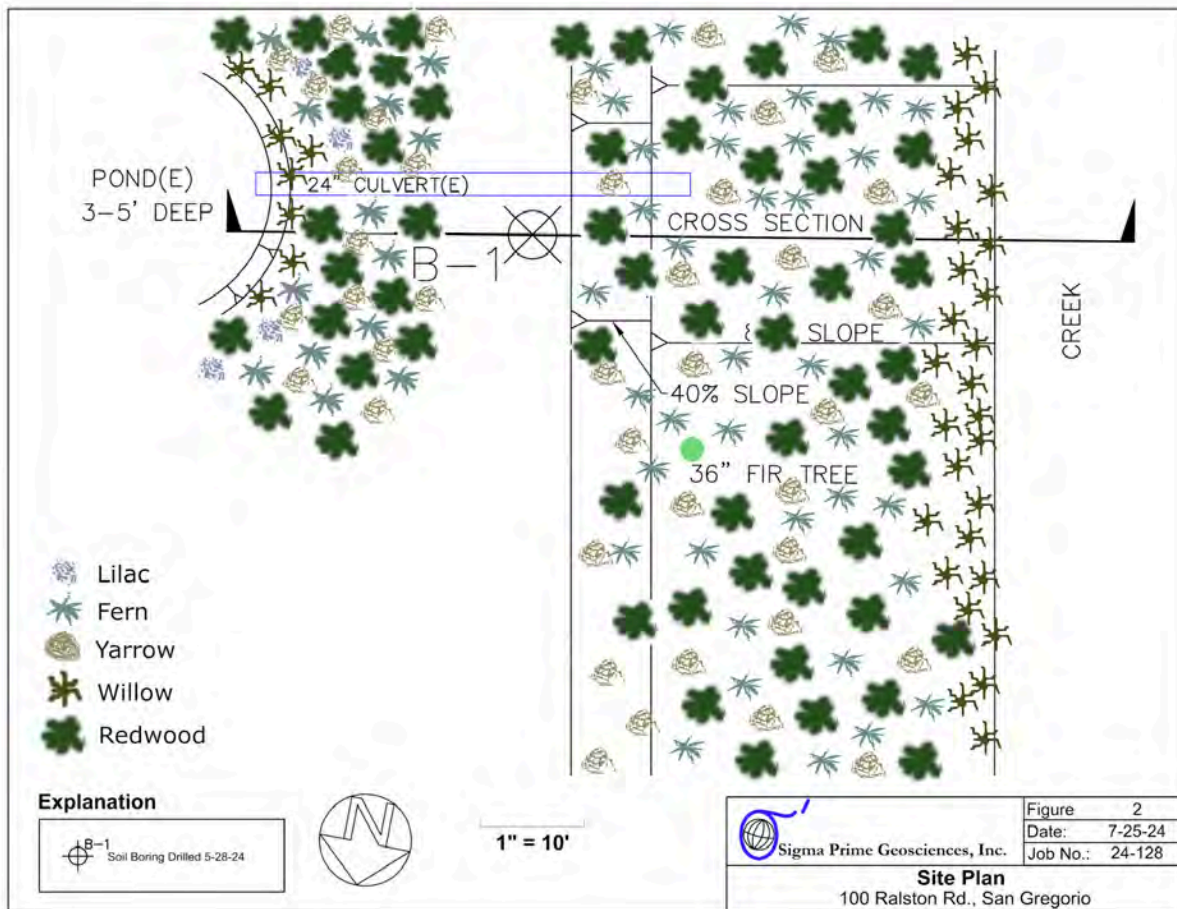
Figure 2 references the variety of California native species used in site re-vegetation, including lilac, fern, yarrow, willow, and redwood. Jonathan Foster, the wetland ecologist who advised the usage of “Vegetated Soil Lift” methodology and completed follow-up riparian habitat assessment commented that these methods produced an increased vegetation cover of 20-65% (2024).

**Figure 2.** Map showing re-vegetation efforts. The key indicates different species utilized, with species intentionally planted and spread apart by size and growth pattern.

The method employed for re-vegetation was “Vegetated Soil Lift” described in the EC-13 section of the SMC Routine Maintenance Program. Soil wrapped in biodegradable straw wattle was placed along the bank and staked in with live native willow cuttings to ensure stability and longevity of wattle. Plug plants were added in regular intervals to further increase stability and for the propagation of native species.
