Reference: 13700 Skyline Blvd., Woodside, Ca. 94062

Tree Protection Plan and Inventory

As per your request, we have performed a geotechnical study for the proposed home at 13700 Skyline Boulevard, Woodside, California. The accompanying report summarizes the results of our field study and engineering analyses, and presents geotechnical recommendations for the planned work.

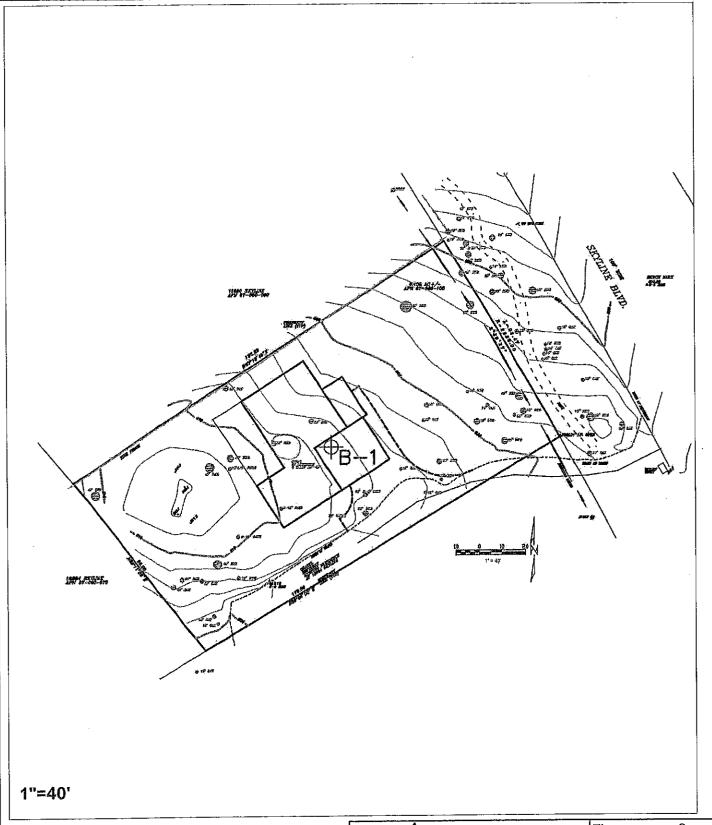
Explanation

B-1 Soil Boring Drilled 5-20-16

We are pleased to present this geotechnical study report for the proposed home at 13700 Skyline Boulevard, Woodside, California, at the location shown in Figure 1. The purpose of this study was to evaluate the subsurface conditions at the site, and to provide geotechnical design recommendations for the proposed construction.
