GEOTECHNICAL INVESTIGATION
Proposed Residence
15<sup>th</sup> Street & East Avenue
(APN 037-015-090)
Montara, California

May 9, 2014 Job #14484.10

RE: GEOTECHNICAL INVESTIGATION Proposed Residence 15<sup>th</sup> Street and East Avenue (APN 037-015-090) Montara, California

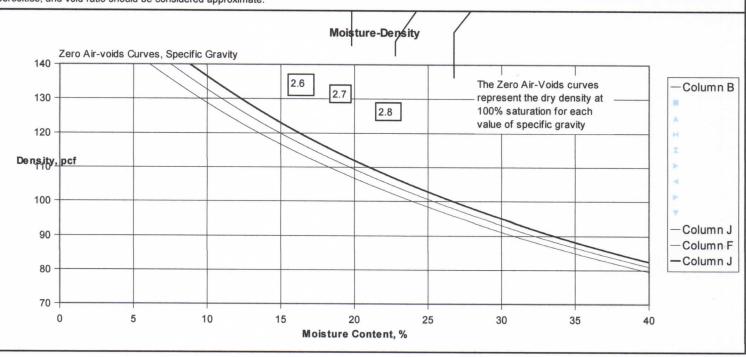
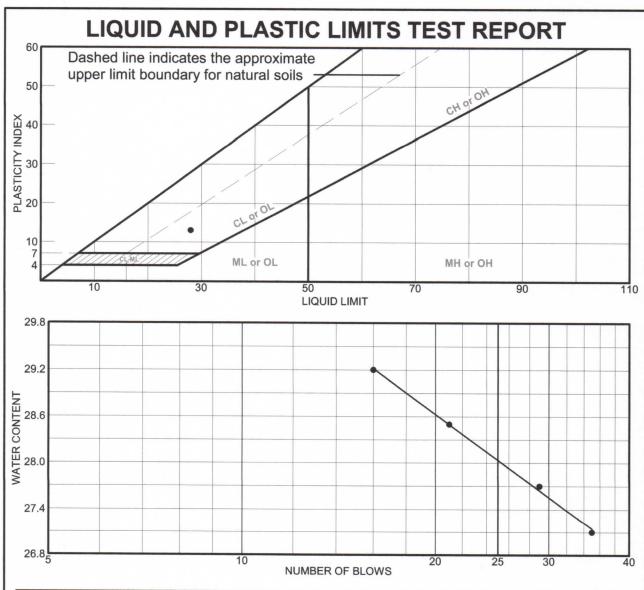
L	MATERIAL DESCRIPTION	LL	PL	PI	%<#40	%<#200	USCS
•	Very Dark Yellowish Brown Lean Clayey SAND	28	15	13			
			185
