**GEOTECHNICAL INVESTIGATION  
FOR PROPOSED NEW RETAINING WALLS,  
CABIN, AND PARKING AREA**

**Healing Cultures Property**

10707 La Honda Road

Subject: **Healing Cultures Property  
10707 La Honda Road  
Woodside, California  
GEOTECHNICAL INVESTIGATION FOR  
PROPOSED NEW RETAINING WALLS,  
CABIN, AND PARKING AREA**

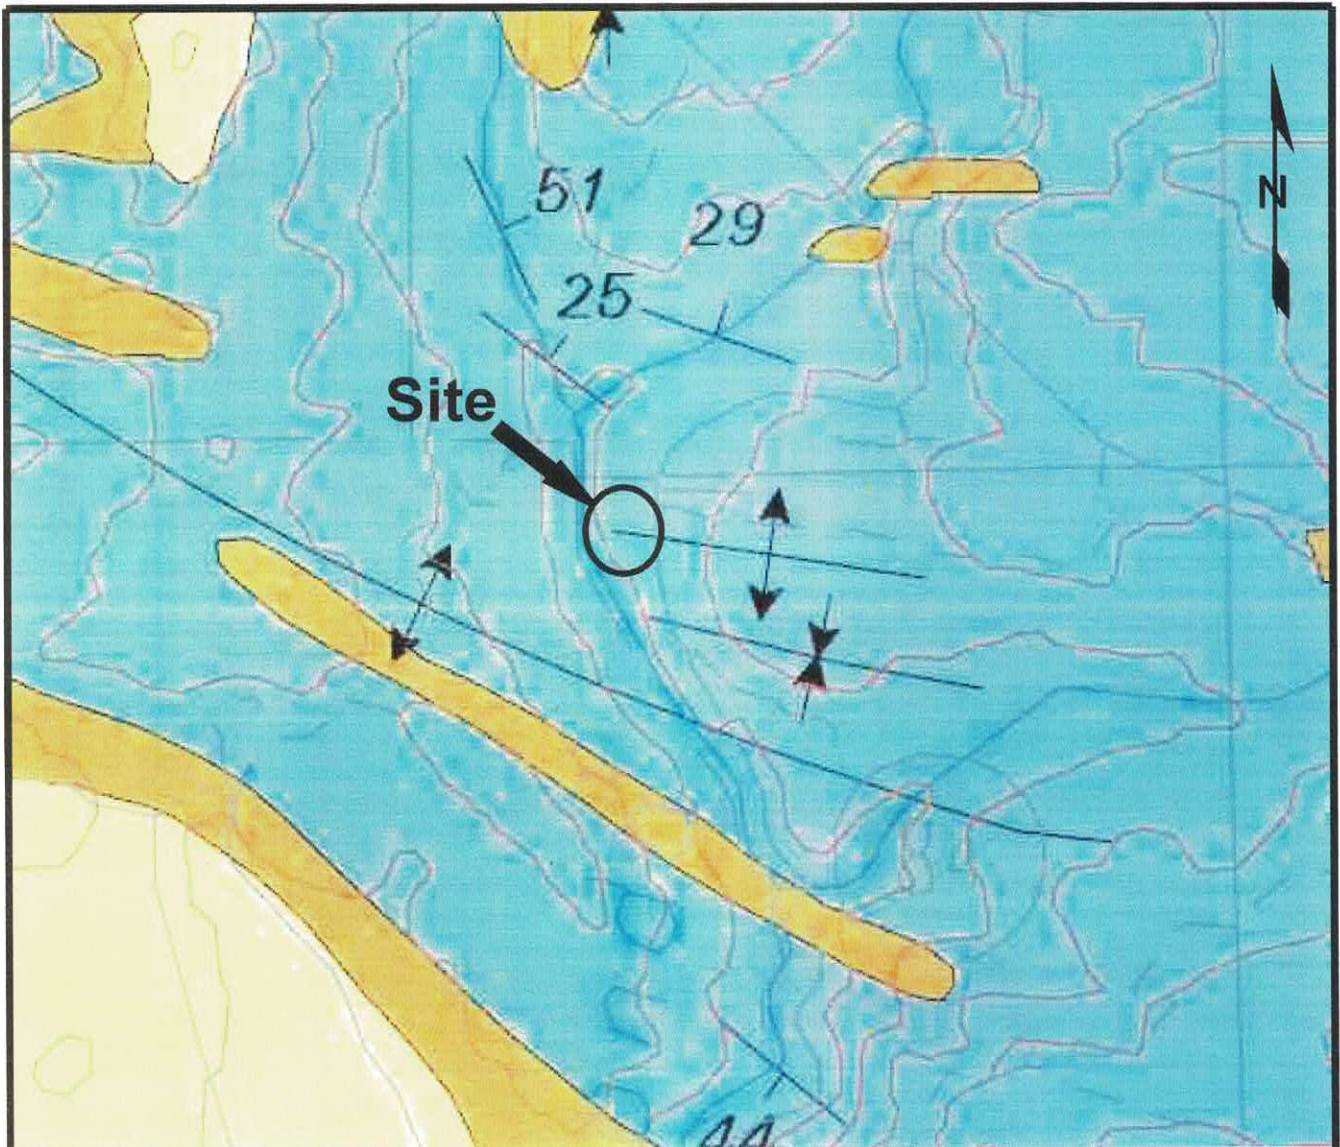
Figure 3 - Geologic Map

**Lambert Shale and San Lorenzo Formation, Undivided (lower Miocene,**

**T1s**

We reviewed the *Geology of the Onshore Part of San Mateo County, California: Derived from the Digital Database Open-File 98-137*, by Earl E. Brabb, R.W. Graymer, and D.L. Jones (1998) and the *Geotechnical Hazards Synthesis Map for San Mateo County*, by Leighton and Associates (1976). The relevant portions of the Brabb, Graymer, and Jones map and Leighton map have been reproduced in Figures 3 and 3a.

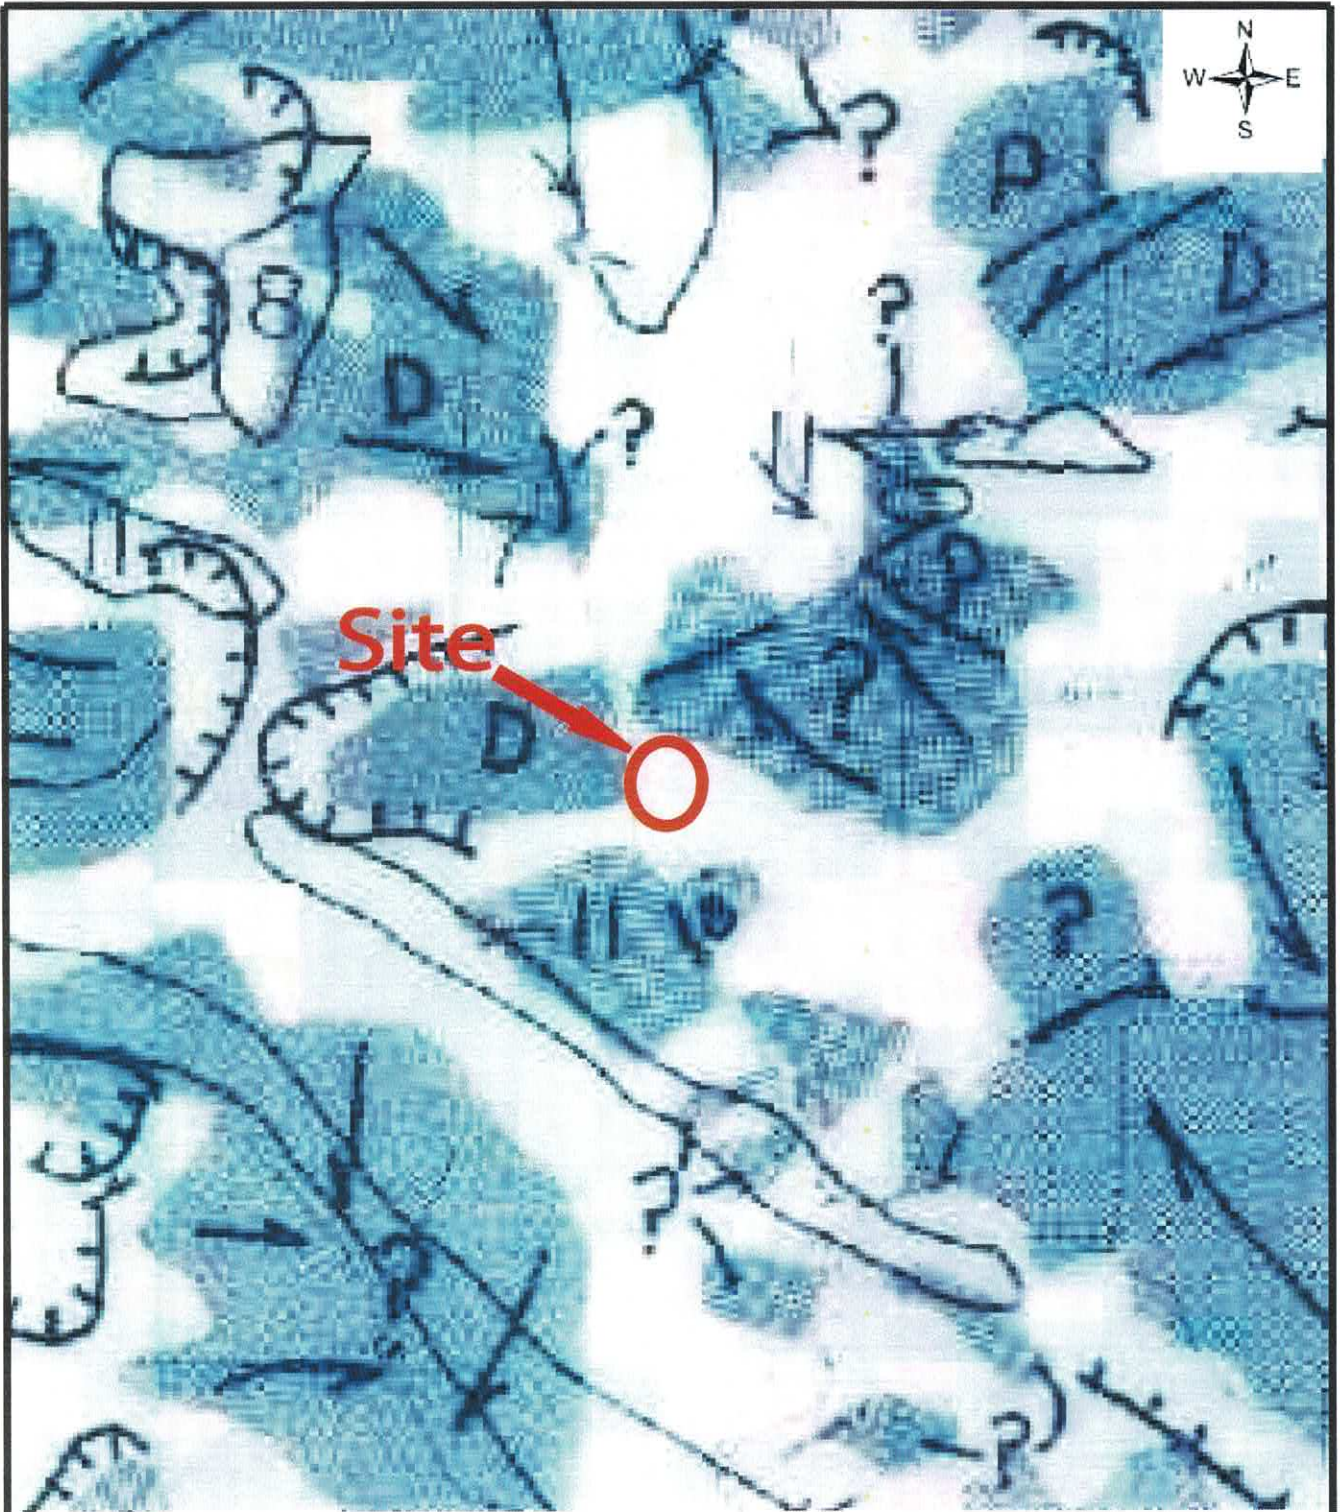
Figure 3a - County of San Mateo Geologic Map

Source: Geolotechnical Hazards Synthesis Map for San Mateo County. Leighton and Associates (1976)

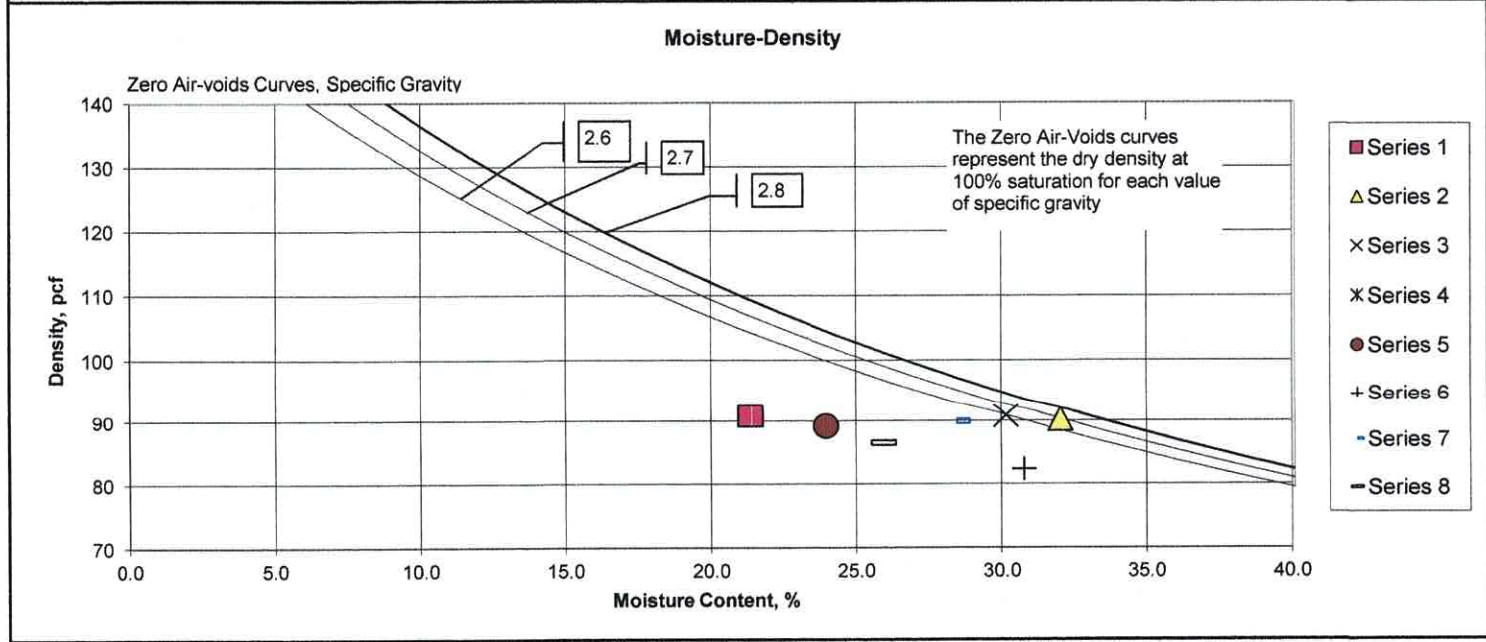
## Moisture-Density-Porosity Report

Boring:	1-1	1-2	1-3	1-4	2-2	3-1	3-2	3-3
Sample:								
Depth, ft:								
Visual Description:	Dark Yellowish Brown Sandy CLAY w/ Gravel	Dark Brown Fat CLAY	Dark Brown CLAY	Dark Brown Sandy CLAY	Dark Brown Sandy CLAY (Claystone)	Yellowish Brown Sandy Elastic SILT	Dark Brown Sandy CLAY	Dark Brown CLAY w/ Sand
Actual $G_s$								
Assumed $G_s$	2.70	2.70	2.70		2.70	2.70	2.70	2.70
Moisture, %	21.4	32.0	30.2	26.9	24.0	30.8	28.5	26.0
Wet Unit wt, pcf	110.5	119.2	118.3		110.6	107.7	115.5	109.0
Dry Unit wt, pcf	91.0	90.3	90.9		89.2	82.3	89.9	86.5
Dry Bulk Dens.pb, (g/cc)	1.46	1.45	1.46		1.43	1.32	1.44	1.39
Saturation, %	67.6	99.6	95.1		72.6	79.3	87.8	73.8
Total Porosity, %	46.0	46.5	46.1		47.1	51.2	46.7	48.7
Volumetric Water Cont, $\theta_w$ , %	31.1	46.3	43.9		34.2	40.6	41.0	35.9
Volumetric Air Cont., $\theta_a$ , %	14.9	0.2	2.3		12.9	10.6	5.7	12.8
Void Ratio	0.85	0.87	0.86		0.89	1.05	0.88	0.95
Series	1	2	3	4	5	6	7	8

Note: All reported parameters are from the as-received sample condition unless otherwise noted. If an assumed specific gravity ( $G_s$ ) was used then the saturation, porosities, and void ratio should be considered approximate.

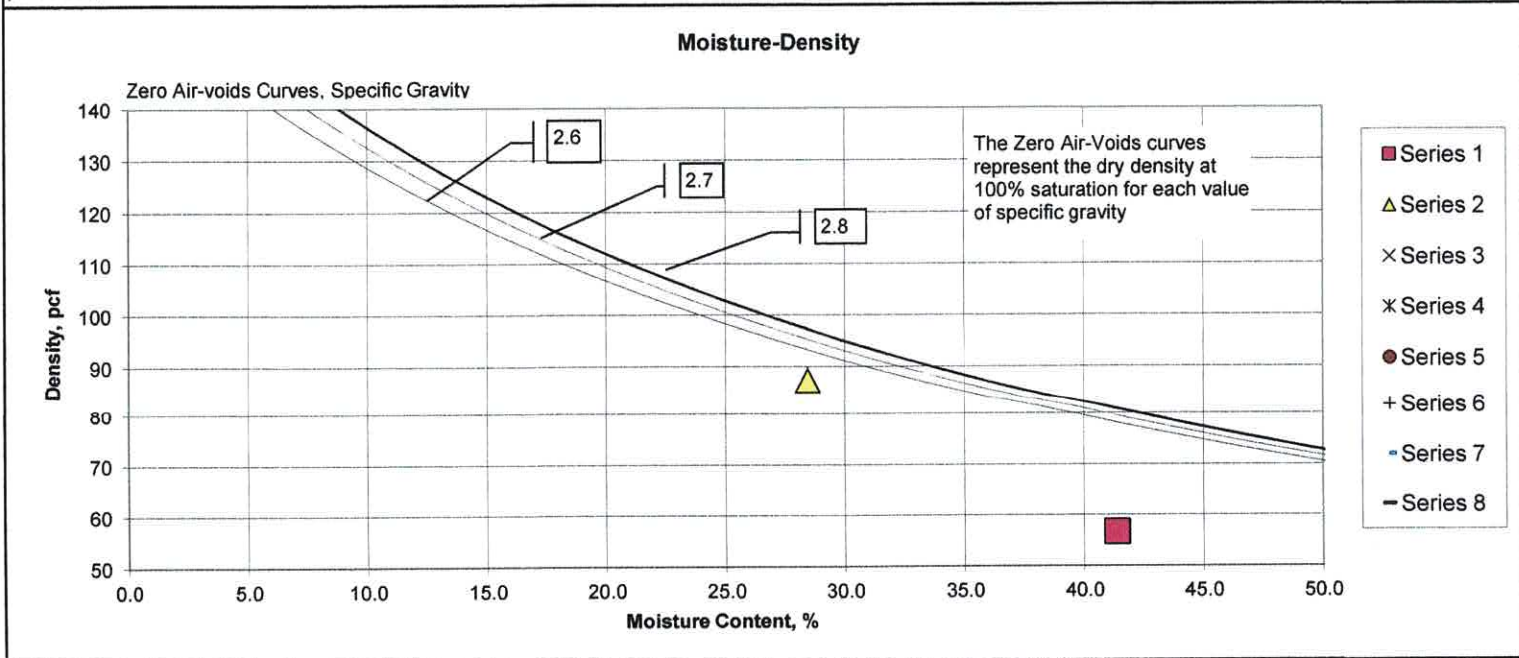
# Moisture-Density-Porosity Report

Boring:	4-1	4-2	4-3					
<b>Sample:</b>								
<b>Depth, ft:</b>								
<b>Visual Description:</b>	Yellowish Brown Sandy Fat CLAY	Dark Reddish Brown Sandy CLAY (Claystone)	Dark Reddish Brown Sandy CLAY (Claystone)					
<b>Actual <math>G_s</math></b>								
<b>Assumed <math>G_s</math></b>	2.70	2.70						
<b>Moisture, %</b>	41.4	28.4	25.5					
<b>Wet Unit wt, pcf</b>	80.2	112.1						
<b>Dry Unit wt, pcf</b>	56.7	87.3						
<b>Dry Bulk Dens.pb, (g/cc)</b>	0.91	1.40						
<b>Saturation, %</b>	56.6	82.3						
<b>Total Porosity, %</b>	66.4	48.3						
<b>Volumetric Water Cont., <math>\theta_w</math>, %</b>	37.6	39.7						
<b>Volumetric Air Cont., <math>\theta_a</math>, %</b>	28.8	8.6						
<b>Void Ratio</b>	1.97	0.93						
<b>Series</b>	1	2	3	4	5	6	7	8

Note: All reported parameters are from the as-received sample condition unless otherwise noted. If an assumed specific gravity ( $G_s$ ) was used then the saturation, porosities, and void ratio should be considered approximate.

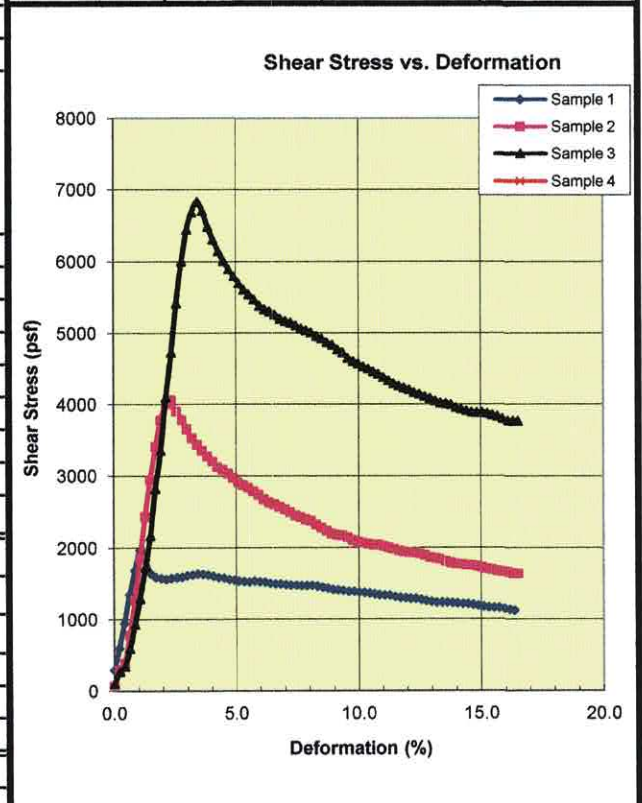
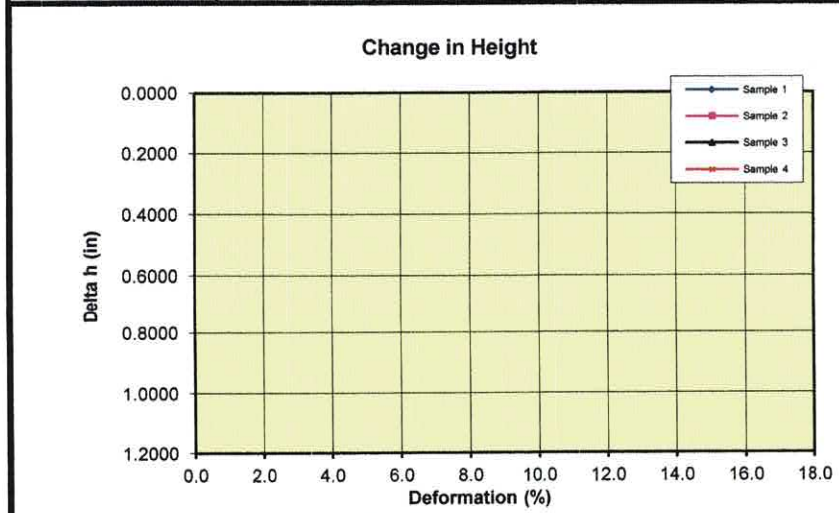
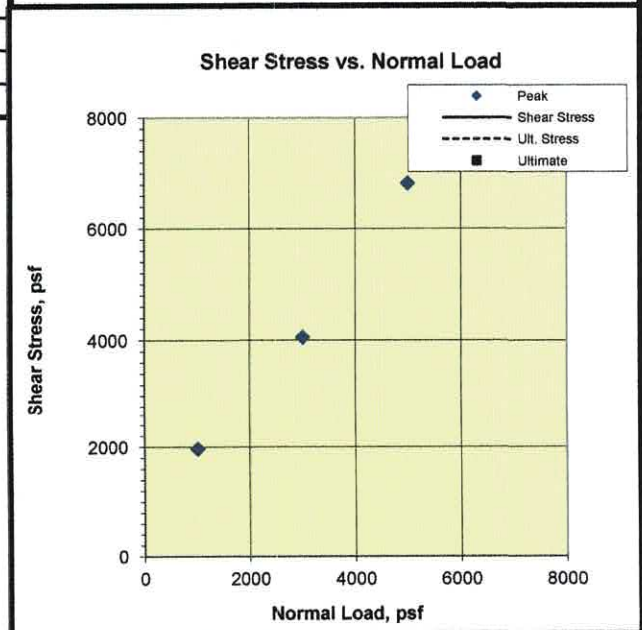
## Consolidated Undrained Direct Shear (ASTM D3080M)

Specimen Data			
	1	2	3
Boring:	2-1	2-1	2-1
Sample:			
Depth (ft):			
Visual Description:	Dark Brown Sandy CLAY (Claystone)	Dark Brown Sandy CLAY (Claystone)	Dark Brown Sandy CLAY (Claystone)
Normal Load (psf)	1000	3000	5000
Dry Mass of Specimen (g)	113.8	116.1	118.8
Initial Height (in)	1.01	1.00	1.01
Initial Diameter (in)	2.42	2.42	2.42
Initial Void Ratio	0.805	0.754	0.725
Initial Moisture (%)	21.8	20.6	21.3
Initial Wet Density (pcf)	113.7	115.8	118.5
Initial Dry Density (pcf)	93.4	96.1	97.7
Initial Saturation (%)	73.0	73.6	79.3
ΔHeight Consol (in)	-0.0006	0.0100	0.0107
At Test Void Ratio	0.806	0.737	0.706
At Test Moisture (%)	28.7	25.5	24.8
At Test Wet Density (pcf)	120.1	121.8	123.3
At Test Dry Density (pcf)	93.3	97.0	98.8
At Test Saturation (%)	96.1	93.4	94.9
Strain Rate (%/min)	1.1	1.1	1.1
Strengths Picked at	Peak	Peak	Peak
Shear Stress (psf)	1969	4061	6831
ΔHeight (in) at Peak			
Ultimate Stress (psf)

**Remarks:** \*DS-CU\* A fully undrained condition may not be attained in this test. ΔH is not measured during undrained direct shear tests. Due to the high apparent phi angle, no phi or cohesion is reported. To add phi and cohesion to the report go to the "phi" tab and in cells G30, G31, H30, and H31 enter end points for a line through the 3 data points. The points plotted can be changed on the "Eng Values" tab using cells L6, A2, C2, and E2.

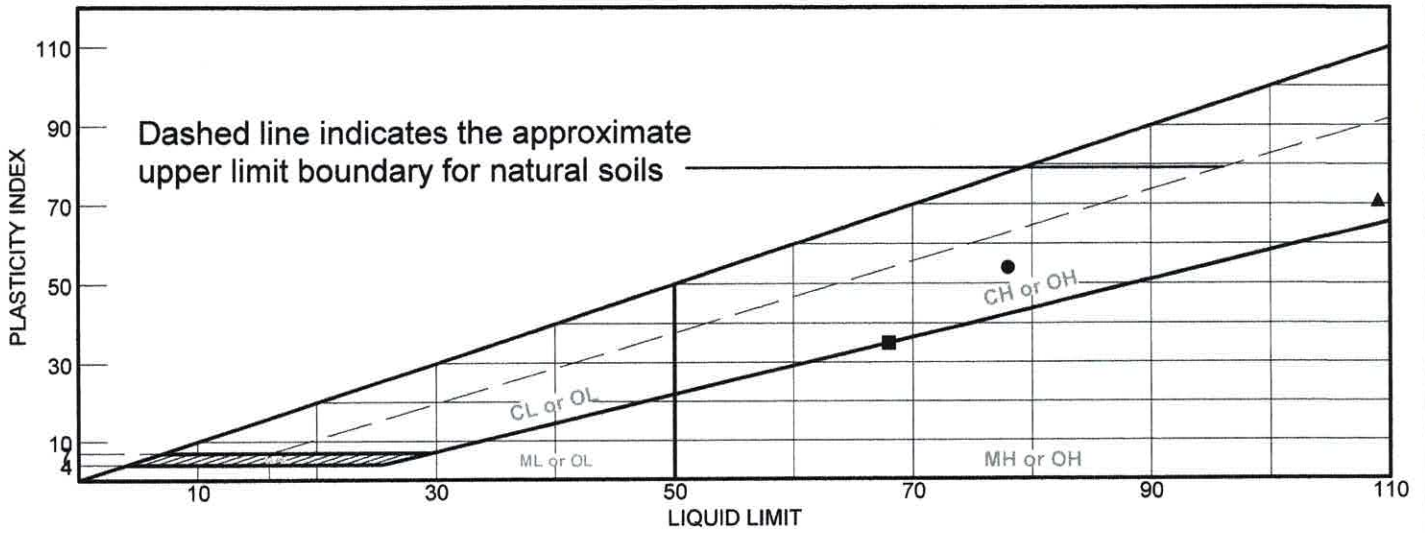
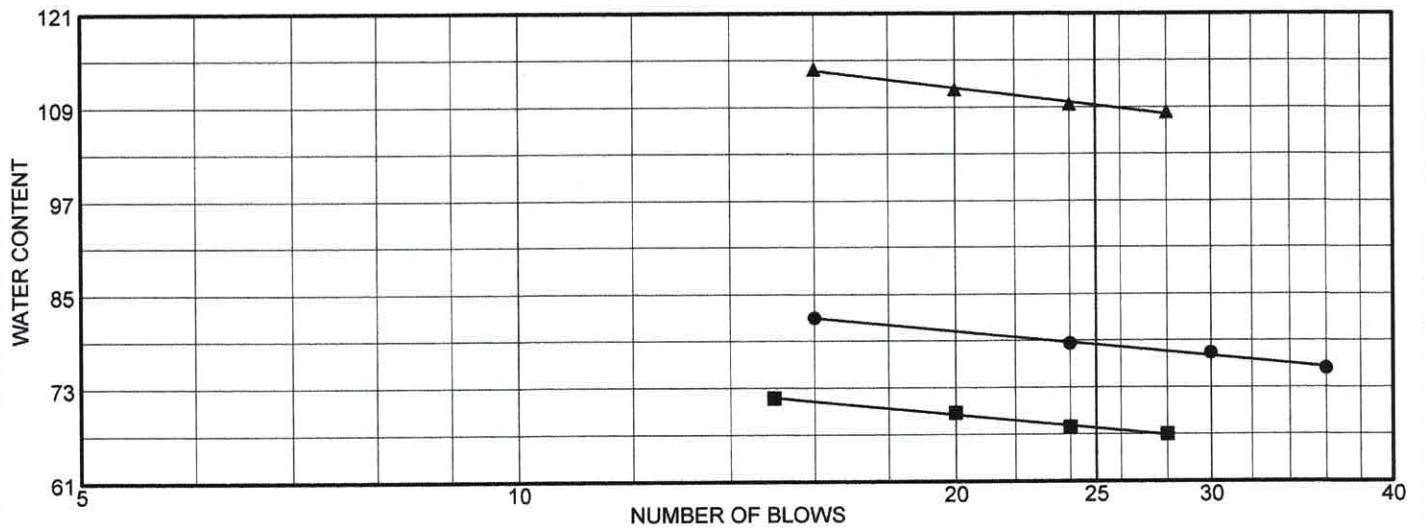
# LIQUID AND PLASTIC LIMITS TEST REPORT

MATERIAL DESCRIPTION	LL	PL	PI	%<#40	%<#200	USCS
●	Dark Brown Fat CLAY	78	24	54			
■	Yellowish Brown Sandy Elastic SILT	68	33	35			
▲	Yellowish Brown Sandy Fat CLAY	109	38	71
