MIRADA ROAD PEDESTRIAN BRIDGE REPLACEMENT PROJECT

FREQUENTLY ASKED QUESTIONS

January 2021

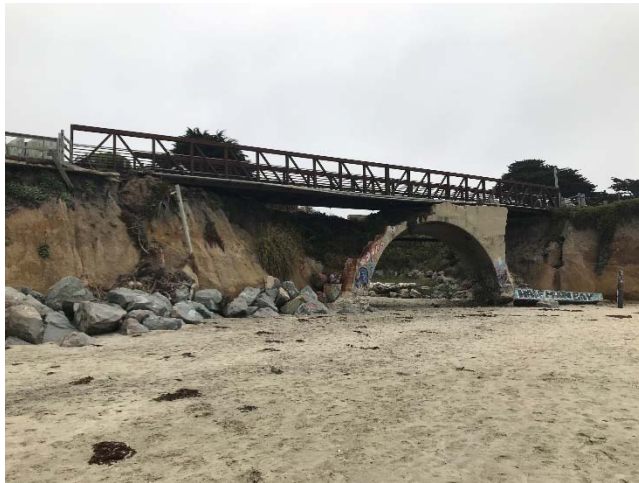
July 2018

The County has observed the performance of the rock rip rap, unprotected bluff, and concrete bridge and has observed no increase in erosion. See the following photographs illustrating conditions.
