## SEAL COVE/MOSS BEACH AREA ROAD IMPROVEMENT PROJECT

Application for San Mateo County Coastal Development Permit

Prepared for San Mateo County Department of Public Works February 2014

Draft Initial Study/Mitigated Negative Declaration

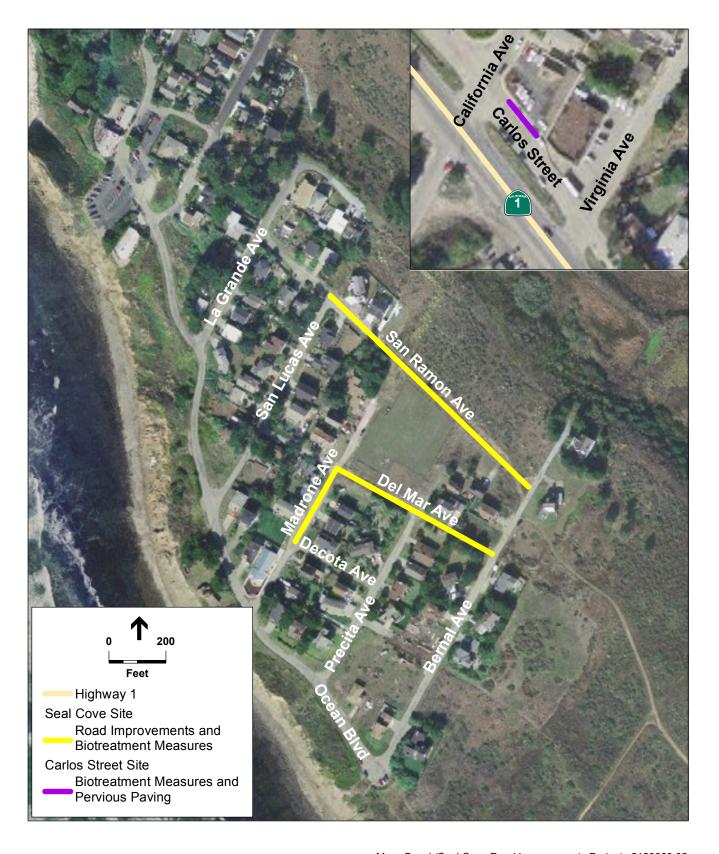
Moss Beach/Seal Cove Road Improvements Project . 2120603.02 Figure 2

At the Seal Cove site, the County proposes approximately 1,500 linear feet of roadway improvements within the County's ROW. Specific road segments to be improved include: (1) San Ramon Avenue, between San Lucas Road and Bernal Avenue (737 linear feet); (2) Del Mar Avenue, between Madrone Avenue and Bernal Avenue (472 linear feet); and (3) Madrone Avenue, between Decota Avenue and Del Mar Avenue (275 linear feet). The above described road segments would be improved by construction of 16-foot-wide paved road sections comprised of approximately three inches of asphalt concrete and nine inches of cement-treated base. Surface drainage features, consisting of vegetated bioretention basins, would be constructed on either side of the roadway to capture and treat stormwater runoff. The biotreatment areas would measure approximately five feet wide and approximately six inches deep. At the Carlos Street site, the County proposes to replace an approximately 1,100-square-foot paved area of County ROW with a combination of vegetated biotreatment facility (60 square feet) and pervious paving (1,040 square feet). Upon completion of construction, the County would assume maintenance responsibility for these road segments and treatment areas.

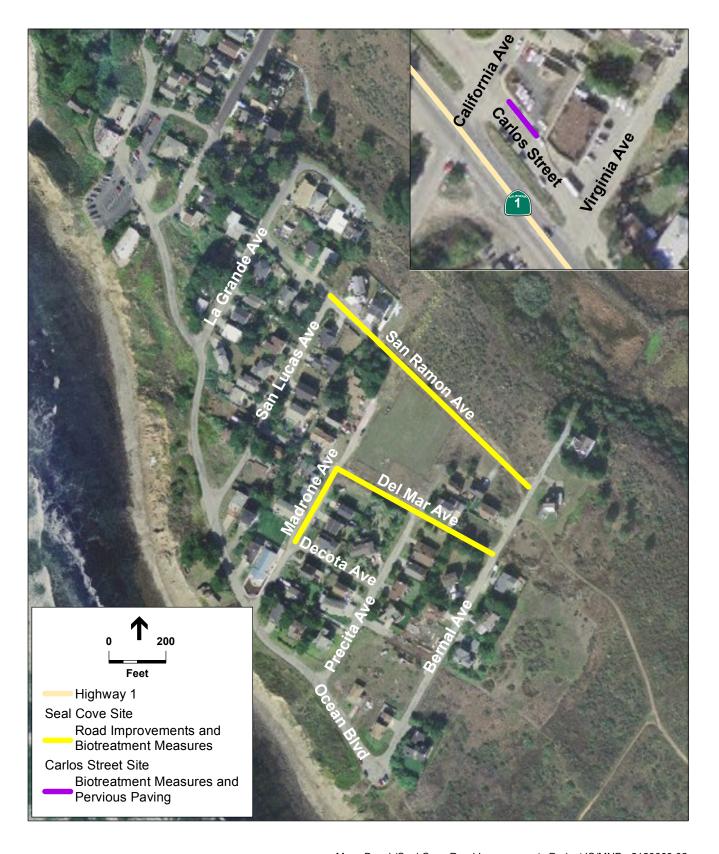
Moss Beach/Seal Cove Road Improvements Project IS/MND . 2120603.02

At the Seal Cove site, the County proposes approximately 1,500 linear feet of roadway improvements within the County's ROW. Specific road segments to be improved include: (1) San Ramon Avenue, between San Lucas Road and Bernal Avenue (737 linear feet); (2) Del Mar Avenue, between Madrone Avenue and Bernal Avenue (472 linear feet); and (3) Madrone Avenue, between Decota Avenue and Del Mar Avenue (275 linear feet). The above described road segments would be improved by construction of 16-foot-wide paved road sections comprised of approximately three inches of asphalt concrete and nine inches of cement-treated base. Surface drainage features, consisting of bioretention facilities separated by check dams, would be constructed on either side of the roadway to capture and treat stormwater runoff. The biotreatment areas would measure approximately five feet wide and approximately six inches deep. At the Carlos Street site, the County proposes to replace an approximately 1,100-square-foot paved area of County ROW with a combination of vegetated biotreatment facility (60 square feet) and pervious paving (1,040 square feet). Upon completion of construction, the County would assume maintenance responsibility for these road segments and treatment areas.

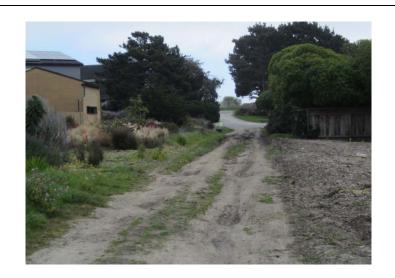
Eastward view of Del Mar Avenue from Madrone Avenue

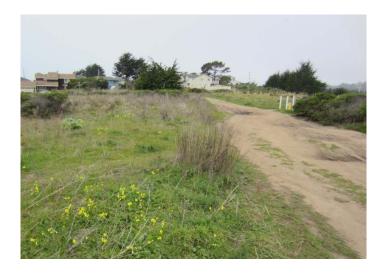
Northward view of San Ramon Avenue from Bernal Avenue

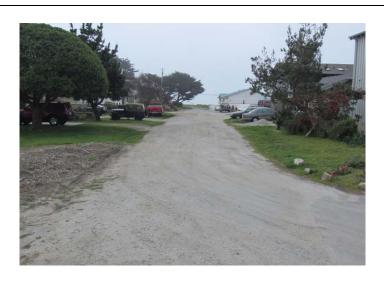
Westward view of Madrone Avenue from Del Mar Avenue

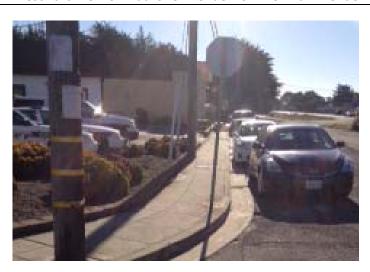
Figure 3
Site Photographs

Southward view of Carlos Street from California Avenue

a, b) There are no identified scenic vistas in the immediate vicinity of the Seal Cove project sites, which is shown in **Figure 3**. The Seal Cove project site is located adjacent to the western extent of the County-designated Highway 1 scenic corridor. The Carlos Street site (see Figure 3) is located within this scenic corridor (County of San Mateo, 2010). This segment is also identified as an eligible state scenic highway, but has not been designated as such at this time (Caltrans, 2007). The proposed work at the Seal Cove site would include approximately 0.85 acre of site disturbance, including grading of existing dirt roads and excavation of approximately 200 cubic yards of soil for bioretention facility construction. Work at the Carlos Street site would entail removal of approximately 1,100 square feet of asphalt surface and excavation of approximately 81 cubic yards of soil for bioretention facility construction and installation of pervious paving. Neither would include a significant change in site topography. No project components would occur on a ridgeline.

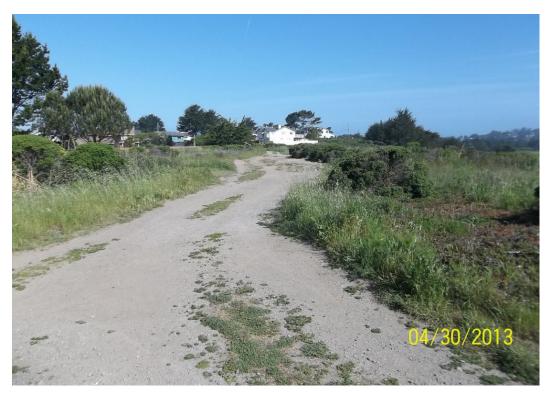
**Photo 1** – View on April 30, 2013 looking northwest along San Ramon Avenue towards the residence at 885 San Ramon Avenue. Habitat at this site is non-native grassland and coyote brush scrub on both sides of the roadway, and ruderal on the dirt road and along the shoulders.

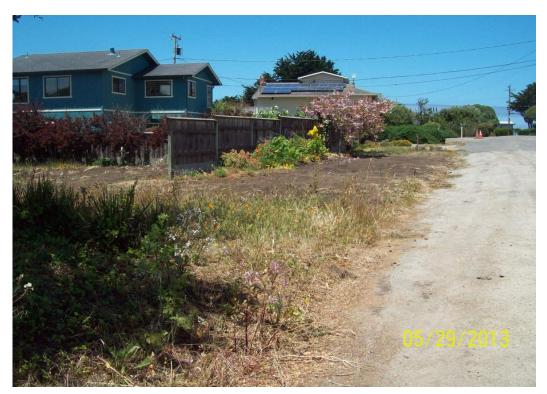
**Photo 3** – View on May 29, 2013 looking northwest along San Ramon Avenue towards the San Lucas Avenue intersection. Habitat at this section of San Ramon Avenue is primarily ruderal and landscape ornamental.

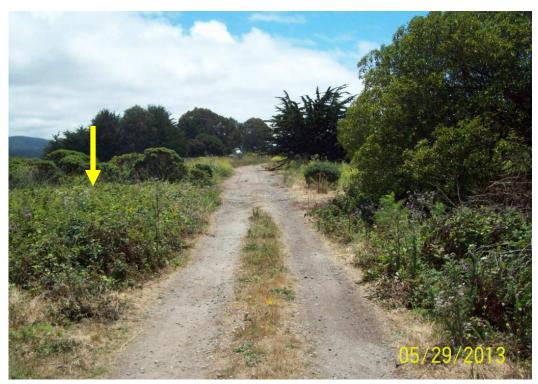
**Photo 4** – View on May 29, 2013 looking southeast along San Ramon Avenue towards the Bernal Avenue intersection. Note the stand of California blackberry (*Rubus ursinus*) on the left side of the photo (location indicated by arrow).

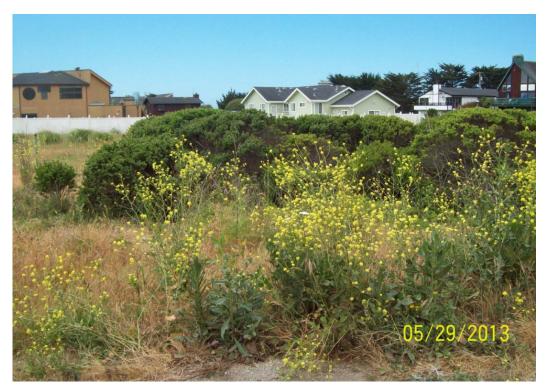
Photo 5 – Photo taken on May 29, 2013 showing example of coyote brush scrub and ruderal roadside shoulder habitat along San Ramon Avenue.

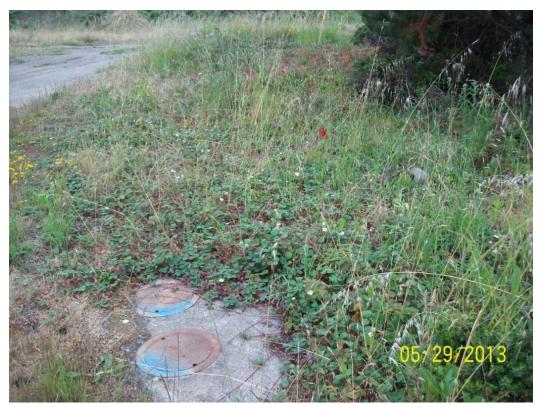
Photo 6 - Large patch of beach strawberry (Fragaria chiloensis) within the San Ramon Avenue right-ofway at the intersection of San Ramon and Bernal Avenues.

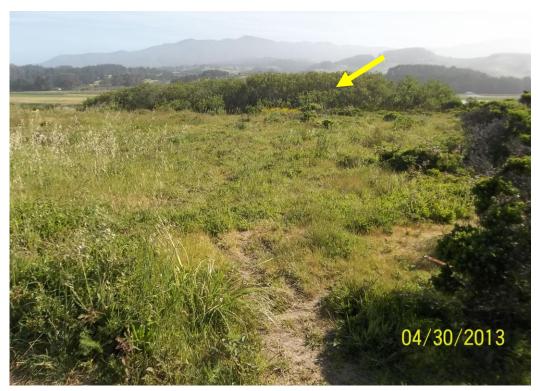
**Photo 7** – View on April 30, 2013 looking east from San Ramon Avenue towards the large willow patch and wetland seep located approximately 200-feet from the Project site (location indicated by arrow).

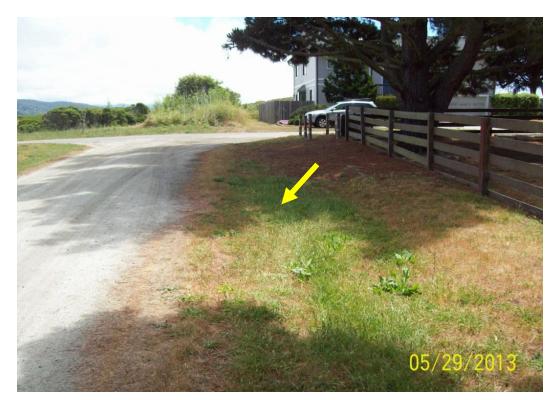
**Photo 8** – View on May 29, 2013 looking southeast on Del Mar Avenue towards the Bernal Avenue intersection. Small patches of beach strawberry occur in the grassy shoulder at this location (as indicated by arrow). The County road right-of-way boundary is located at the fence line shown in the photo.

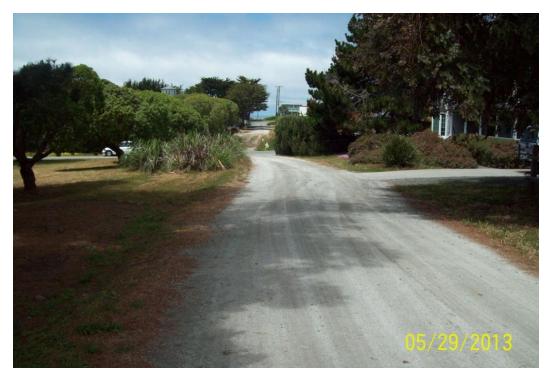
**Photo 9**– View on May 29, 2013 looking northwest on Del Mar Avenue towards the Precita Avenue intersection. Habitat at this location is primarily landscape ornamental with small patches of beach strawberry along the grassy shoulders.

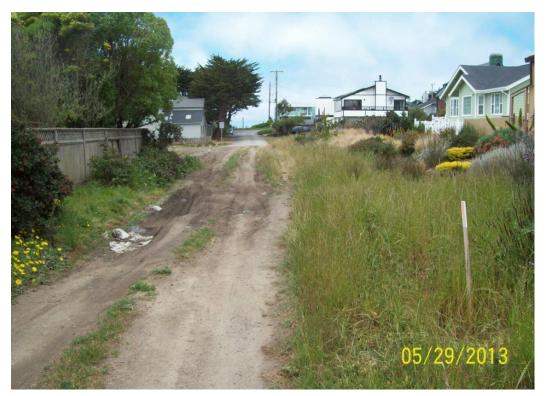
**Photo 10** – View on May 29, 2013 looking northwest along Del Mar Avenue towards the Madrone Avenue intersection. Habitat at this location is primarily ruderal on the dirt road and ruderal/landscape ornamental with small patches of beach strawberry along the shoulders within the County road ROW.

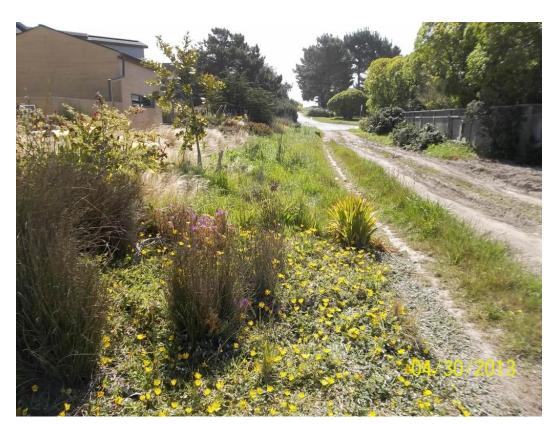
**Photo 11** – View on April 30, 2013 looking southeast along Del Mar Avenue towards the Precita Avenue intersection. Habitat at this location is primarily ruderal on the dirt road and ruderal/landscape ornamental with small patches of beach strawberry along the shoulders within the County road ROW.

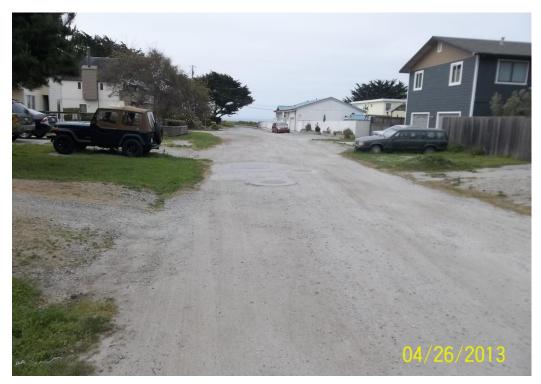
**Photo 12** – View on April 26, 2013 looking west along Madrone Avenue toward the Pacific Ocean. Habitat at this location is exclusively ruderal and landscape ornamental.

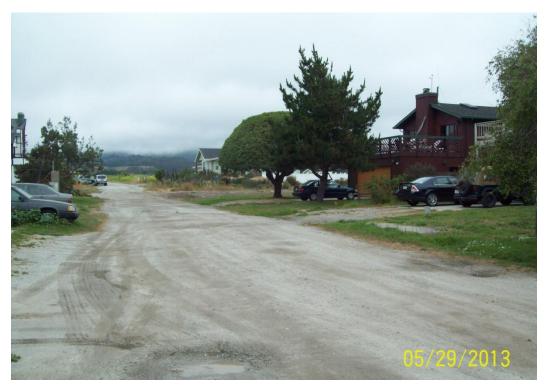
**Photo 13** – View on May 29, 2013 looking east along Madrone Avenue towards the Del Mar Avenue intersection. Habitat at this location is exclusively ruderal and landscape ornamental. Small patches of beach strawberry occur in residential lawns beyond the Project impact area (outside of the County road ROW).

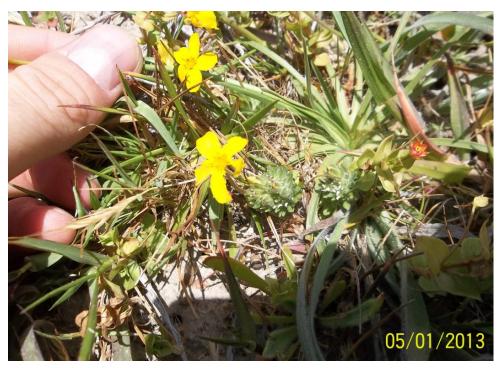
**Photo 14** – Photo of flowering coast yellow leptosiphon (*Leptosiphon croceus*) taken on May 1, 2013 to verify surveys were conducted during the appropriate local blooming period for this species. The reference site is located on Vallemar Bluff in the Moss Beach area, approximately 1 mile north of the Project site.

The CNPS lists coast yellow leptosiphon as a 1B species, meaning that it is rare, threatened, or endangered in California and elsewhere. Coast yellow leptosiphon blooms from April through May and is typically found within coastal bluff scrub and coastal prairie habitats (CNPS, 2013). An extant CNDDB documented occurrence of this species is located within coastal prairie habitat north of Juliana Avenue in Moss Beach (Appendix A – Figure 3). This site was used as a reference site to verify blooming status during the survey period. The plants were observed growing approximately 275 feet north of Juliana Avenue on the edge of a coastal bluff. Although coastal prairie and coastal bluff scrub habitats exists at the Project site in the vicinity of San Ramon Avenue, the area was extensively surveyed and coast yellow leptosiphon was not detected. Therefore, this species will not be impacted by the proposed Project.

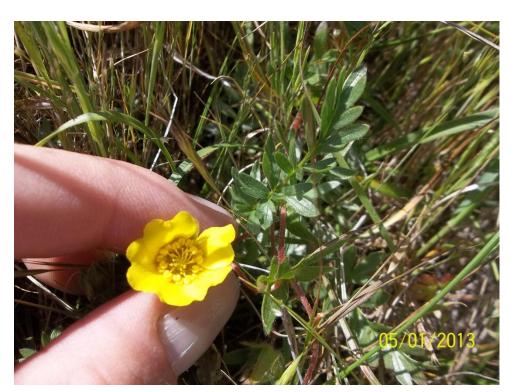
**Photo 15** – Photo of flowering Hickman's cinquefoil (*Potentilla hickmanii*) taken on May 1, 2013 to verify surveys were conducted during the appropriate local blooming period for this species. The reference site is located in the Rancho Corral de Tierra park in the Montara area, approximately 2.5 miles north of the Project site.

Hickman's cinquefoil is listed as an Endangered species under the Federal Endangered Species Act (FESA) and the California Endangered Species Act (CESA). The CNPS lists Hickman's cinquefoil as a 1B species, meaning that it is rare, threatened, or endangered in California and elsewhere. Hickman's cinquefoil blooms from April through August and is typically found within coastal bluff scrub, closed-cone coniferous forest, meadows and seeps, and freshwater marshes and swamps (CNPS, 2013). Hickman's cinquefoil was historically reported within 0.7 miles of the Project site growing near the coastal bluff edge (Appendix A – Figure 3), but is believed to be extirpated at that location due to developmental pressures and erosion. Several colonies of Hickman's cinquefoil have been reported within 2.3 miles of the Project site within the Corral de Tierra open space north of Montara. This site was used as a reference site to verify blooming status during the survey period. Within the Project area, suitable habitat for Hickman's cinquefoil may exist within the coastal bluff scrub habitat around San Ramon Avenue or in the seeps and willow thickets to the east of San Ramon Avenue. However, Hickman's cinquefoil has not been reported at the Project site (CNDDB, 2013) and was not detected during the site surveys. Therefore, this species will not be impacted by

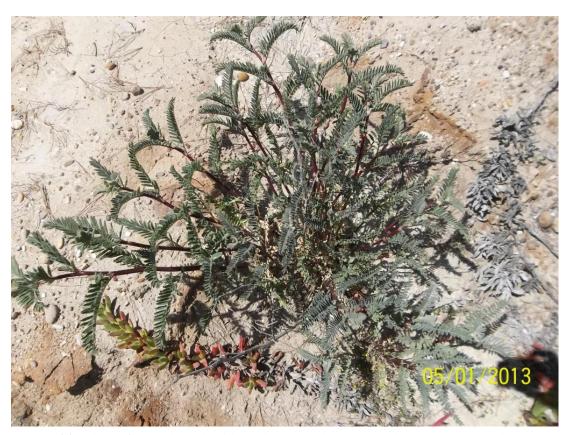
Photo 16 – Photo of coastal marsh milk-vetch (Astragalus pycnostachyus var. pycnostachyus) taken on May 1, 2013. Although this species was not flowering during the site visit, the foliage is distinctive and easily identifiable during its non-blooming period. The reference site is located south of San Gregorio Creek along Highway 1.

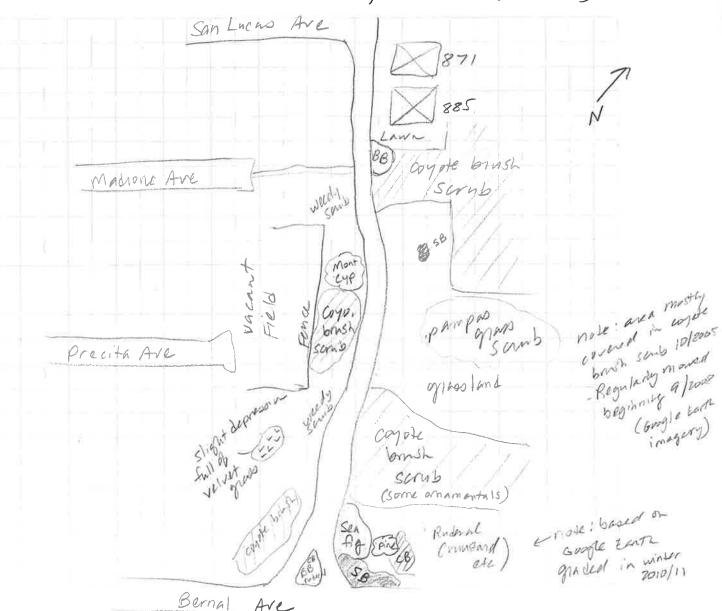
Total area surveyed: 71,375 ft 2 (1.6 ac)

CB- coyate brush

SB - Beach Strawberry

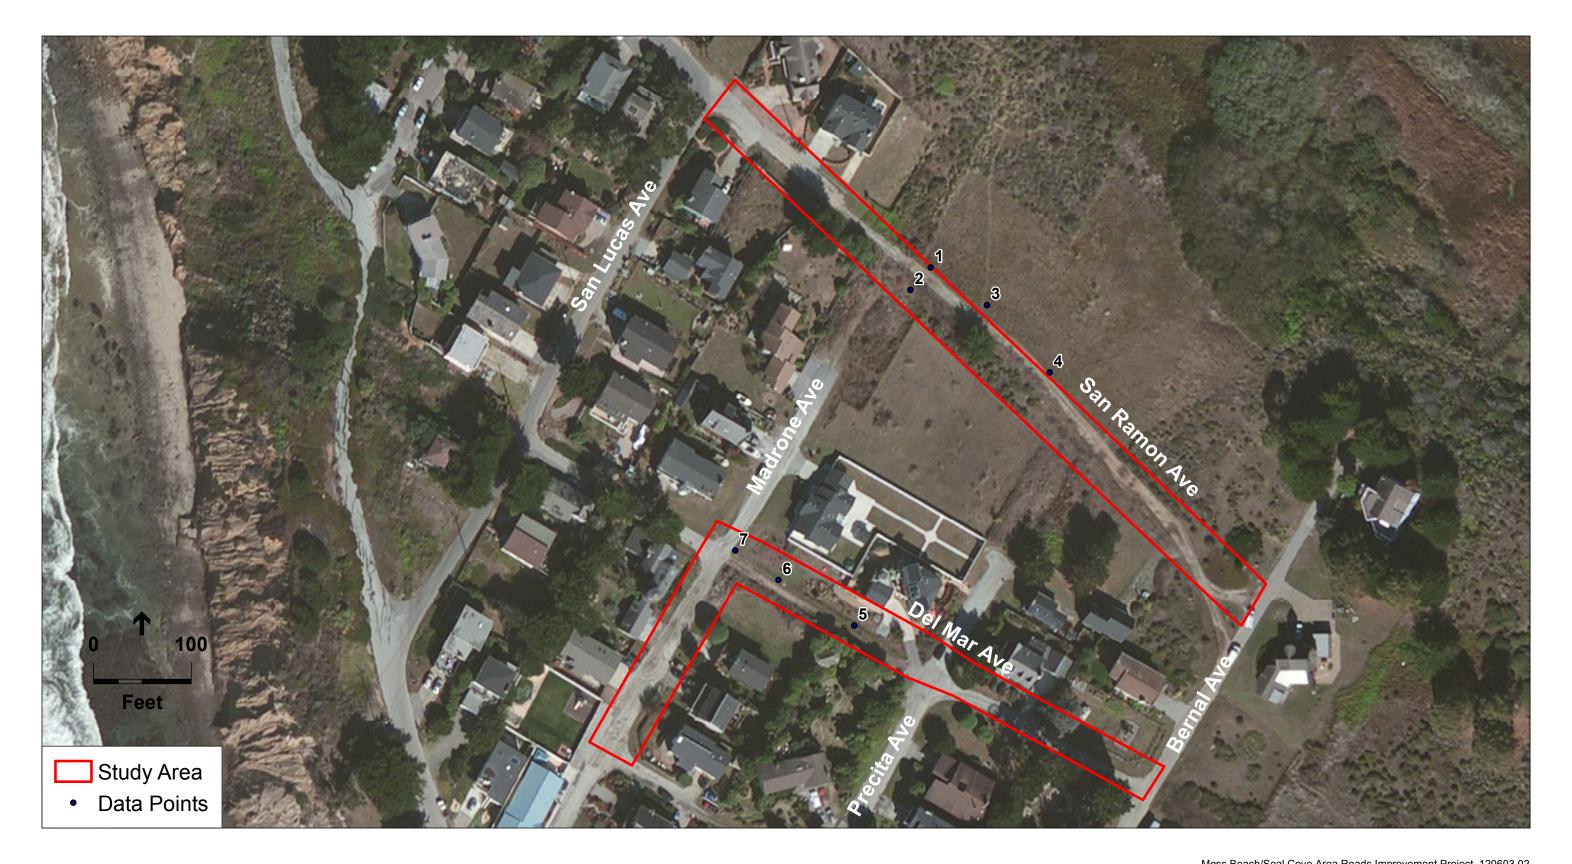
Features and data points were mapped by hand on aerial images and field notes were taken on the characteristics of each feature (vegetation type and quality, disturbance levels, etc.). Data points were then digitized using ArcGIS 10.1.

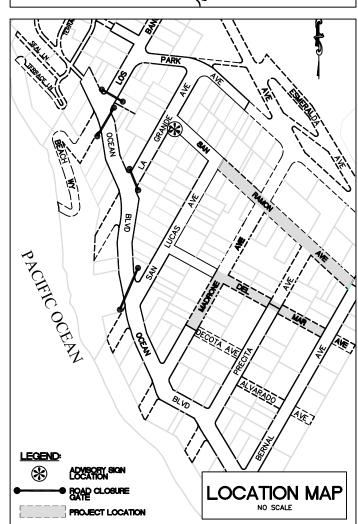
NOTES FOR TYPICAL SECTIONS

(g) ROW WIDTHS ARE 50 FEET FOR MADRONE AND SAN RAMON AVENUES, AND 40 FEET FOR DEL MAR AVENUE.

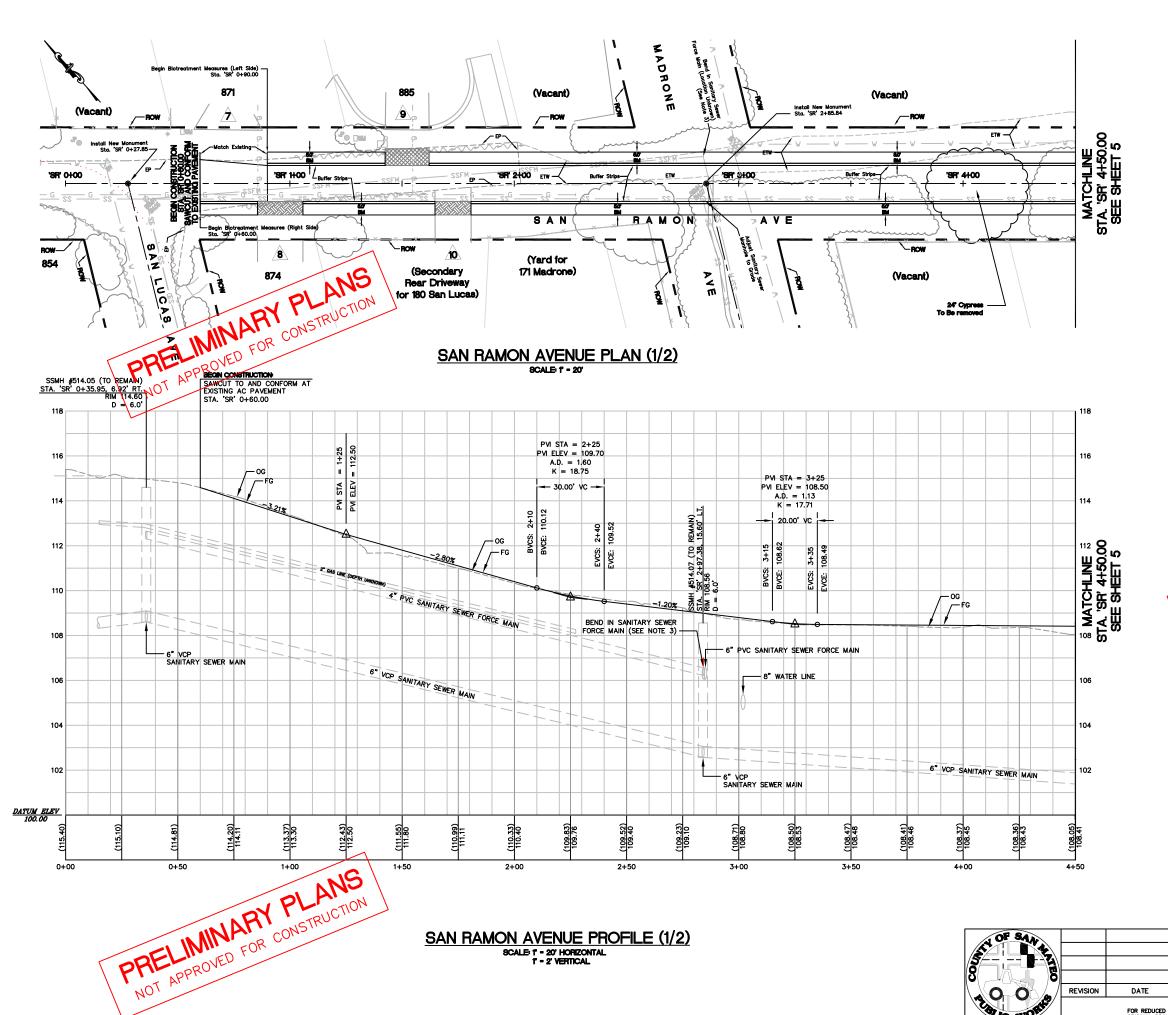
SAN RAMON AVENUE PROFILE (1/2)

SCALE: 1" = 20" HORIZONTAL 1" = 2" VERTICAL

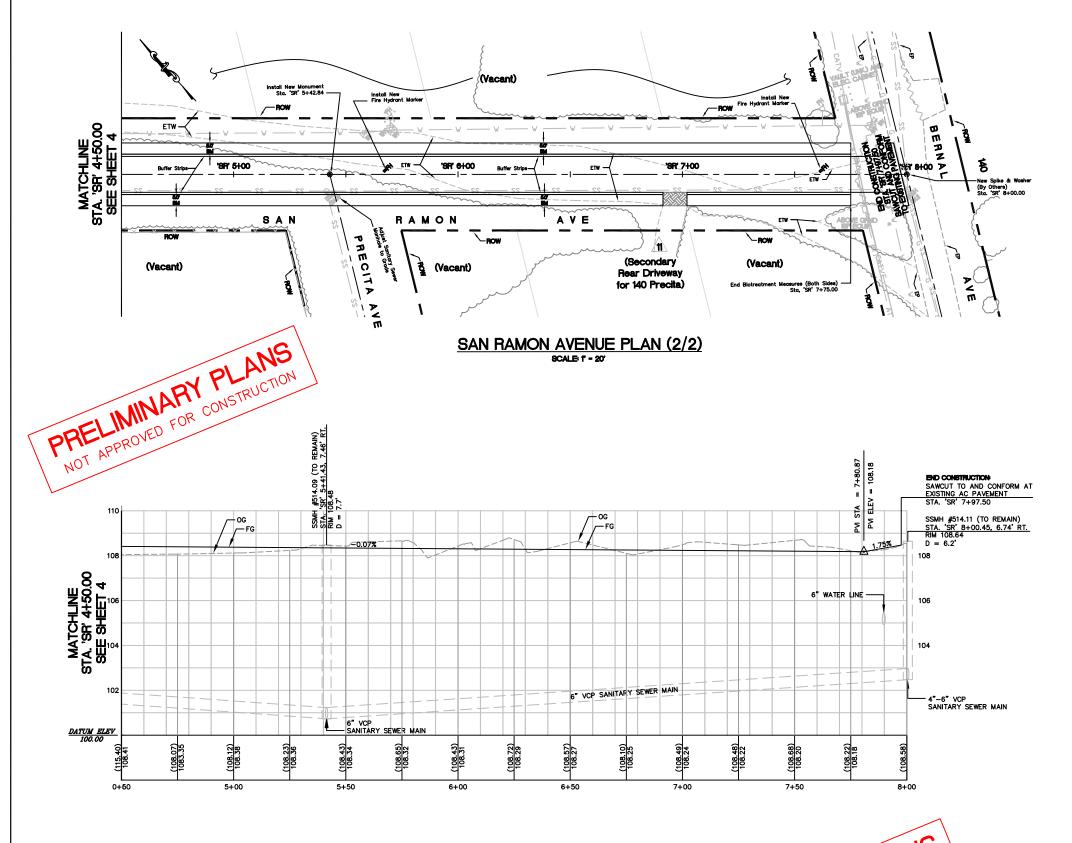
SAN RAMON AVENUE PROFILE (2/2)

SCALE F = 20' HORIZONTAL

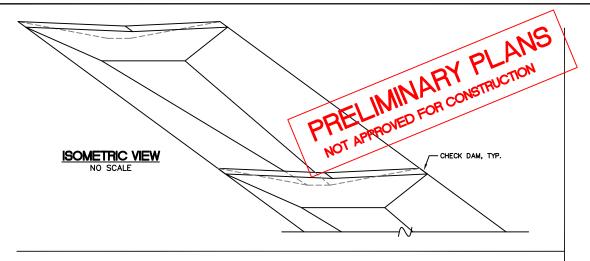
TYPICAL CROSS-SECTION

- ROCKS, OR A COMBINATION THEREOF.
    THE NUMBER OF ROCKS PER CHECK DAM MAY VARY DEPENDING UPON THE ACTUAL SIZE AND SHAPE OF EACH ROCK.
- (7) SCOUR—CONTROL FOOTER: REFERENCE IS MADE TO SECTION 71-4b, "DRAIN ROCK (3/4" CRUSHED)," OF THE SPECIAL PROVISIONS.

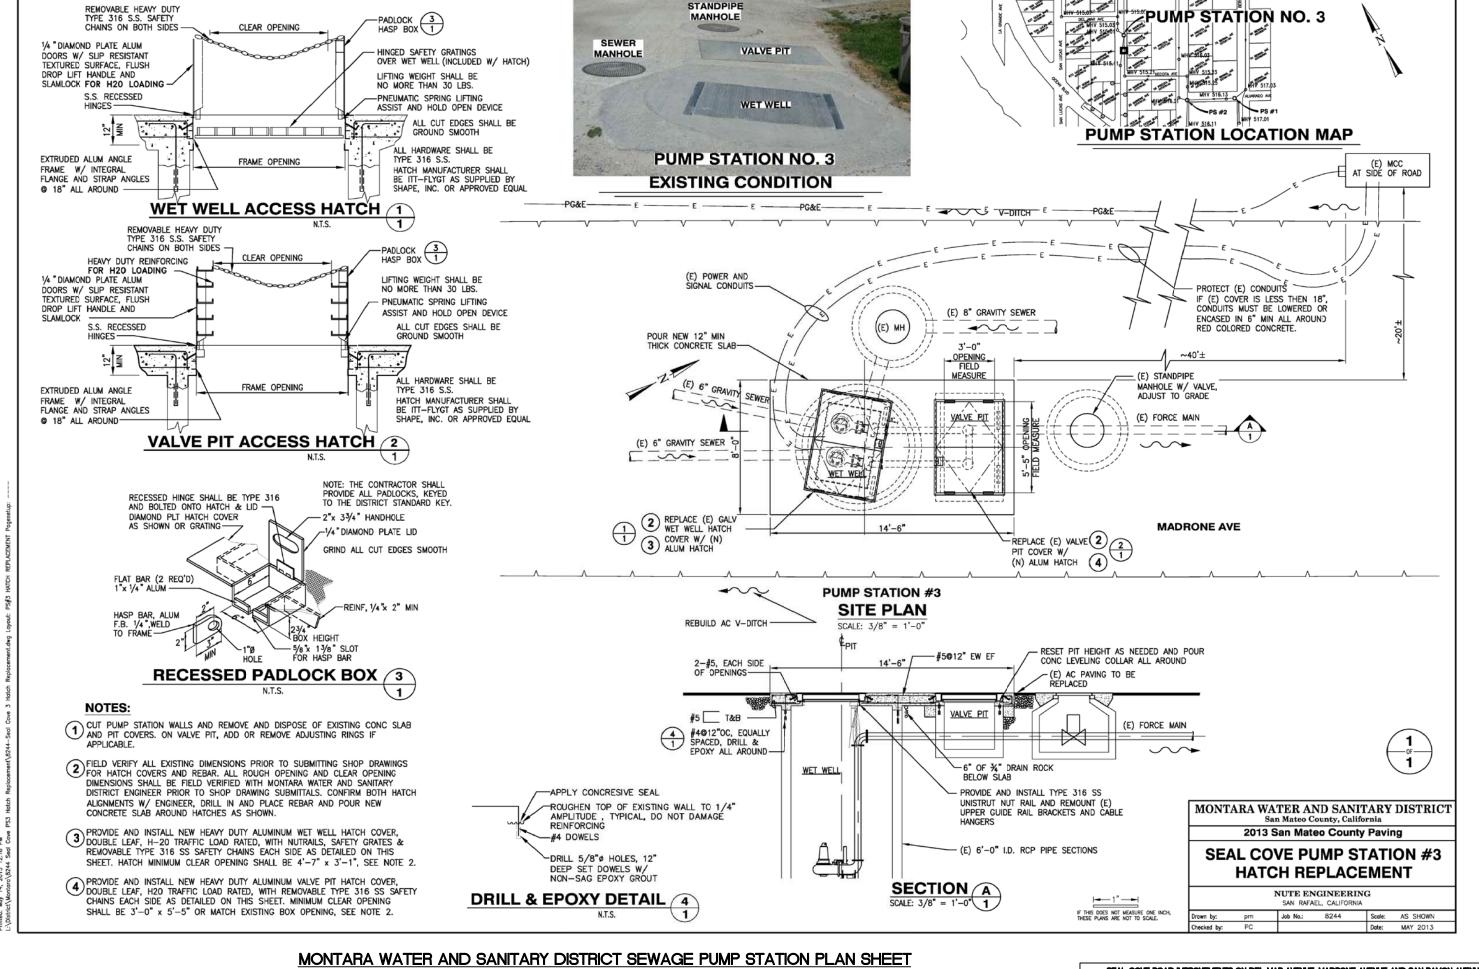
SEAL COVE ROAD IMPROVEMENTS ON DEL MAR AVENUE, MADRONE AVENUE AND SAN RAMON AVENUE
DETAILS: UTILITY

## MONTARA WATER AND SANITARY DISTRICT DETAILS
