**COUNTY OF SAN MATEO
PLANNING AND BUILDING DEPARTMENT**

SUBJECT: SUPPLEMENTAL STAFF REPORT: Consideration of a Coastal Development Permit and Timberland Preserve/Coastal Zone Minor Development Permit, pursuant to Sections 6328.4 and 6965 of the County Zoning Regulations, respectively; and a Grading Permit, pursuant to Section 8602 of the County Grading Ordinance; for the removal and replacement of an existing vehicular bridge at a location on Purisima Creek, in the Purisima Creek Redwoods Open Space Preserve. This project is appealable to the California Coastal Commission.

County File Number: PLN 2015-00006
(Mid-Peninsula Regional Open Space District)

HARKINS BRIDGE REPLACEMENT PLAN

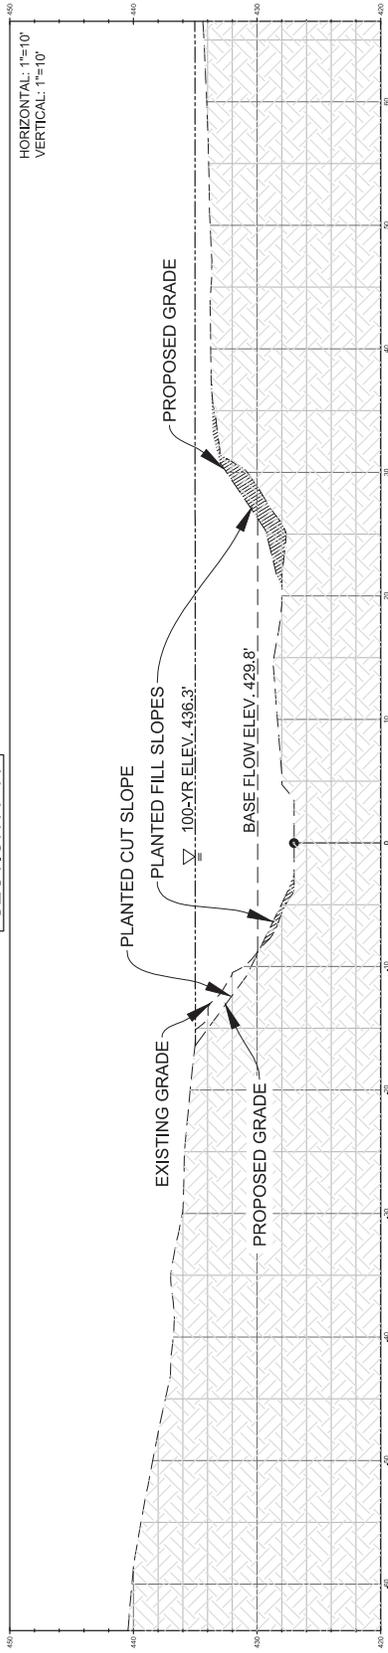
**STATION 101+42
SECTION A-A'**

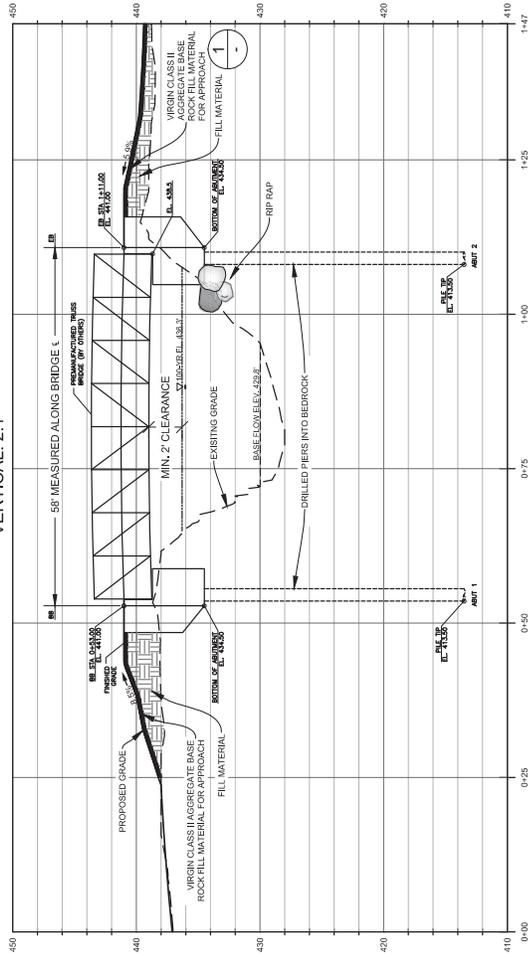
**NEW HARKINS BRIDGE PROFILE
SCALE: 1" = 10'
VERTICAL: 2:1**

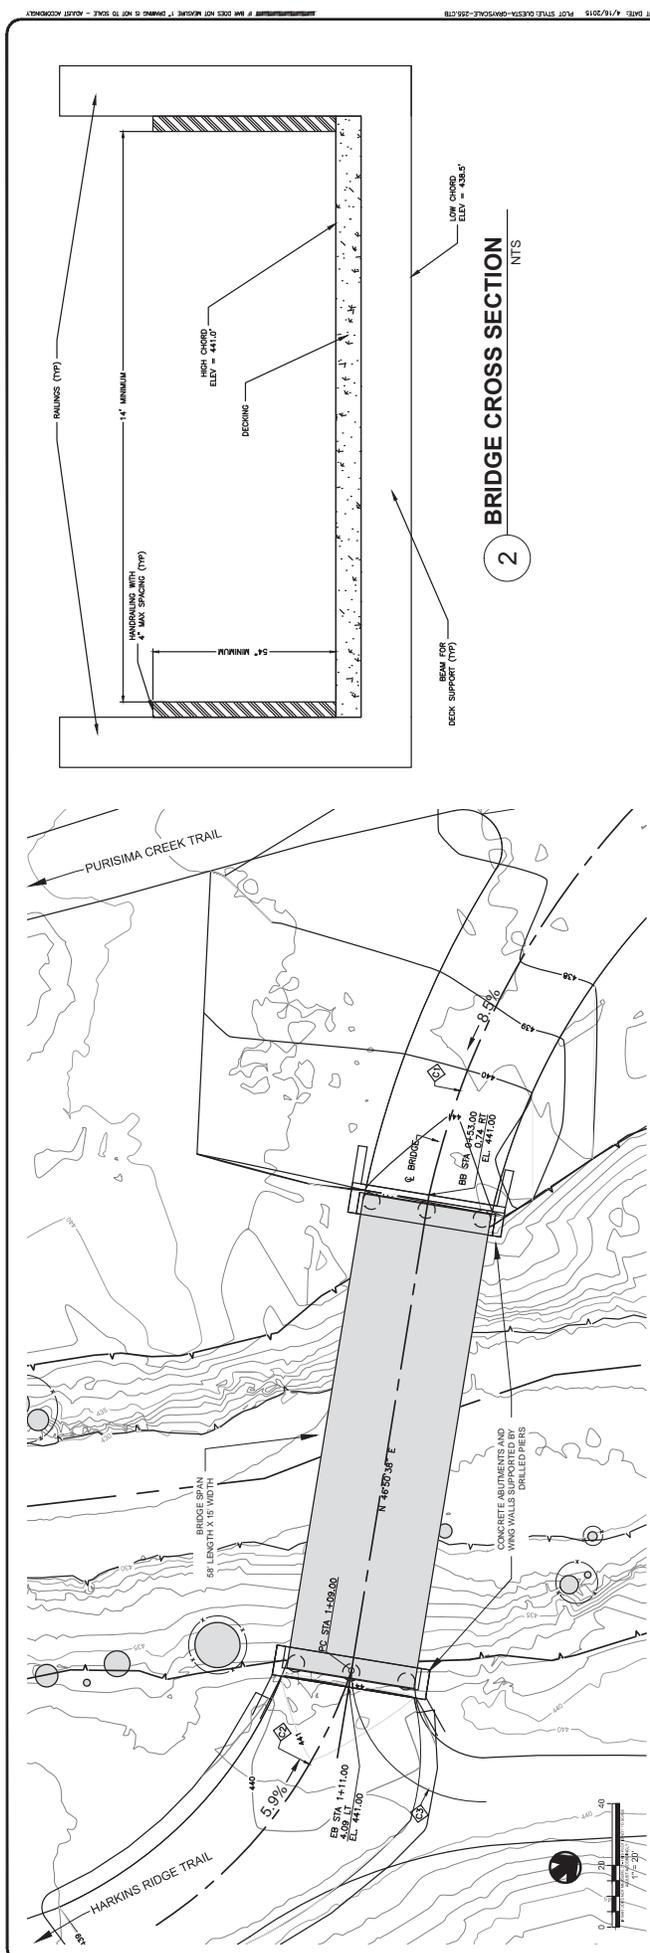
1 BRIDGE PLAN IE

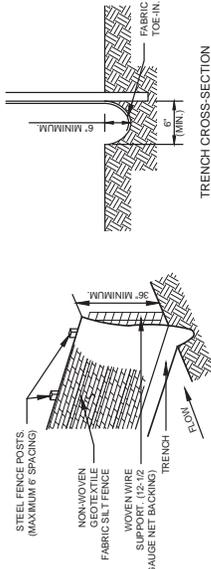
2 SILT/BIO EXCLUSION FENCE INSTALLATION
NOTES

- NOTES:
1. STEEL POSTS WHICH SUPPORT THE SILT EXCLUSION FENCE SHALL BE INSTALLED ON A SLIGHT ANGLE TOWARD THE ANTICIPATED RUNOFF SOURCE.
 2. THE TOE OF THE SILT FENCE SHALL BE TRENCHED IN WITH A SPADE OR MECHANICAL TRENCHER, SO THAT THE DOWNSLOPE FACE OF THE TRENCH IS FLAT AND PERPENDICULAR TO THE LINE OF FLOW. WHERE FENCE CANNOT BE TRENCHED, IT SHALL BE TRENCHED BY HAND WITH WASHED GRAVEL ON UPHILL SIDE TO PREVENT FLOW UNDER FENCE.

5. INSPECTION SHALL BE MADE WEEKLY AND REPAIR OR REPLACEMENT SHALL BE MADE PROMPTLY AS NEEDED.
 6. FENCE SHALL BE REMOVED WHEN THE SITE IS COMPLETELY STABILIZED SO AS NOT TO BLOCK OR IMPEDE STORM FLOW OR DRAINAGE.

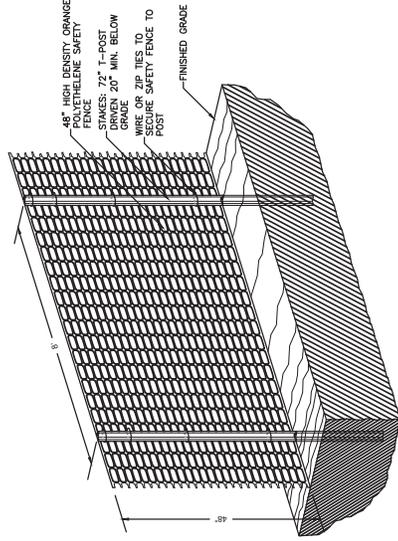
3A TEMPORARY CHAIN-LINK SECURITY FENCE
NOTES

- NOTES:
1. ALL SENSITIVE AREAS SHALL BE PROTECTED AS PER PLAN.
 2. ALL SENSITIVE AREAS SHALL BE PROTECTED WITH HIGH VISIBILITY FENCE AS PER PLAN.
 3. WHERE PRACTICABLE, INSTALL HIGH VISIBILITY 3 FEET OUTSIDE OF THE DRP LINE OF THE TREE.
 4. SAFETY FENCE SHOULD BE FASTENED SECURELY TO THE T-POSTS.
 5. CHANGE OF THE PROTECTIVE FENCING MUST BE APPROVED.

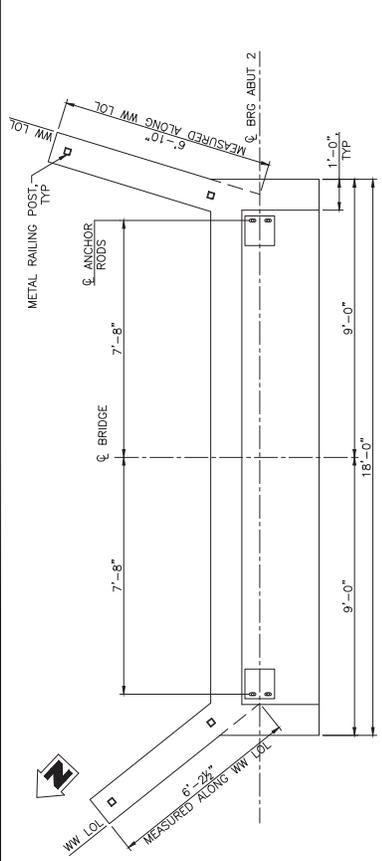
ABUTMENT 2 PLAN
SCALE: 1/2" = 1'-0"

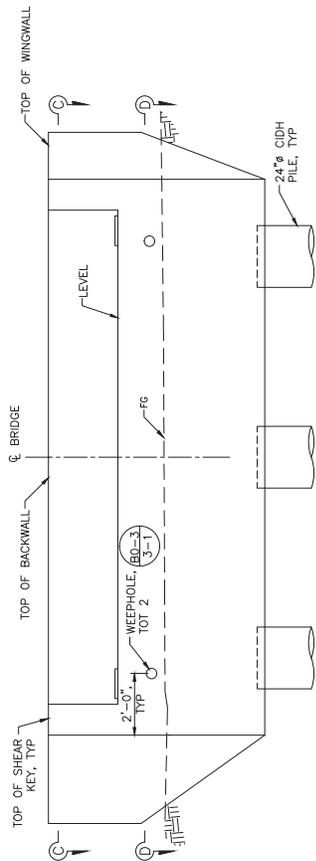
ABUTMENT 2 ELEVATION
SCALE: 1/2" = 1'-0"

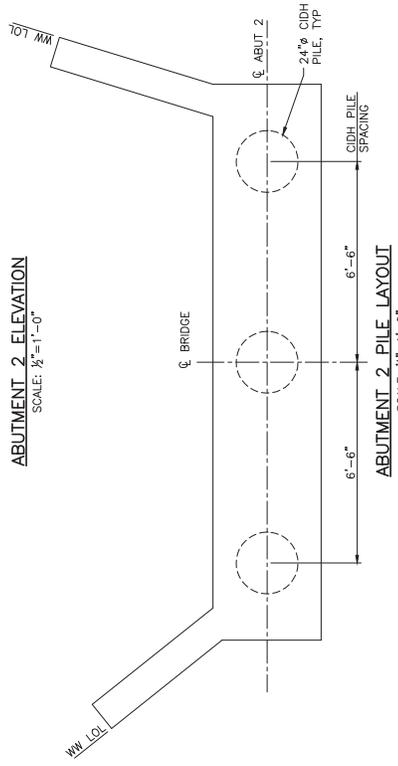
ABUTMENT 2 PILE LAYOUT
SCALE: 1/2" = 1'-0"

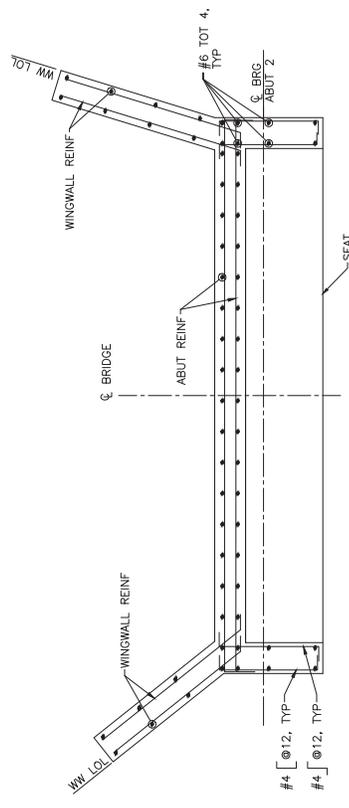
SECTION C-C
SCALE: 1/2" = 1'-0"

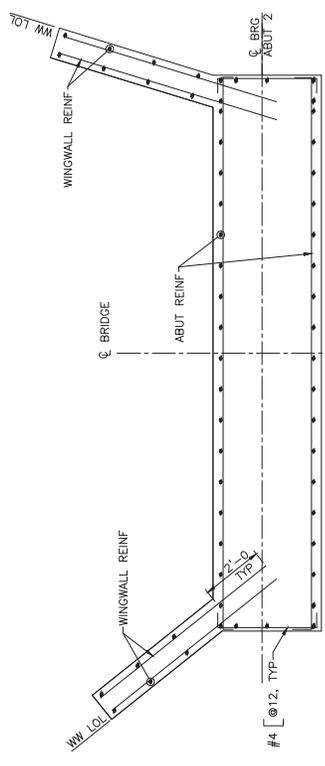
SECTION D-D
SCALE: 1/2" = 1'-0"

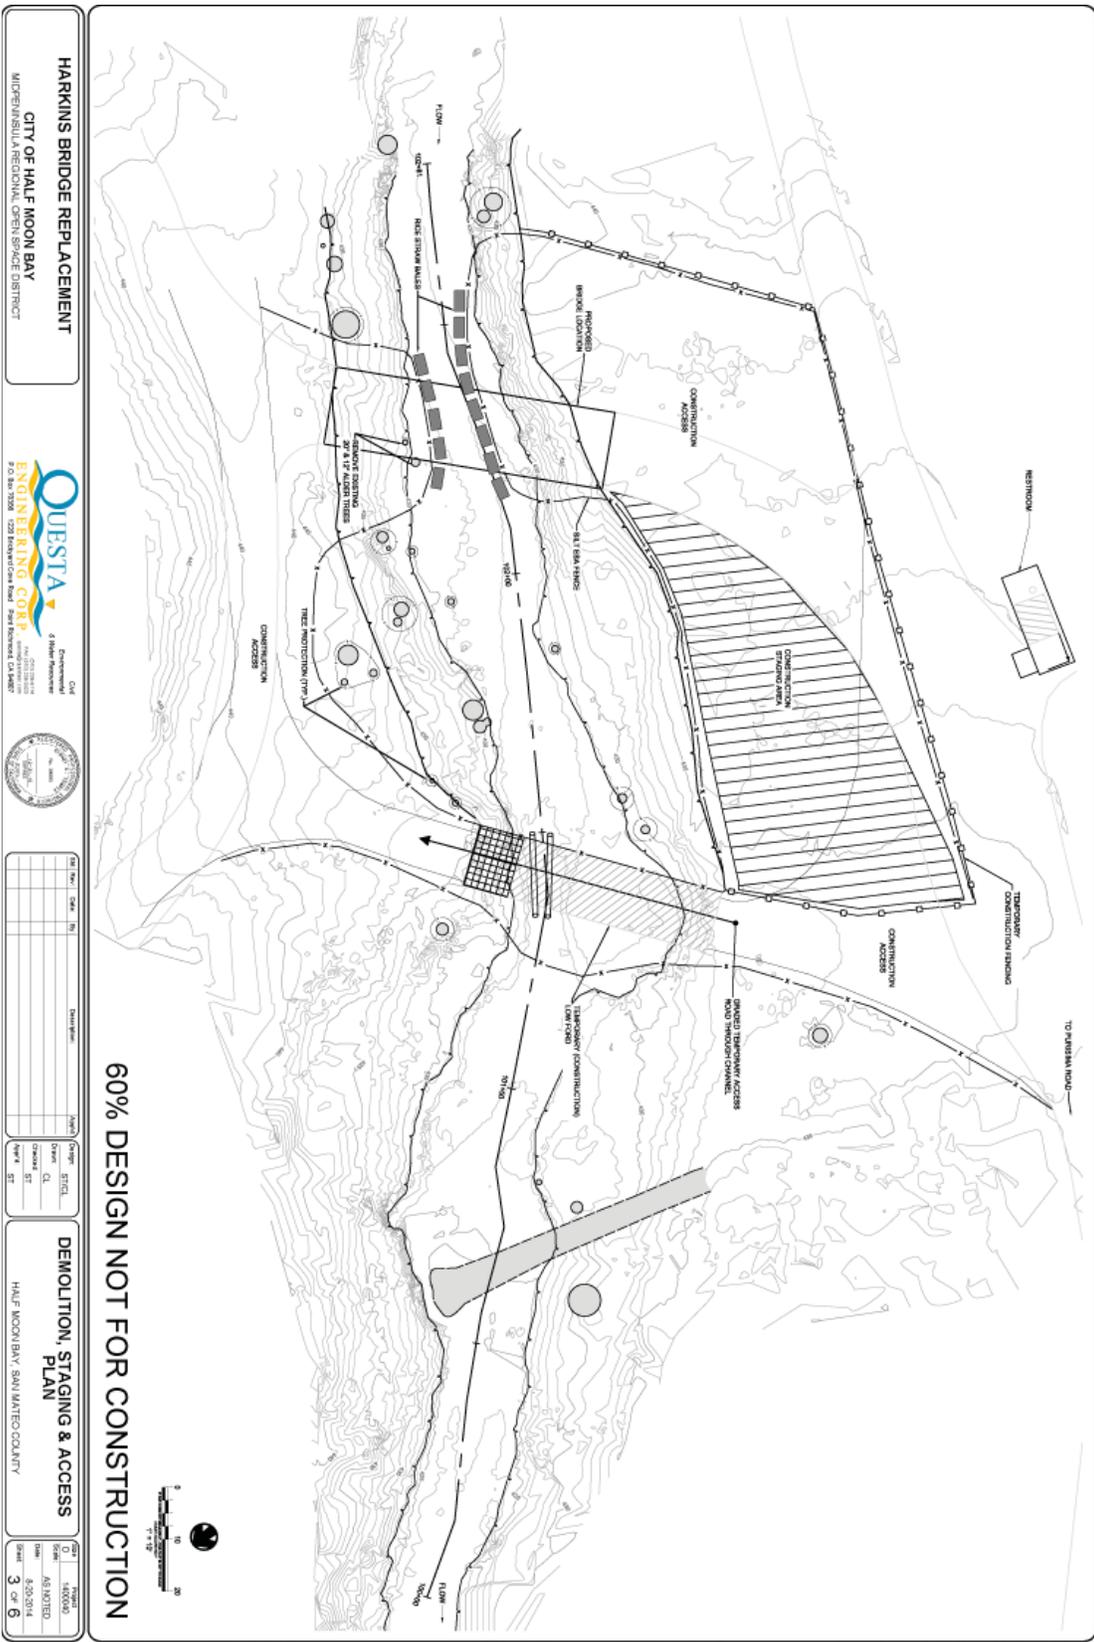
Figure 3: Proposed Bridge

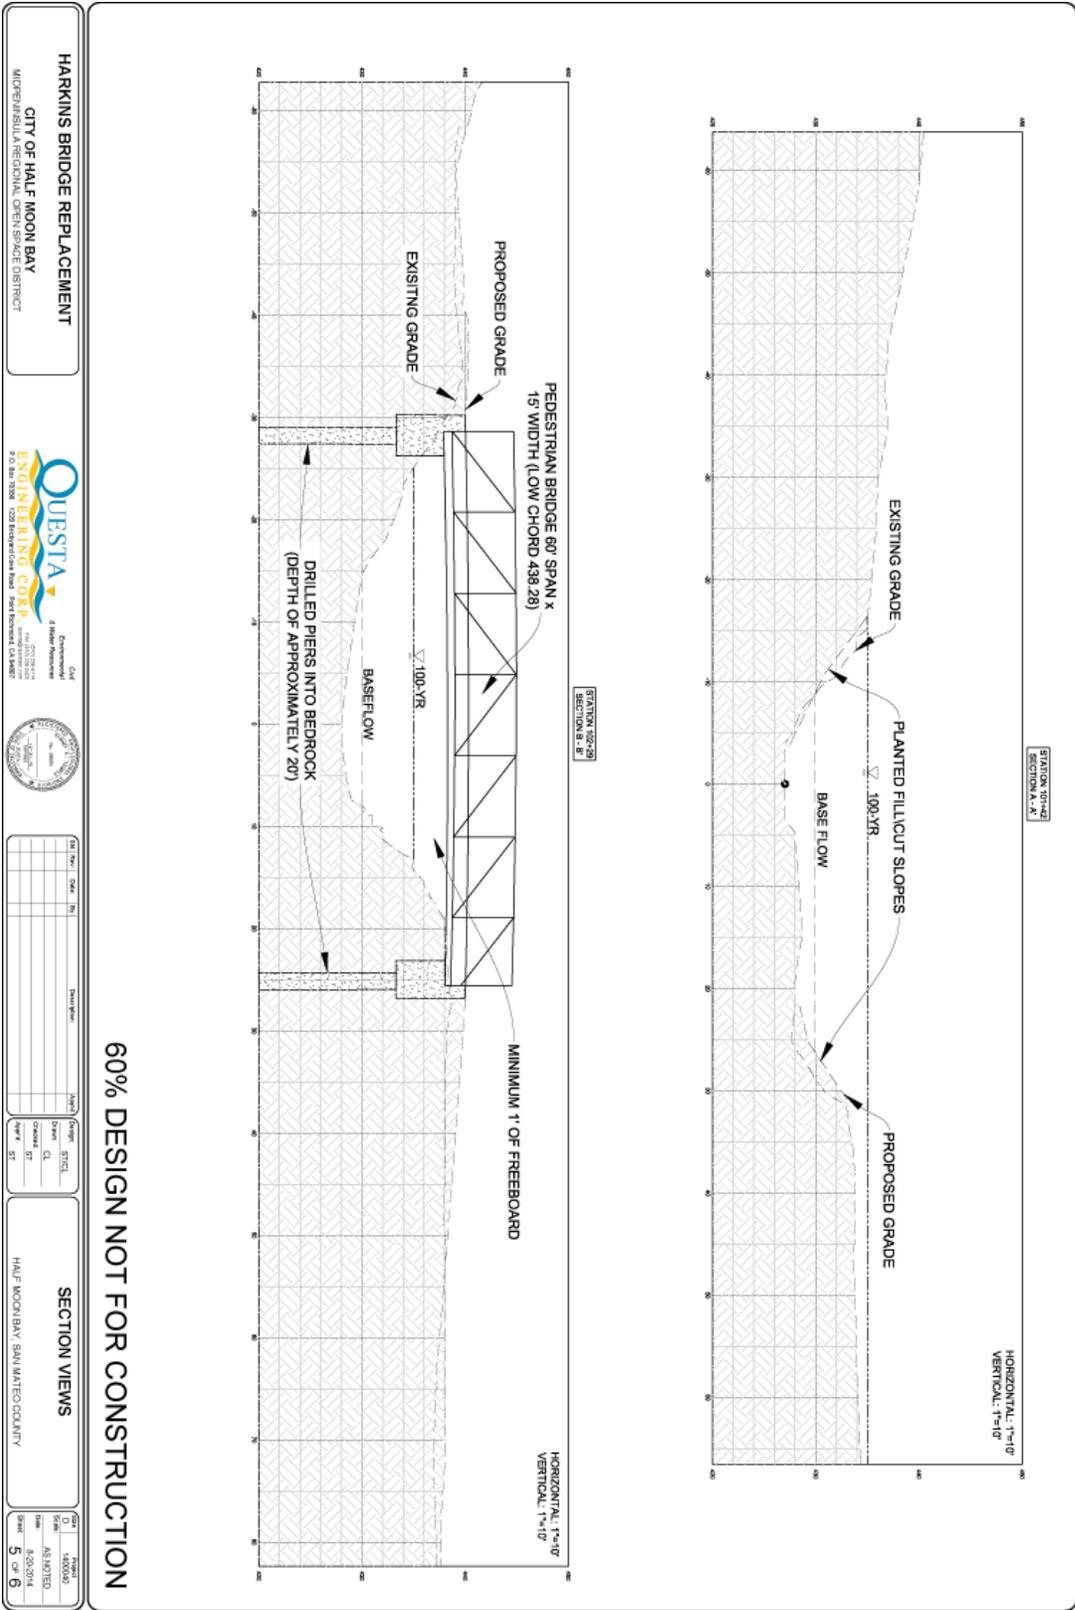
Figure 4: Proposed Bridge Profile

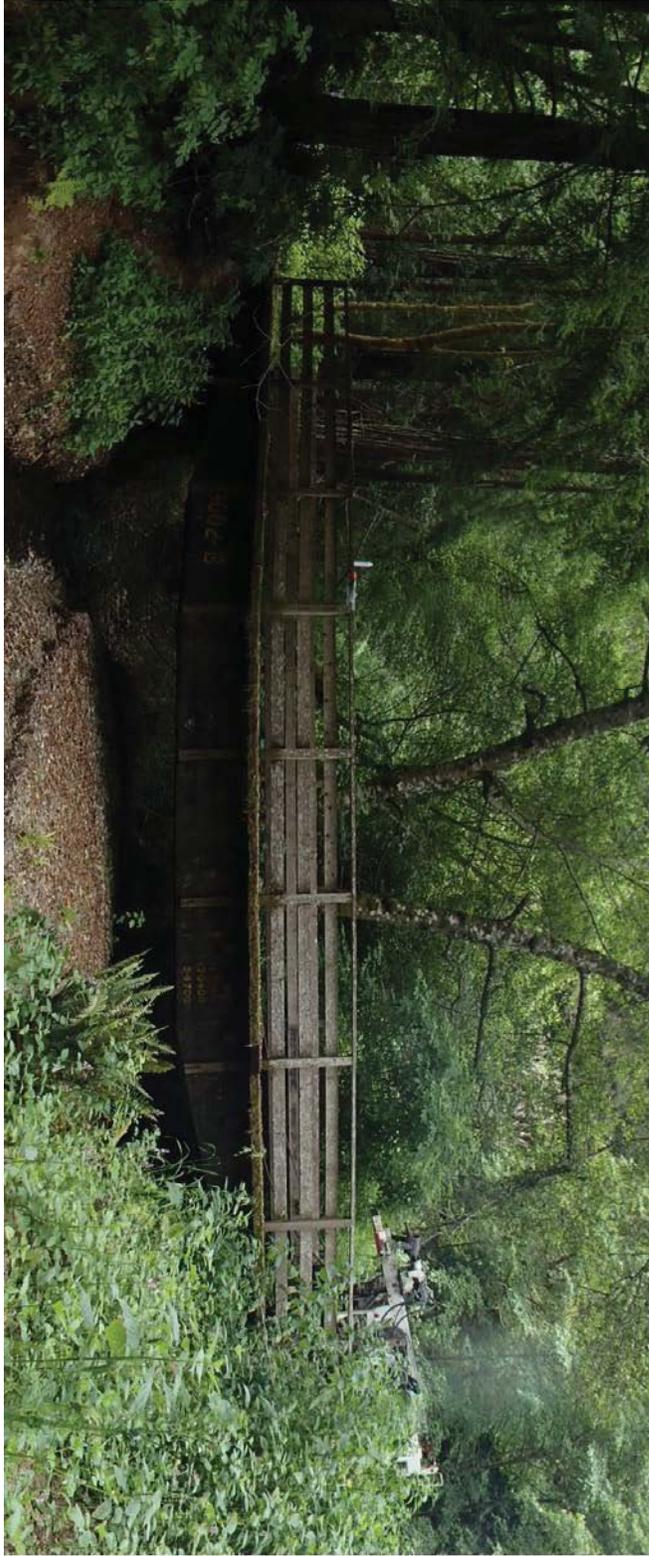
Figure 6: Photo of Existing Bridge Looking Upstream

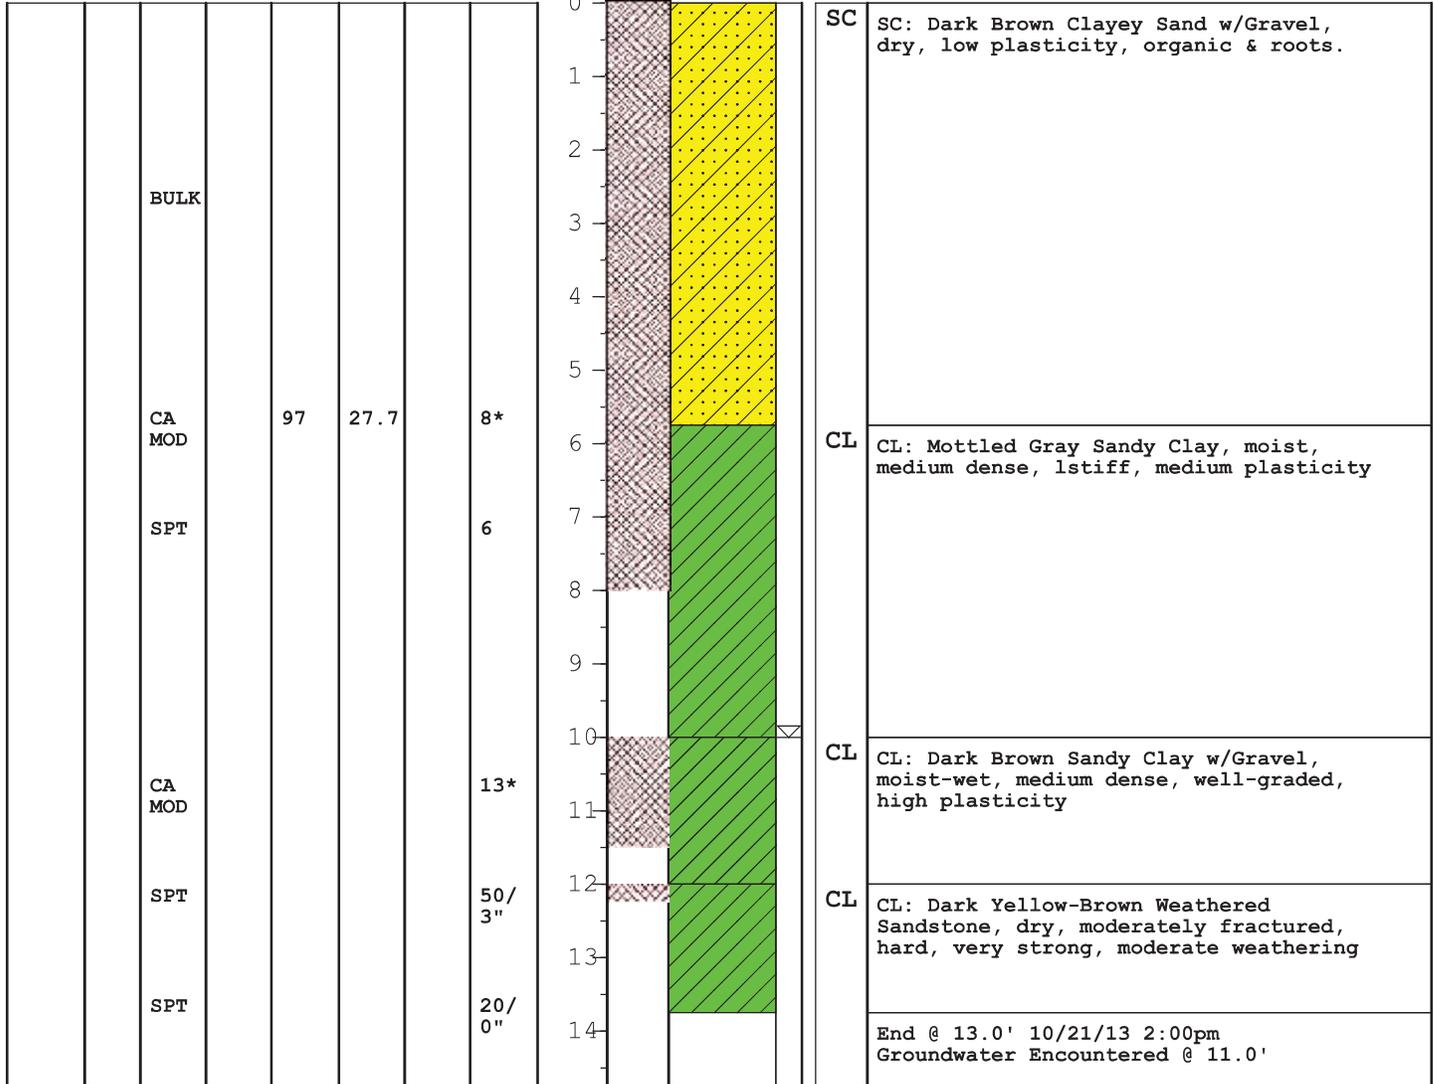
LOG OF BOREHOLE B-3
 Harkins Bridge
 Half Moon Bay, CA

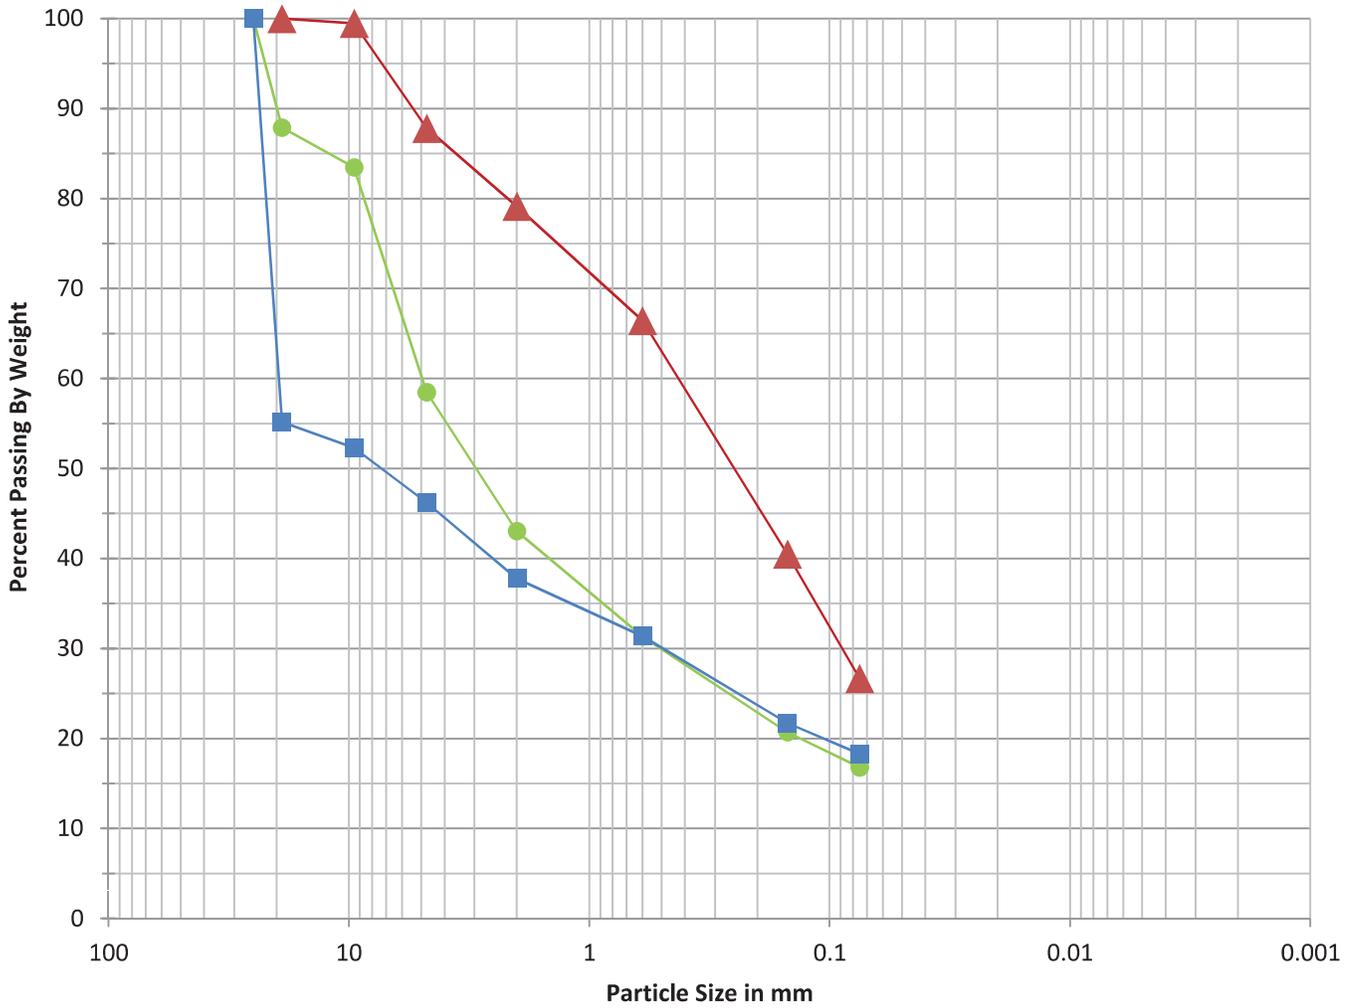
Particle Size Analysis

Symbol	Source
●	B2 at 3'
▲	B2 at 6.5'
■	B-2 at 9-10.5'

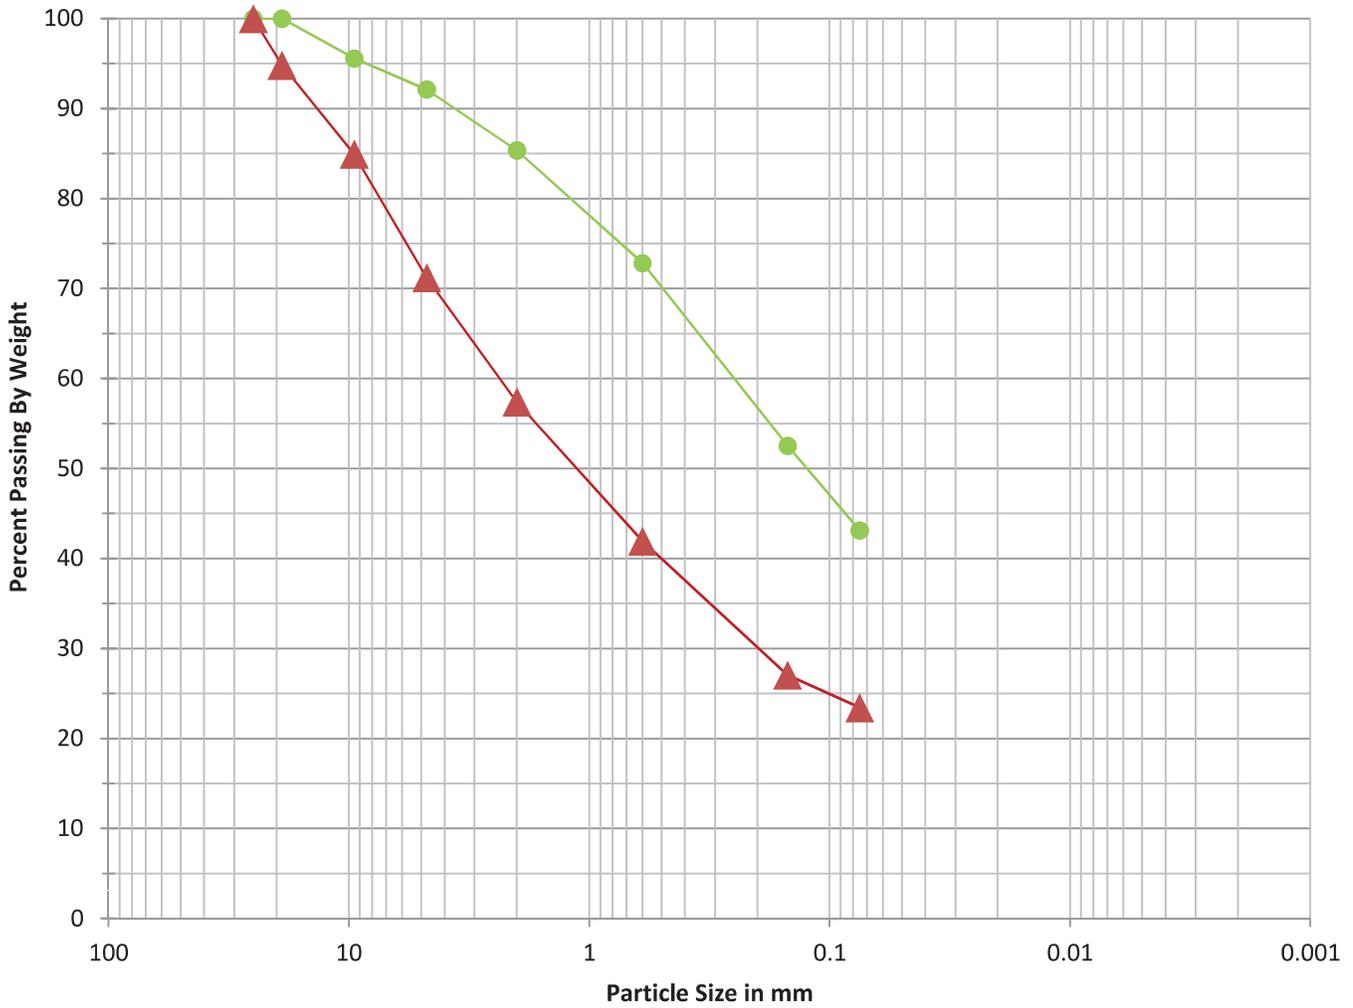
Particle Size Analysis

Symbol	Source
● (Green)	B4 at 4.5-6.0'
▲ (Red)	B4 at 9.5-11.0'
■ (Blue)

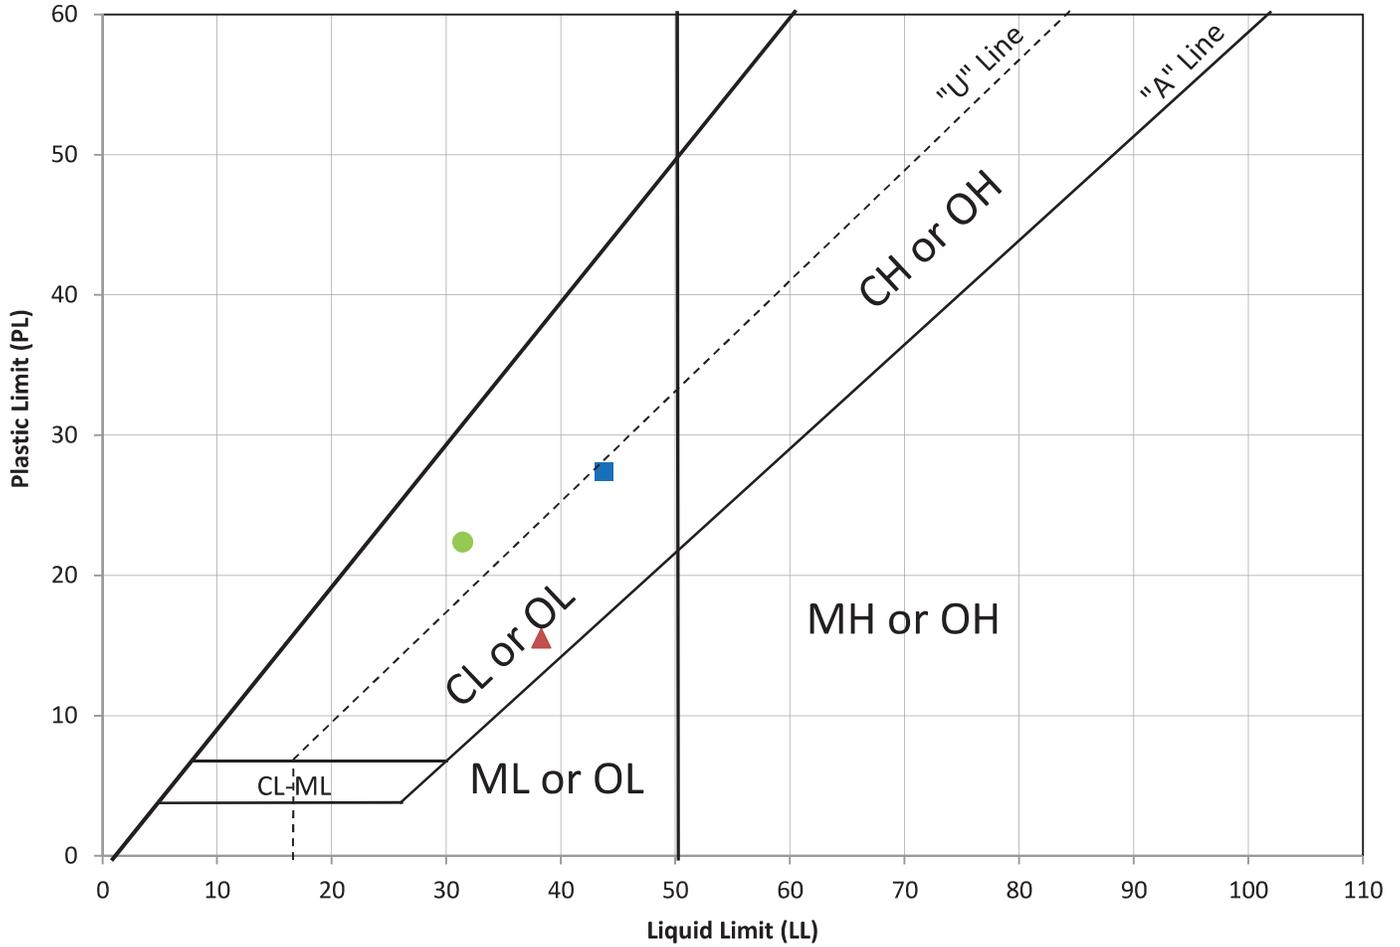
Atterberg Limits

Symbol	Classification & Source	Liquid Limit	Plastic Limit	Plasticity Index	% Passing #200 Sieve
●	B4 at 4.5-6.0'	31	22	9	42.9
▲	B4 at 9.5-11.0'	38	16	23	23.4
■	B2 at 6.5'	44	27	16	26.7

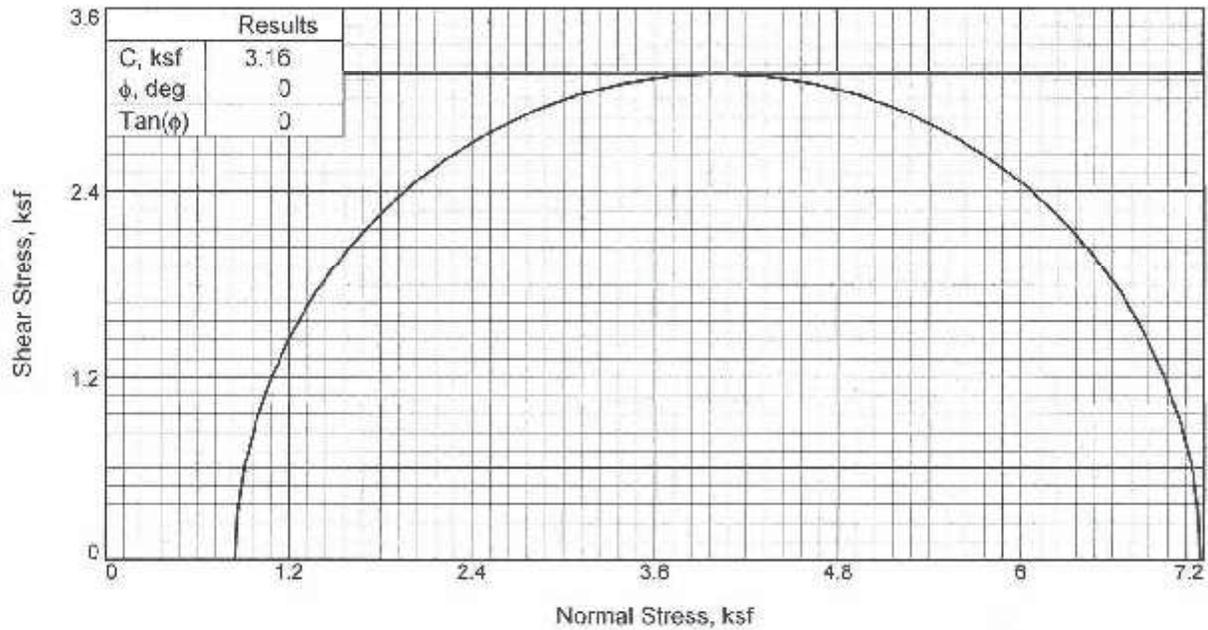
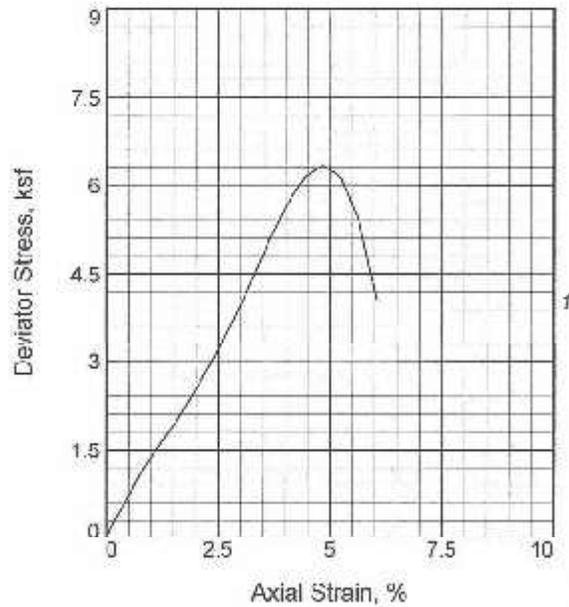
Sample No.	1	
Initial	Water Content, %	18.8
	Dry Density, pcf	103.5
	Saturation, %	80.5
	Void Ratio	0.6293
	Diameter, in.	2.42
At Test	Height, in.	4.96
	Water Content, %	18.8
	Dry Density, pcf	103.5
	Saturation, %	80.5
	Void Ratio	0.6293
	Diameter, in.	2.42
	Height, in.	4.96
	Strain rate, in./min.	0.08
	Back Pressure, psi	0.00
	Cell Pressure, psi	5.90
Fail. Stress, ksf	6.33	
Ult. Stress, ksf		
σ_1 Failure, ksf	7.18	
σ_3 Failure, ksf	0.85

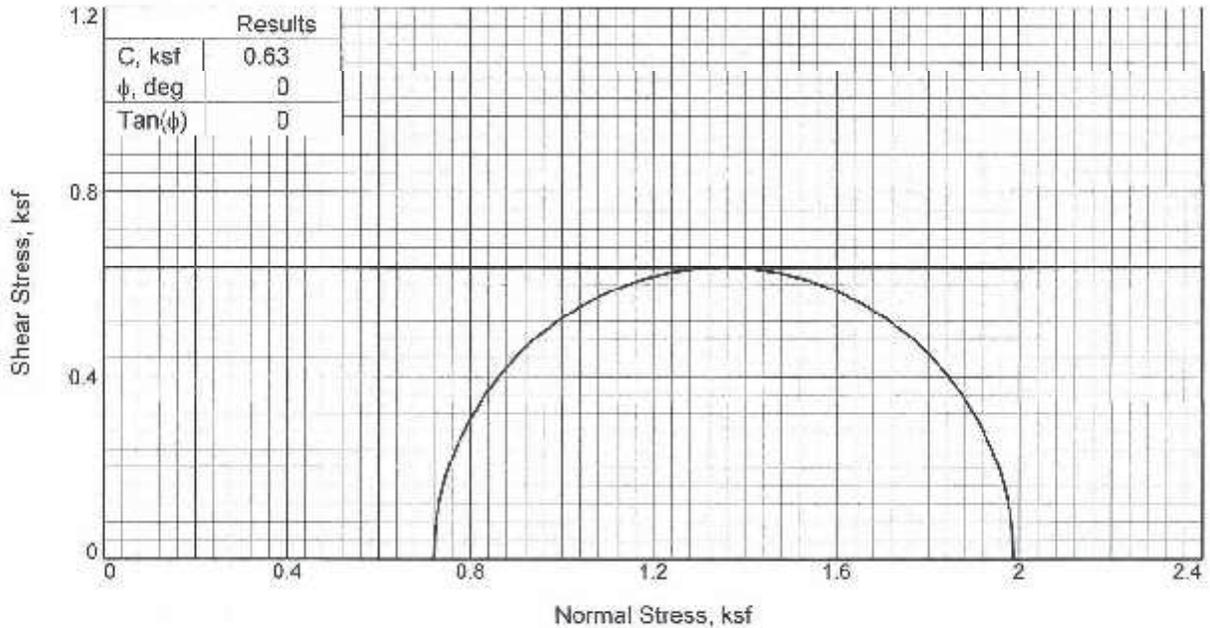
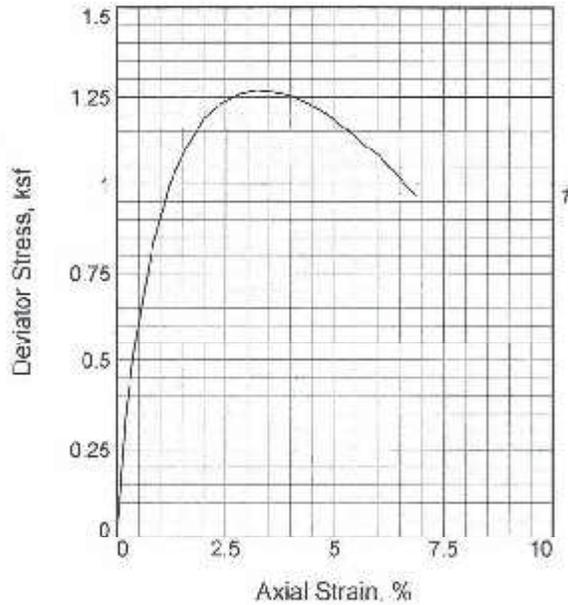
Sample No.	1	
Initial	Water Content, %	27.2
	Dry Density, pcf	94.8
	Saturation, %	94.2
	Void Ratio	0.7785
	Diameter, in.	2.42
	Height, in.	4.97
At Test	Water Content, %	27.2
	Dry Density, pcf	94.8
	Saturation, %	94.2
	Void Ratio	0.7785
	Diameter, in.	2.42
	Height, in.	4.97
Strain rate, in./min.	0.08	
Back Pressure, psi	0.00	
Cell Pressure, psi	5.00	
Fail. Stress, ksf	1.27	
Ult. Stress, ksf		
σ_1 Failure, ksf	1.99	
σ_3 Failure, ksf	0.72

Type of Test:
Unconsolidated Undrained

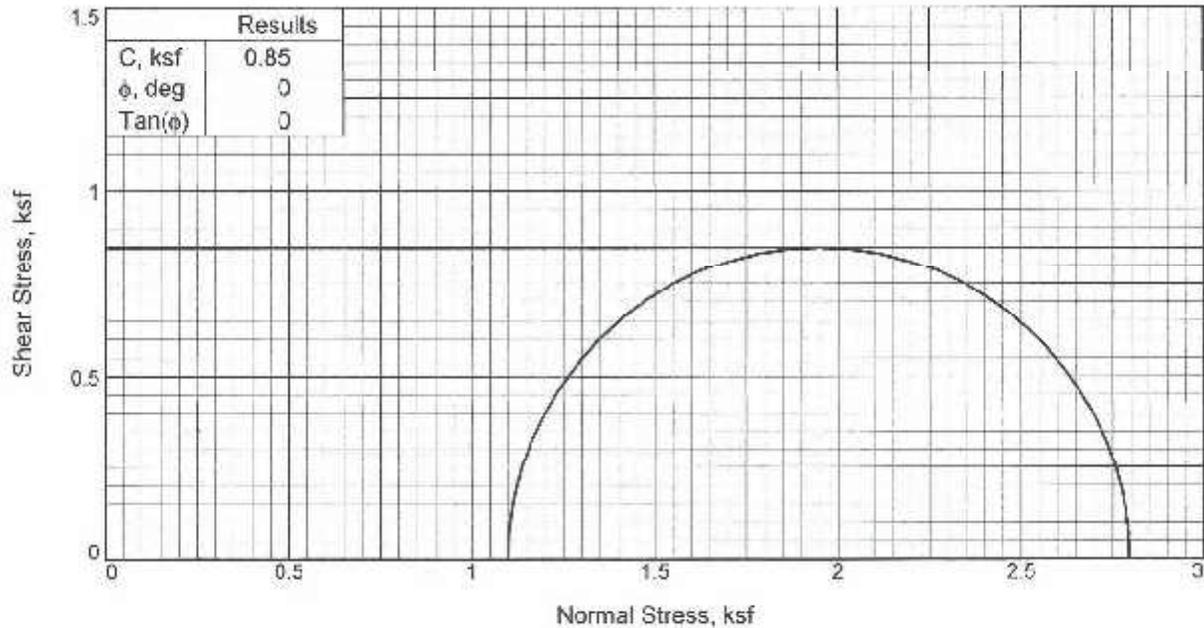
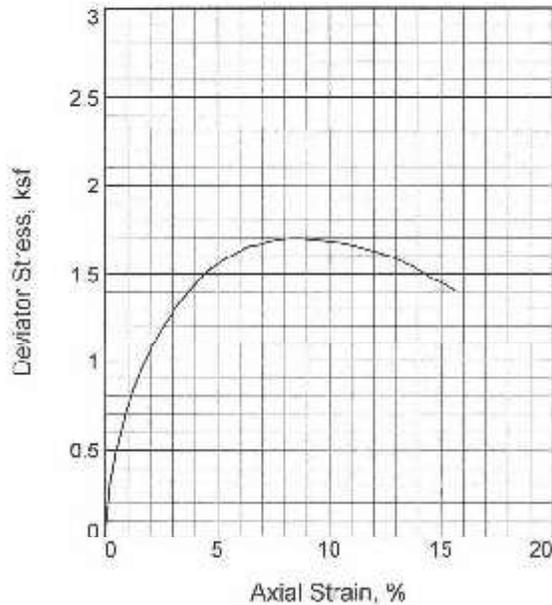
Sample No.	1	
Initial	Water Content, %	25.3
	Dry Density, pcf	96.0
	Saturation, %	90.3
	Void Ratio	0.7558
	Diameter, in.	2.42
At Test	Height, in.	4.36
	Water Content, %	28.0
	Dry Density, pcf	96.0
	Saturation, %	100.0
	Void Ratio	0.7558
Diameter, in.	2.42	
Height, in.	4.36	
Strain rate, in./min.	0.08	
Back Pressure, psi	0.00	
Cell Pressure, psi	7.63	
Fail. Stress, ksf	1.70	
Ult. Stress, ksf		
σ_1 Failure, ksf	2.80	
σ_3 Failure, ksf	1.10

Type of Test:
Unconsolidated Undrained
Sample Type: Mod. Cal.
Description: Stiff, dark gray sandy CLAY (CL).

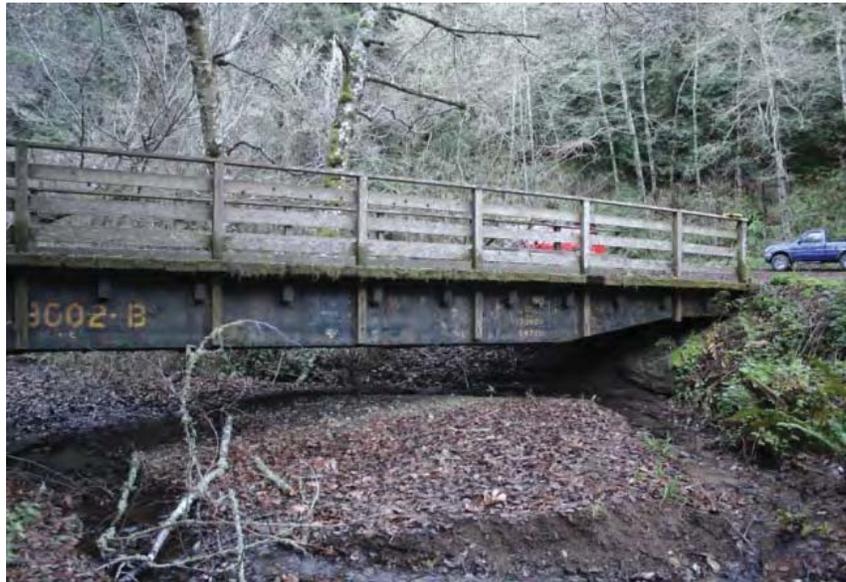
From the previous inspection report done in 2012: “The steel substructure, runners and transverse beams, are in extremely poor condition and are an immediate hazard to vehicle traffic. Some elements have rusted completely away and have fallen off. There is an elevated risk of a heavily loaded wheel penetrating through the deck due to these deficiencies. The girders appear in medium-poor condition with significant rust and degradation. They are of sufficient size, however, that

they still have plenty of capacity to support even the heaviest highway trucks, HS20 loading. It is questionable whether or not abutments exist under the girder ends – none were observed. It is possible that the girders are placed directly on soil. Regardless, this system appears to be functioning adequately.

The load capacity of this bridge is limited by the poor condition of the substructure (steel runners and transverse beams.) Until these items are replaced or repaired, we suggest that the maximum load not exceed 6,000 lb. (passenger vehicle or light truck.)”

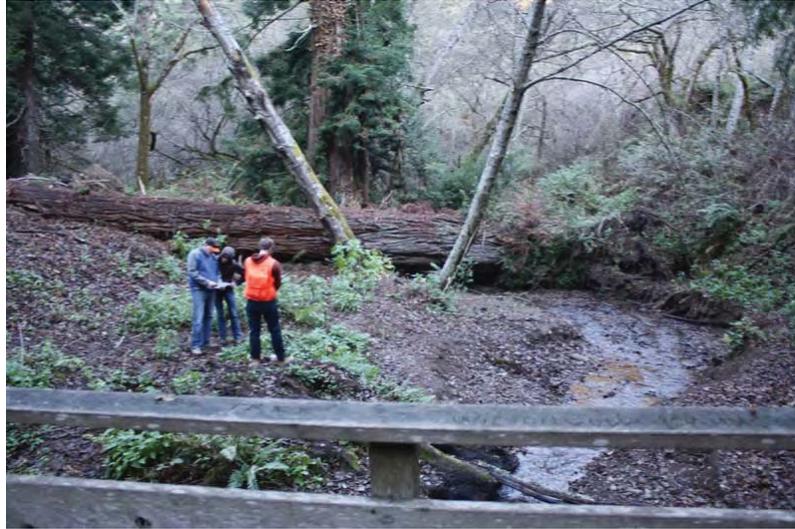
As can be seen in the adjacent photo, there is limited flow capacity underneath the tree ("freeboard") and on the right side which causes high flows to back up upstream. This will cause flooding of the adjacent areas and impact the bridge capacity at high flows.

The fallen tree is also causing sediment to accumulate upstream. Witness accounts estimate recent sediment aggradations of the bed on the order of 2 to 3 feet. It should be noted that falling woody debris and its subsequent geomorphic effects are a natural process of stabilization in this mountainous creek system.

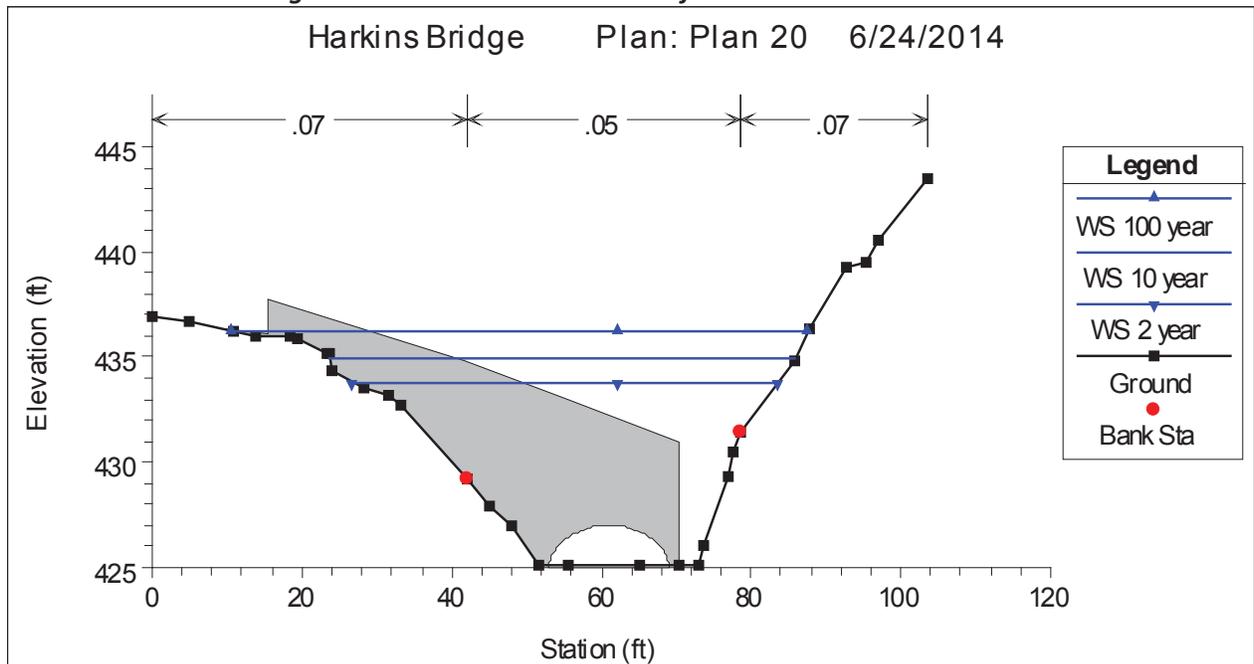
Figure 2. Modeled Cross Section of Downed Redwood Tree

*Note the X-axis scaled ~2:1 to the Y-Axis.
