**COUNTY OF SAN MATEO
PLANNING AND BUILDING DEPARTMENT**

SUBJECT: SUPPLEMENTAL STAFF REPORT: Consideration of a Coastal Development Permit and Timberland Preserve/Coastal Zone Minor Development Permit, pursuant to Sections 6328.4 and 6965 of the County Zoning Regulations, respectively; and a Grading Permit, pursuant to Section 8602 of the County Grading Ordinance; for the removal and replacement of an existing vehicular bridge at a location on Purisima Creek, in the Purisima Creek Redwoods Open Space Preserve. This project is appealable to the California Coastal Commission.

County File Number: PLN 2015-00006
(Mid-Peninsula Regional Open Space District)

HARKINS BRIDGE REPLACEMENT PLAN

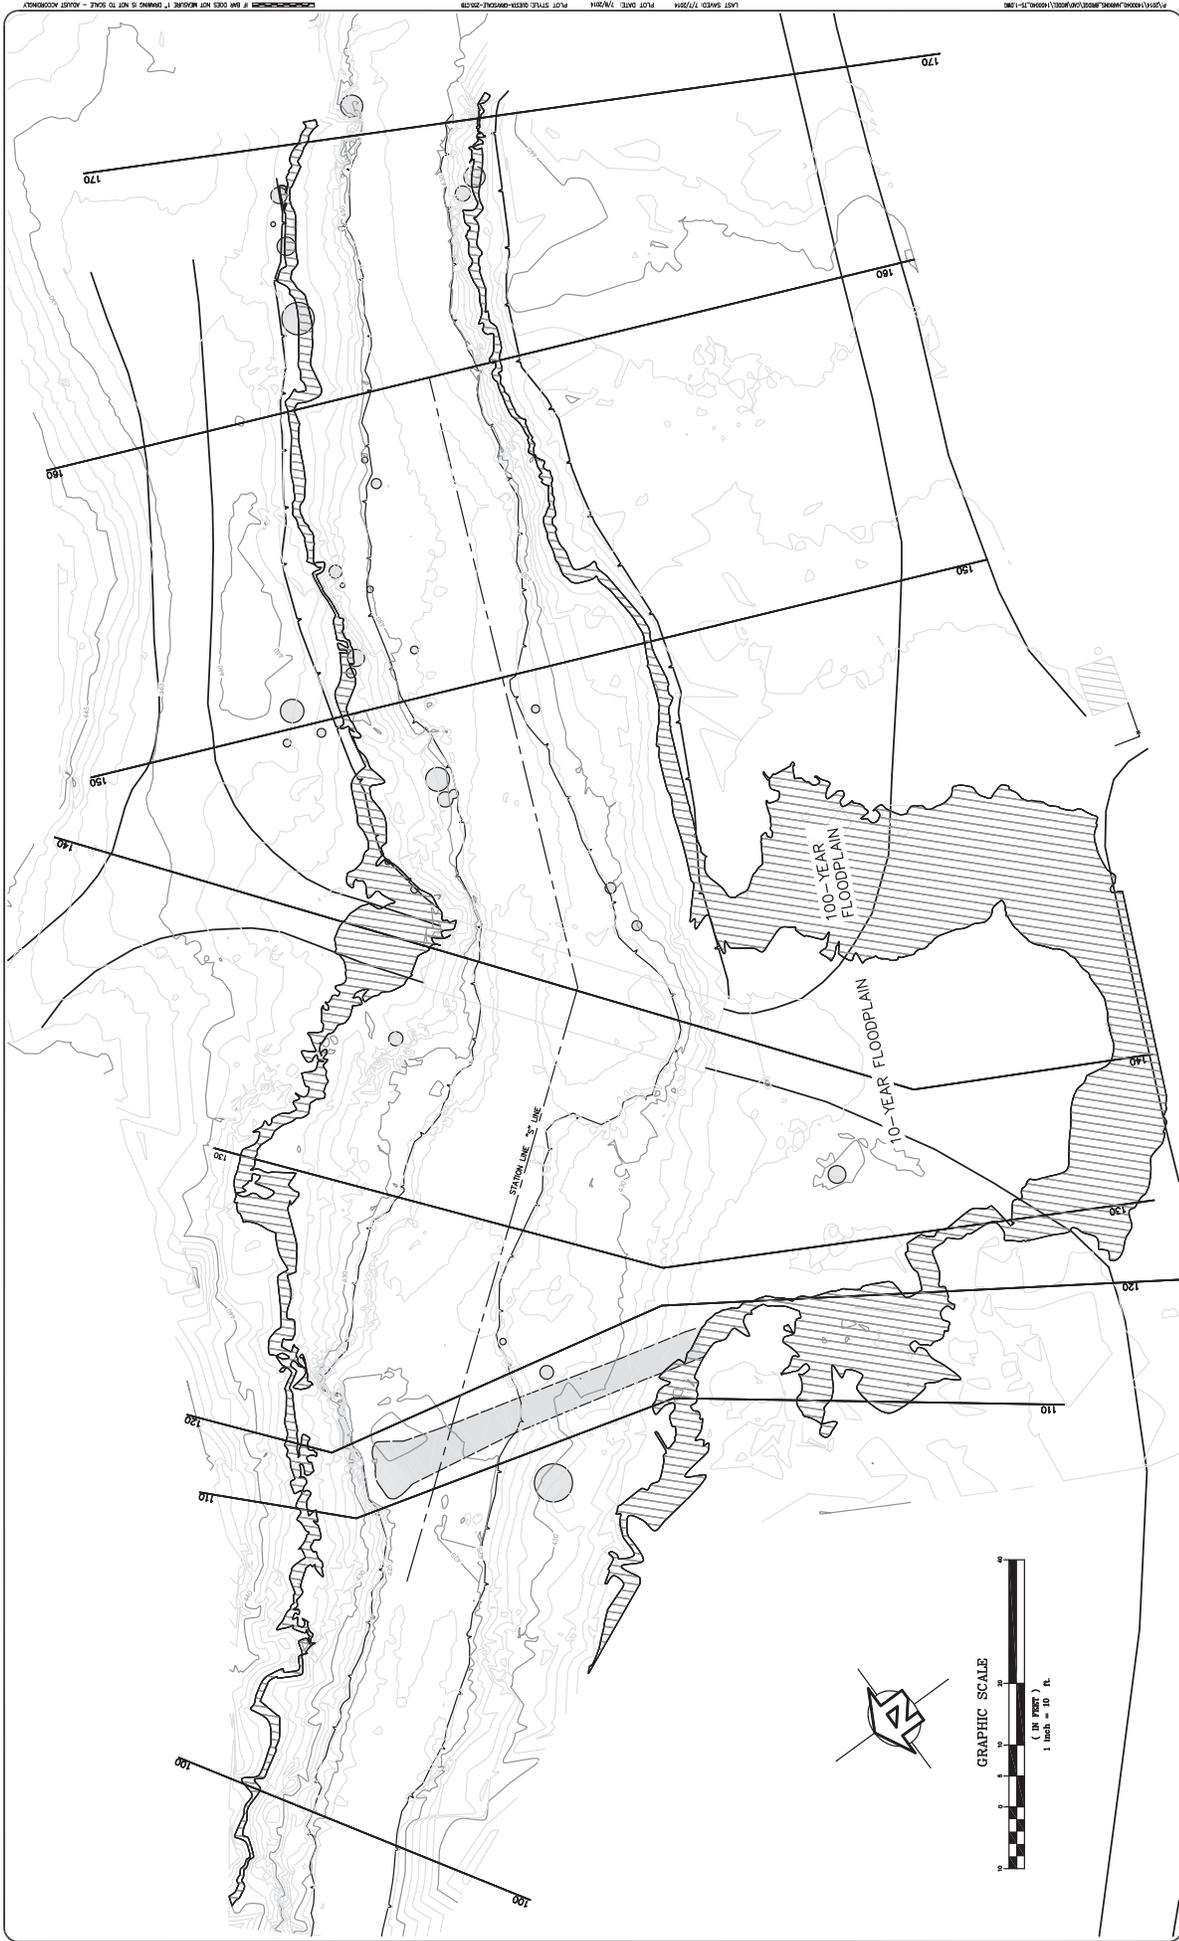
**PURISIMA CREEK
10 & 100 YEAR FLOODPLAINS**
PURISIMA CREEK, SAN MATEO COUNTY

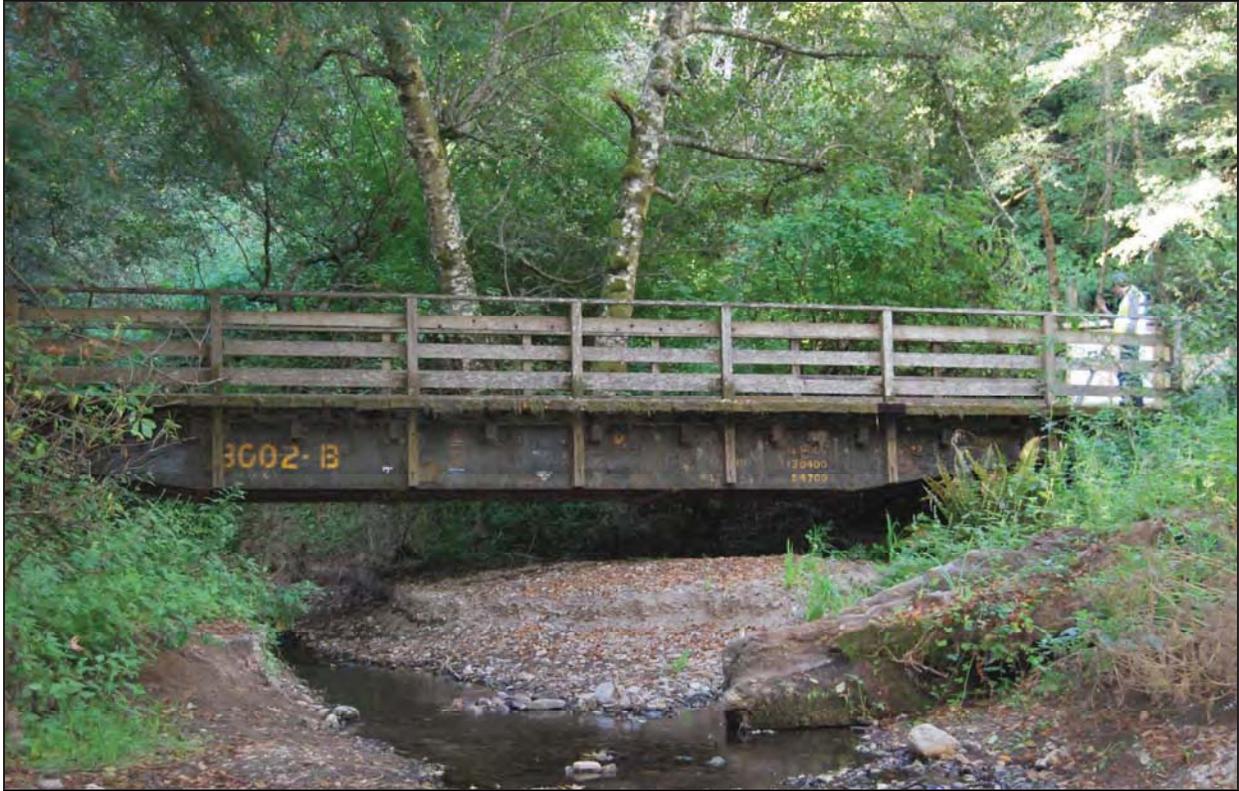
Figure 5: Harkins Bridge, view east

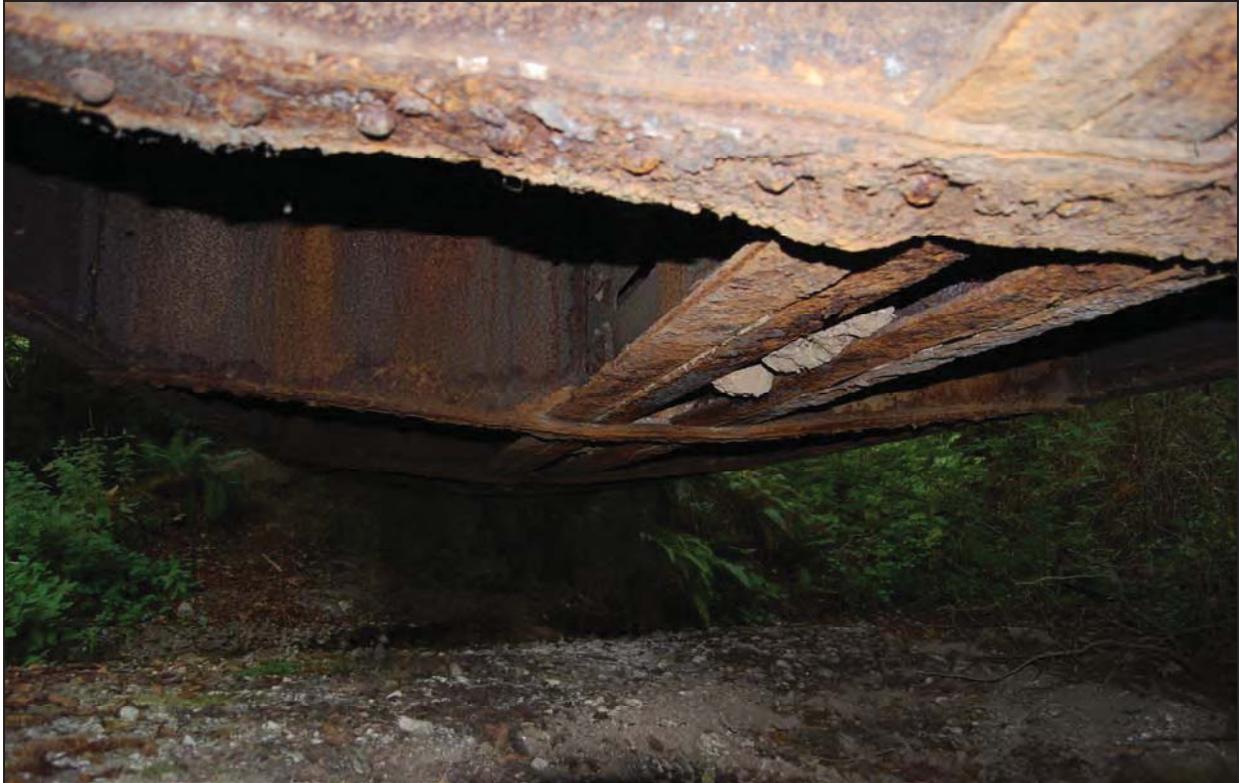
Figure 6: Harkins Bridge, redundant box girder and stringers

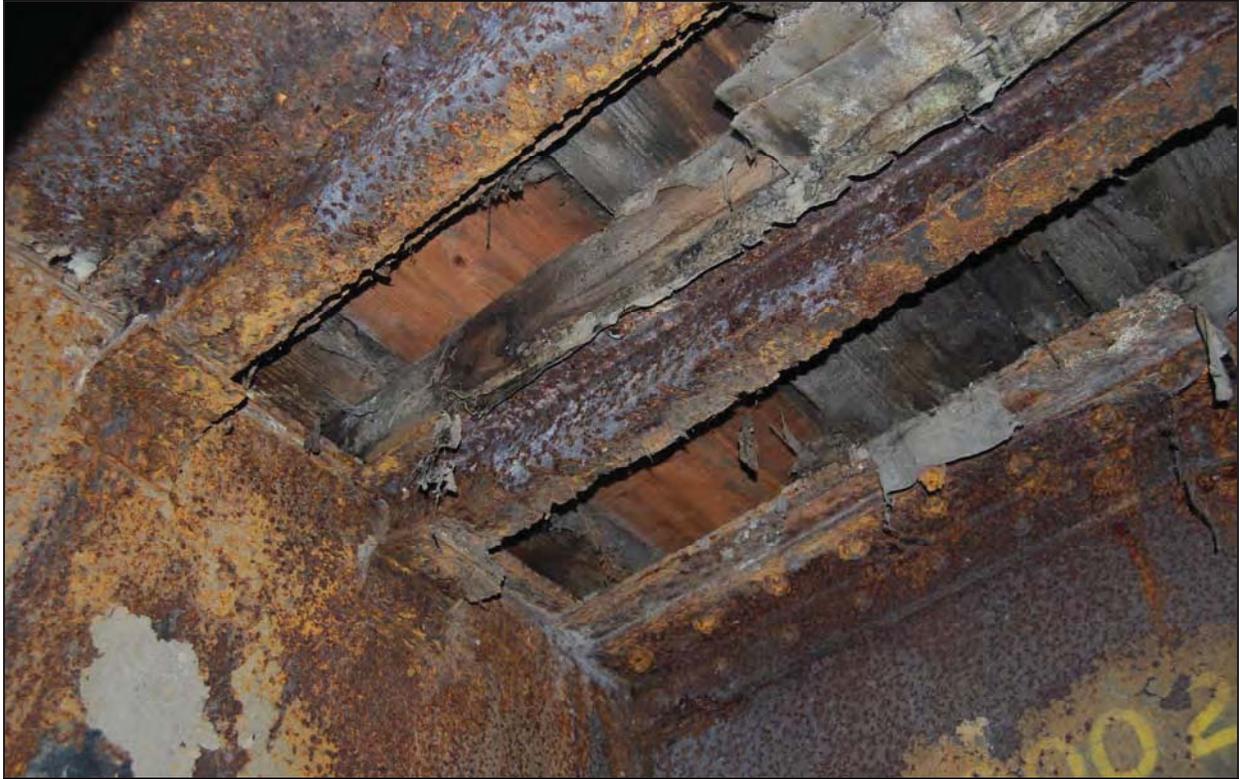
Figure 7: Harkins Bridge floor beams, exterior girder with markings (SP 13002-B)

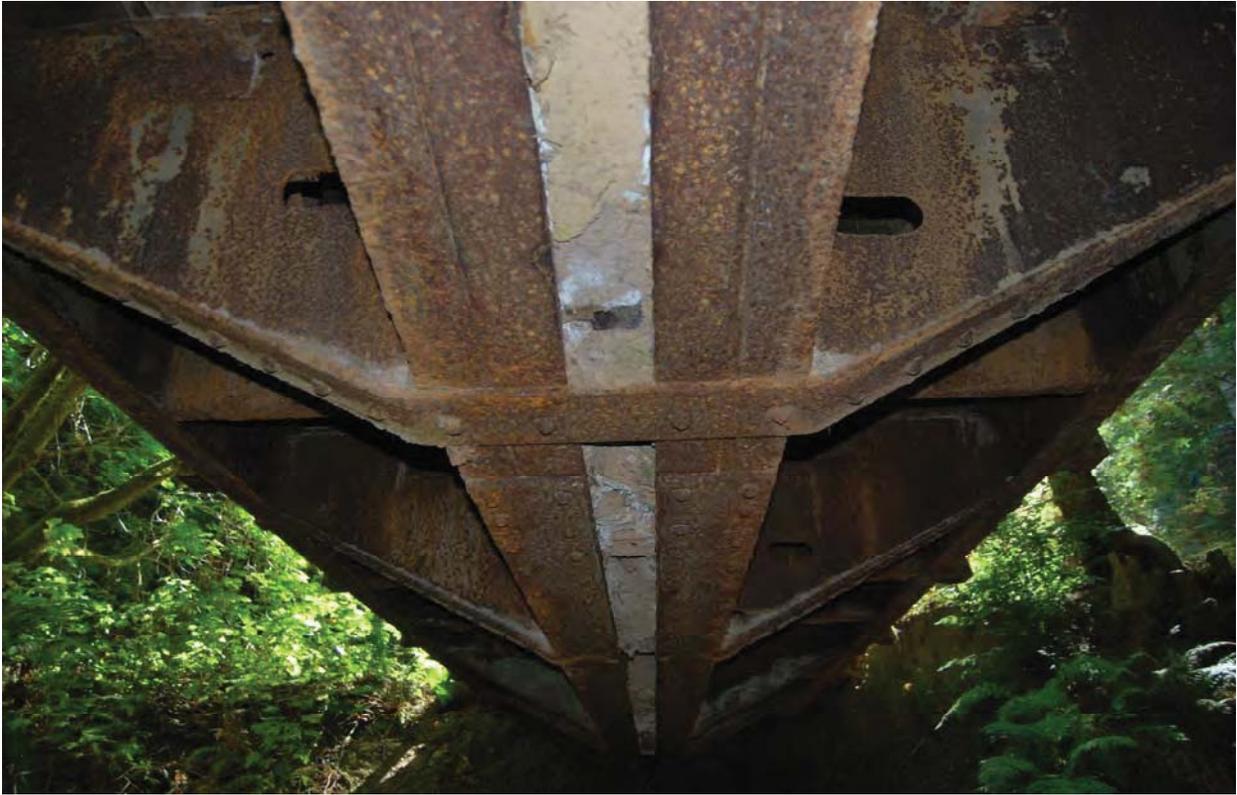
Figure 9: Purisima Bridge 1, view of redundant main box girder and stringers

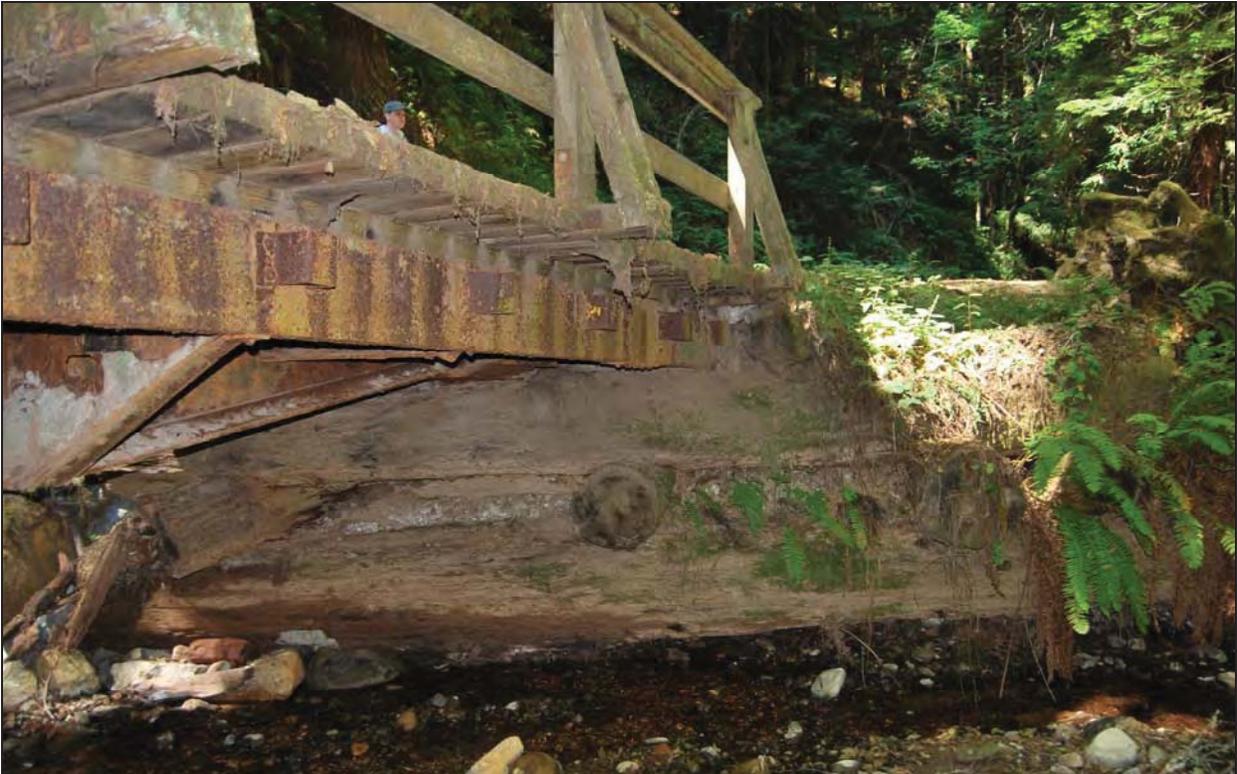
Figure 10: Purisima Bridge 1, view west at redwood abutment

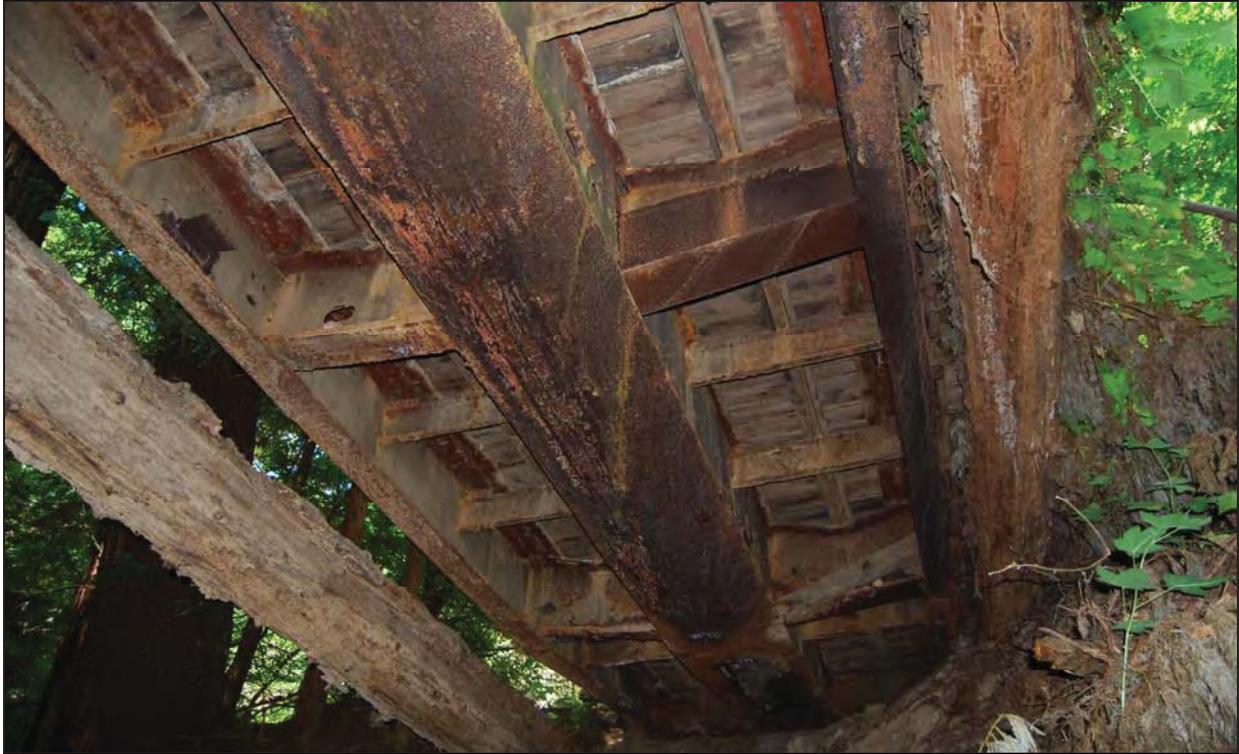
Figure 13: Soda Gulch Bridge, non-redundant main box girder with stringers, exterior girder and floor beams

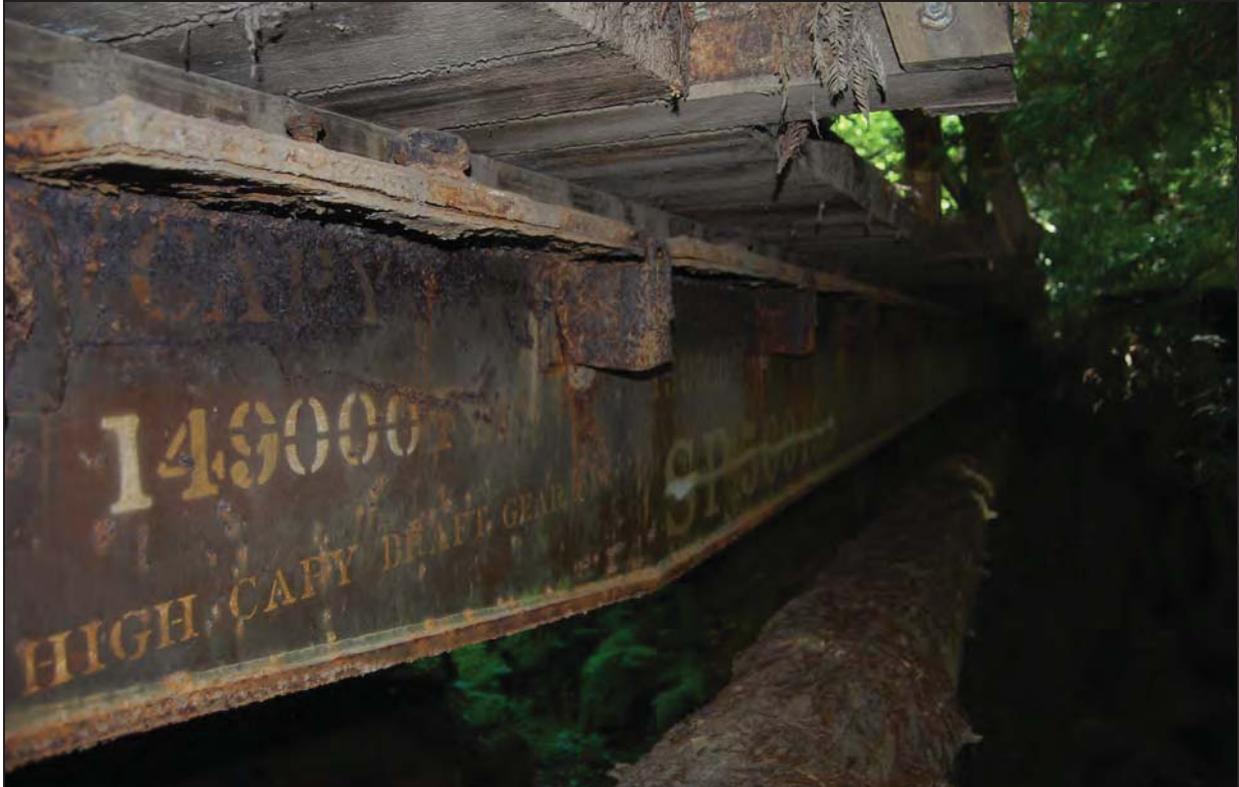
Figure 14: Soda Gulch Bridge, exterior girder with markings (SP 509193)

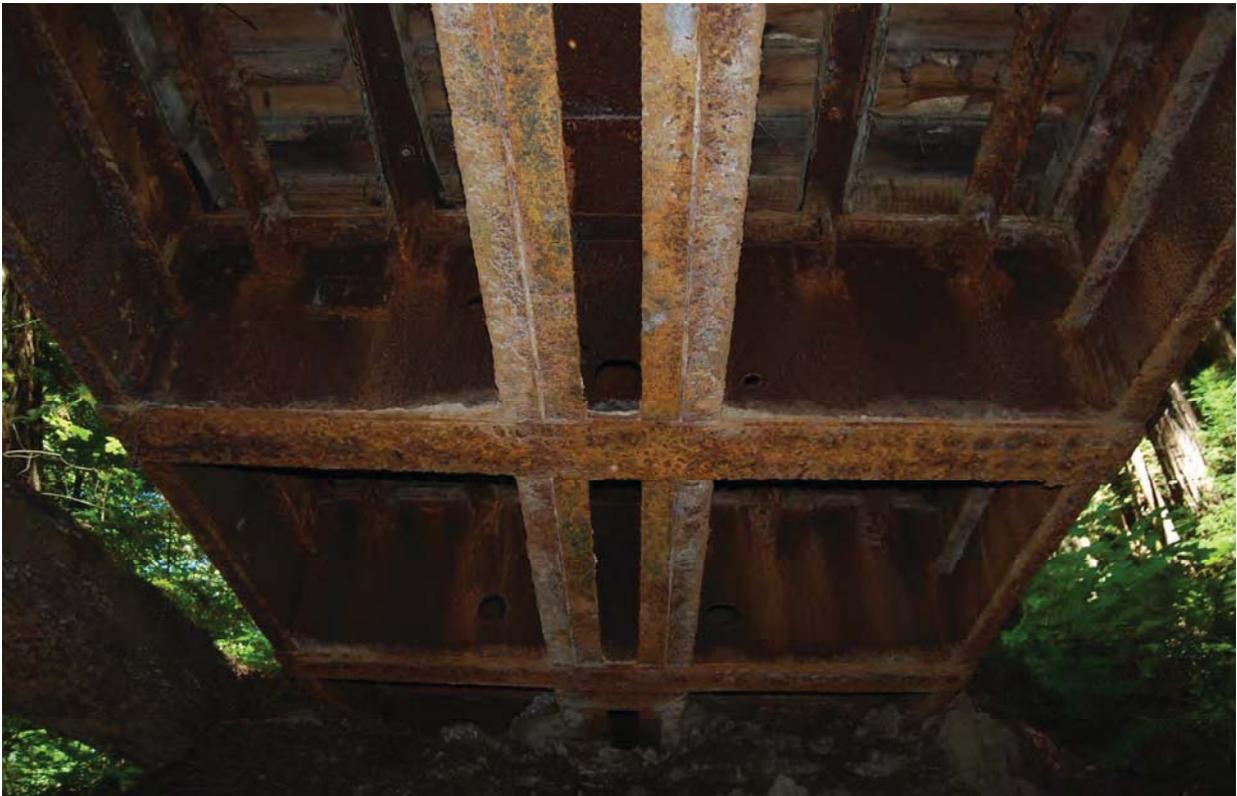
Figure 16: Purisima Bridge 2, redundant main box girder and stringers

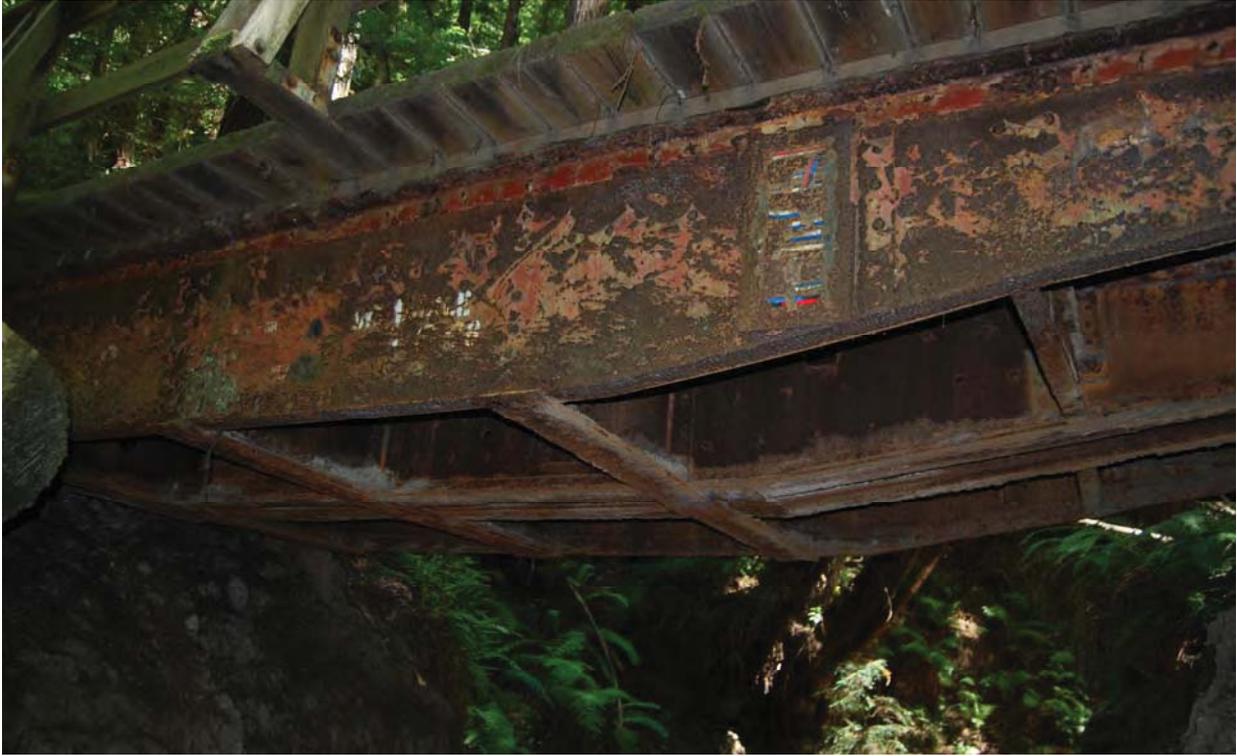
Figure 17: Purisima Bridge 2, view of exterior girders, stringers, and main box girder
